VIE: Ha Noi and Ho Chi Minh City Power Grid
Development Sector Project

SEMI-ANNUAL ENVIRONMENTAL MONITORING REPORT

Period July – December 2016

Loans 3161/8286-VIE: HA NOI AND HO CHI MINH CITY POWER GRID DEVELOPMENT SECTOR PROJECT

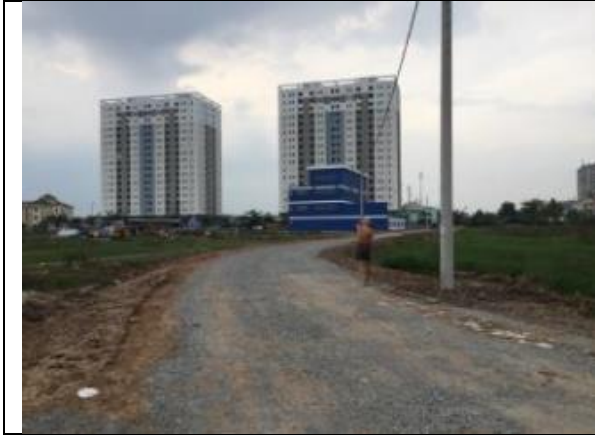
Photo 1: The access road to the new substation has been repaired, upgraded and cleaned

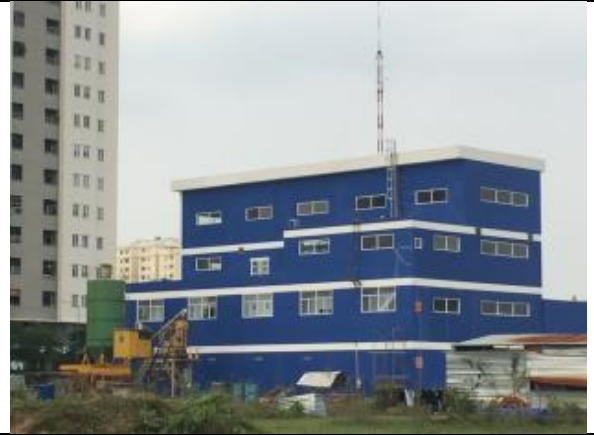
Tham Luong substation has been finished at the end of December 2016. In general the environment rehabilitation process is very good. The access road to the new substation has been repaired, upgraded and cleaned (Photo 1). No remained construction solid waste and unused material at substation area. However, at the back of the substation are still some temporary houses or camp and construction machine that should be uninstalled if they are not used (Photo 2).

Photo 2: A temporary camp should soon be cleared up

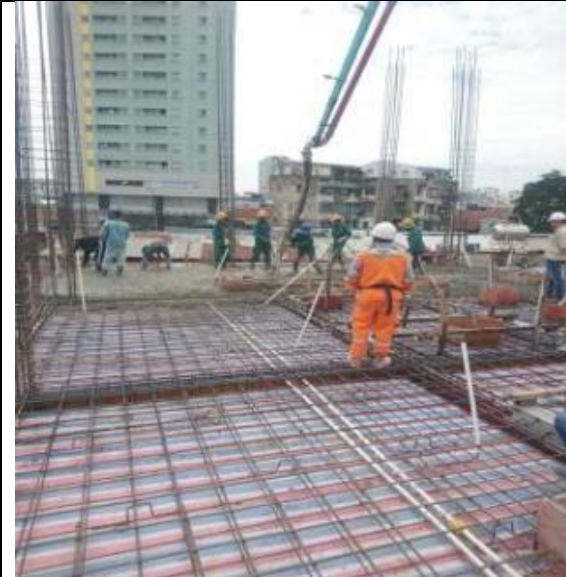
Photo 13: The workers were using proper protective equipment and were provided with satisfactory facilities

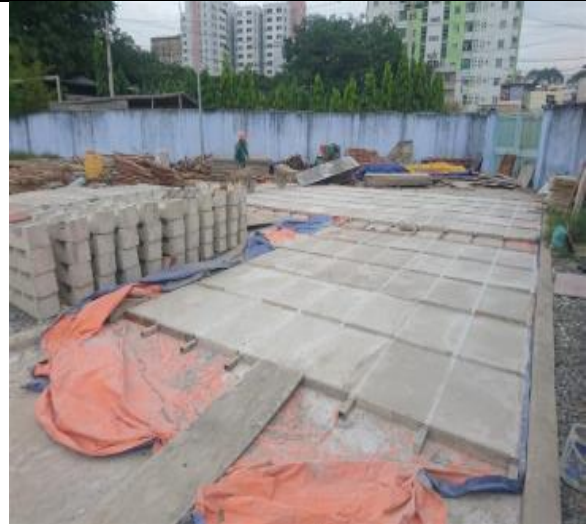
Photo 14: The construction materials are stored or made at separated place in the substation area

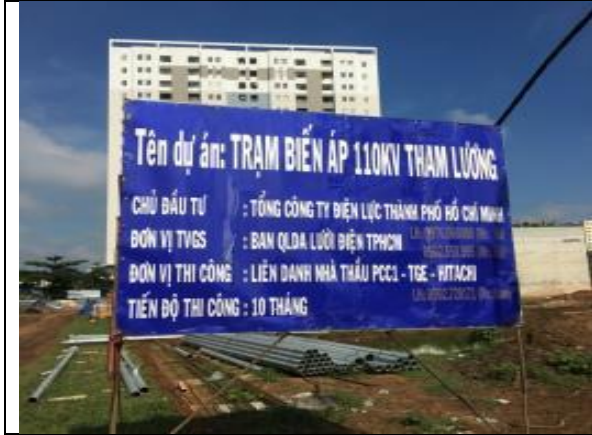
Photo 15: Subproject information board has additional phone numbers of contractors and construction supervision unit

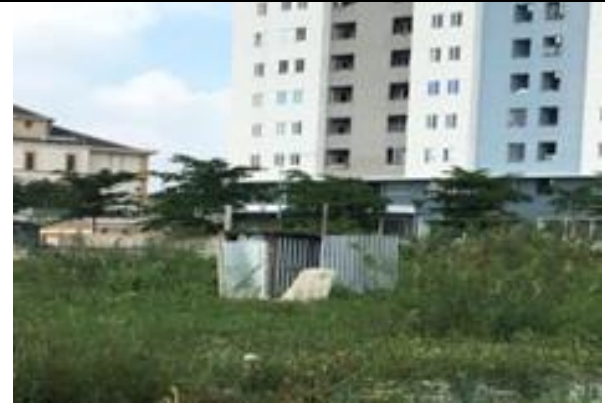
Photo 16: Temporary toilet is installed for workers at construction site

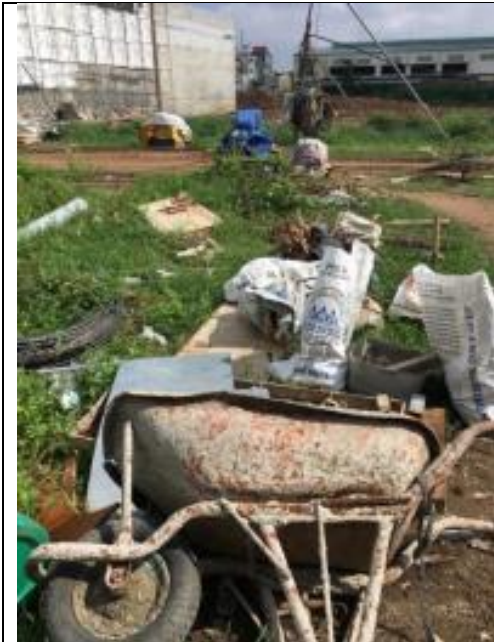
- Construction and domestic solid waste should be collected into dust bin or gathered in one point, not to dispose directly into the surrounding area (**Photo 17, Photo 18**).
- The excavated soil pile should be covered by plastic cloth if it does not be used shortly to prevent dust generation (**Photo 19**),
- A emergency first aid box should be sufficient with medicines but not only cotton (**Photo 20**)
- The list of training participant should be recorded after each training course
- Construction diary should include also the section on environmental safety and environmental hygiene

Photo 17: Construction solid waste is not gathered properly

- Construction and domestic solid waste should be collected into dust bin or gathered in one point, not to dispose directly into the surrounding area
- The excavated soil pile should be covered by plastic cloth if it is not used shortly to prevent dust generation
- An emergency first aid box should be sufficient with medicine but not only cotton
- The list of training participant should be recorded after each training course
- Construction diary should include also the section on environmental safety and environmental hygiene
- Contractors should dismantle/transport away temporary camps and construction machine, if they are not in use

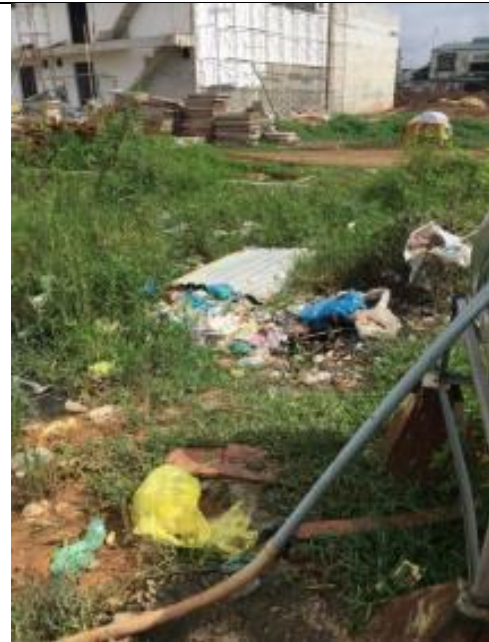
Photo 18: Domestic solid waste is not gathered properly

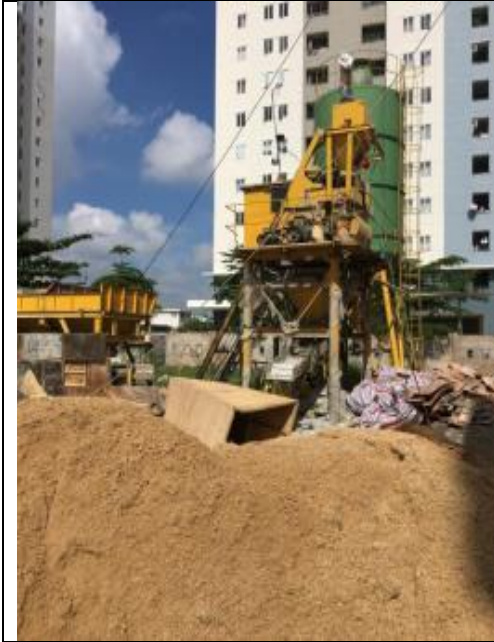
Photo 19: Uncovered excavated soil pile

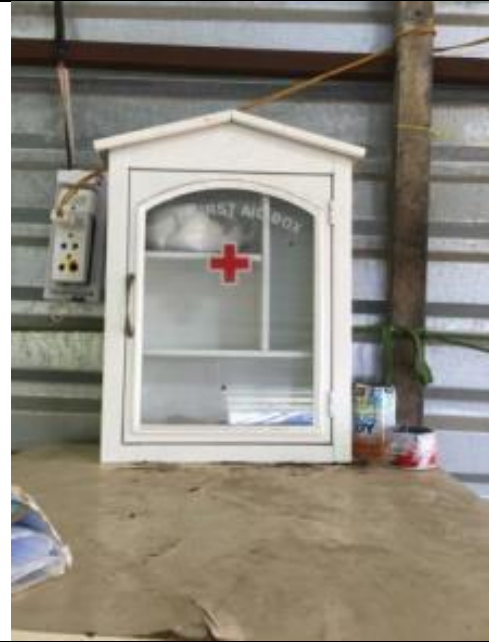
Photo 20: Emergency first aid box has only cotton

8 TL and Medium (No. 3) for the Tham Luong SS, South and Cau Bong-Binh Tan TL because: A emergency first aid kit is insufficient; At one location the iron fences are not fit making large crevice; and the construction workers did not wear working protection equipment while working, respectively.

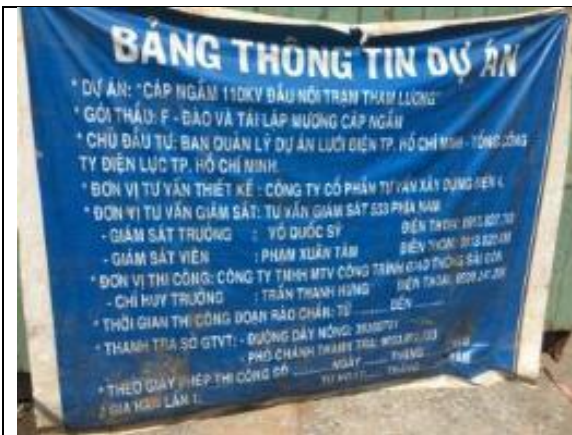
Photo 21: Suproject information board with full information

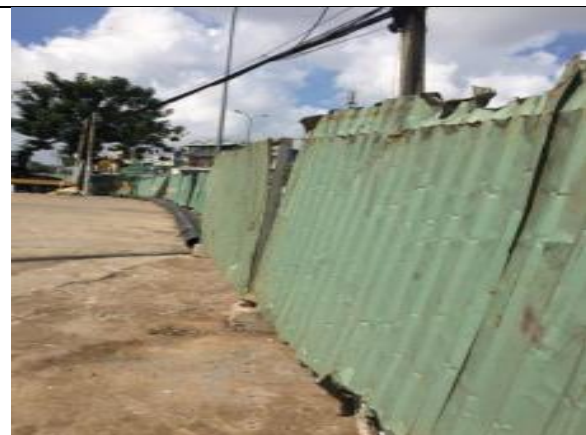
Photo 22: Iron plate fence around the construction area during day time

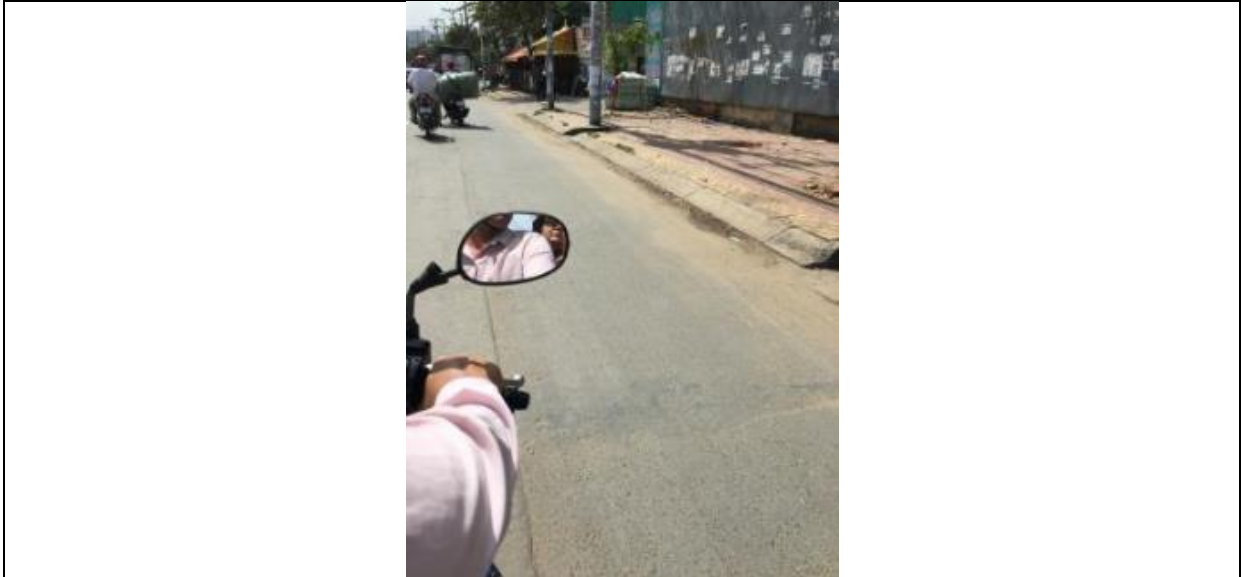
Photo 23: Road is rehabilitated to the original condition after construction finished

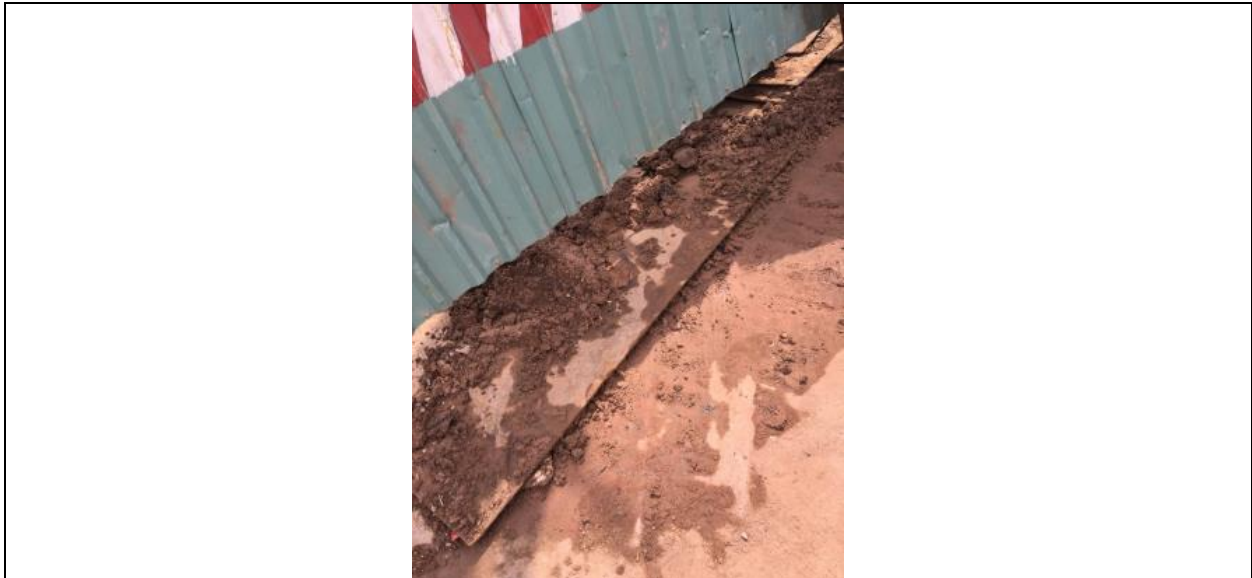
It needs to clean up soil on the road because soil is still spreaded over outside the fence, can drift down the drainage system when it rains.

Photo 24: Soil is not cleaned on the road

Tham Luong underground cable: It needs to clean up soil on the road because soil is still spreaded over outside the fence, can drift down the drainage system when it rains.

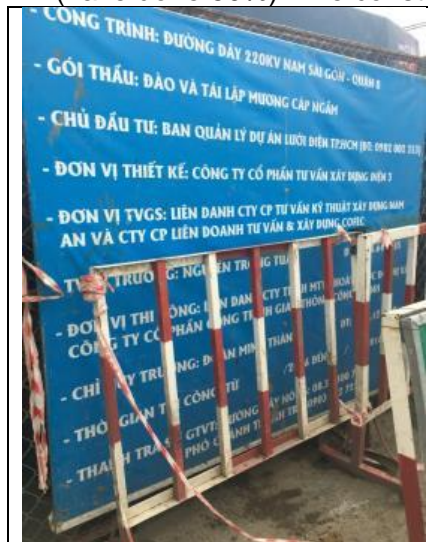
Photo 25: The subproject information board is with full information

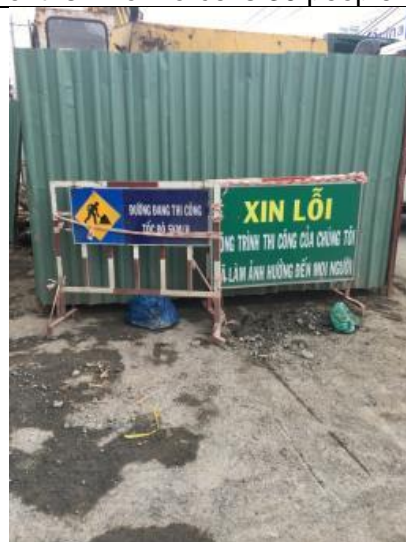
Photo 26: the iron plate fence is surrounding the construction site

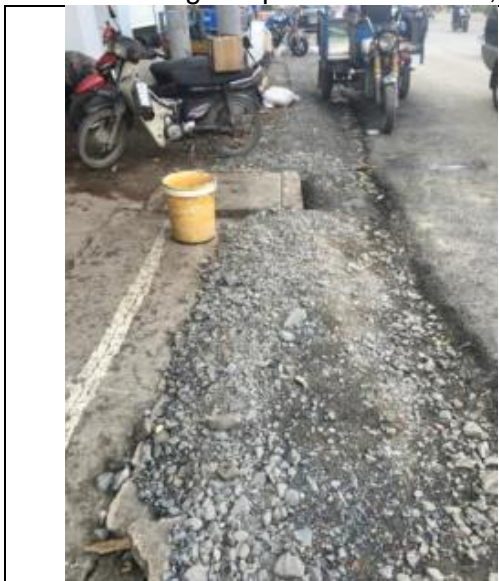
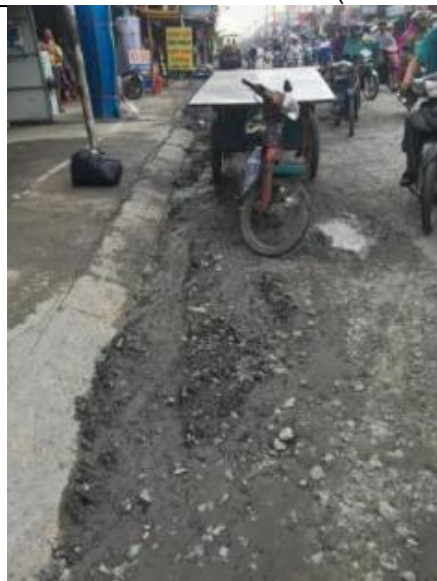
- At the construction site, many road sections are not still completely finished (**Photo 27**).
- Some road sections where commercial shops face at, have not to be recovered yet as the original condition (**Photo 28**).
- At one place, fences are not fit making large crevice (**Photo 29**), kids can squeeze into while inside the fence is deep pit (**Photo 30**) which likely to cause accidents to young children.
- There is a big soil pile without cover, which occurs in front of some houses (**Photo 31**)

<p>Photo 27: A road sections is not still completely finished</p>	<p>Photo 28: A road section where commercial shops face at have yet not to be recovered as the original condition</p>

220KV South Sai Gon-District 8 underground cable: Contractors should rehabilitate road sections after cable installation properly right after construction finished; Contractors should fence properly the dug road section to prevent accidents to small children; Contractors should cover soil pile or place iron plates around it to prevent dust impacting nearby houses

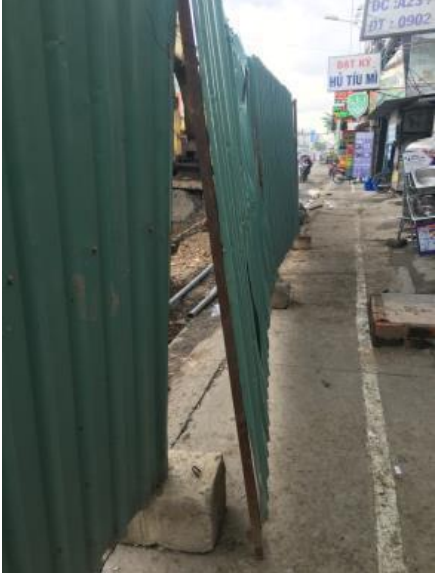
<p>Photo 29: Fences are not fit making large crevice</p>	<p>Photo 30: deep pit is inside the fence</p>

220KV South Sai Gon-District 8 underground cable: At the construction site, many road sections are not still completely finished. At one place, fences are not fit making large crevice kids can squeeze into while inside the fence is deep pit which likely to cause accidents to young children. There is a big soil pile without cover, which occurs in front of some houses.

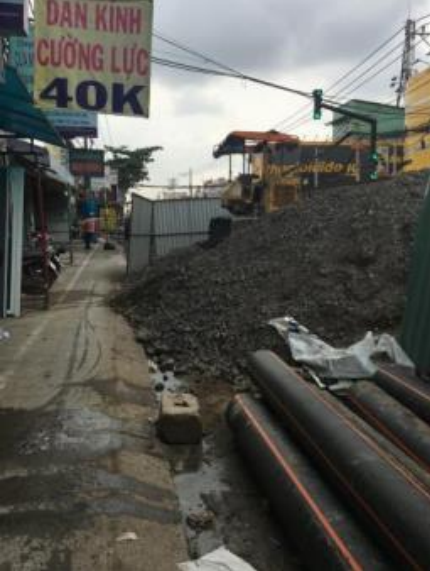
<p>Photo 31: A big soil pile without cover, which occurs in front of several houses</p>

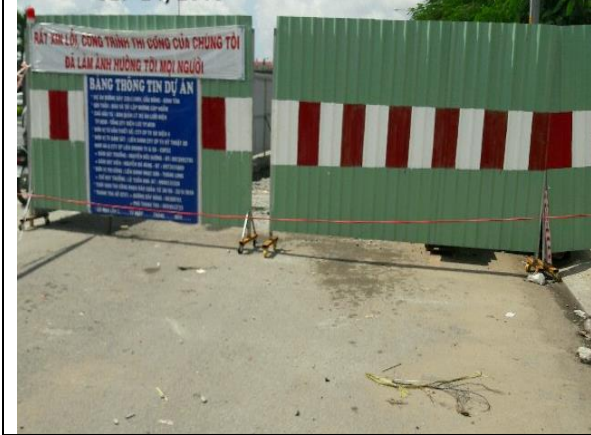
Photo 32: The subproject information board is with full information

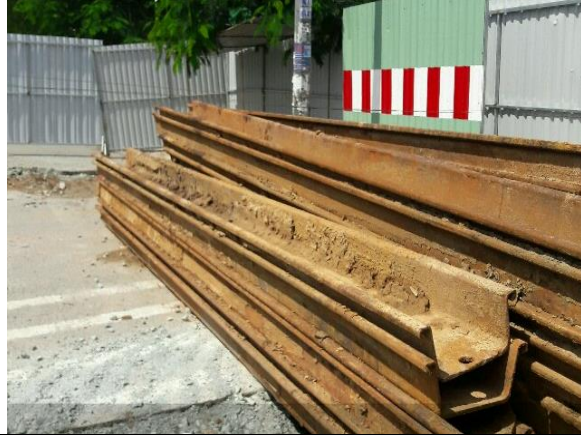
Photo 33: Construction materials were gathered tidy at the site

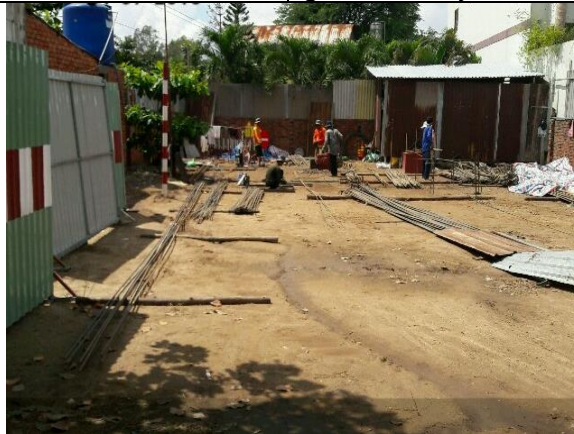
Photo 34: Workers prepared the materials in the fenced construction area

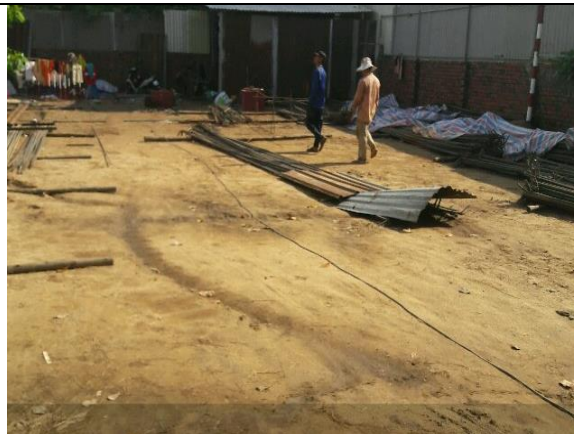
The construction workers did not wear working protection equipment while working (**Photo 35**)

Photo 35: The construction workers did not wear working protection equipment

220KV Cầu Bông-Bình Tân transmission line: The construction workers did not wear working protection equipment while working.

220KV Cầu Bông-Bình Tân transmission line: Contractors should provide protective facilities to workes and urge workers to wear them.
