Project Number: 47085  
September 2015

## Lao People's Democratic Republic: Road Sector Governance and Maintenance Project (Financed by the Asian Development Bank)

**ADB TA-8492 LAO:  
ROAD SECTOR GOVERNANCE  
AND MAINTENANCE PROJECT  
(47085-001)**

**Final Report  
Volume 2: Annexes B – Q  
[Chapters 2, 3 & 4]**

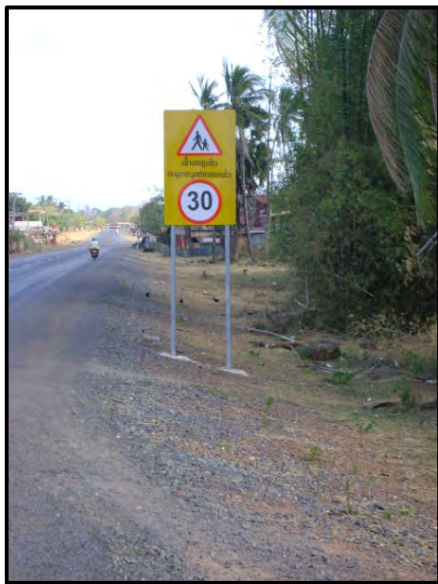
### **1. School Zone Warning Sign**

Sign is large and brightly coloured and therefore highly visible.

30 km/h speed is perhaps too low and likely to be ignored.

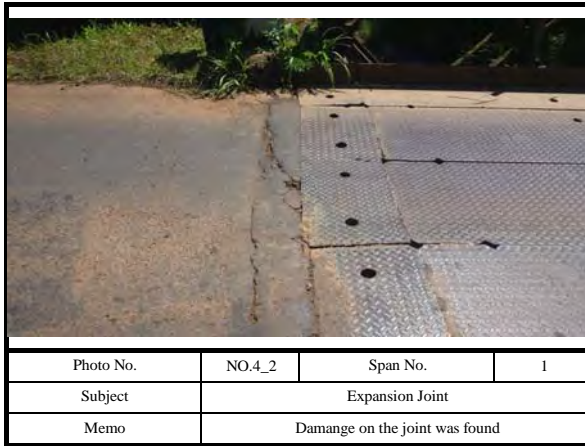
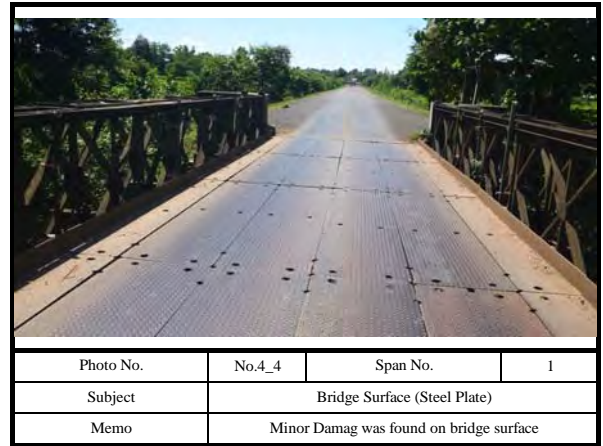
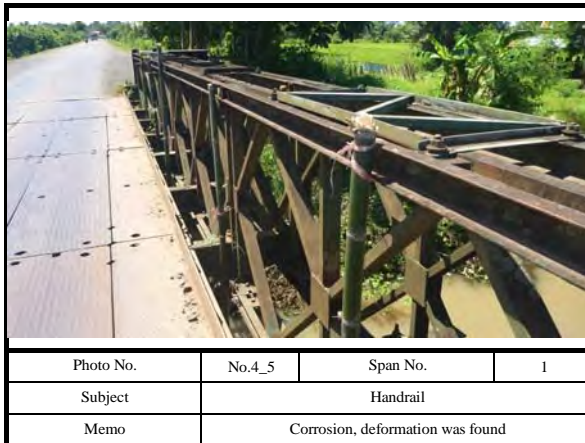
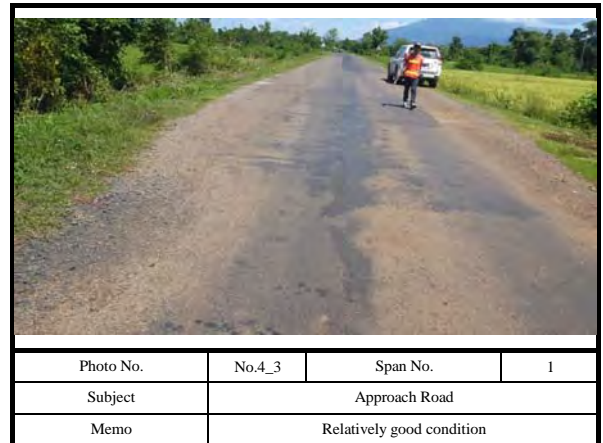
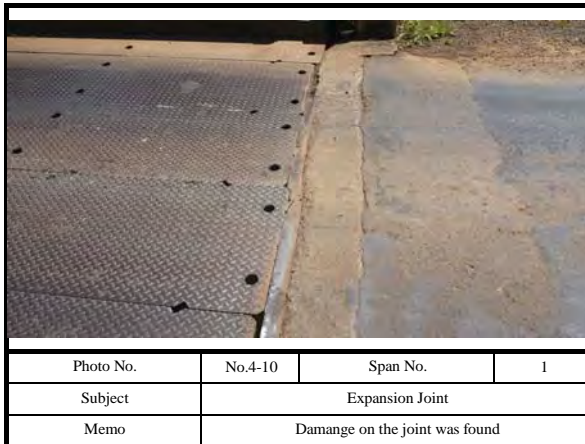
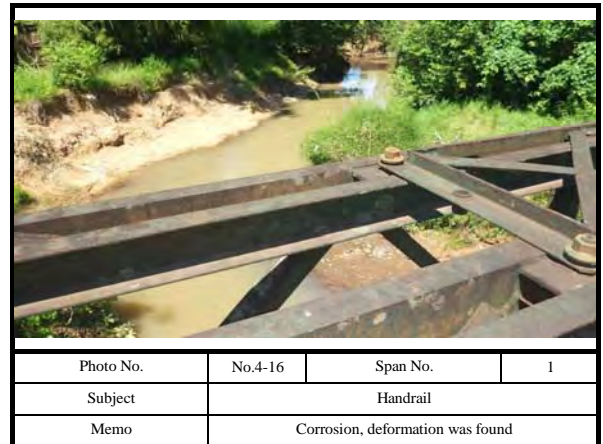
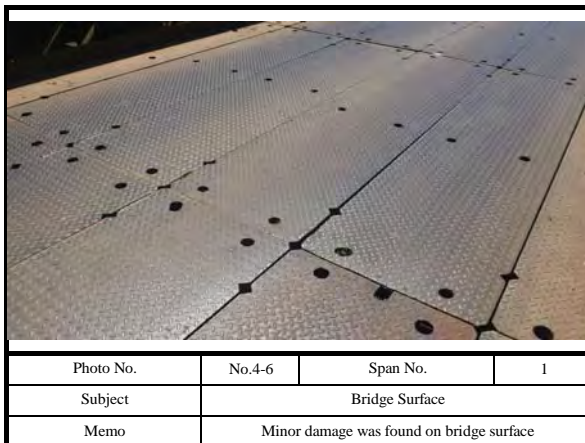
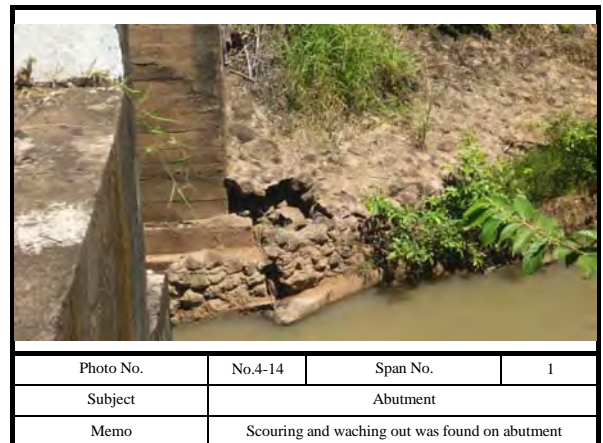
- Corrosion and damage was found on handrail (Structure)
- Scouring and washing out was found on abutment
- Damage on expansion joint was found

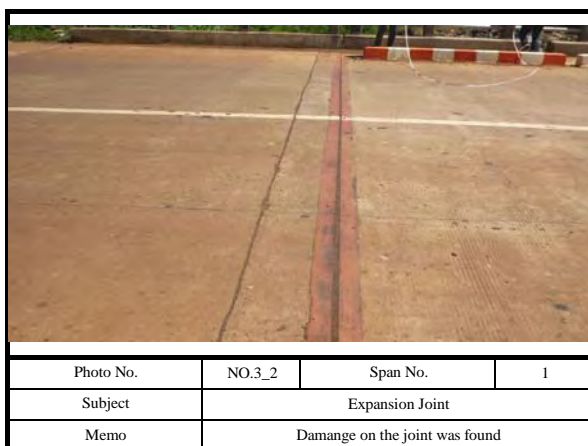
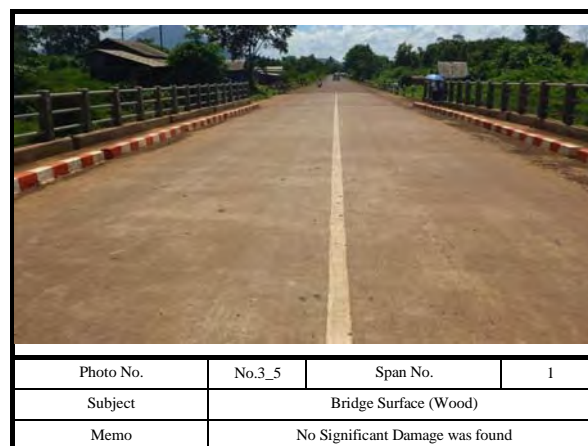
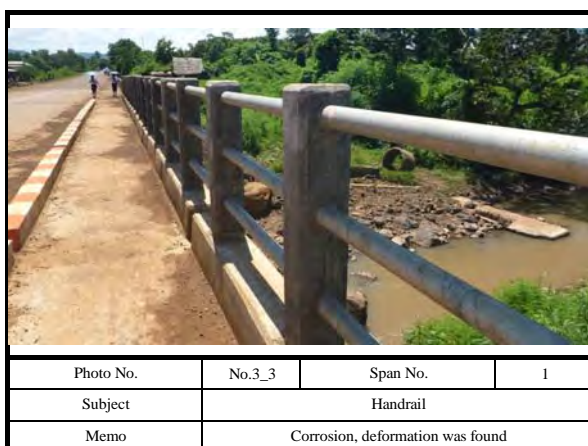
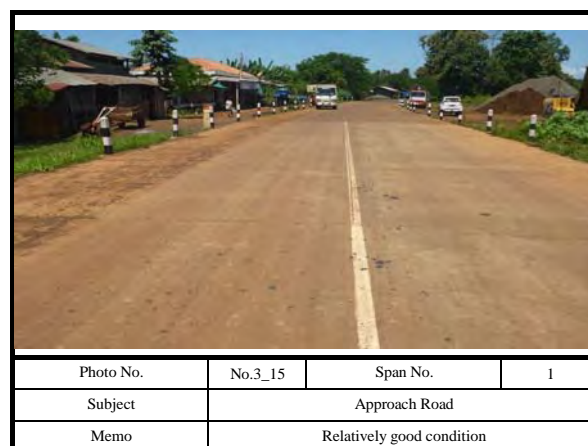
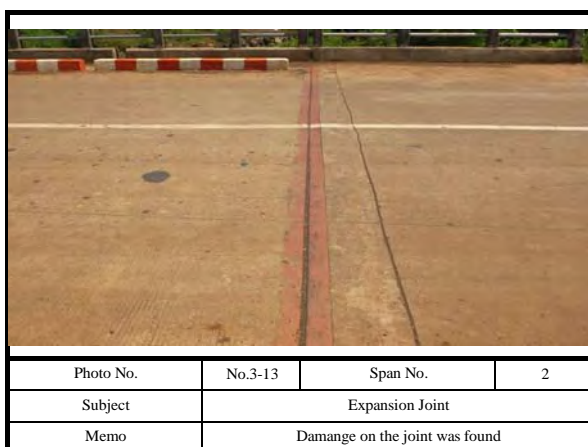
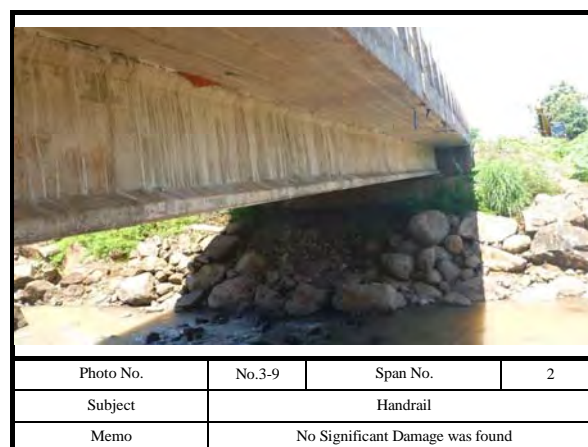
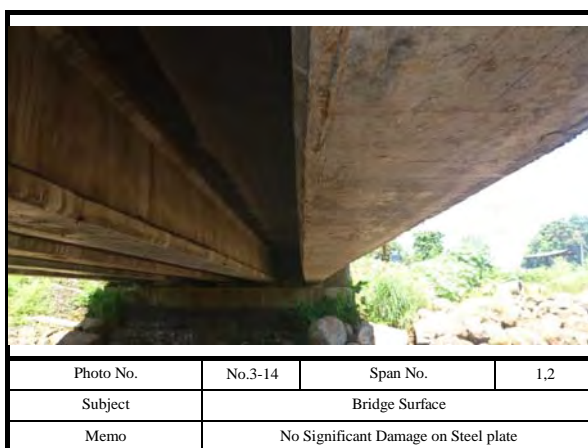
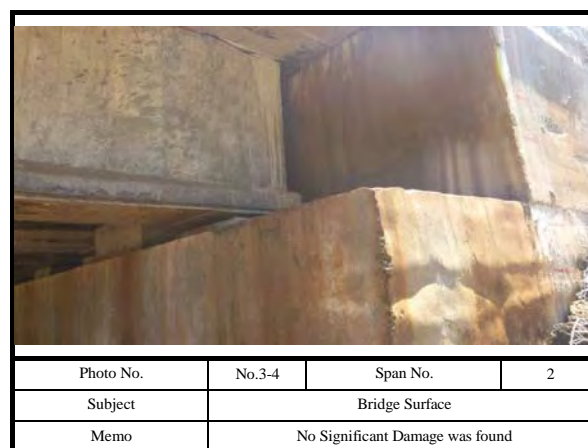
- Bridge is new (re-construction and complete on the year 2014)
- Bridge condition is good

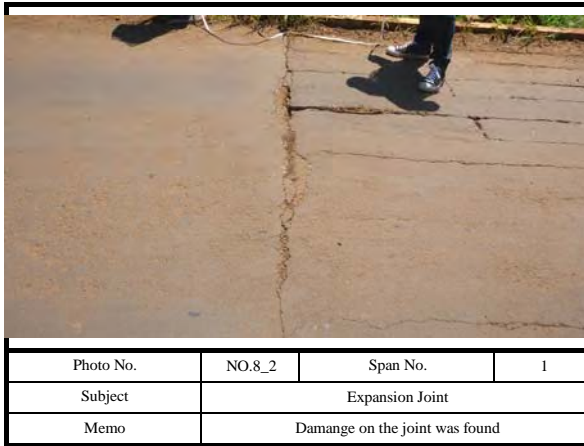
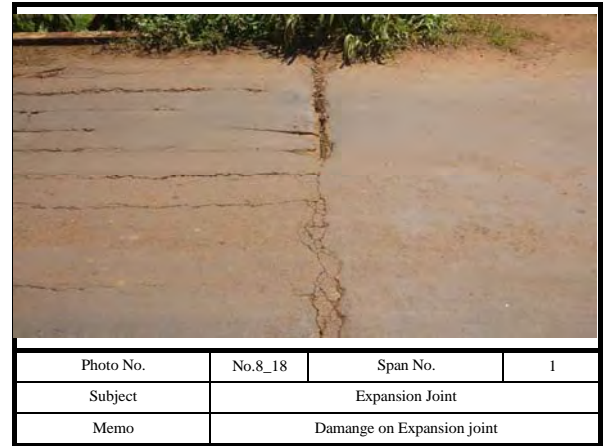
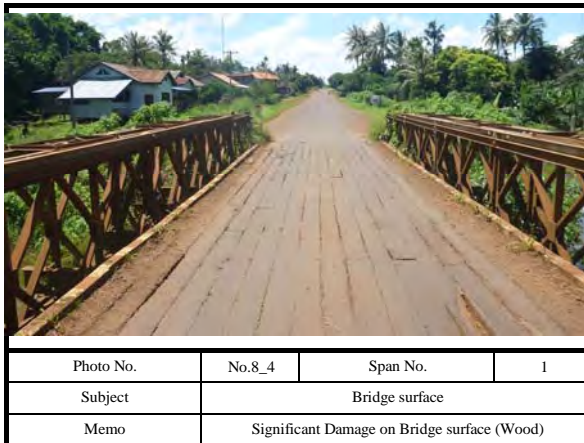
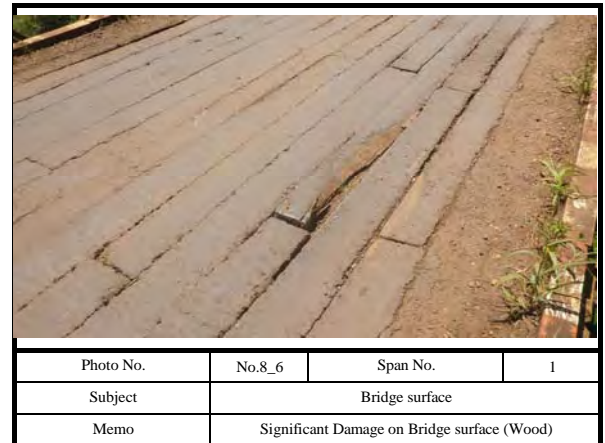
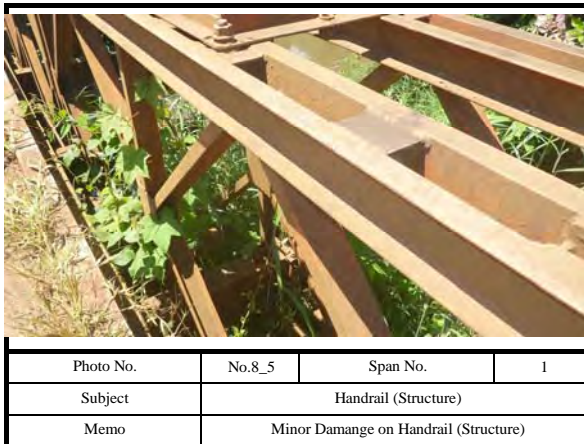
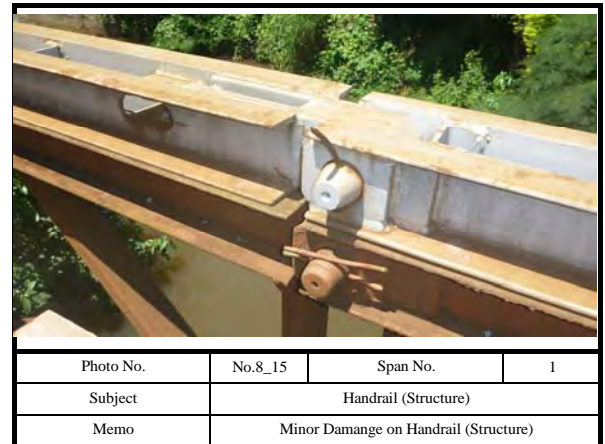
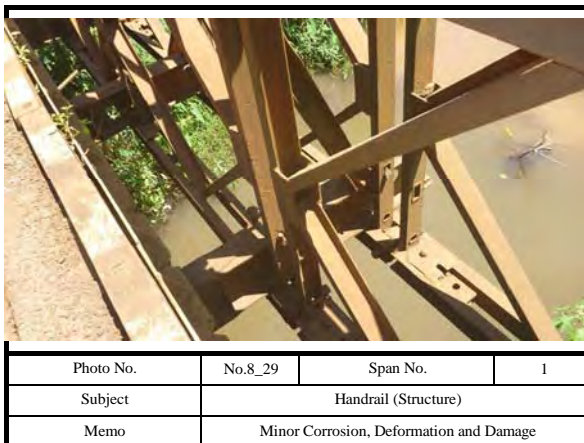
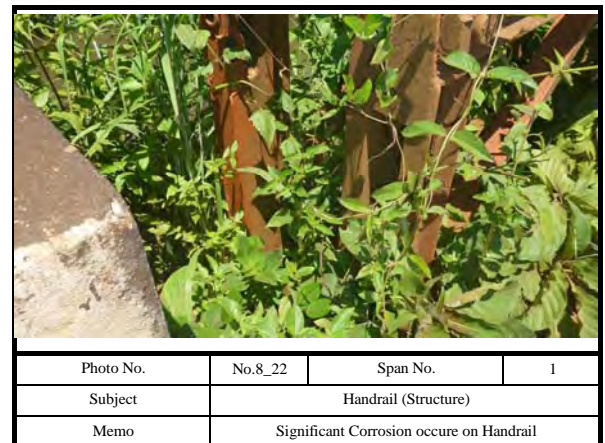
- Significant Damage on Expansion Joint
- Corrosion, deformation and damage occur on Handrail.
- Significant damage on bridge surface (Wood) which is recommended to be repalce as soon as possible for road safety.
- Damage on steel bearing was found.
