# Environmental and Social Monitoring Report

Annual Report  
Project Number: 47929-001  
February 2015 to December 2015

## PAK: Gulpur Hydropower Project

**Pre-Construction Progress Report**

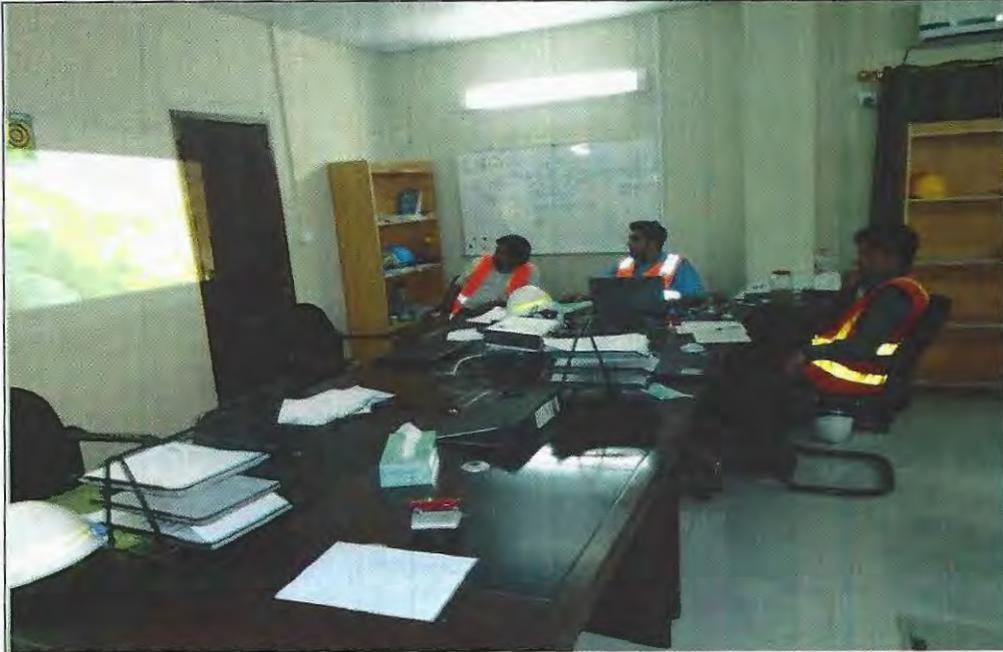
Meeting with Sub-Contractor on the issue of spoil disposal practices and non compliances. Videos were presented to stop such violations at site and commitments were provided by Sub-Contractors to ensure proper disposal of materials.

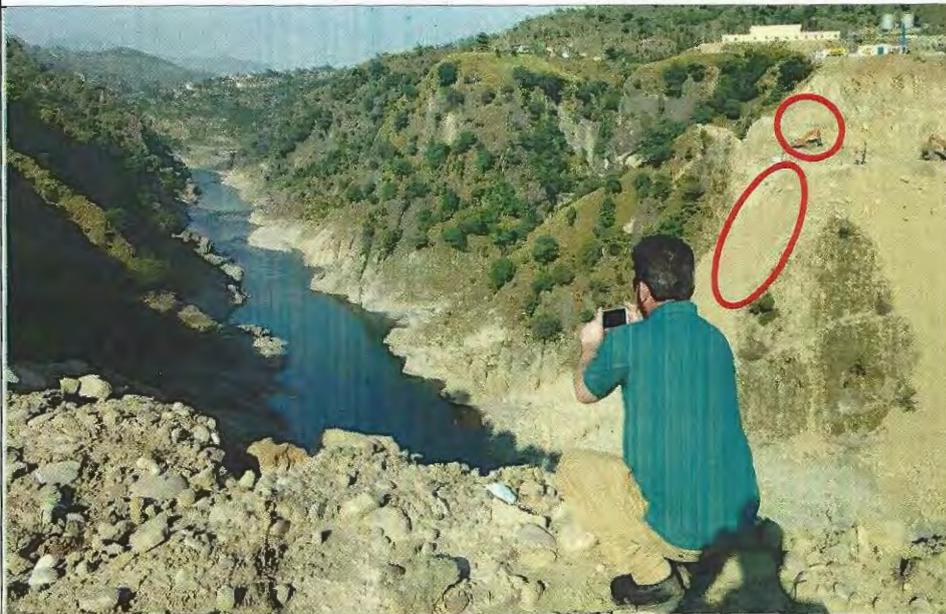
Client visit on 07-October-2015 highlighting spoil disposal issues and non-compliance during that time activity.

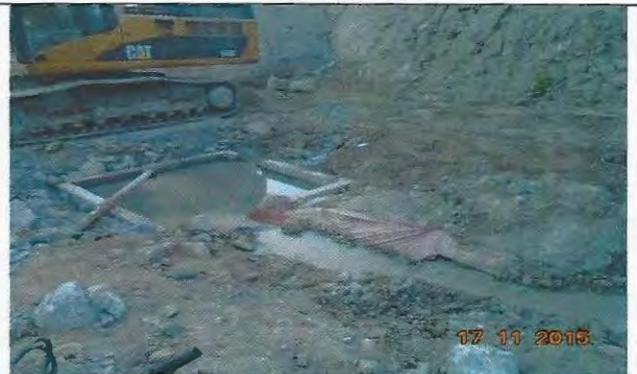
Figure 2 View of improper drains with effluent moving out and contaminating soil, suggestion to cement drain between sedimentation ponds

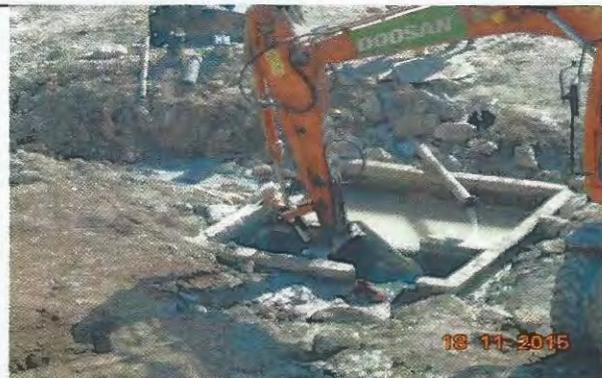
Figure 3 Chemical Sludge collection view

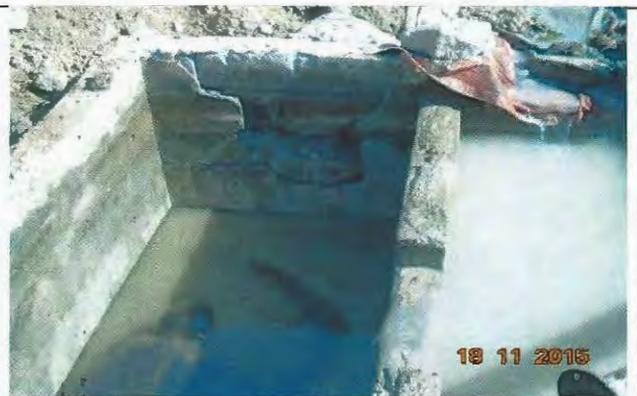
Figure 4 Damage boundary wall of sedimentation pond, leakage for contamination

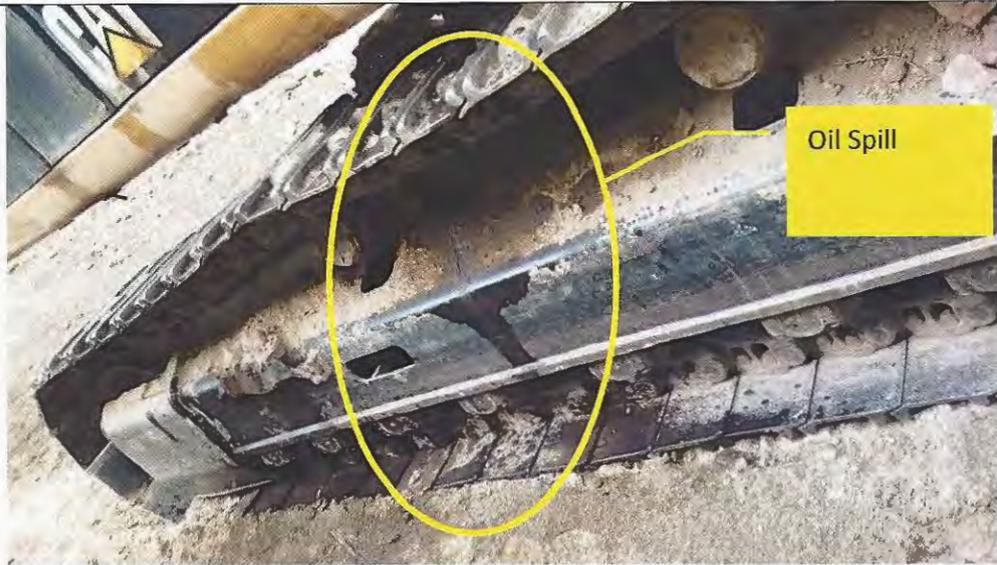
Figure 1 Contaminated soil on the ground due to oil spill during improper refueling

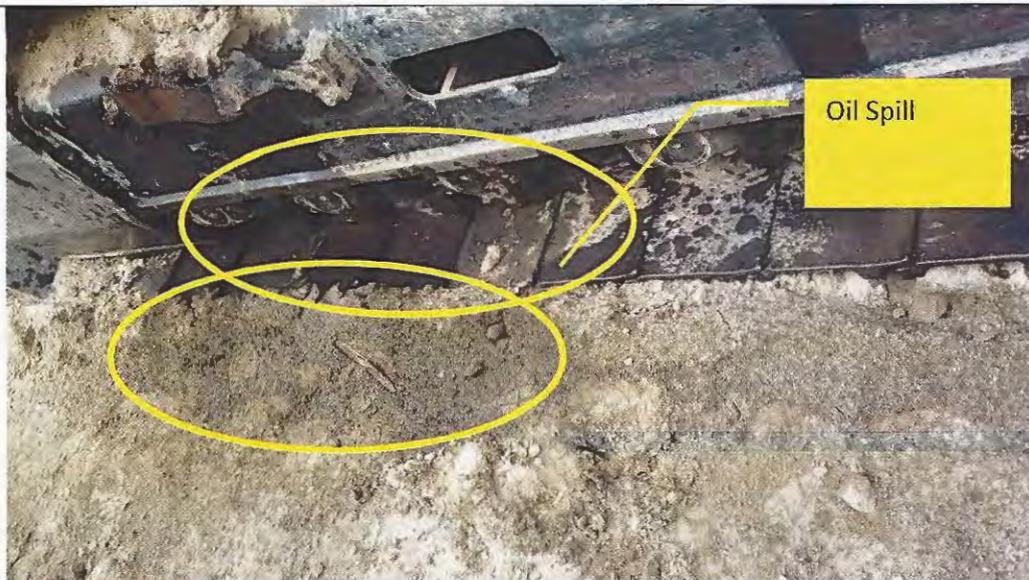
Figure 2 Contaminated soil on the ground due to oil spill during improper refueling

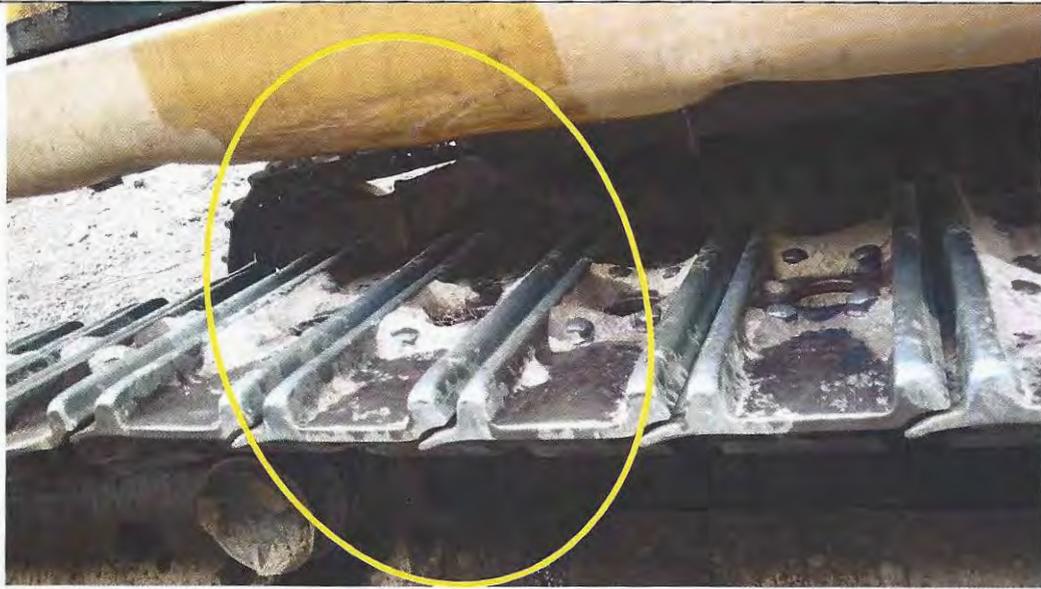
Figure 3 Leakage of Oil

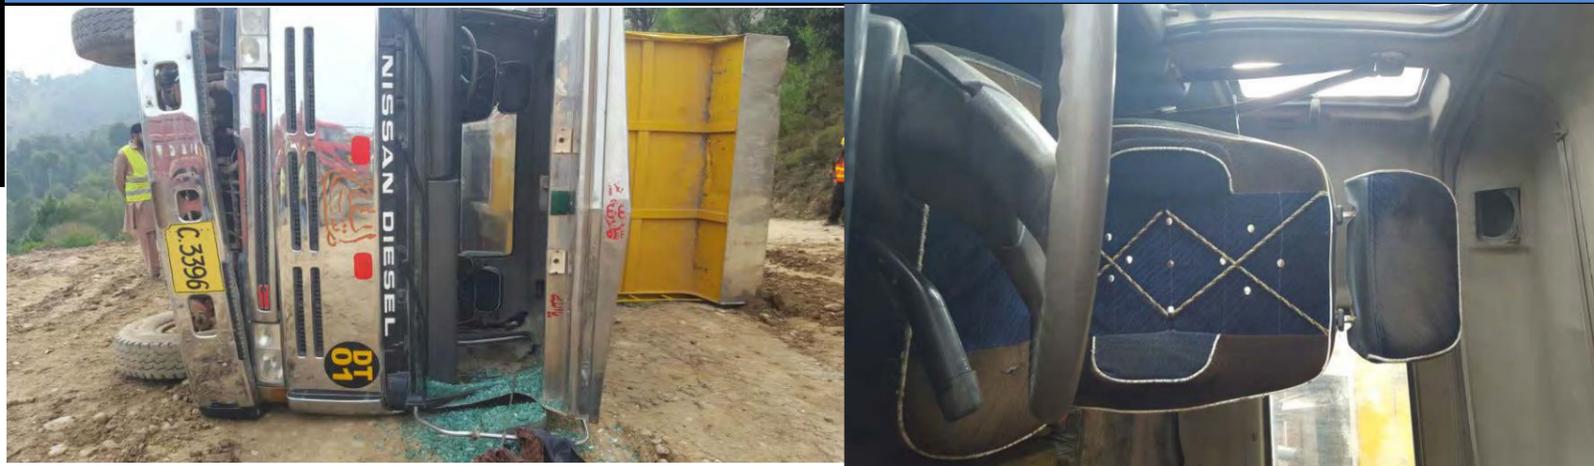
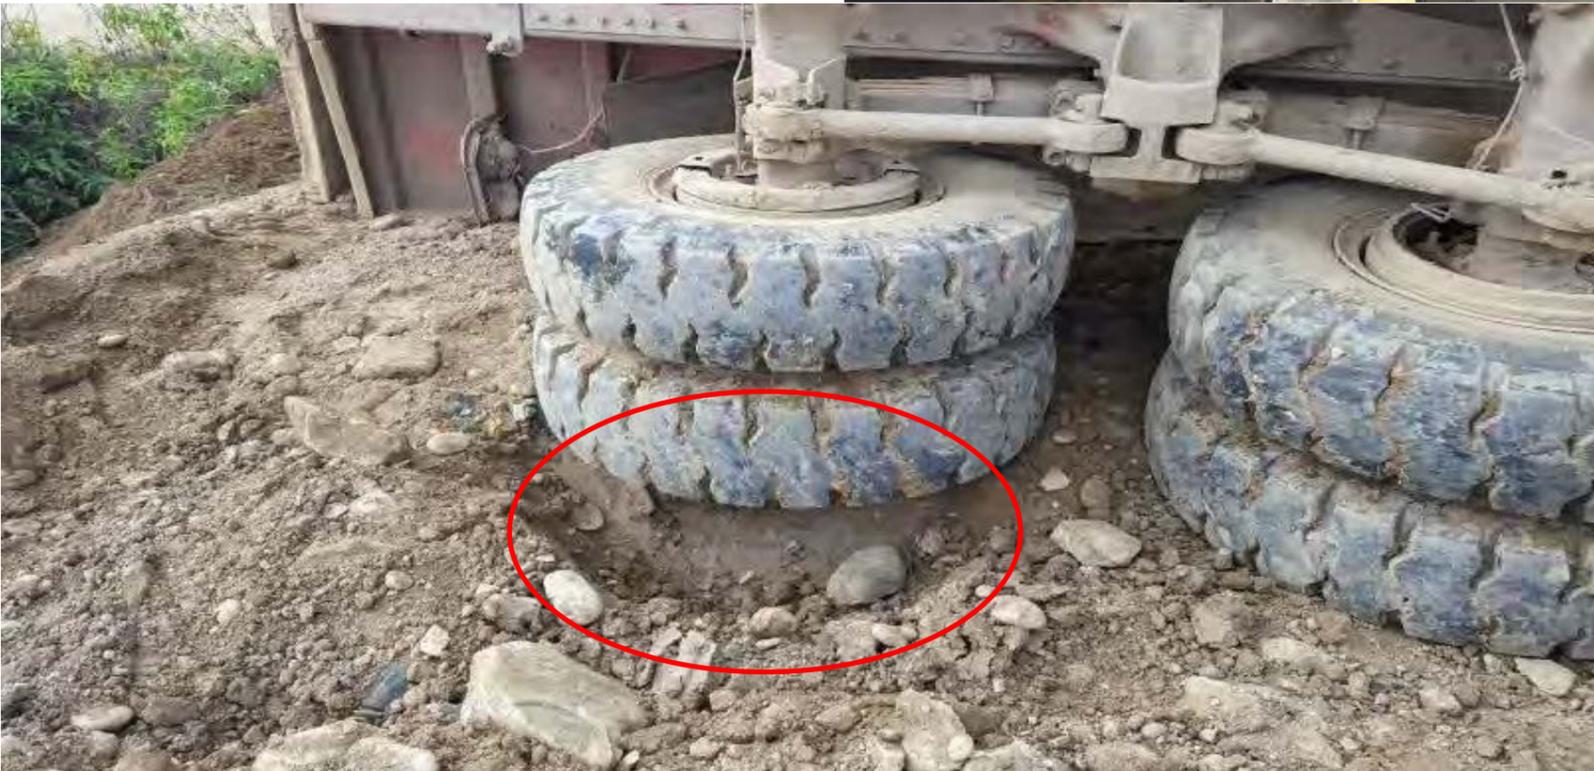
loose un compacted surface for unloading activity caused tyre to pressed into soil

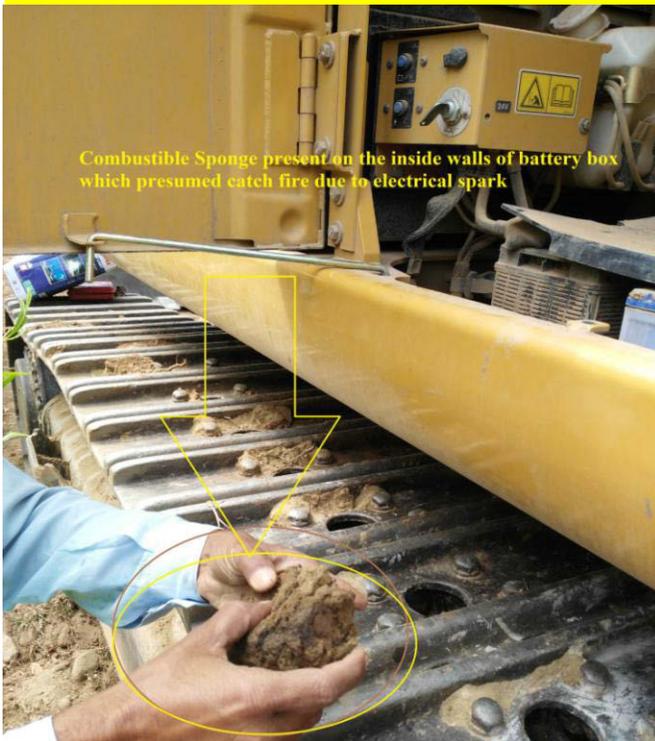
1. Absence of Excavator Helper
- 2: Absence of Signalman
- 3: Absence of Fire fighting equipment inside excavator
4. Presence of combustible materials inside Battery Box

**Sponge combustible material on inside walls of battery box**

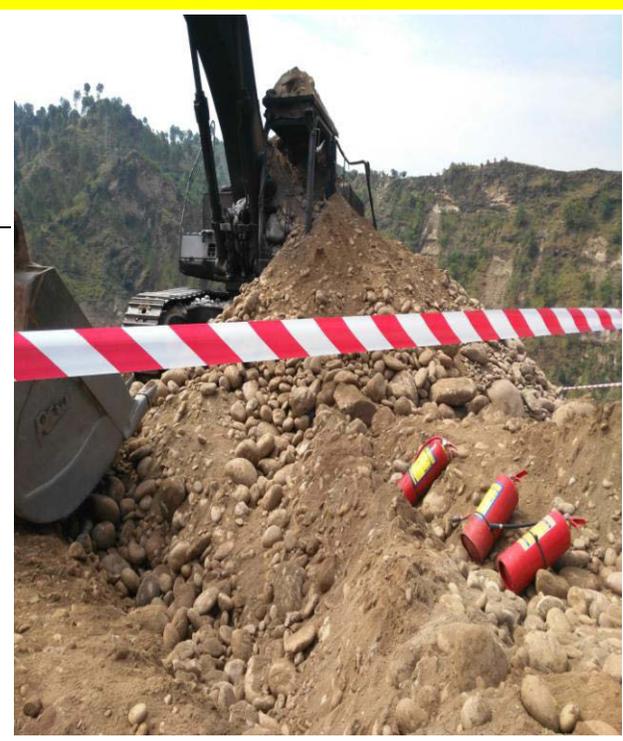
**View of burnt excavator**

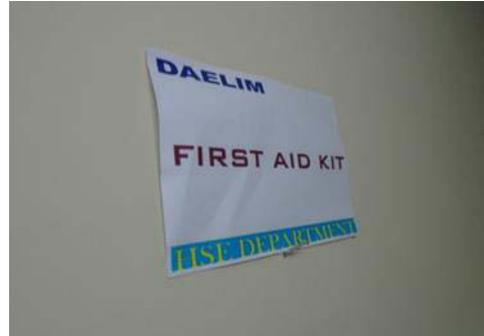
*First aid box missing*

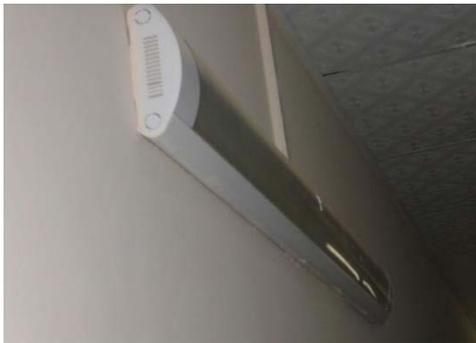
*Secondary cover of tube light broken*

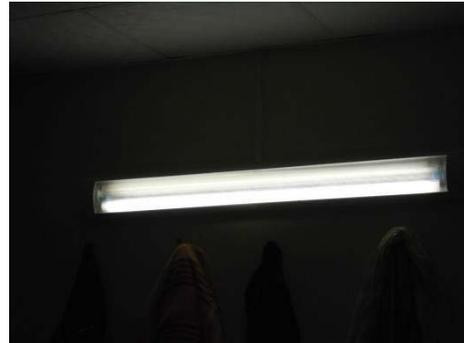
*Clothes hangers mounted beneath tube light*

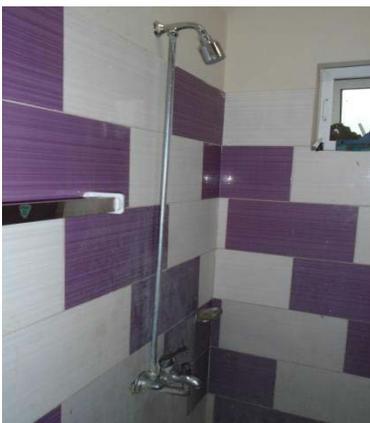
*Shower & tape valve broken*

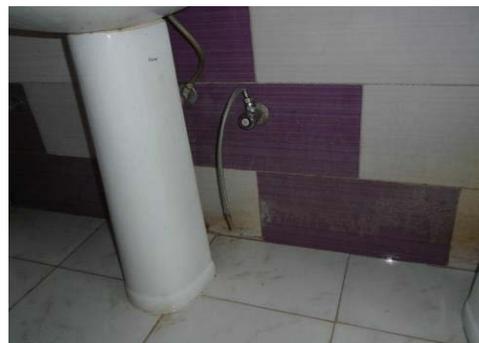
*Pipe beneath the sink is broken*

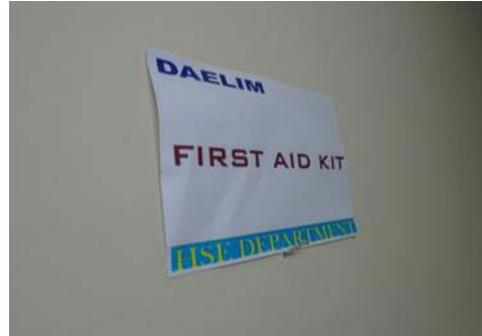
*First aid box missing*

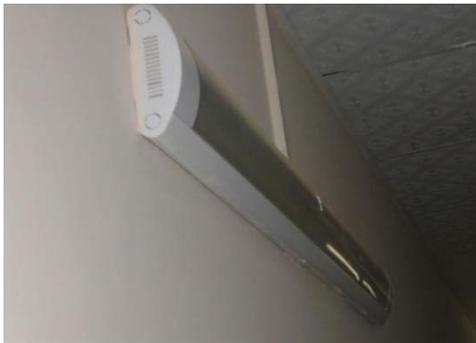
*Secondary cover of tube light broken*

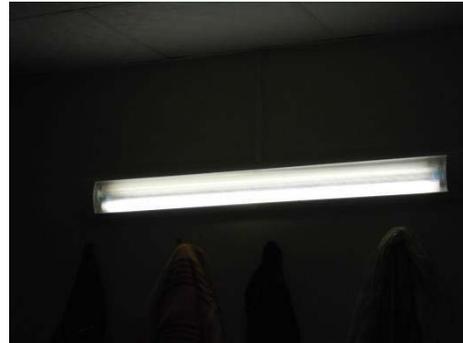
*Clothes hangers mounted beneath tube light*

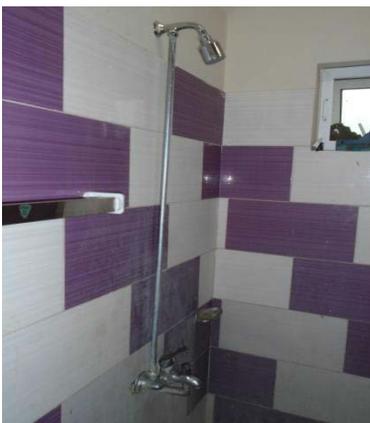
*Shower & tape valve broken*

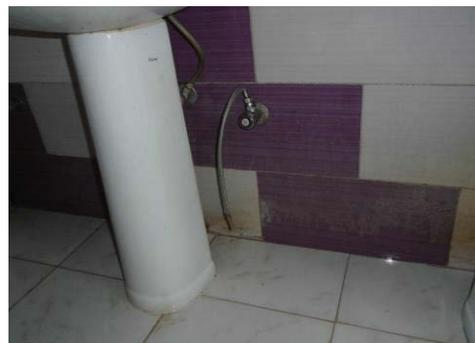
*Pipe beneath the sink is broken*
