**Project Number: 48192**

Tonga: Cyclone Ian Recovery Project

Initial Environmental Examination – Disaster Relief Funding - School Reconstruction Projects

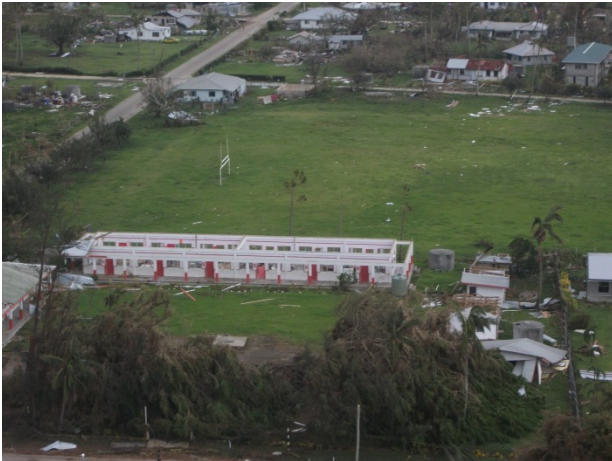
**Figure 3 Damage at Pangai Government School post Tropical Cyclone Ian (Jan 2014) - Photographs courtesy of the New Zealand Air Force**

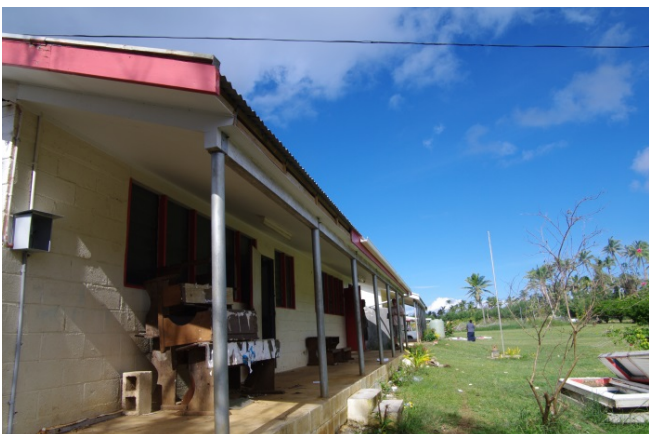
22. The two buildings are relatively undamaged and there appears to be no earthquake or cyclone structural weaknesses. The main damage to the two buildings was to the fascia, gutters and about 50% of the eaves and ceilings in the older of the two classrooms have been damaged (Figure 15 and Figure 16). The roof has been repaired for any damage and lost sheeting that may have been sustained although there has been no work undertaken to the fascia and gutters.

**Figure 15 Koulo Government Primary School – Older Japanese Designed Classroom with gutters missing**

27. The proposed work at the school includes the replacement of gutters and fascia to the two main classrooms and toilets. Where ceiling damage has been sustained in the older of the two classroom blocks, this will be replaced as needed. Further, all debris should be removed from the school compound to a waste facility for recycling and reuse where possible. This work should provide safe schooling facilities for the 43 children that attend Koulo GPS.

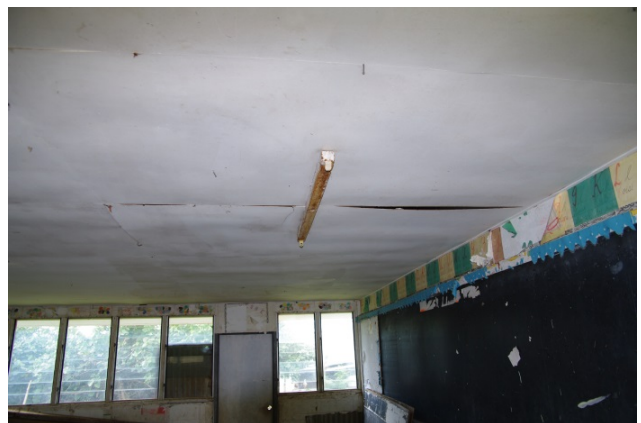
**Figure 16 Internal Ceiling Damage to older Japanese Designed Classroom at Koulo Government Primary School**

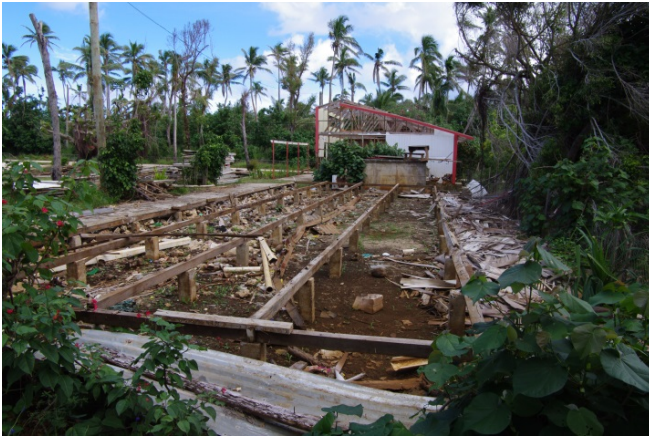
**Figure 17 Koulo Government Primary School Kindergarten destroyed by Tropical Cyclone Ian**

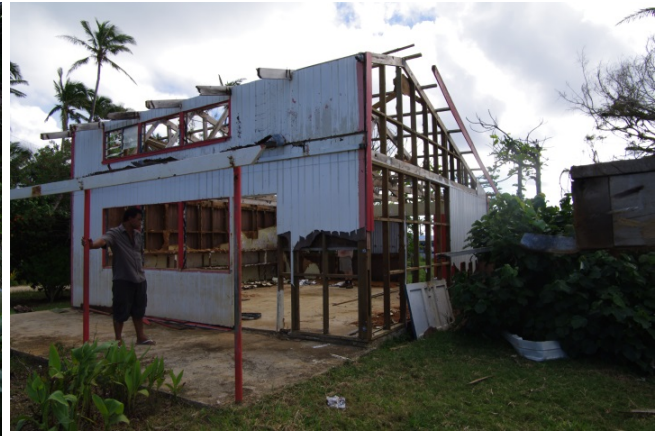
**Figure 18 Koulo Government Primary School - building destroyed by Tropical Cyclone Ian**

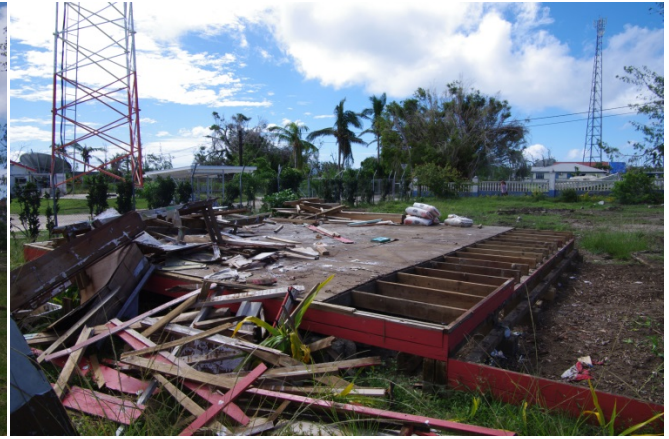
**Figure 24 Destroyed Small Classroom at Pangai Government Primary School**

- 35. It is recommend that all existing structures left from the cyclone damages be demolished and the school be rebuilt consistent with earthquake and cyclone design. Based on conversations with Pangai GPS staff during a visit to Ha'apai High School, the would be pleased to retain dividing classrooms as it gave them flexibility with class sizes.
- 36. Considerations should also be given to the specific design and potential location of new buildings given Pangai GPS's location within the Coastal High Hazard Area based on the SOPAC modeling.

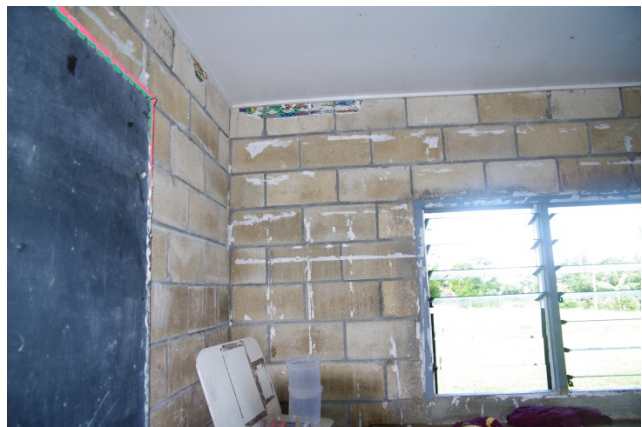
**Figure 28 Water damage in northern classroom at Tongoleleka Government Primary School**

42. The proposed work at the school includes the replacement of gutters and fascia to the two main classrooms and toilets. The walls inside the classroom will also be painted with water proof paint to reduce the future impacts on intrusion. All debris should be removed from the school compound to a waste facility for recycling and reuse where possible. This work should provide safe schooling facilities for the 128 children that attend Tongoleleka GPS.

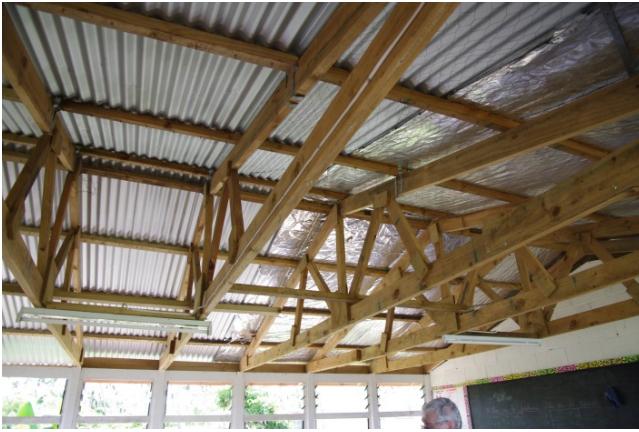
**Figure 31 Missing Ceiling in the Classrooms of Faleloa Government Primary School**

49. Given the nature and extent of the damage; and in that, the existing five room classroom building is not earthquake and cyclone proof, it is recommended that the whole school be demolished and a new school be constructed on the site. There is significant land available that would allow for temporary repairs to the existing large classroom building while constructing new buildings adjacent to the current buildings that could accommodate all the students within either a single structure, or something similar to Koulo GPS.
50. The site will also need to be cleaned and all the cyclone debris removed. Where possible, recycling and reuse should occur. Any contaminated material should be taken to Tapuhia landfill in Nuku'alofa, Tongatapu.

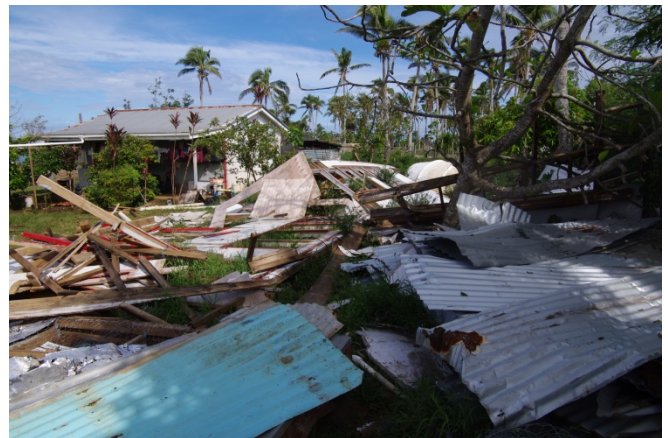
**Figure 34 Debris from destroyed building at Faleloa Government Primary School**

60. The site will also need to be cleaned and all the cyclone debris removed. Where possible, recycling and reuse should occur. Any contaminated material should be taken to Tapuhia landfill in Nuku'alofa, Tongatapu.

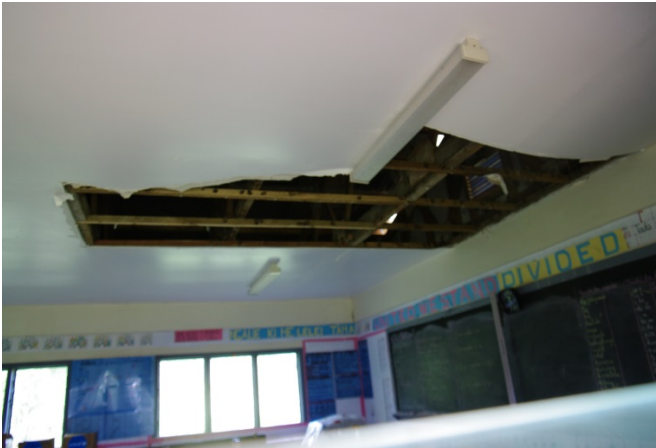
**Figure 37** Lost Ceiling in main classroom block at Fotua Government Primary School

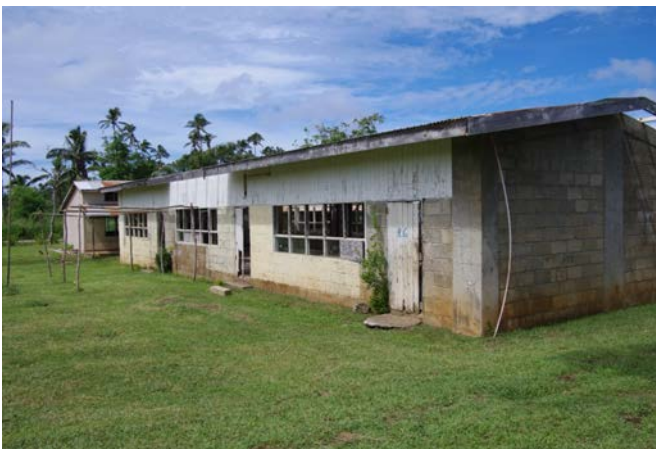
**Figure 39** Abandoned Classroom Block at Fotua Government Primary School

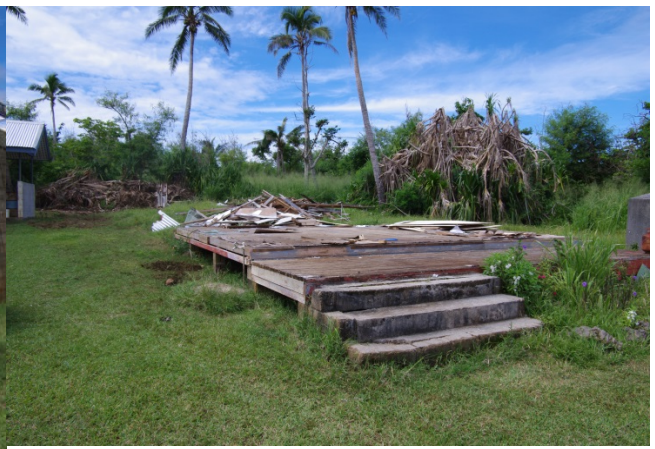
**Figure 40** Small Classroom that was destroyed at Fotua Government Primary School

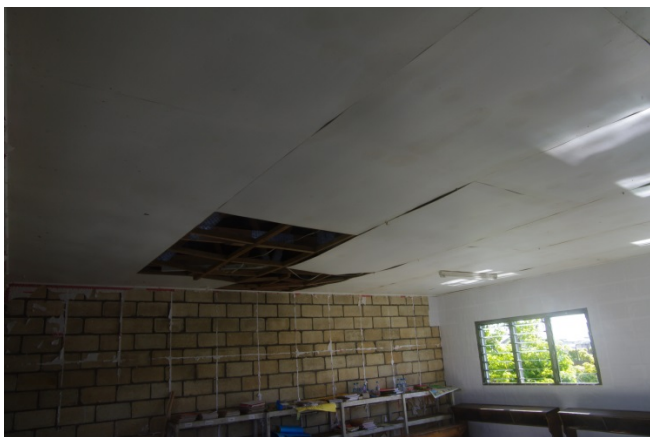
**Figure 49 Internal Damage to main classroom building at Ha'ano Government Primary School**

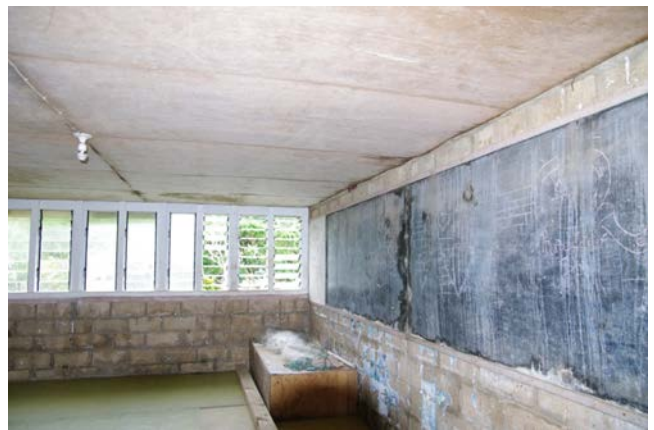
**Figure 58 Water Damage to a classroom at Lofanga Government Primary School**

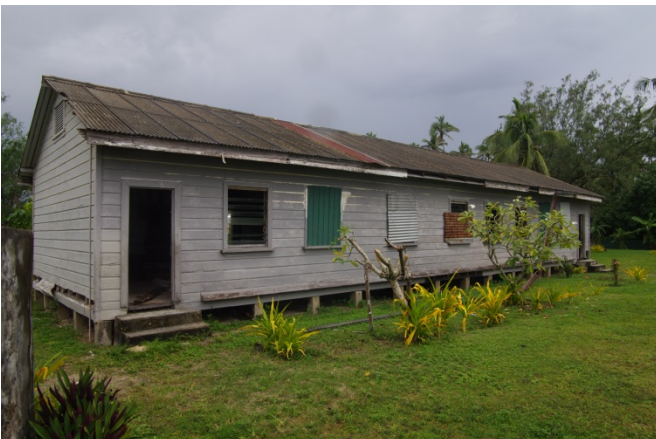
**Figure 63 Proposed Kindergarten with Asbestos Roof at Mata'aho Government Primary School**

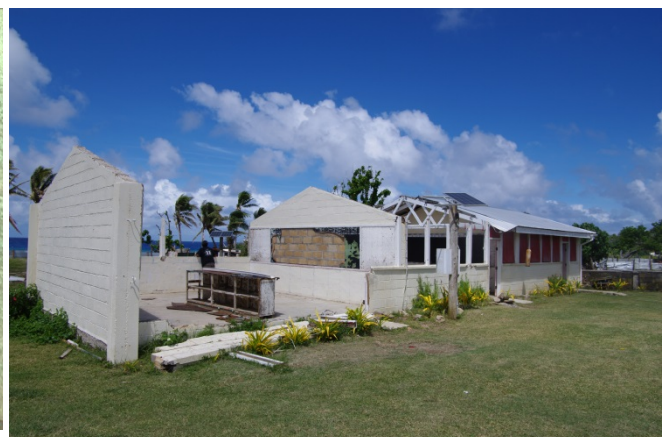
**Figure 66 Destroyed Classroom Building at Mo'unga'one Government Primary School**

100. Given the damage sustained to the existing building and that is considered unsafe, the school will be demolished and replaced with a new school building to cater for the small number of students that attend the school.
101. The site will also need to be cleaned and all the cyclone debris removed. Where possible, recycling and reuse should occur. Any contaminated material should be taken to Tapuhia landfill in Nuku'alofa, Tongatapu.

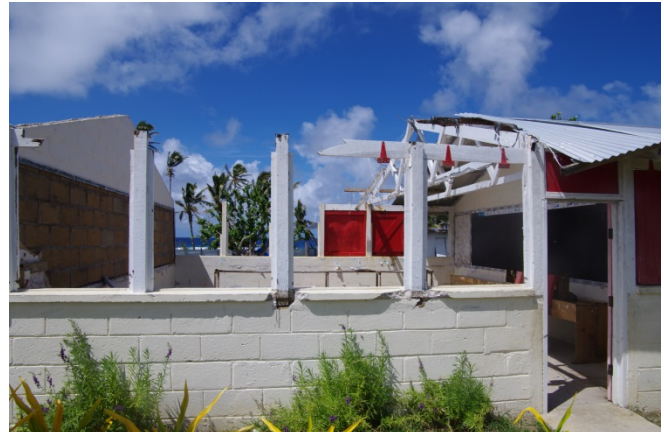
**Figure 68 Destroyed Classroom Building at Mo'unga'one Government Primary School**

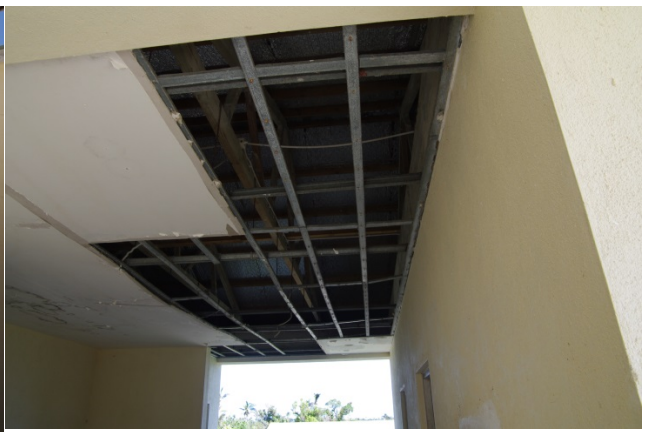
**Figure 74 Damage Ceiling at Ha'apai High School**

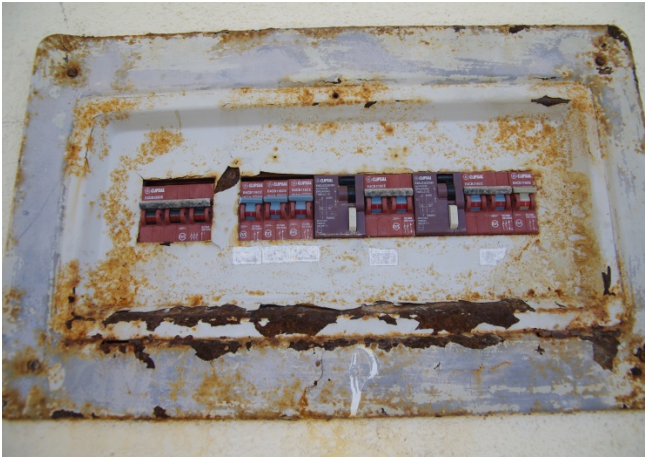
**Figure 75 Rusted Electrical Switch Board at Ha'apai High School Hall**

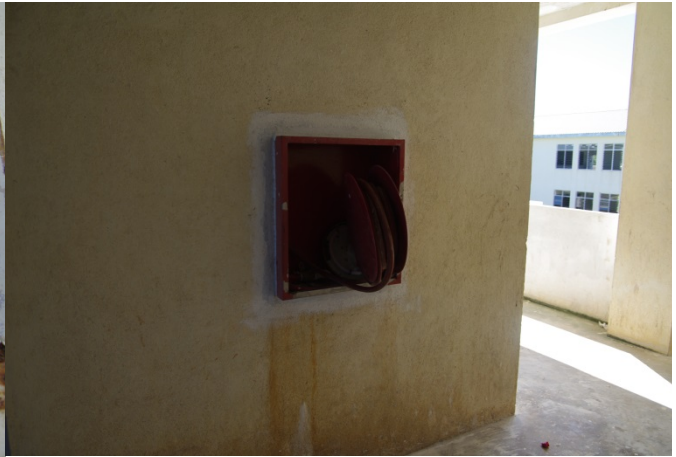
**Figure 76 Damaged Fire Hose at Ha'apai High School**

- 108. Following the upgrading, the fire equipment at Ha'apai High School will also be repaired to ensure the safety of staff and students alike.
- 109. The main hall at Ha'apai High School is part of the climate proofing of schools project funded through the Strategic Program for Climate Resilience under the Pilot Program for Climate Resilience. The funding is being provided by the Climate Investment Fund. The proposed upgrading of the gutters and linking with the storage of water tanks will assist the students of Ha'apai High School to be provided with high quality drinking water as well as linking the proposed works at the school with the new hospital located on the current rugby oval at the school. This work will make Ha'apai High School an ideal evacuation center prior, during and post emergency incidents such as cyclones and tsunamis.

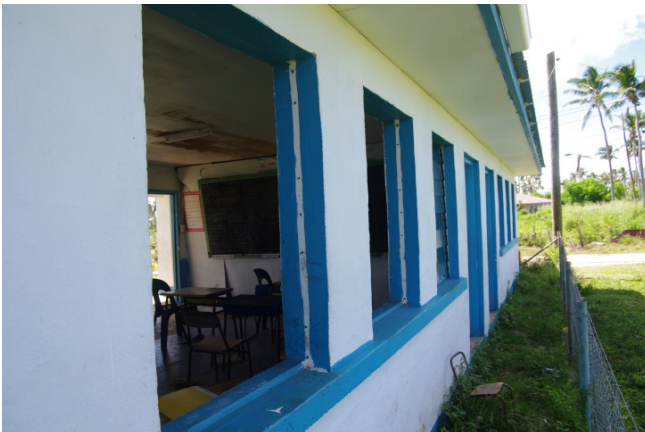
**Figure 79 Damaged windows in the Primary Classroom Block at Ofamo’oni Primary and Secondary School**

116. The proposed work includes the replacement of the ceiling in the second classroom block and the replacement of gutters, window frames and louvers in all three buildings. Further, strapping will be undertaken to better secure the roof. This will result in the building being in good working order.

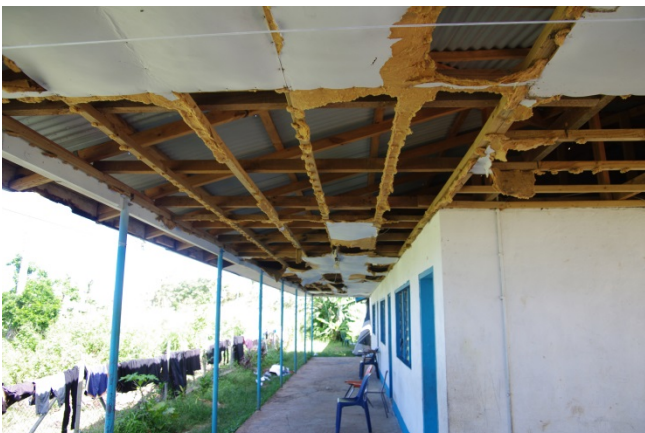
**Figure 81 Damaged Ceiling in the Secondary Classroom Block at Ofamo’oni Primary and Secondary School**

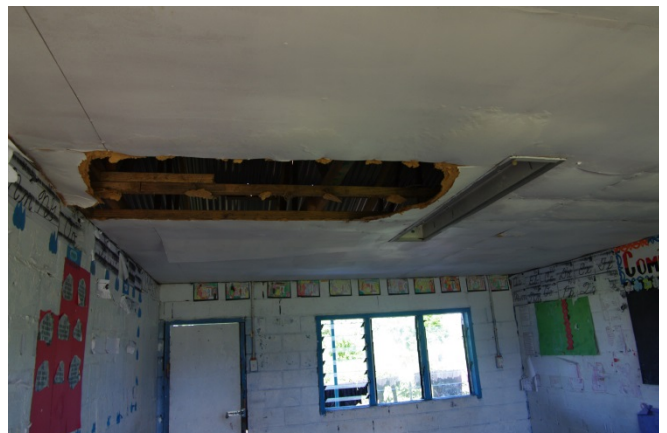
**Figure 82 Damaged Internal Ceiling in the Secondary Classroom Block at Ofamo’oni Primary and Secondary School**

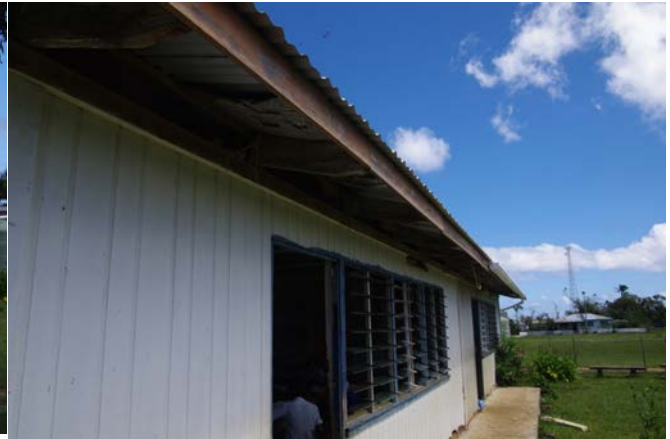
**Figure 86 Missing Gutter on Main Classroom at Petani Bilingual Free Wesley Church School**

123. Guttering and the ceilings will be replaced/repared as part of the proposed works.

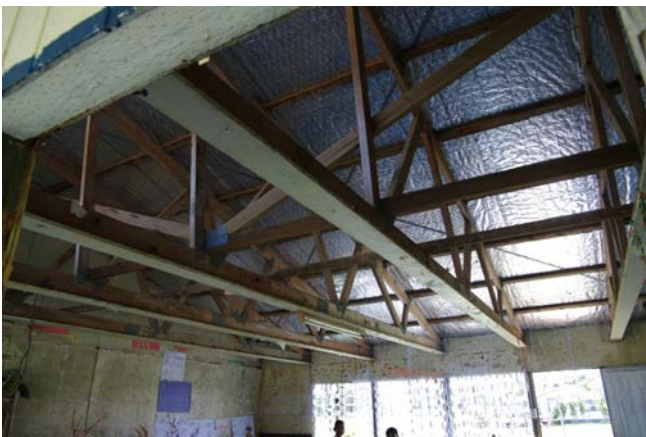
**Figure 87 Damaged Ceiling in Main Classroom Building at Petani Bilingual Free Wesley Church School**

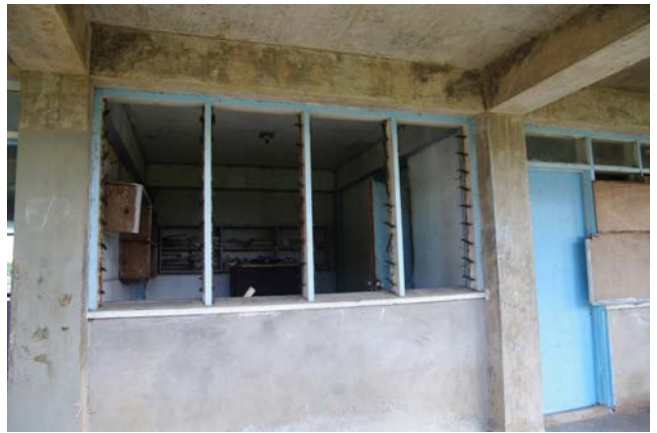
**Figure 92 Missing Louvers in Main Classroom Block at St Joseph's Roman Catholic Church School**

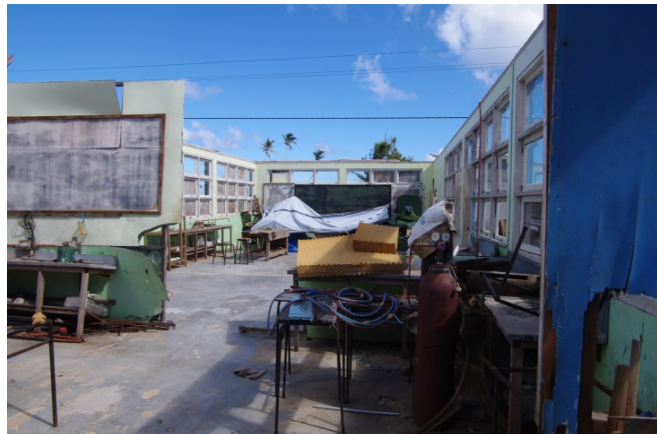
**Figure 94 Destroyed Machinery Workshop at St Joseph's Roman Catholic Church School**

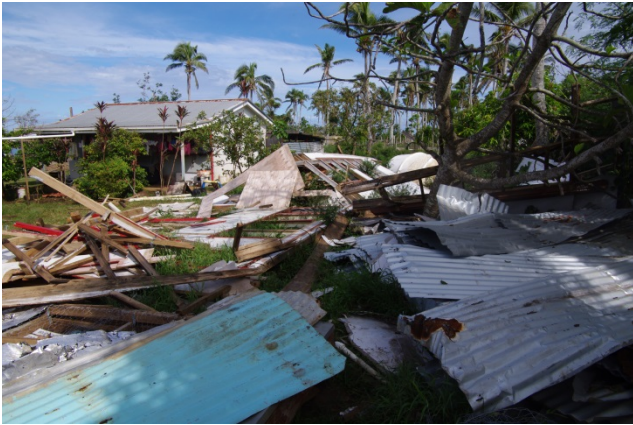
**Figure 109 Piled Debris at Faleloa GPS**

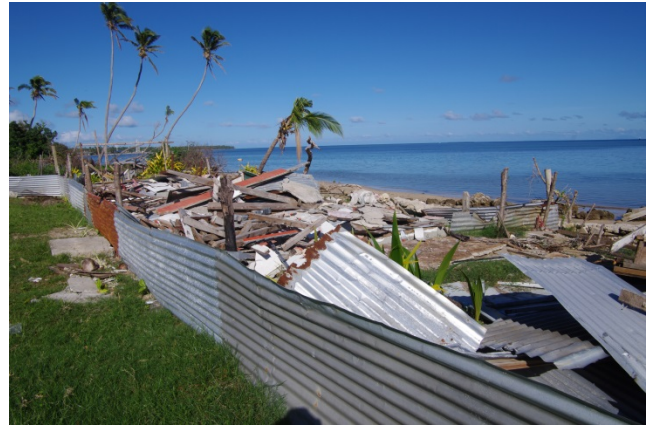
**Figure 110 Piled Debris at Tailulu College**
