# Environmental Monitoring Report

Semi-Annual Report (January-June 2016)  
October 2016

## MYA: Maubin-Phyapon Road Rehabilitation Project

## **SEMI-ANNUAL REPORT NO. 1**

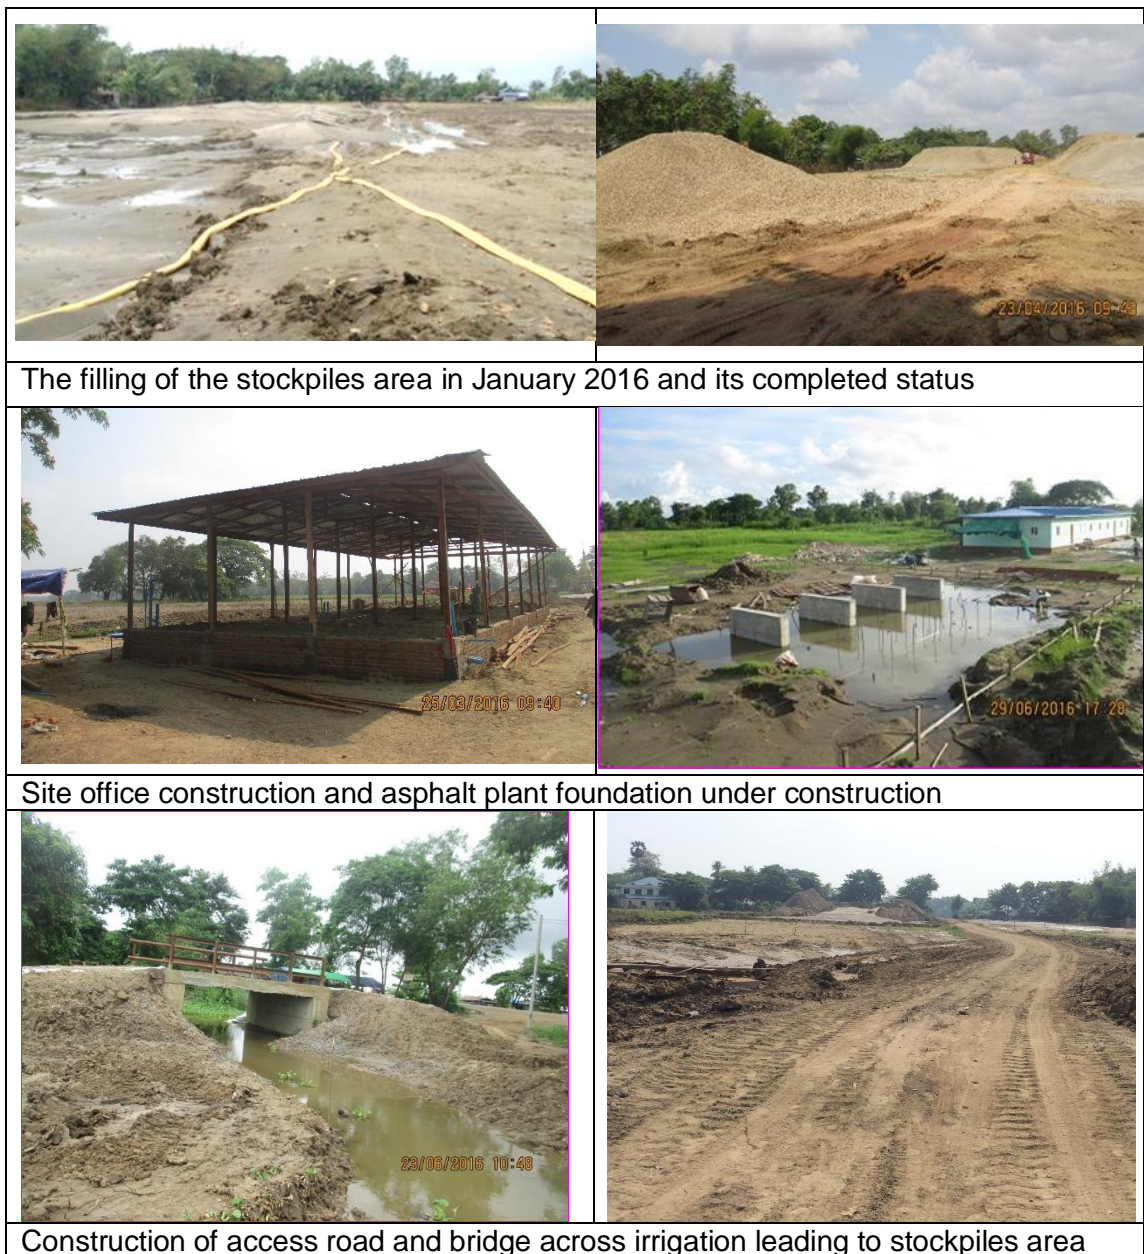
Figure 2. Progress of construction of different facilities of ICB-1

The site office and asphalt plant site of ICB-1 generally complies with EMP guideline for site selection. Among the environmental management concerns during development of the camp site and stockpiles areas is the protection of the irrigation ditch during construction of access roads. The dredging of sand near the banks of Pyapon River used for filling the ICB-1 sites raised concern among the village residents leading them to bring the matter to the attention of the Administrative Office of Kyaiklatt. In response, the Administrative Office directed the ICB-1 contractor to cease dredging from the said location.

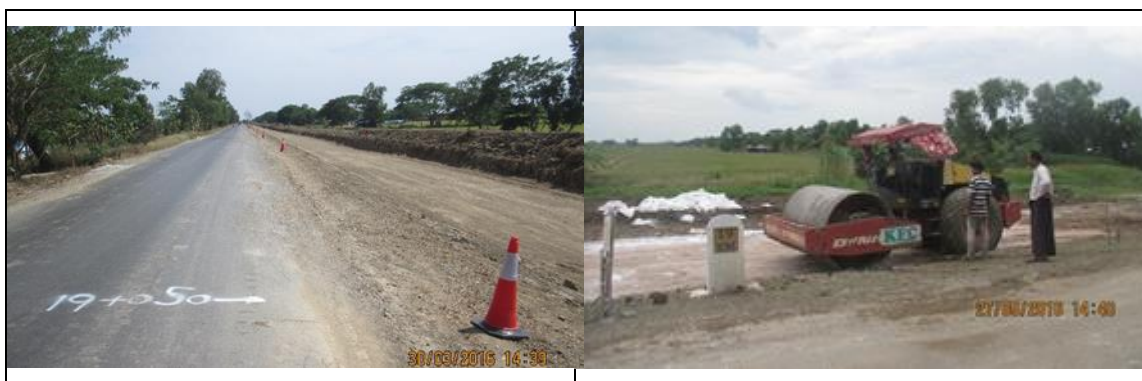
Figure 4. Excavation of unsuitable materials Km 19 to 22 and lime stabilization

The environmental management concern noted with the excavation of the widening lane is the flooding of the excavated section during the recent rainy season which

created a road hazard. But with the end of rainy season and resumption of road work, this section has now been drained.

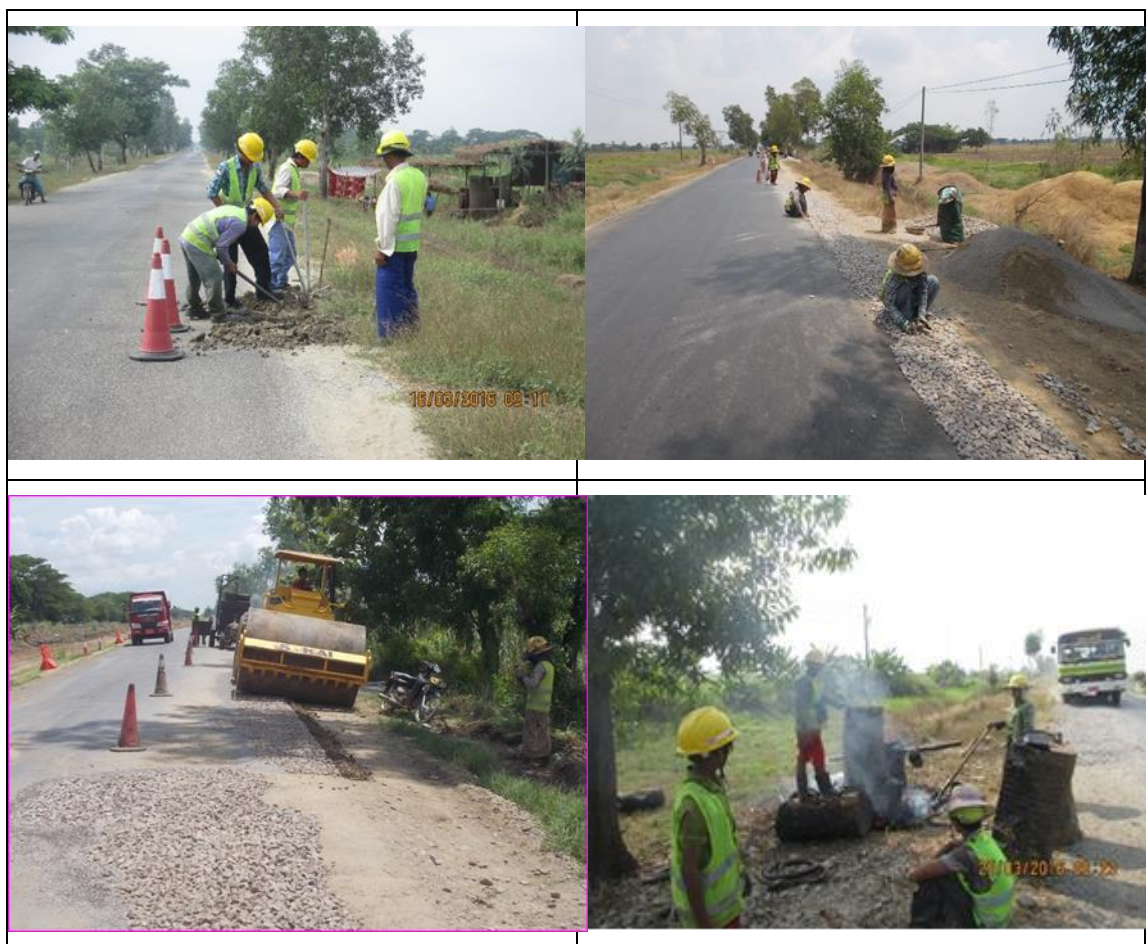
Figure 5. Road repair and maintenance work

As shown at the bottom right photo, the bitumen is heated on site using wood fuel in the premix area (Figure 5).

The environmental management concern with the road repair and maintenance work is the clean-up of the premix site. Rubbish, discarded plastic packaging, bitumen spillage and empty bitumen drums are strewn about the premix site. The Contractor should clean up the site in accordance with Volume 2 Section 116 of the Contract. Traffic safety concern noted with road repair and maintenance work is the need for additional safety items such as barriers and road signs during repair and maintenance work. Contractor should provide the necessary safety item in accordance with the Traffic Safety Plan.

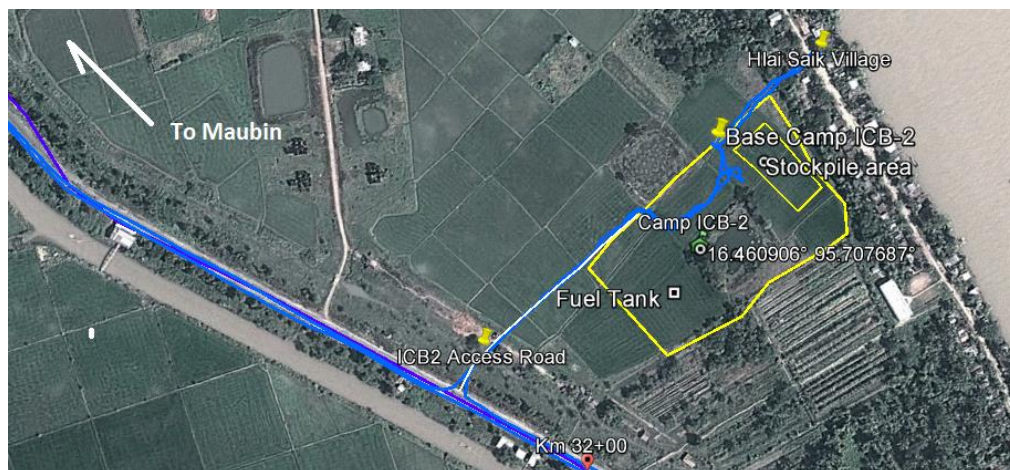
Figure 6. Location of the ICB-2 Camp and batching plant

One obvious environmental concern of the batching plant and stockpiles area are the proximity to the community. The separation of the batching plant from the nearest house is only about 50 m (as compared to the EMP guideline of 300 m minimum distance). The other concern with the camp is the inclusion of the community pond within the land leased by the ICB-2 Contractor.

Non-compliance with EMP guidelines, particularly on separation of contractor's facility from residences and other sensitive receptors has occurred at ICB2. ICB-2's batching plant is only about 60 to 70 m from the nearest house, the EMP guidelines recommends minimum of 300 m. Contractor has been reminded to strictly implement noise and dust control at the facility. Monitoring of impacts through interview of the residents is being undertaken by the NES. So far, no significant impacts have been detected and no major complaint or opposition has been received.

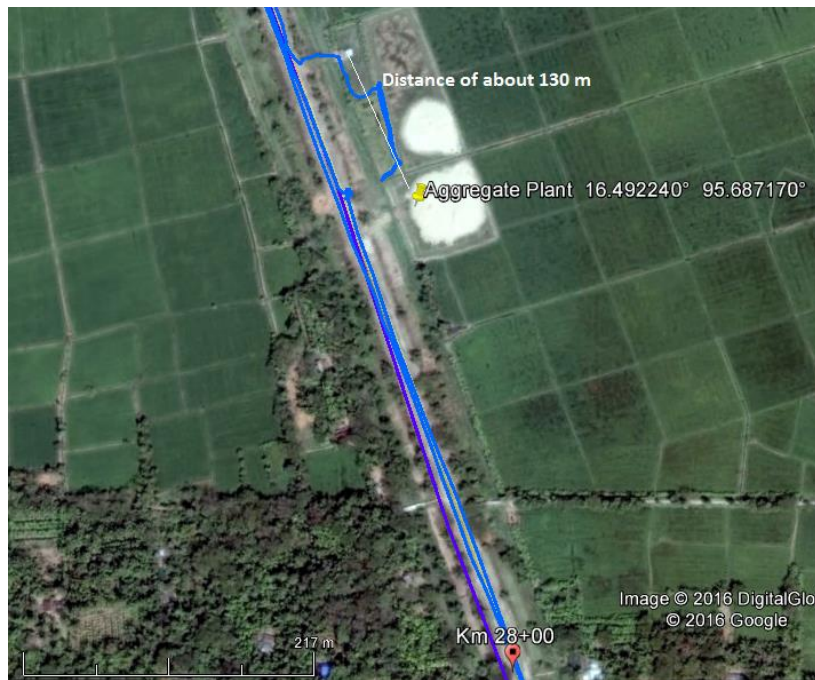
Figure 7. Location of ICB-2's aggregate crushing plant

The location generally follows the EMP guidelines for distance from nearest community, except for the presence one house along the road located about 130 m from the present position of the crusher (Figure 7). This house will likely be affected by noise when the crusher operates, assuming it generates a noise level of about 90db(A) measured at distance of 10 m from source. Applying the doubling distance rule, i.e noise reduction of 6 db(A) as distance between source and receptor is doubled, the house may experience noise levels of 60 to 70 db(A). The noise maybe attenuated by the placement of a barrier using aggregate stockpile between the crusher and the house. Depending on the actual condition on site, the house may still experience nuisance noise. Noise monitoring at this location should be done during the operations of the crusher plant.

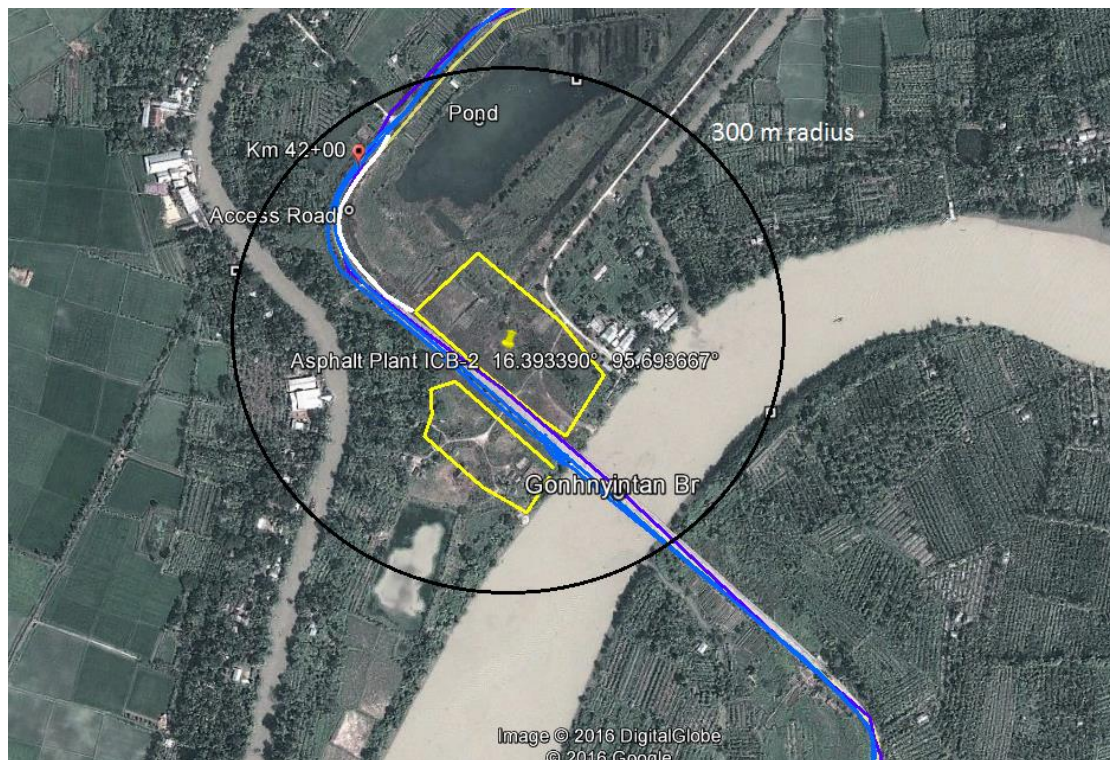
Figure 8. Location of the ICB-2 asphalt and aggregate stockpiles area

Assuming that the asphalt plant will be installed at the previously identified location (center of circle with 300 m radius shown in Figure 8), a few residences will be within 300 m of the assumed location, but mostly along the periphery. The structures located east of the assumed plant location (see Figure 8) are MOC buildings. The magnitude of the impacts of noise, dust and emissions during operations of the asphalt plant on those residences within 300 m are considered low considering the existing environmental condition. The site is open country, vegetated and sparsely populated. However, monitoring nuisance and other impacts through interview of residences shall be done when the asphalt plant is operational.

The main social and public safety concern in this site is that the access road of the asphalt plant and stockpiles site joins the main road near the junction of a community access road. It was observed during monitoring that people from the village wait for the buses at this intersection. The people waiting for bus ride congregate underneath a tree at the junction. The movement of trucks and project vehicles in and out of the site when the asphalt plant operates can expose pedestrians to traffic hazards. The Contractor should consult the village people regarding pedestrian and traffic safety and the need for a bus stop away from the intersection.

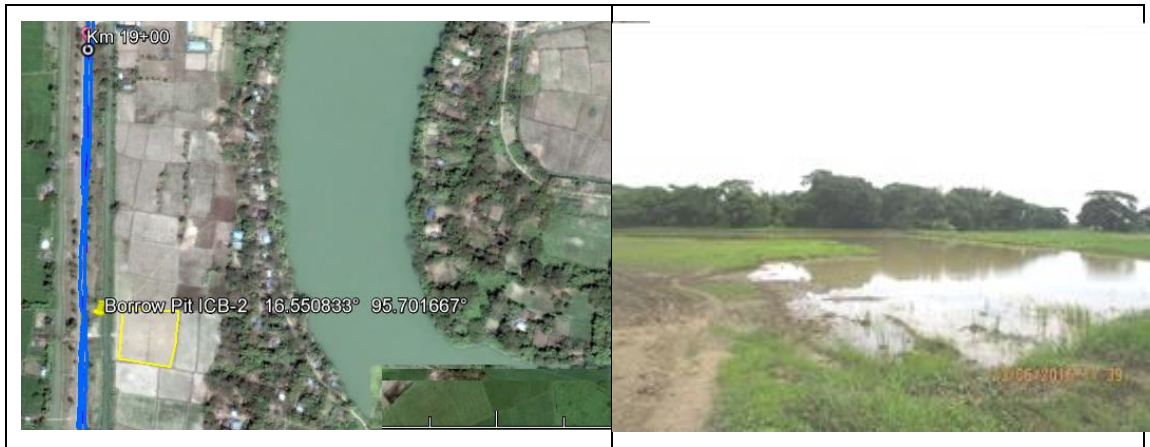
Figure 9. The location and present condition of the borrow pit

ICB-2 has purchase a land for a borrow pit located at about Km19+34. The location of the borrow pit is shown in Figure 9. Materials have been excavated and the pit is presently flooded (see photo in Figure 9). The borrow pit is still active as ICB-2 has still to excavate materials from it. According to ICB2, the site will be filled with sand after the excavation is completed as part of the abandonment plan.

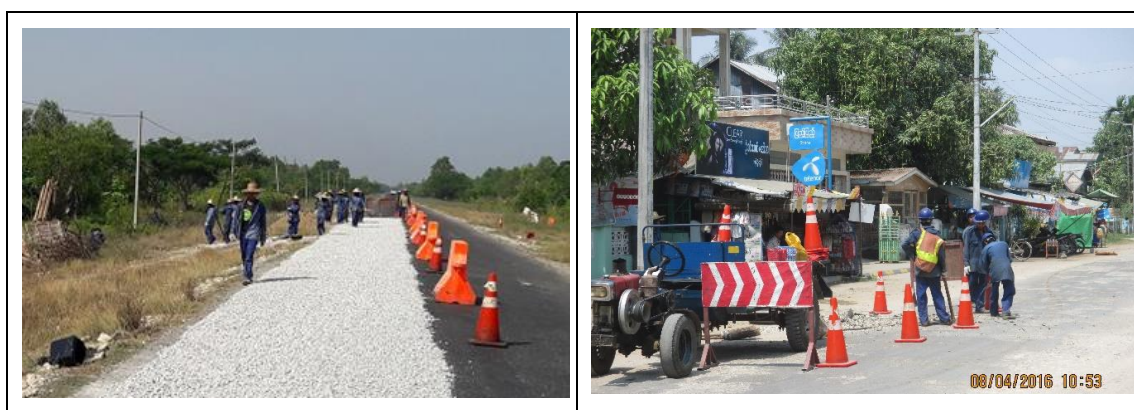
Figure 12. Road repair and maintenance, ICB-2 section

The repair and maintenance work requires the use of asphalt mix for repairing potholes and for this purpose, premix sites are set up. This is where bitumen is heated by open fire using firewood and then mixed with aggregate. The environmental concerns with this activity are the spillage of bitumen into the adjoining areas of the premix site and the general upkeep of the site. Empty bitumen drums, plastic packaging materials and other rubbish are strewn about the premix site. The Contractor should see to it that the workers tidy up the work place, collect and pile up the wastes for collection and disposal. Safety concerns regarding use of PPEs and use of sufficient traffic safety devices were also brought up to the Contractor's attention.
