PAKISTAN: New Bong Escape Hydropower Project Laraib Energy Limited Environmental and Social Issues Compliance Report (January 2014 to March 2014)

New Bong Escape Hydroelectric Power Project

Environmental and Social Issues Compliance Report

Jan 01, 2014 – Mar 31, 2014

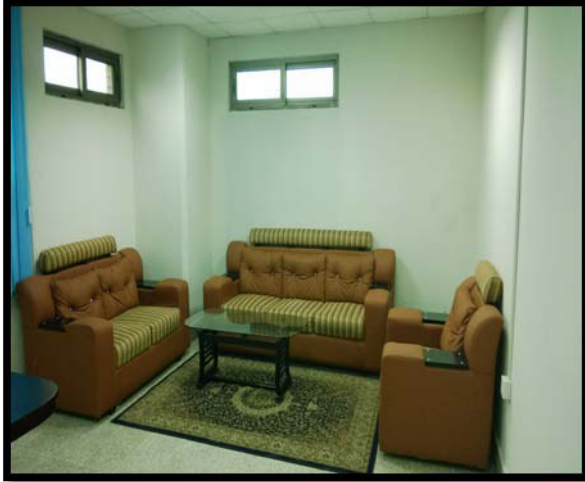
Observation No. 01

1. "No smoking" signboard found missing inside visitor room of Power Complex.			HSE Dept.	UC	Serious/Minor
2. Area segregation signboard inside the workshop is found missing for essential requirement of PPEs.			HSE Dept.	UC	Serious/Minor

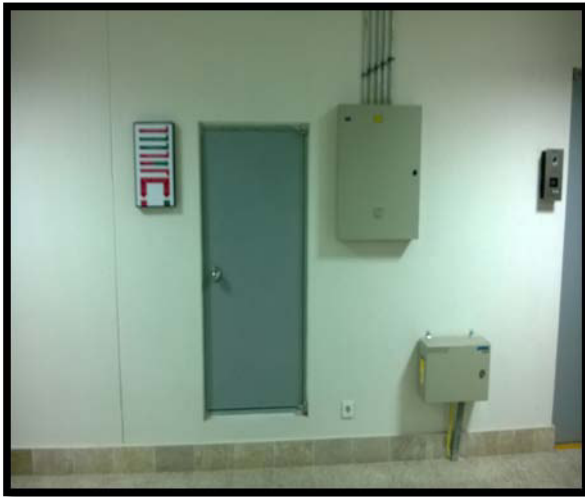
Observation No. 03

3. Warning sign found missing on all doors accessing to the cable shaft which falling hazard and have a potential of fatality. All doors which are not used in routine should be locked and warning sign should be pasted on all doors and panels.			HSE Dept.	UC	Fatality

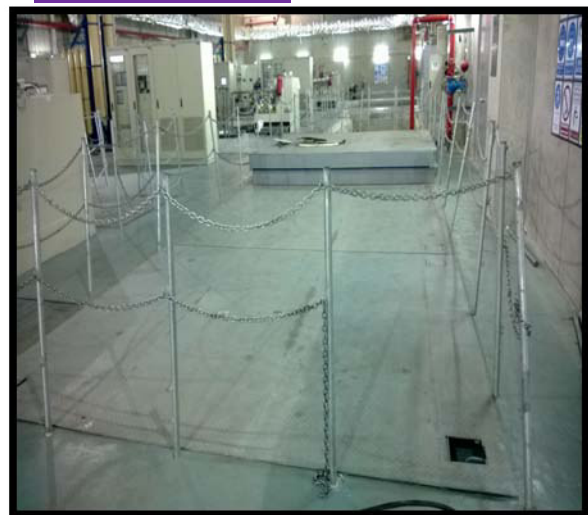
Observation No. 06

6. Safety hand railing at EL. 245 is found loose which has potential of fatality during the maintenance activities. Proper arrangement be made for properly fixing the safety railing			Maintenance (Civil) Dept	UC	Fatality

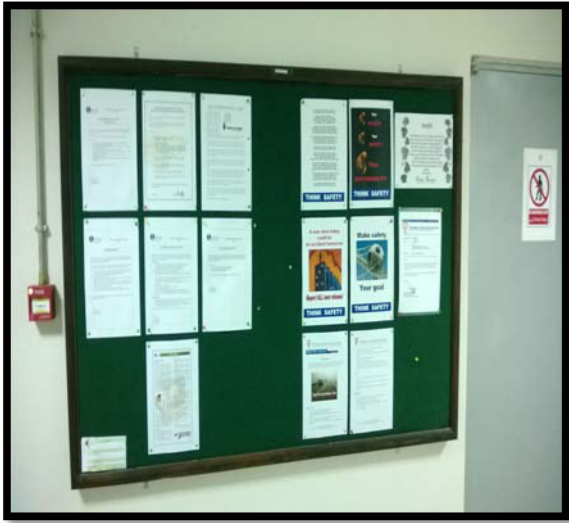
Observation No. 07

7. Signboard for Emergency exit /evacuation plan found missing on each notice boards at each Elevations.			HSE Dept	Procedure violation	Serious

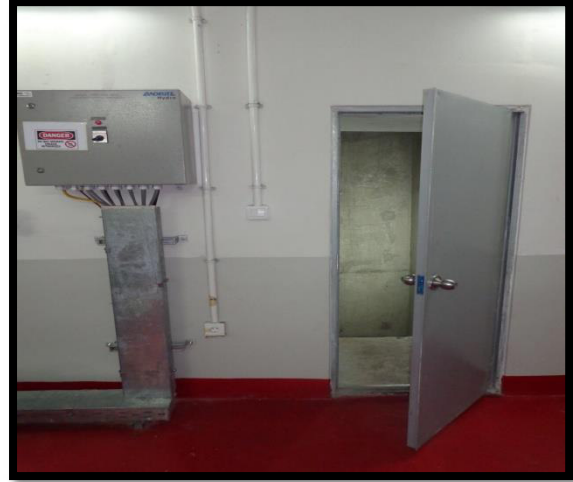
Observation No. 02

2. Warning sign found missing on all doors accessing to the cable shaft which is falling hazard and have a potential of fatality. All doors which are not used in routine should be locked. And warning sign should be pasted on all doors accessing the cable shaft.		HSE Dept.	UC	Fatality

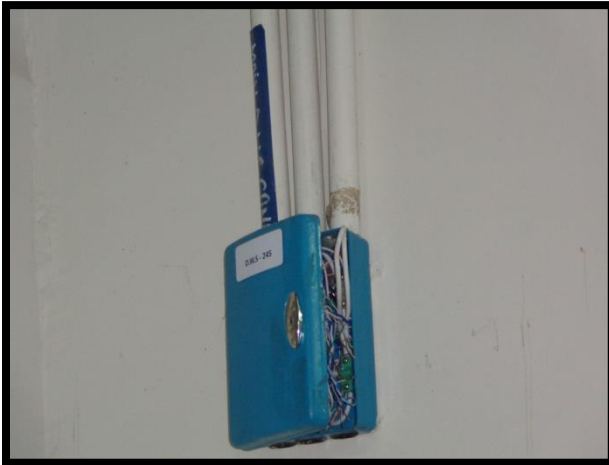
Observation No. 03

3. Telephone connection boxes found open and improper cables observed. All wiring should be properly dressed and cover closed.		Maintenance (C & I) Dept.	UC	Minor

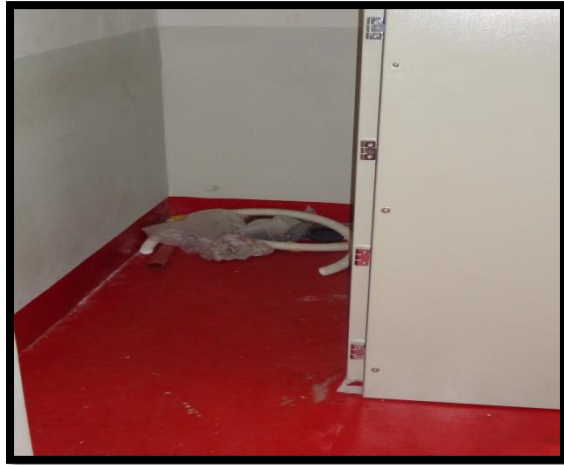
Observation No. 04

4. Waste material observed behind newly installed 11 kV colony power supply feed. Area should be cleaned		Support Services Dept.	UC	Minor	
5. 750 kVA DG radiator's water overflow pipe direction on floor which may cause slippery hazard when overflow. Plastic contained be placed under the overflow pipe.		Operation Dept.	UC	Minor

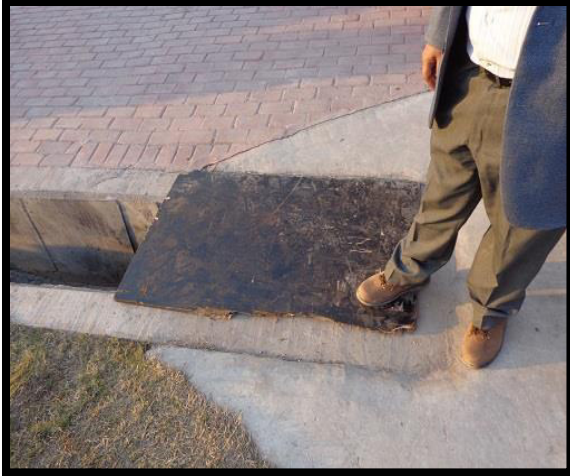
Observation No. 01

1. A trench covers with wooden piece near parking area which is a tripping hazard. It should be properly covered with a cemented blocks.		Civil Dept. (TNBRP/SAMBU)	-	UC	Serious/Minor

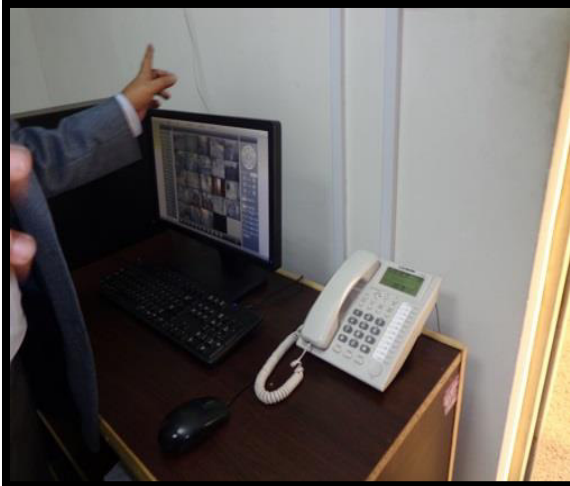
Observation No. 03

3. CCTV Camera No. 24 found out of order and display screen is very small. Camera has to installed according to drawing and small screen should be replace with large one		Maintenance (C & I) Dept.	-	UC	Minor

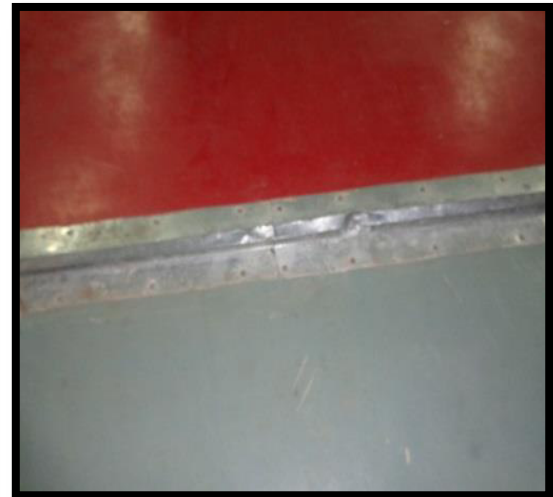
Observation No. 04

4. Power house floor joints cover is tripping hazard. Warning paint (yellow/black) should be applied on all covers.		Support Services Dept.	-	UC	-
5. Portable fire extinguisher inspection tags found blank. All inspection tags should be up to date according to inspection frequency.		HSE Dept.	-	UC	-

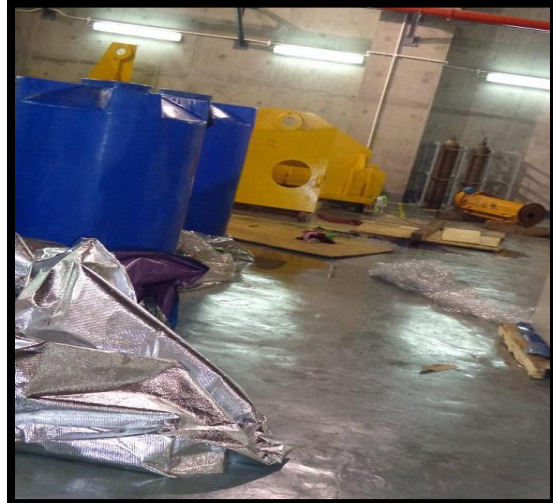
Observation No. 06

6. Oil spill observed on the floor of 245-elevation which is slipping hazard. Floor should be clean and dry.		Support Services Dept.	-	UC	Minor
7. Trench cover has found on floor which is tripping hazard. During maintenance work area should be barricaded.		Maintenance (Elec) Dept.	-	UA	Minor

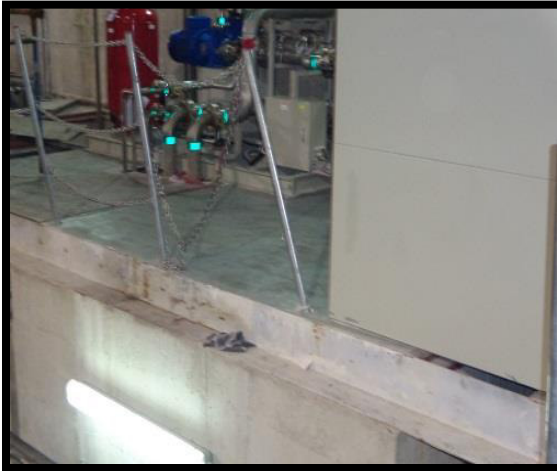
Observation No. 09

9. Loose portable railing observed at unit one 245-elevation. A warning tag and tape should display at location.		Maintenance (Mech) Dept.	-	UC	Fatality

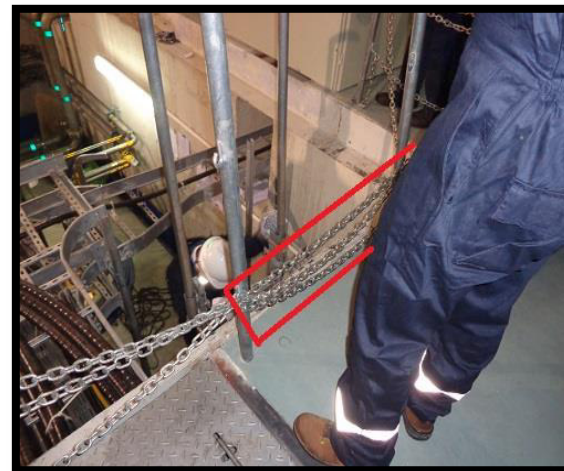
Observation No. 10

10. Portable railing chain of Unit 1 (bulb nose hatch cover) was not properly installed and has a potential of serious injury (tripping and falling hazard).		Maintenance (Mech) Dept.	-	UC	Serious/Minor

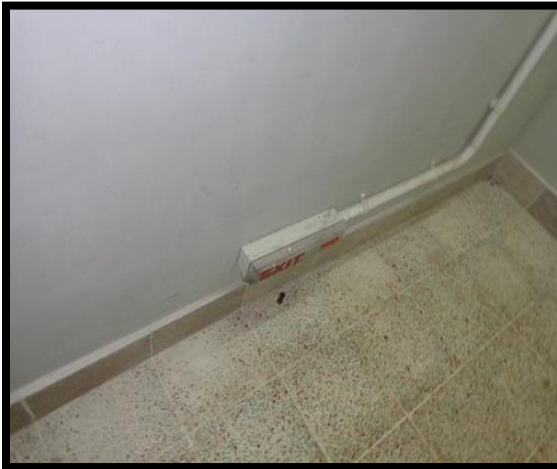
Observation No. 11

11. Some emergency lights found out of order, it could very dangerous in emergency situation. A thorough inspection of all emergency lights should be carried out during the annual turn around.		Maintenance (Elec) Dept.	-	UC	Serious/Minor

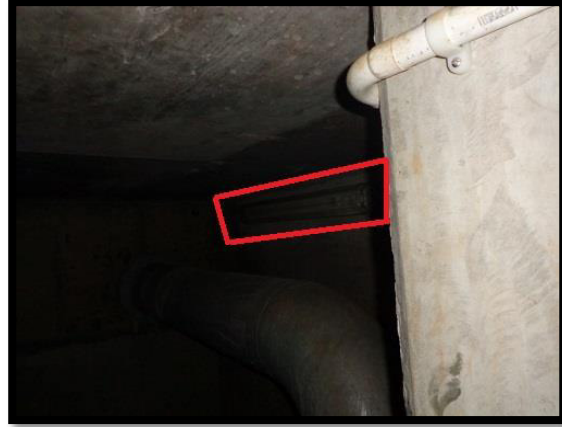
Observation No. 14

14. Drainage water Lights at 227- elevation observed out of order and No alternative arrangement is available.		Maintenance (Elec) Dept.	-	UC	Serious/Minor

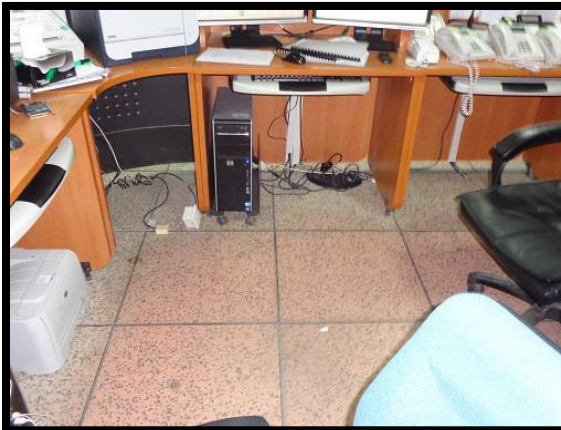
Observation No. 15

15. Loose wiring used in control with SCADA system. All loose wiring needed to be channelize properly through a duct.		Maintenance (Elec) Dept.	-	UC	Serious/Minor

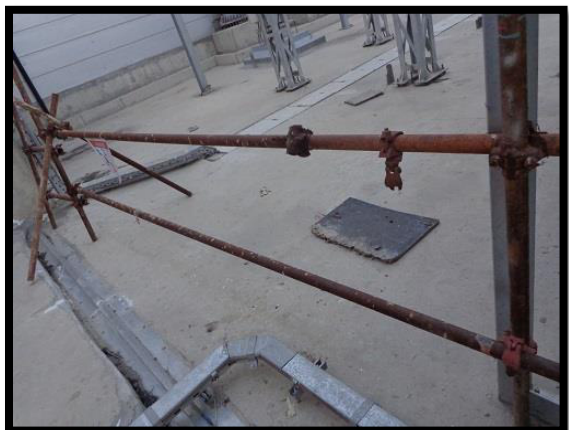
Observation No. 16

16. Rusty scaffolding used to barricade the transformer area. Scaffolding should be painted.		Maintenance (Mech) Dept.	-	UC	Serious/Minor
17. Electric cable lying on ground at intake stop log area which is a tripping hazard. Cable should be passing through the underground.		Maintenance (Elec) Dept.	-	UC	Serious/Minor

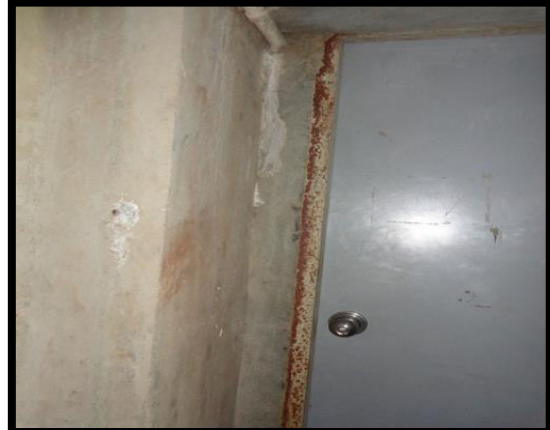
Observation No. 18

18. Rusty door observed at 227- elevation, it should be painted.		Maintenance (Mech) Dept.	-	UC	Minor
