Nam Ngiep 1 Hydropower Project (Lao People's Democratic Republic)

Quarterly Monitoring Report 2015 – Q3 Environmental

Third Quarterly Monitoring Report (3rd QMR)

July to September 2015

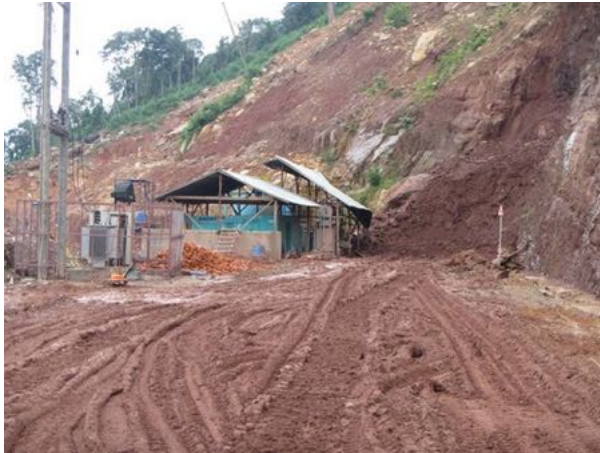
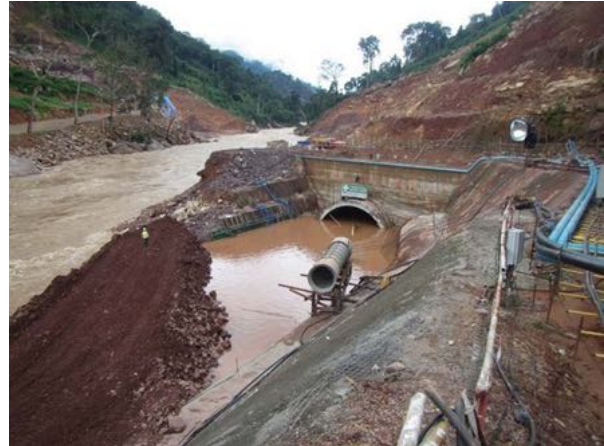
On 30 July 2015 at 7.00 a.m., prolonged heavy rain triggered slope collapse (100m³) which damaged a part of the Turbid Water Treatment Plant, specifically the pipes that connect chemical tanks to the filtration system at the Outlet Diversion Tunnel site (see Photo 1 and 2). The broken pipes caused an uncontrolled leakage of 150 litres of Sulfuric Acid- H₂SO₄ at 25% dilution (i.e. 75% water) and polymer into the local environment. No injuries were recorded.

As soon as the site was safe to access, at 9.00 a.m., water samples from the nearby pools and the tunnel site were tested by the main Contractor. These were found to have a normal range of pH. Spills were contained to local areas with some over flow into the tunnel excavation site that was inundated by floodwaters at the time. Two EMO Compliance Officers were deployed to assist the contractor and to independently evaluate the situation. Environmental Monitoring Team was deployed to Hat Gnuin village to sample the Nam Ngiep located downstream of the incident site for pH and to monitor if there were fish kills. It was found that the pH level was normal and that no fish kills were occurred.

At the time of the deployment the actual volume of leaked acid and polymer could not be verified. No delay of construction schedule resulted from this incident, but tunnel flooding delayed works for several weeks. After carrying out the initial responses and assessments, the main contractor removed overburden from the treatment plant and started repair.

Photo 1 and 2: Landslides and Treatment Pond Pipes (Second picture on the left in blue) Relative to the Tunnel

It was agreed that since there is less than four weeks of construction activities remaining at the site and if the current manual treatment remains effective, then repairing and re-commissioning of turbid water treatment system is not warranted. The manual treatment of effluent will continue until the completion of the diversion tunnel construction works.

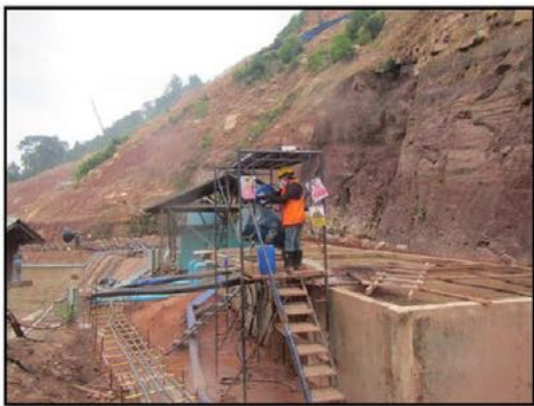
Photo 3: Manual Application of Sulphuric Acid (H_2SO_4) at the Diversion Tunnel Sediment Ponds

is filtered and treated to meet the required Standard, it is discharged directly into the Nam Ngiep. Due to the landslide occurred at the end of July 2015, the filtration plant at the Diversion tunnel was broken and out of use since then. However, Sulfuric Acid (H_2SO_4) was manually added to the sediment ponds as a temporary method for pH adjustment.

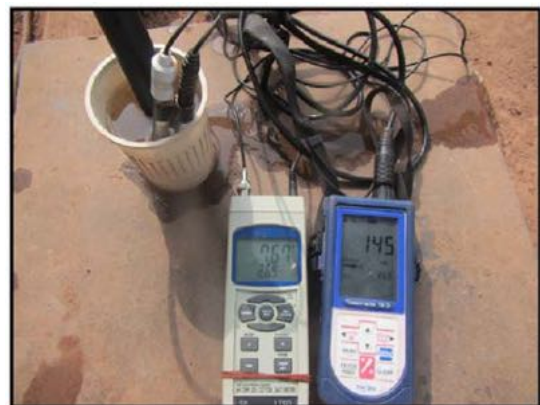
Photo 4: Manual Monitoring of pH and Turbidity at the Diversion Tunnel Sediment Ponds

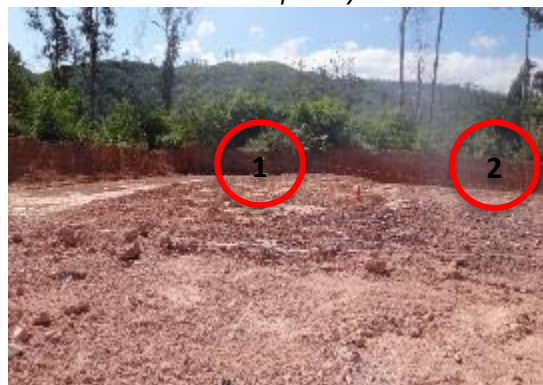
With approximately 2200 workers on site, the project generates about 117 m³ of uncompressed solid waste each month. Each cubic meter of solid wastes is approximately 200 kg, but this increases to 500 kg when compressed. This will occur after the transfer to the completed landfill. Originally two temporary pits (each of approximately 300 m³ capacity) were installed at the landfill site in March 2015 by the Civil Work Contractor (see Photo 6 and 7 below). Once a permanent landfill construction is completed, wastes in these pits will be exhumed and placed in the properly designed landfill. At the end of September four temporary pits were opened at the landfill site.

Photo 6: First Two Temporary Waste Pits

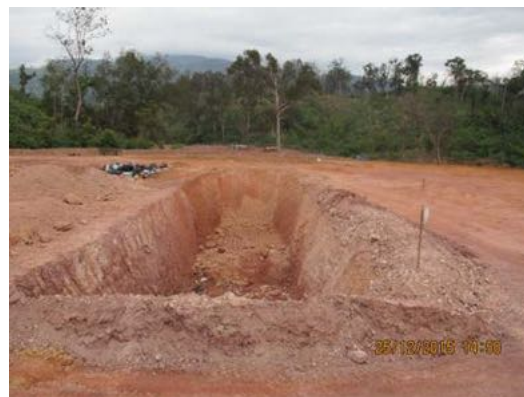
Photo 7: The Fourth Waste Pit

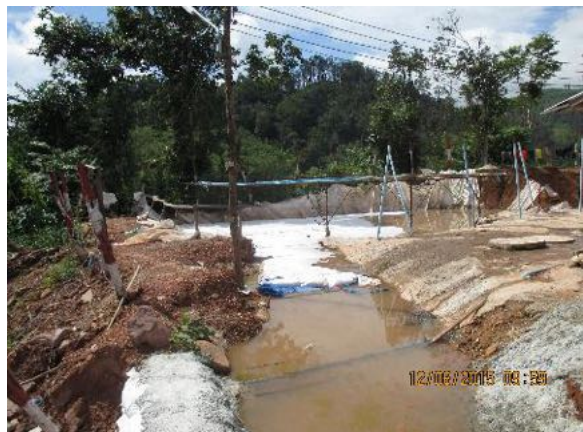
RT Camp (EF05): It was found that Fecal and Total Coliforms exceeded the National Standard for the Third Quarter. The estimated volume being discharged was approximately 100 m³ per day. The wastewater separation system (kitchen wastewater and general wastewater) of the RT and improvement of an aeration system at wastewater treatment pond are significant factors to improve the effluent discharge from this camp.

Photo 21: Right Tunnel Camp's Grey Water Treatment Pond

However, the monthly site inspection at this camp found that seepage from the system continues to be a problem and additional improvements to the system have been requested to the sub-contractor. Thus, all camps' WWTS were assessed by an independent consultant-Pacific Aquatech Pty. Ltd., a Thai based environmental engineering company experienced in WWTS design. In September 2015, a final report on the recommended design changes for the camps was provided to NNP1PC. A joint internal review of these recommendations will be carried out in October to agree on the next steps.

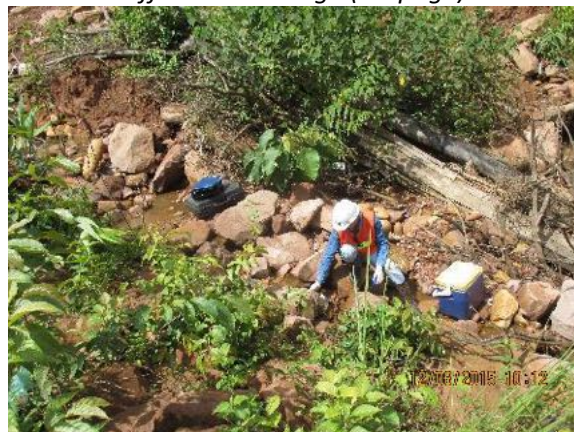
Photo 122: Location of the Right Tunnel Camp Effluent Discharge (seepage)

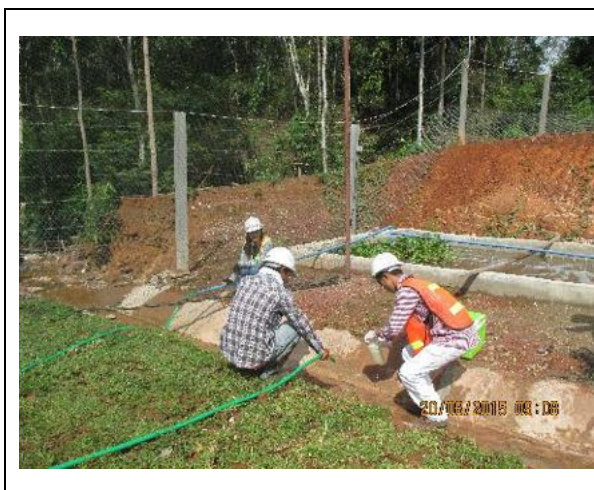
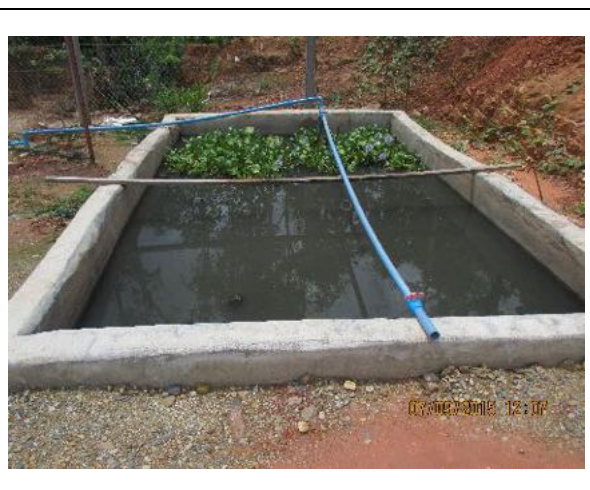
Obayashi Camp (EF02): It was found that the Total Suspended Solids (TSS), BOD, COD, Ammonia-Nitrogen, Faecal Coliforms and Total Coliforms were above the prescribed National Standard for the Third Quarter. Total discharge volume was approximately 200 m³/day.

Photo 23: Obayashi Grey Water Treatment System Discharge Location

For more information on the corrective actions, refer to a section on Results of Non-Compliance Management in Appendix 2.
