Draft Environment and Social Compliance Audit – Part 2

GEO: Adjaristsqali Hydropower Project

Prepared by Mott MacDonald for Adjaristsqali Georgia LLC

Environmental and Social Compliance - Verification Audit

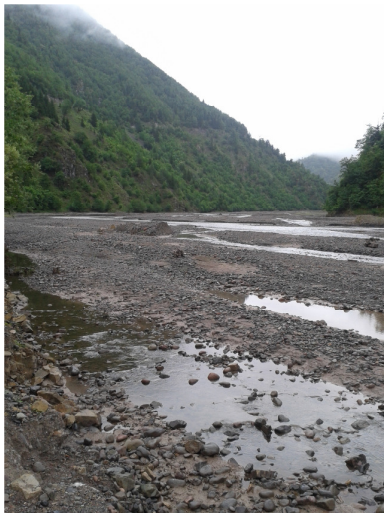
Photo A.1: View across the washed out road at Tsblana Photo A.2: New bridge and access road at Didachara

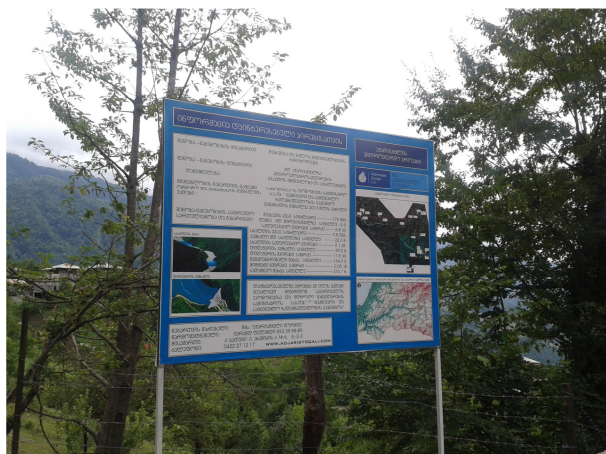
Photo A.5: Site signage on the road at Akhaldaba

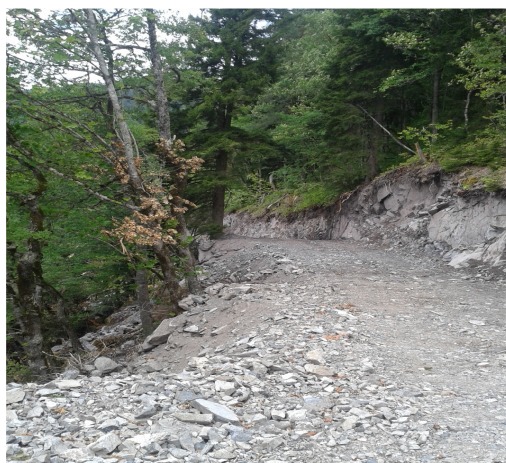
Photo A.6: Access road up to the tunnel site at Akhaldaba
