Semi-annual Environment & Social Monitoring Report (January to June 2015)

GEO: Adjaristsqali Hydropower Project

Prepared by Adjaristsqali Georgia LLC

Reporting Period: 01 Jan 2015 – 30 Jun 2015

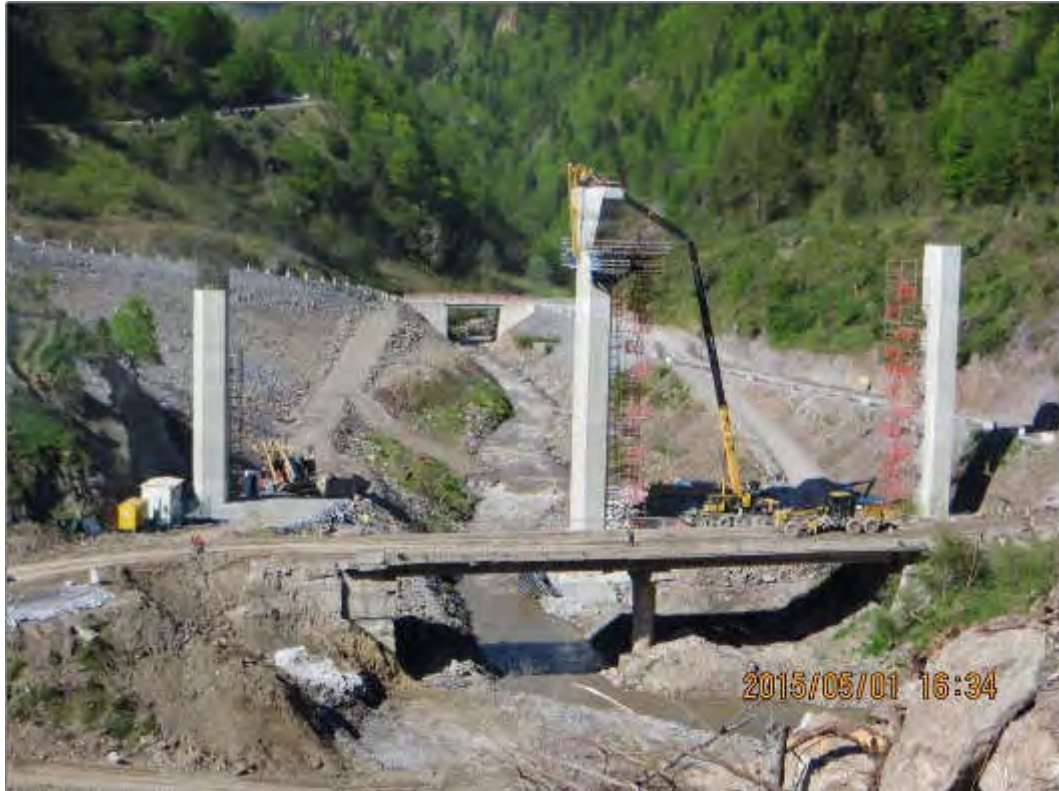
Photograph 1 Crane with buckled mast and fly-jib

- Failure to stop work and to reassess the situation which should have resulted in a decision to cut the “carrot” where it was stuck.
- The crane did not have an overload alarm to warn when exceeding the safe working load, which may have acted as a warning.

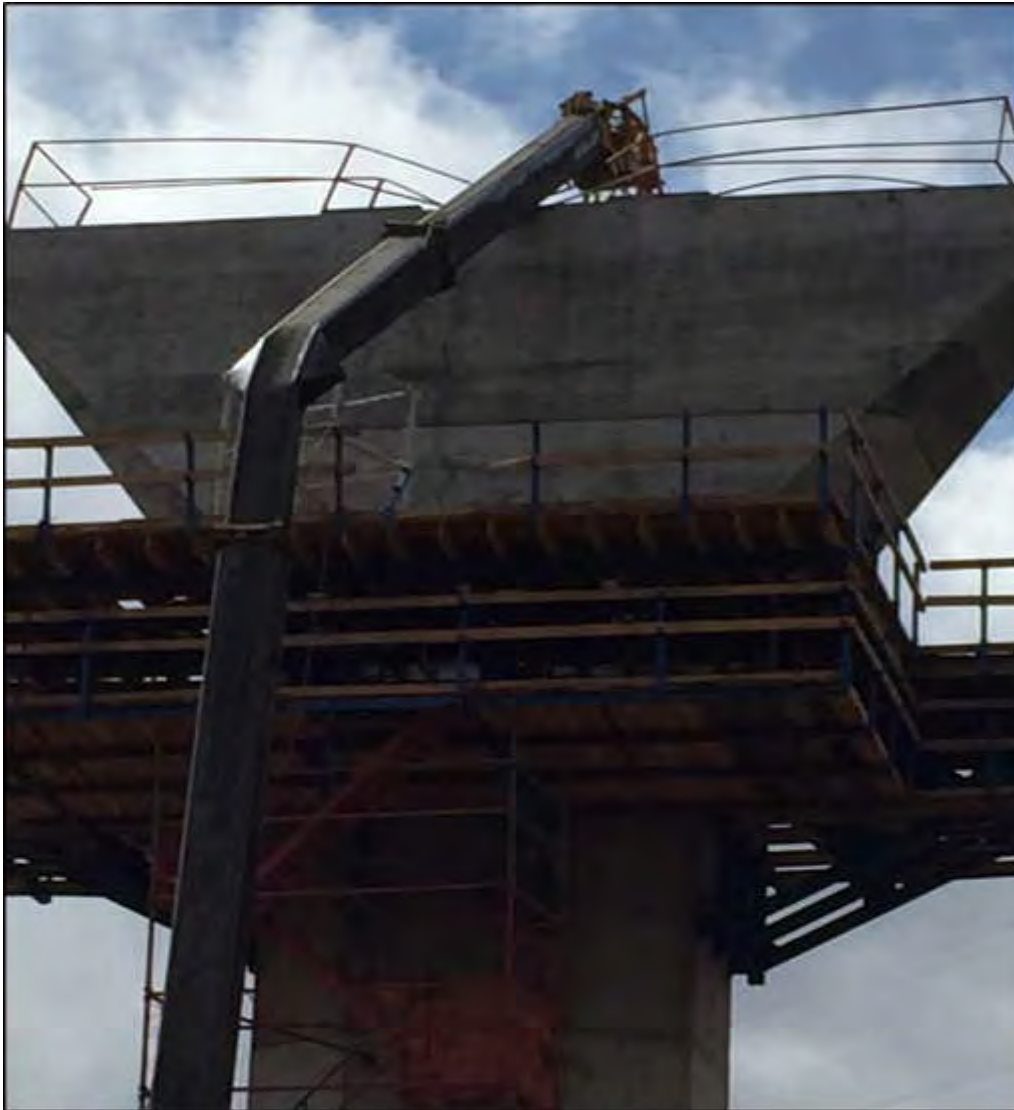
Photograph 2 Crane mast buckled

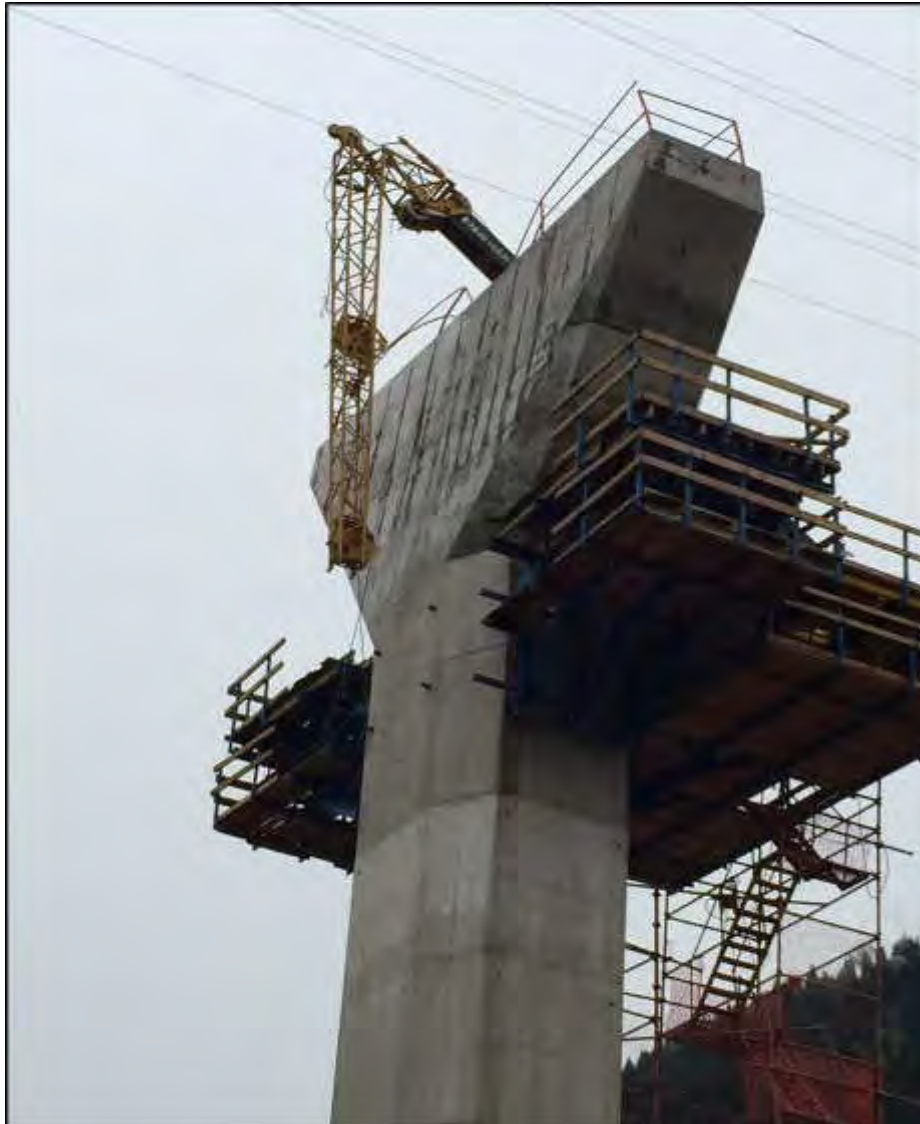
Photograph 3 Fly-jib buckled, showing two sections of fly-jib were used

During the investigation, an alternate crane table was also being referred to by the contractor which was labelled as being for a Liebherr LTM 1050-4 (with 4 axles) and this indicated a capacity of 3.6 tonnes without a fly-jib and was reduced to 3.05 tonnes with two sections of fly-jib. It was not known which (if either) of these two crane tables were used by the crane operator and the AGE Works Manager to determine the safe working load of the crane for the failed lift.

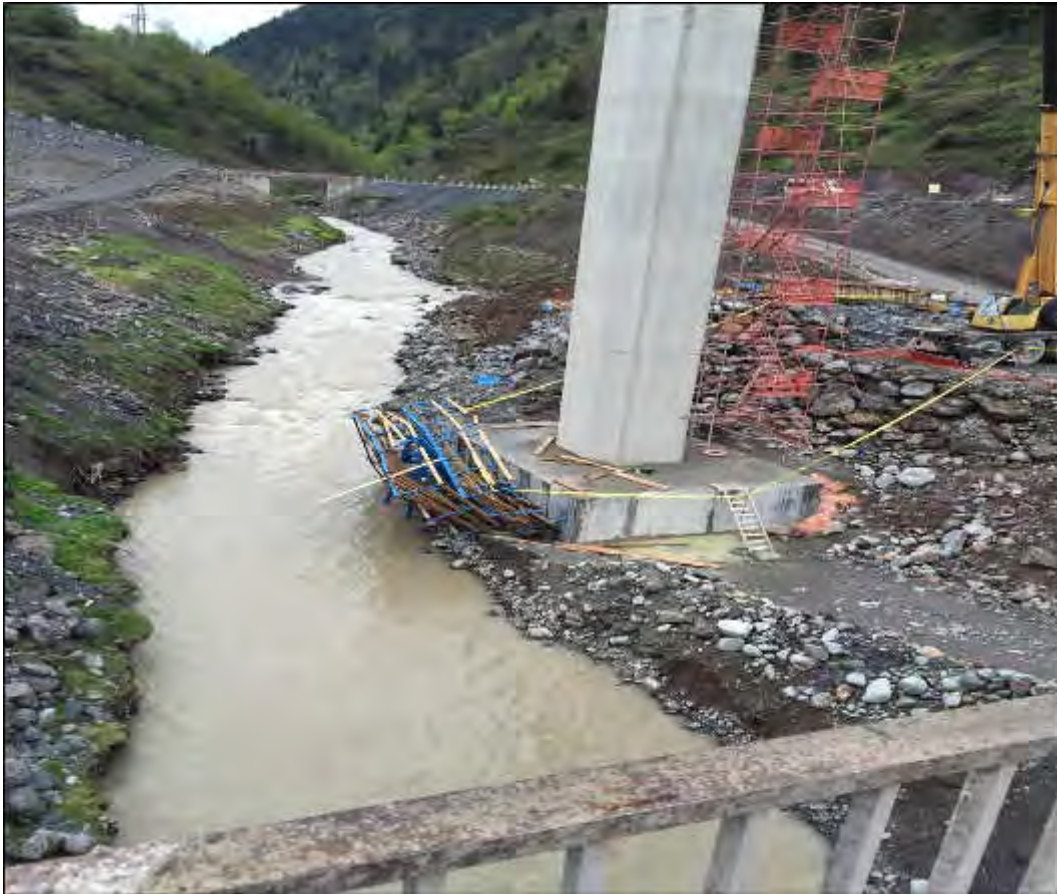
Photograph 4 Fallen work platform

The contractor's investigation report noted that the working environment and conditions had changed, as the platform had additional elements added after it was first installed. This was supported by comments made during the interview with the survivor of the accident who said that it was the largest platform so far to be dismantled. He said that it was the largest platform used so far because the size of the pier increased towards the top of it, and it was the first time that this larger platform had had to be disassembled and removed from the top of the pier.

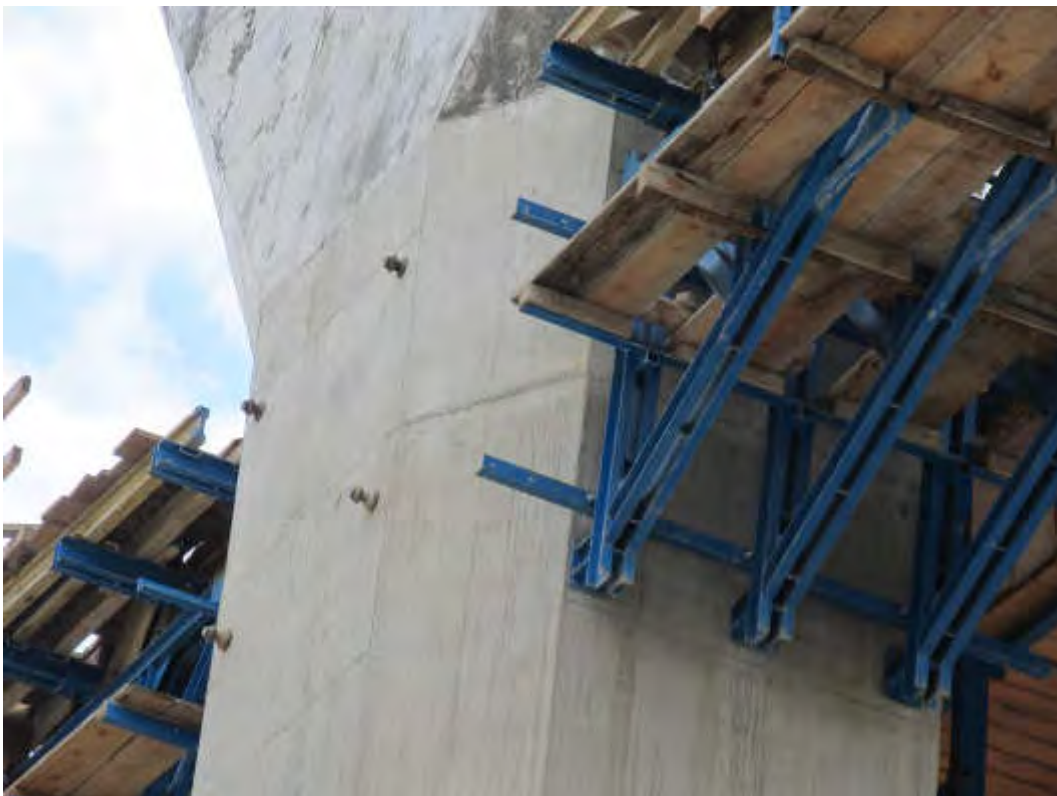
The team on site found that the tapered locking pin, locally referred to as a “carrot” (which was supporting the platform) and the platform were stuck when they tried to remove the platform from its position, and it could not be lifted up to release it from the “carrot”.

Photograph 5 Tapered locking pins where the fallen platform had been fixed to pier 2

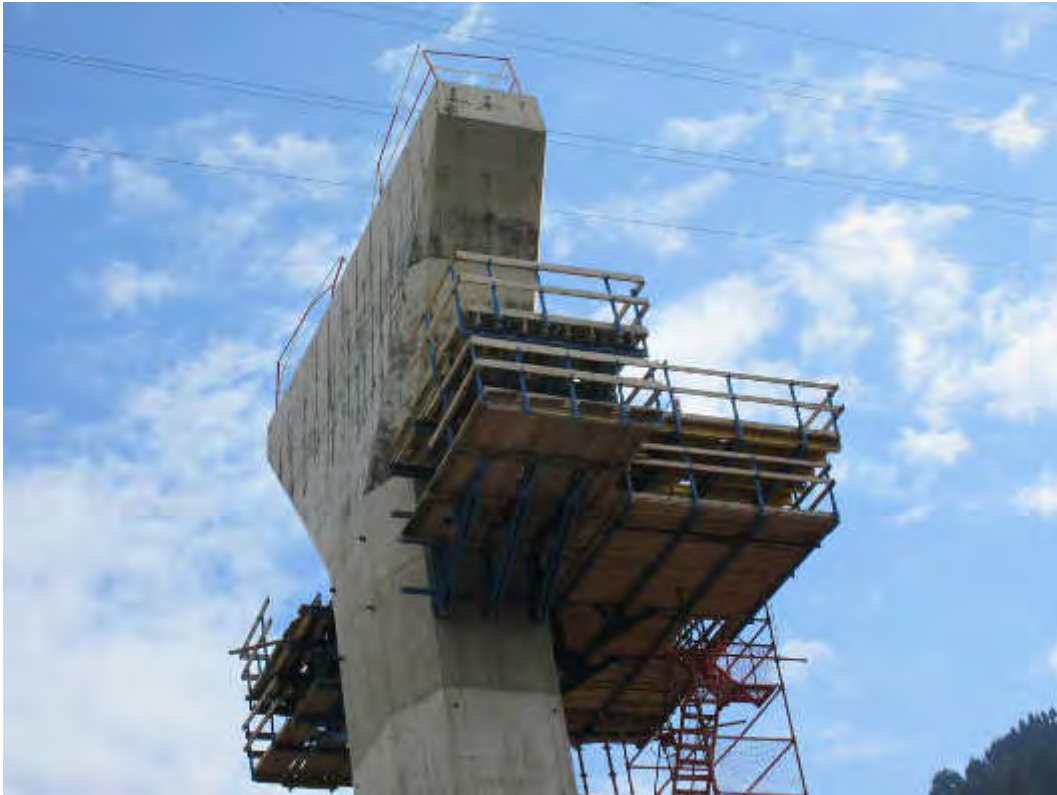
Photograph 6 Pier 2 at the time of the site visit for this investigation

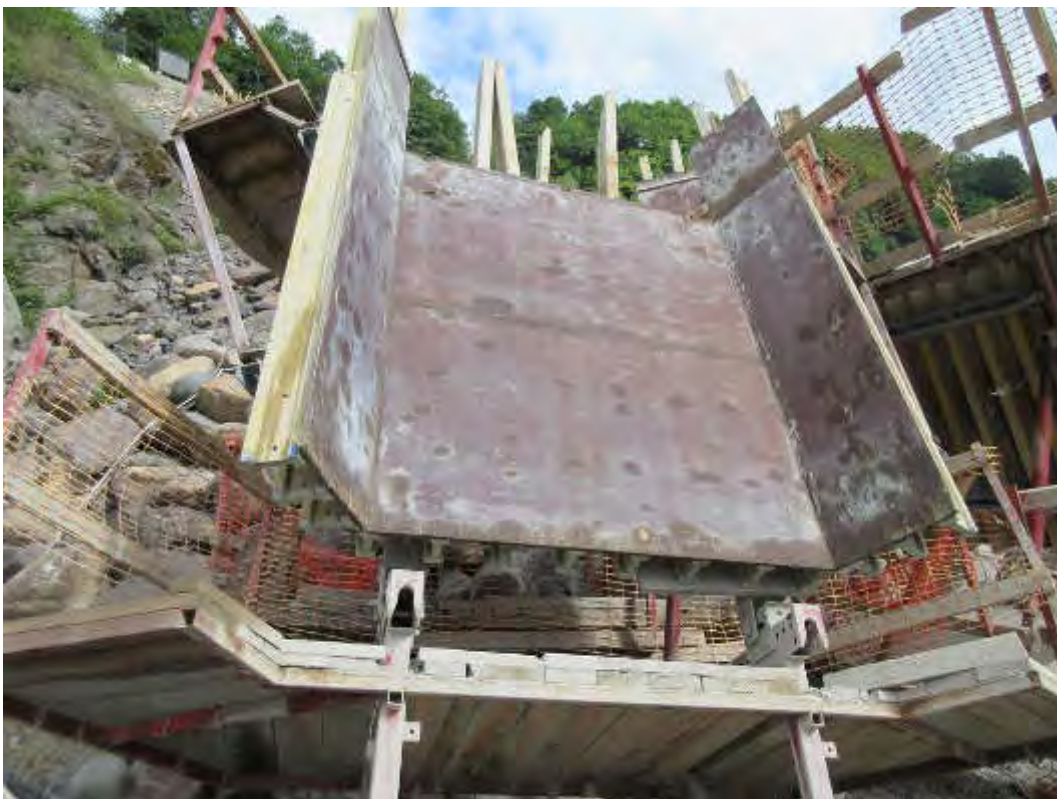
Photograph 7 Platform which had been removed from pier 1 showing slot that receives the tapered locking pin

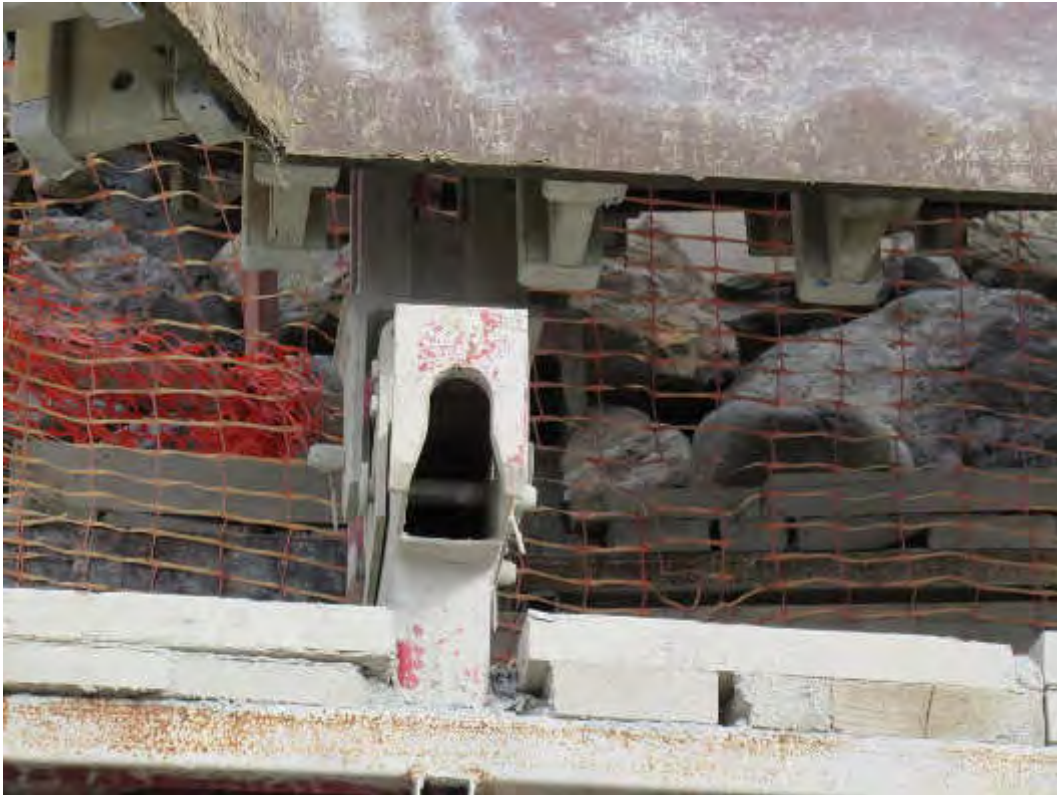
Photograph 8 Close up of slot mechanism that receives the tapered locking pin
