Environmental Monitoring Report

Project No. 42122-013 and 42122-016
Biannual Report
August 2017

Loan 2761 & Loan 3256-BAN(COL): Third Primary Education Development Project and Third Primary Education Development Project- Additional Financing

REPORT ON ENVIRONMENTAL SCREENING AND MONITORING OF
WATER SOURCES AND WASH BLOCKS INSTALLED AND HANDED
OVER TO PRIMARY SCHOOLS FROM (JANUARY 2017 TO JUNE 2017)

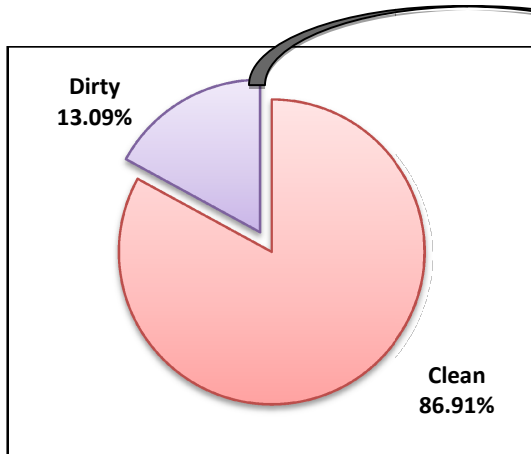
Figure 7: Environment of Water Supply Facility

In most of the cases environment have been found clean (86.91% of total 4,034). Out of 4,034 Water Points, environment of 13.09% are found dirty [Figure-7]. Water Points installed in Dhaka, Sylhet, Khulna, Rangpur, & Chittagong division have got mostly clean environment whereas, the worst condition (16.34%) is found in Barisal division. Though Barisal was found as worst condition division in last report also but the percentage is decreased. Worst case scenario for other divisions is in the range of 10.29-15.6%. Causes of dirty environment of water supply facility are improper drainage, growth of algae, dumping of waste near tube well, inadequate cleaning of platform etc.

It has been revealed that even after several caretakers' training, monitoring and routine maintenance, 1.56% of the water points sites were found unclean/dirty. However, the overall situation improves from the previous three of four submitted environmental reports (6%, 4% & 1.7% in the earlier reports) produced but close to the last report (1.45%).

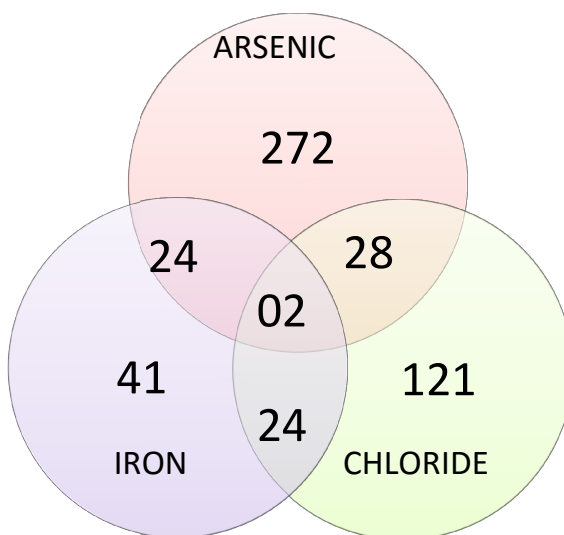
Figure 10: Arsenic, Iron & Chloride Contamination

Out of 32,721 water sources (as shown in Table-1) as installed so far under this project, 512 had serious concern about water quality i.e., the arsenic, iron and chloride content exceeds 50ppb, 10mg/l and 600mg/l (1000 mg/l in coastal belt) respectively. The water quality of the installed water points in this tenure was found in allowable limit. Figure below shows the fact in details. As per MoU between DPE and DPHE, these water sources were not handed over to the primary schools.

In cases where arsenic/iron/chloride is found beyond allowable limit in installed water source, DPHE adopts other approved alternate water options DPHE goes for options like deep tube well of greater depth, ring well, pond sand filter, rain water harvesting, AIRP etc. whichever is feasible.

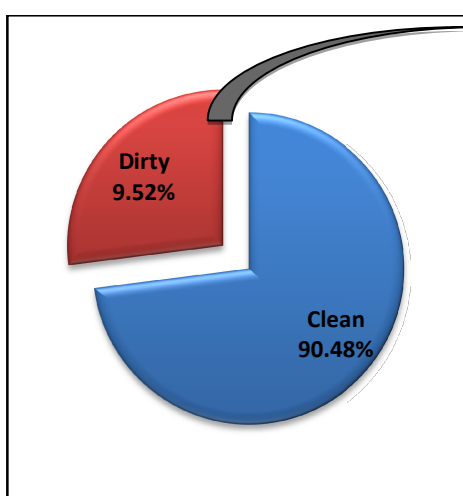
**Figure 15: Cleanliness of Wash block**

It was found during the monitoring phase that, out of 42 handed over wash blocks, only 9.52% was dirty [Figure-16]. The major reasons of the unclean environment were less or no use of water, clogged drains, breaking of soil pipe, robbing of water tap, basin, pump etc.

The schools having concerns about cleanliness, were taken into consideration and mitigation measures were suggested during implementation and monitoring phase. Upazilla level officers of DPHE such as Assistant Engineer, Sub assistant Engineer conducted through promotions and campaign in this regard. Figure-17 below shows that, Executive Engineer, DPHE, Bandarban is in a hygiene promotion campaign all the teachers of primary school. Figure-16 shows that, because of taking mitigation measures during implementation and monitoring phase, Cleanliness of Wash Block improves and thus reduces the percentage of dirty environment from 9.52% to 4.76% i.e. dirty environmental condition improves.

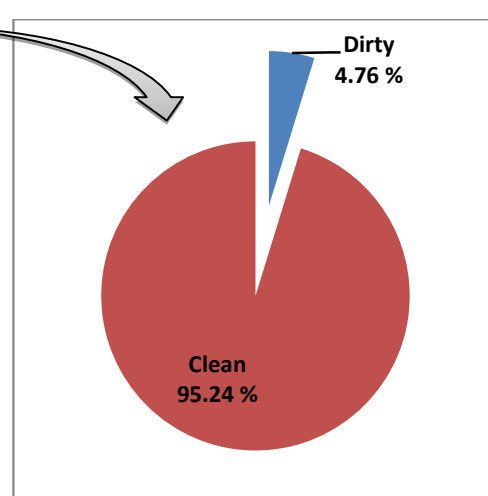
**Figure 16: Impact after Implementation**

It has been revealed that even after several caretakers' training, monitoring and routine maintenance, 4.76% of the Wash Blocks were found unclean/dirty in this tenure. This is a much improved condition in comparison to the earlier observed environmental reports. It is suggested that SMC should look after and pay proper attention in protecting the fixtures provided with Wash block and run regular cleanliness program.

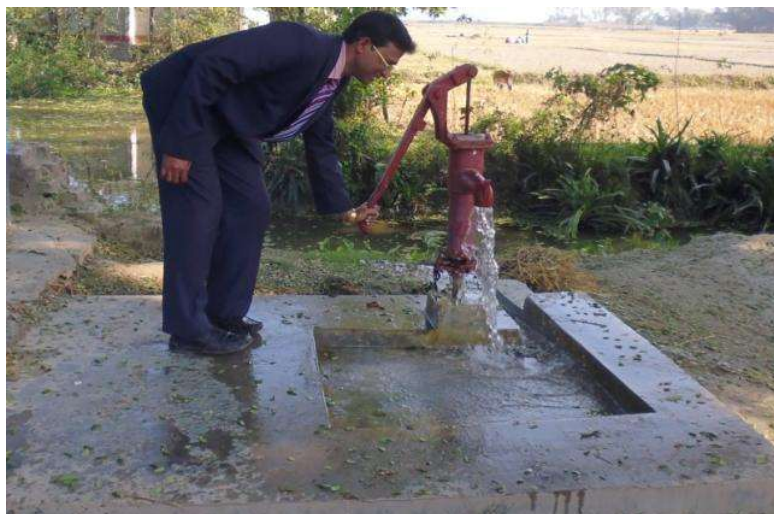
Figure-20: Water Source

After installation of tube well, DPHE local office monitor the water quality and also will monitor functionality, use and cleanliness of the water supply facilities for at least two years after the handing over of the facility. If the water quality parameters are within allowable ranges, the tube-well is treated as a successful one. Then the platform including drainage is constructed as per standard design & specification. Tube well was installed in this school in 2017. During visiting time functionality of the tube well and cleanliness of platform was found ok and drainage facility was also monitored it was found ok. DPHE local office took initiative in solving these issues. Mechanics along with concerned contractor facilitated the drainage system and improved the environmental condition. However, even after taking mitigation measures, if the school drainage remain congestion. Then it is hence suggested that, SMC needs to look after this issue and run regular cleanliness program in the existing drains.

During post evaluation phase in June, 2017 the findings were found satisfactory and the water source was found functional.

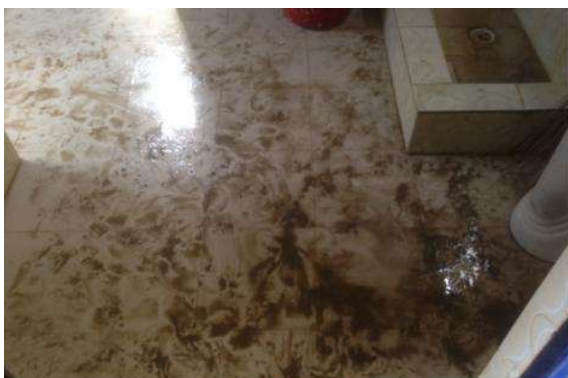
Figure 21: Before Cleaning

Wash Blocks for MT & Boys and FT & Girls were constructed in the above mentioned school during November, 2016 to February, 2017. The wash block was handed over to SMC. During Care Taker training regular cleaning and process how to clean of WASH Block was discussed. It was found during the first monitoring phase that WASH Block was dirty. The major reasons of the unclean environment were less use of water, clogged drains, breaking of soil pipe, robbing of water tap, basin, pump etc. The schools having concerns about cleanliness, were taken into consideration and mitigation measures were suggested during implementation and monitoring phase. The WASH Block has been monitored 2nd time after 2 months of hand over. It was found that The WASH Block was found clean. It is however suggested that SMC should look after and pay proper attention in protecting the fixtures provided with Wash block and run regular cleanliness program In each and every wash block, there exists a foot washing facility with a water point. Figure below shows the pictures were taken before cleaning and after cleaning during monitoring phase.

At the time of handover to SMC, Sub-Assistant Engineer, Kamalganj, Moulvibazar took initiative in giving caretaker training to the school. During caretaker training, following issues were covered:

- a) Proper use of wash block
- b) Hygiene practice
- c) Cleanliness & maintenance aspect
- d) Emergency contact to DPHE local office shortly

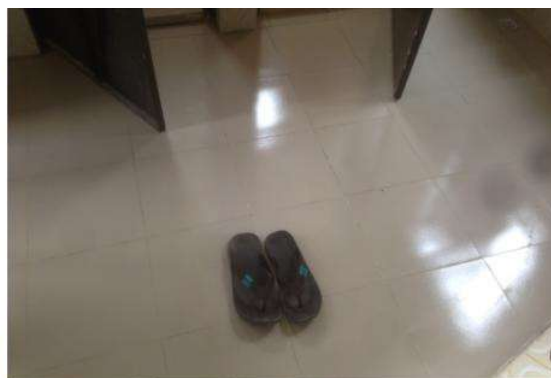
Figure 22: After Cleaning

The post monitoring visit on June, 2017 by SAE of Kamalganj Upazilla shows that the school is following the maintenance scheme properly.
