Environmental Monitoring Report

Annual Report
January 2013

**GEO: Sustainable Urban Transport Investment
Program — Tranche 1**
(Rehabilitation and Reconstruction of Secondary
Road Zugdidi-Jvari-Mestia-Lasdili KM.74-KM.80,
KM.89, KM.91-103 and KM.21-KM.125)

**Project: Rehabilitation and Reconstruction of Secondary Road Zugdidi-Jvari-Mestia-
Lasdili KM.74– KM.80, KM.89, KM.91 - 103 and KM.21-KM.125**

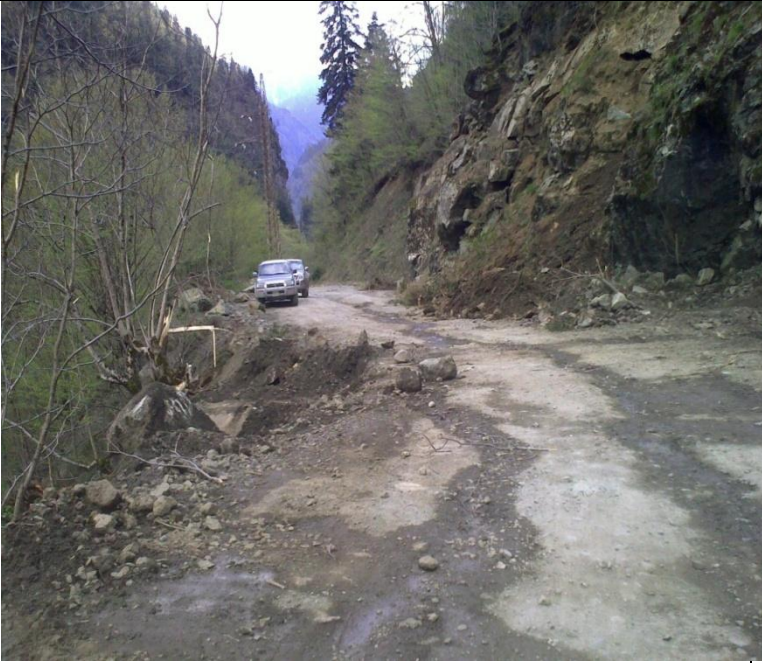
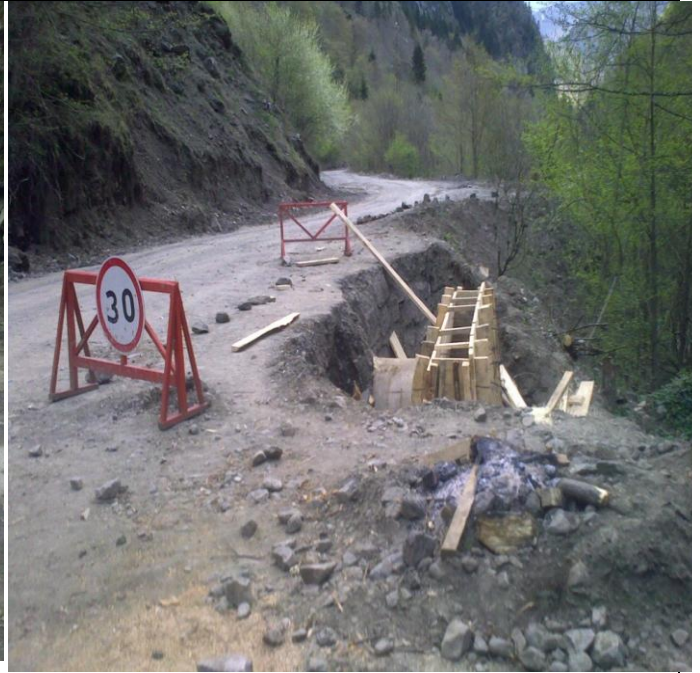
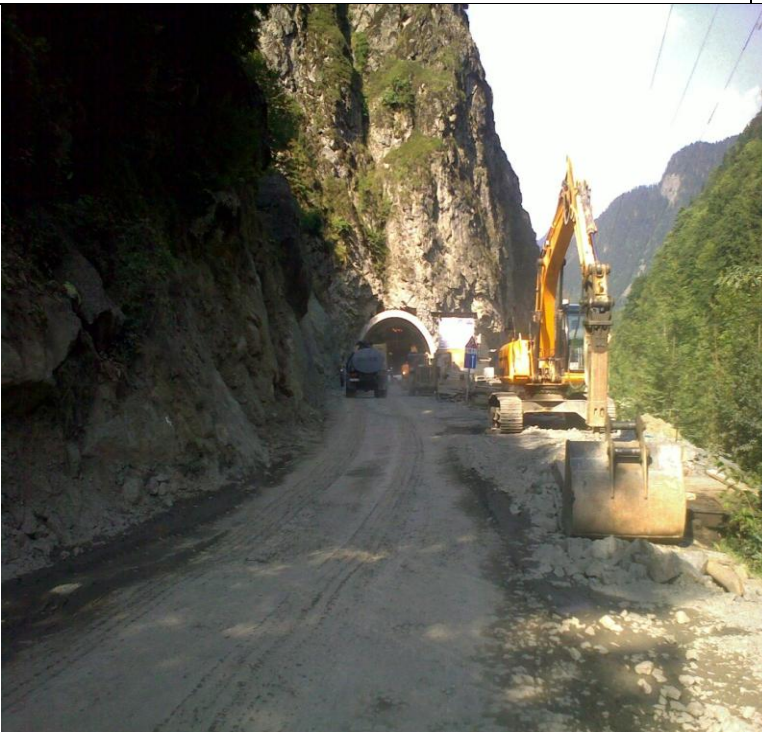
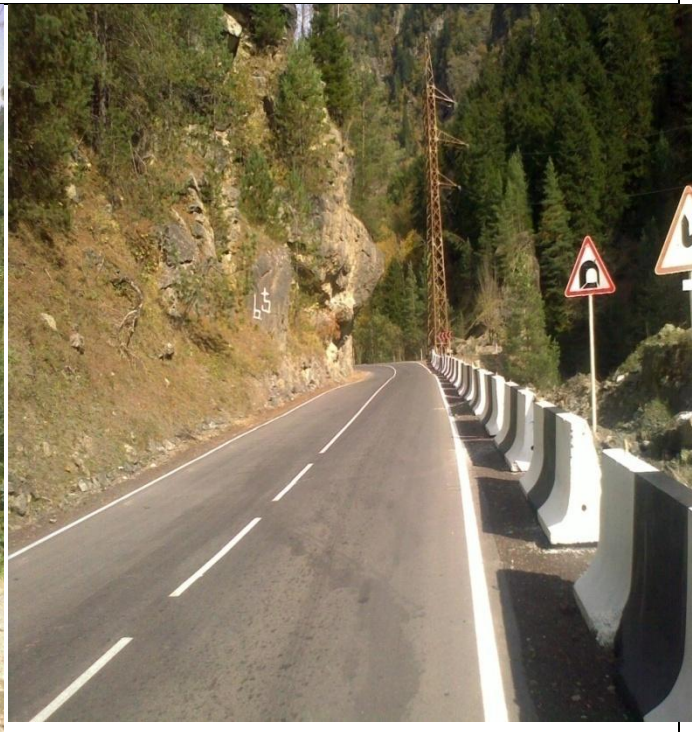
Rehabilitation of section km 74 – km 80 of the Secondary Road Zugdidi-Jvari-Mestia-Lasdili

During monitorings in 2011.04.27 and 2011.05.23 contractor was issued a warning concerning road signs (installing of road signs on construction site, camps and access roads).MDF supervisor was informed about all the above-mentioned to take relevant measures. During monitoring in 2011.06.27 was observed the same violation. First Deputy of Executive Director of MDF was notified about the above-mentioned. Her had a meeting with contractor and issued a strict warning to avoid the similar cases.Due to 2011.07.26 monitoring contractor took into consideration issued remarks and provided certain section with road signs.

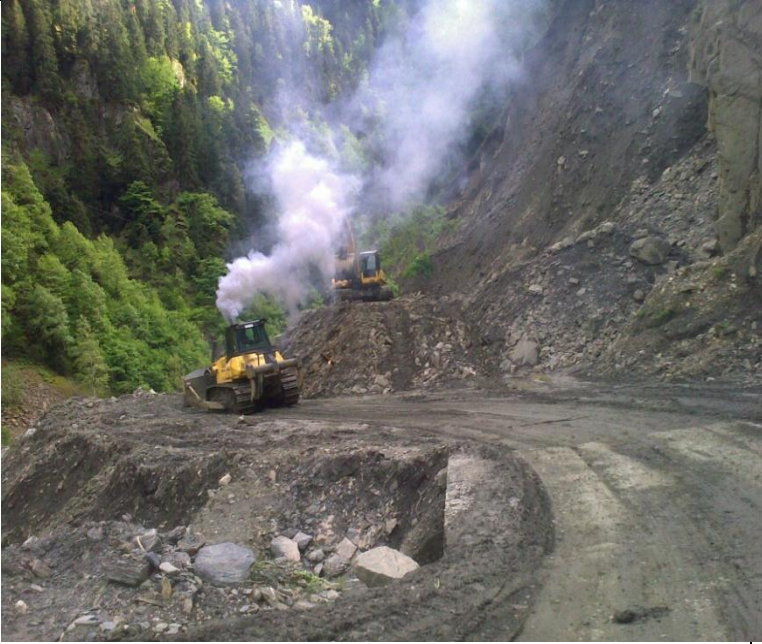
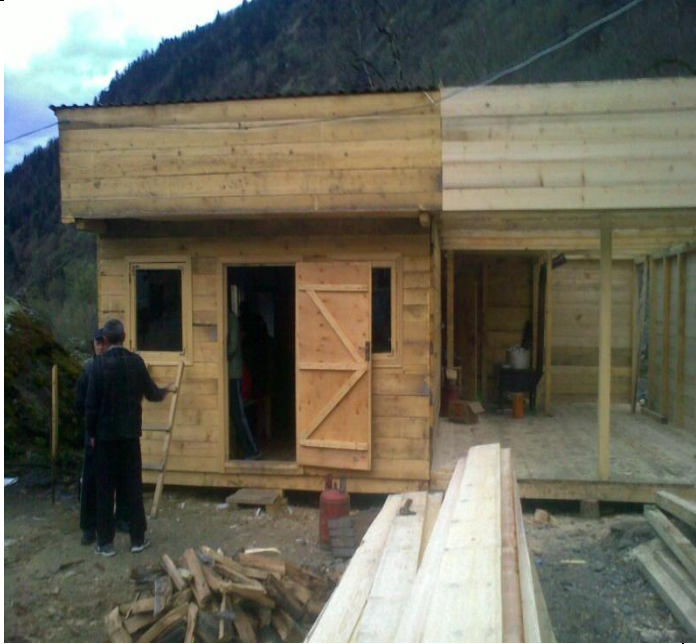
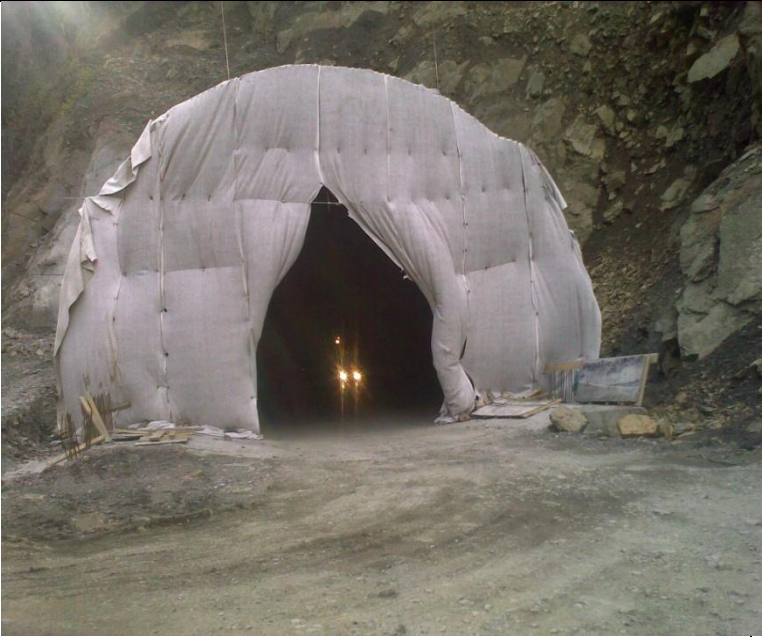
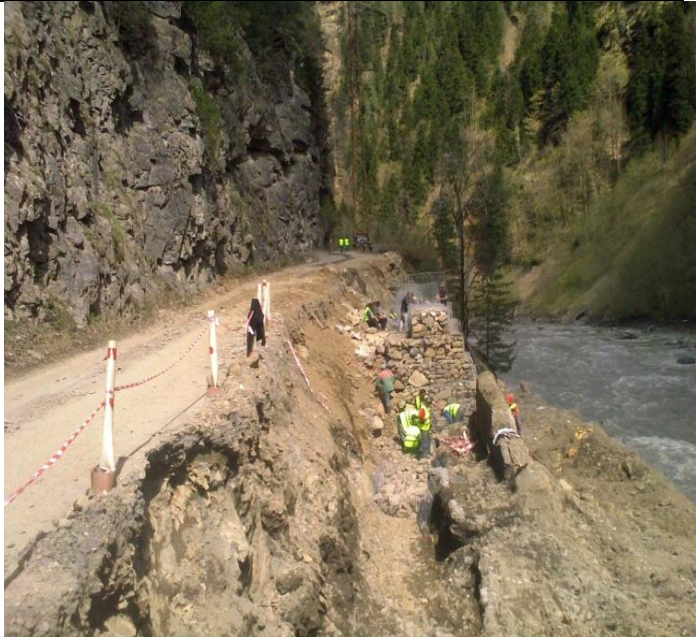
Reconstruction of section km 89 (Tunnel and Gallery) of the Secondary Road Zugdidi-Jvari-Mestia-Lasdili

During monitoring in 2011.04.27 appeared, that certain part of machinery were in defective condition, namely, oil was leaking. Also, there was a problem with demolition waste management and the constructor was issued a warning concerning this issue. On the basis of 11.05.23 monitoring constructor repaired the machinery, but couldn't arrange the problem with demolition waste. Moreover, there weren't enough number of road signs and they weren't installed in a proper way. MDF supervisor was informed concerning the above-mentioned. Constructor took into account 2011.06.27 monitoring remarks, but couldn't solve the problem with installation of road signs.

Pursuant to 2011.07.25 monitoring, contractor installed road signs on the site, but during monitoring of 2011.08.30 still appeared the same deficiencies. It was proved that closed trucks weren't used for transportation of construction materials and waste. MDF supervisor and L.L.C."Sani" representatives were informed about the above-mentioned and they were asked to improve the situation.

In 2011.09.28 it was obvious that contractor remedied part of defects, but transportation of construction materials with open trucks was still noticed. 2011.10.25 monitoring proved that materials has been transported with open trucks. Contractor took into account the rest of remarks. MDF supervisor was informed about the above-mentioned issue again and was asked to avoid similar cases.

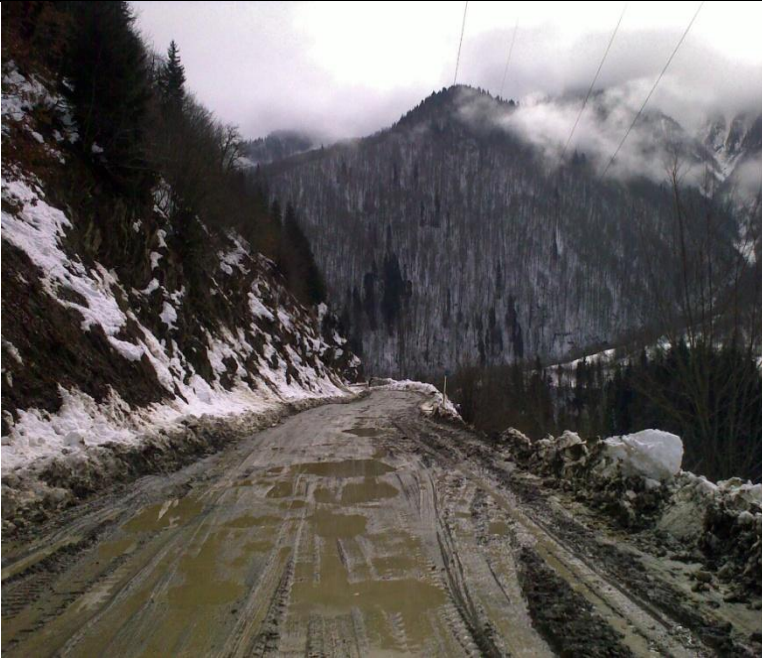
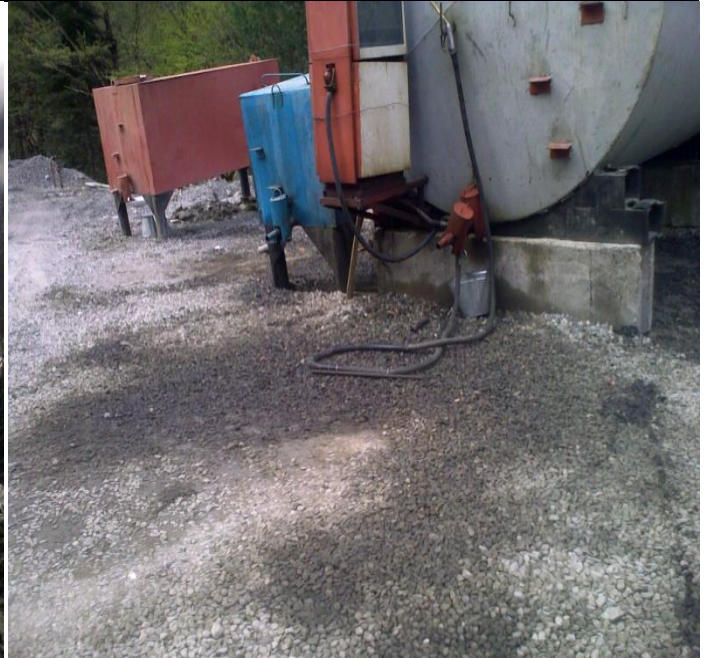
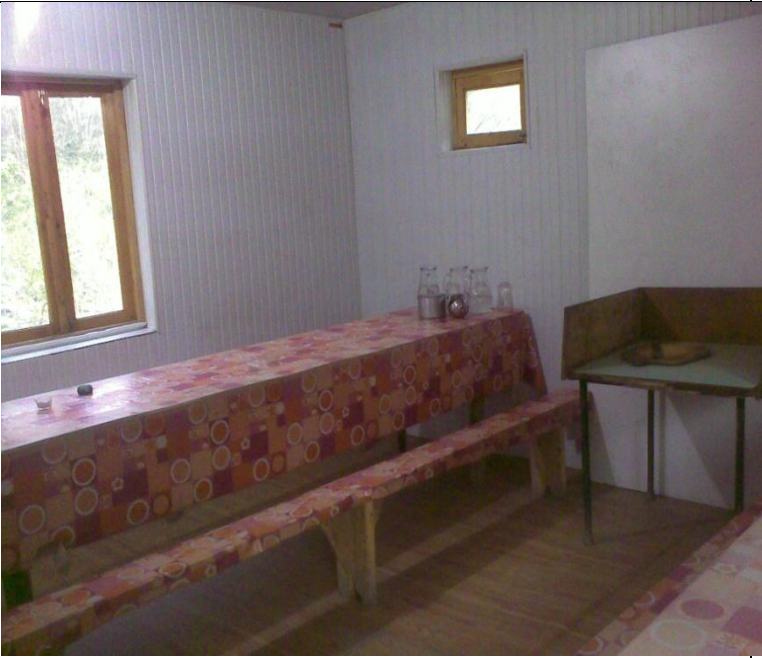
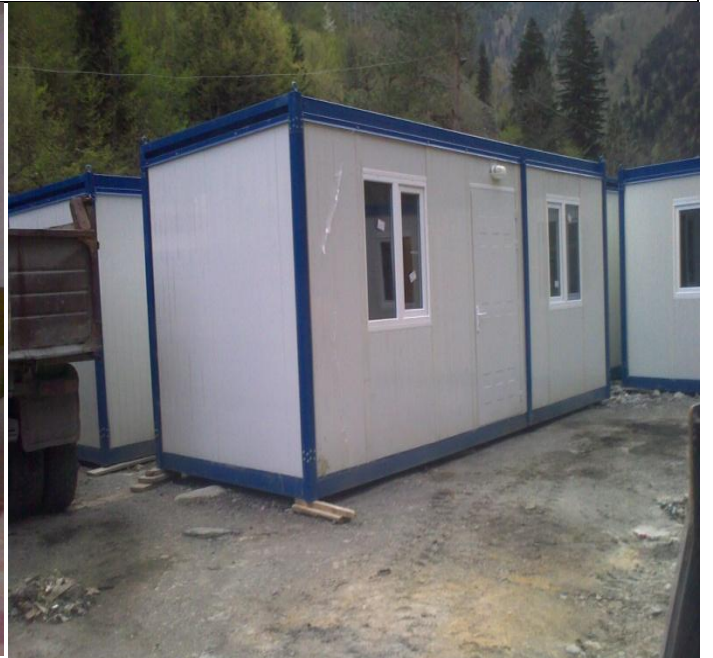
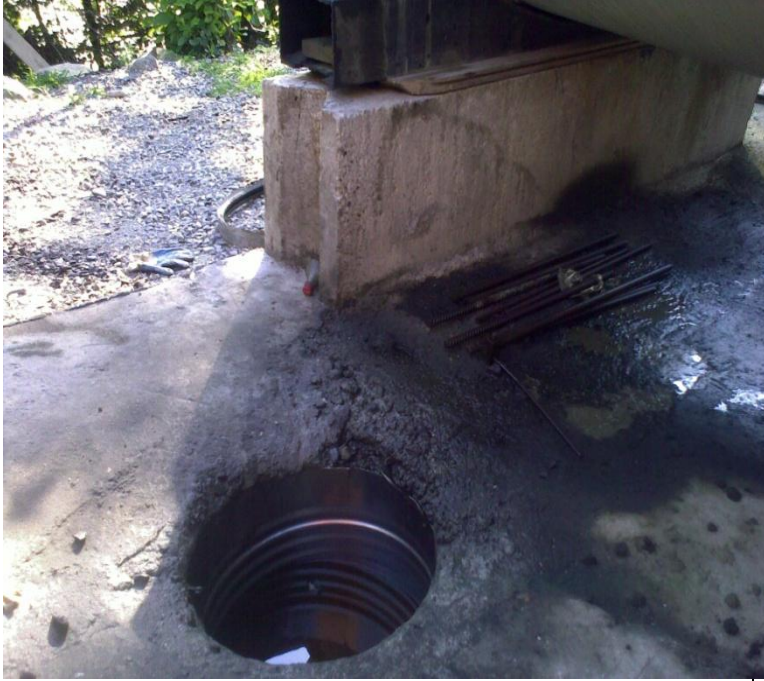
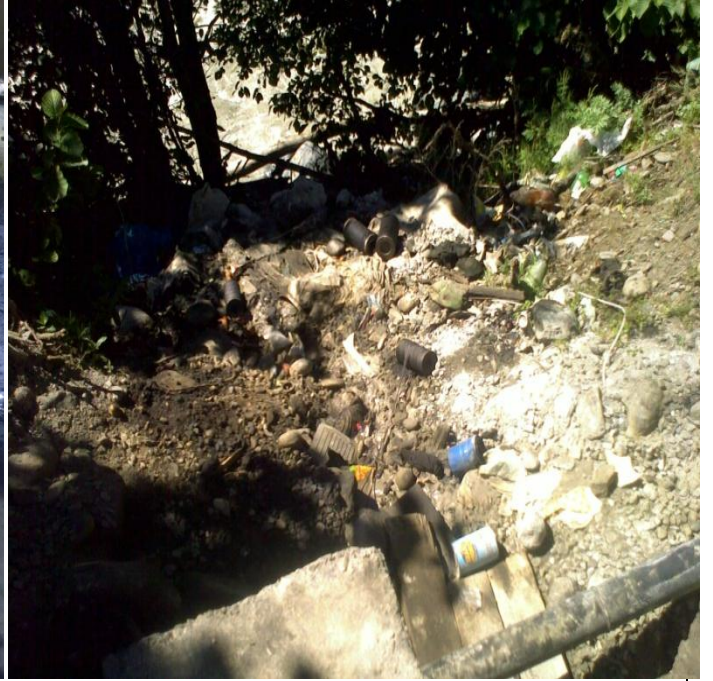
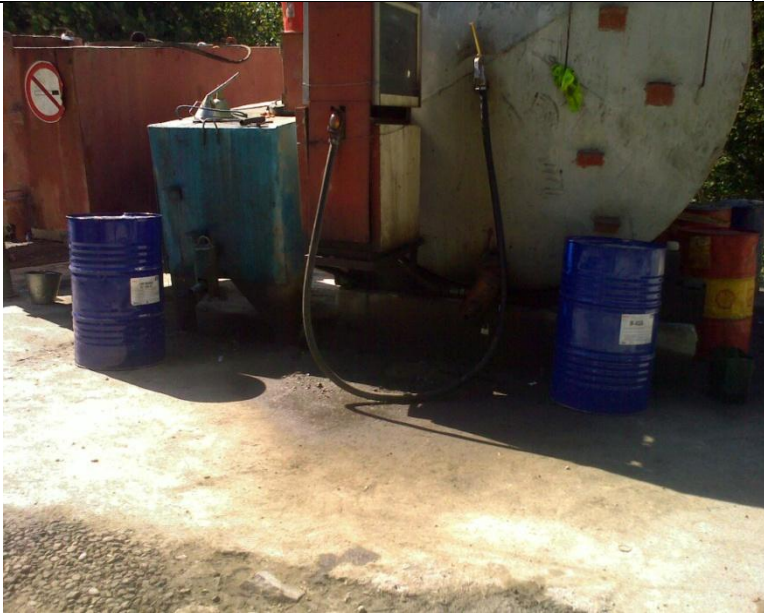
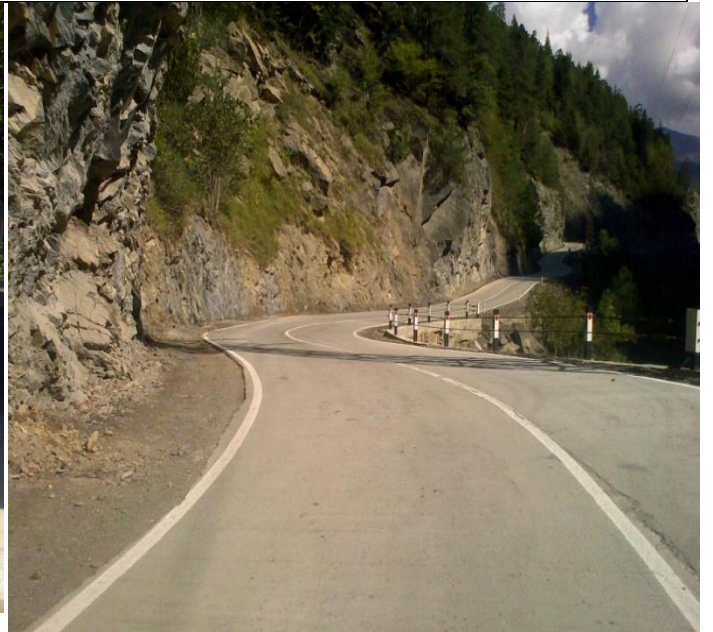
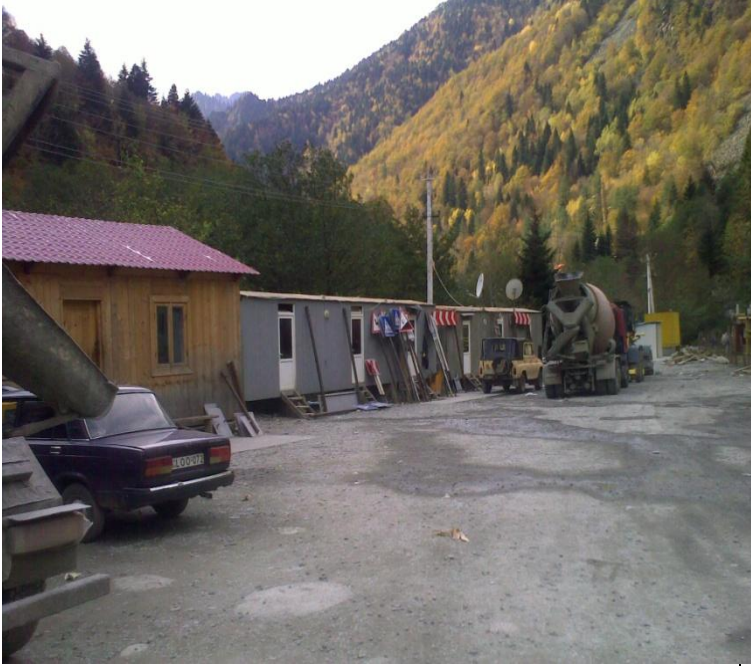
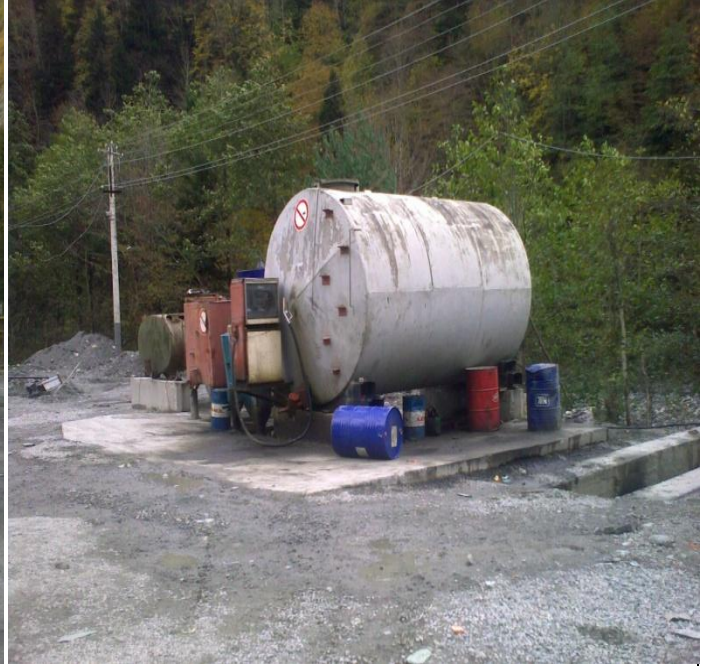
Reconstruction of section km 91- km 103 of the Secondary Road Zugdidi-Jvari-Mestia-Lasdili

During 2011.04.28 monitoring appeared, that certain part of machinery were in defective condition, namely, oil was leaking. Insulator wasn't arranged under the fuel reservoir that was set for machinery supply and there was no barrier around it. The site wasn't provided with warning signs and contractor couldn't present license for excavation of borrow area on site. Contractor was issued a warning and time to remedy defects.

flanks(edges) for the mentioned reservoir. Contractor promised to repair machinery in a couple of days and remedy the defects. Contractor presented the license for excavation of borrow area during construction works, but couldn't provide the site with warning road signs. MDF supervisor was informed concerning the deficiencies.

According to 2011.07.26 monitoring, part of defects has been remedied. Drainage was installed on the arranged area around the fuel reservoir. The problem of site provision with road signs was still unsettled. MDF environment specialist and MDF engineer had a meeting with LLC "Archeopolis" representatives and asked them to take into consideration made remarks.

2011.09.28 monitoring revealed that the problem with road signs was solved. Fuel leakage from the reservoir has stopped, oil filters and all the similar stuff has been collected. Area was cleaned and MDF representative was given a promise to dispose waste from the territory.

2011.10.25 – there weren't enough number of warning road signs and they weren't installed in a proper way. Machinery repair waste wasn't disposed in the vicinity of construction area, oil filters and all the similar stuff collected during the previous monitoring hasn't been disposed from the camp area during 1 month.

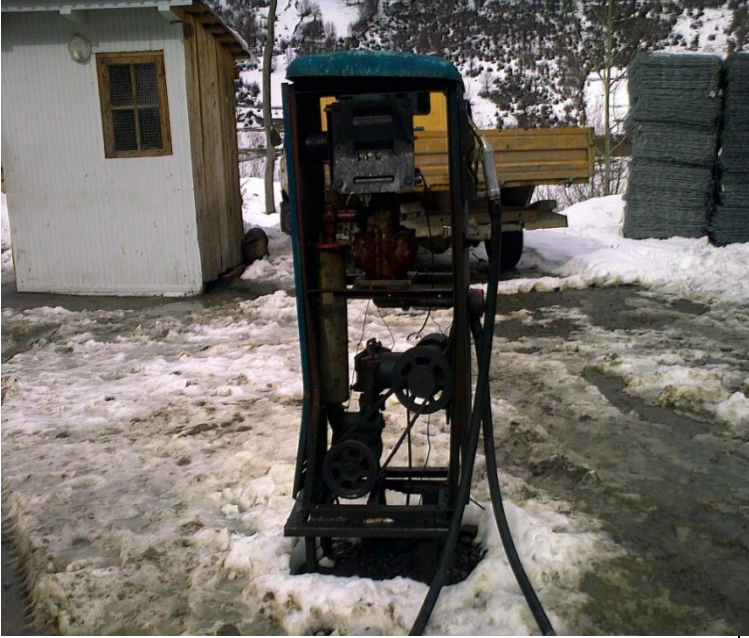
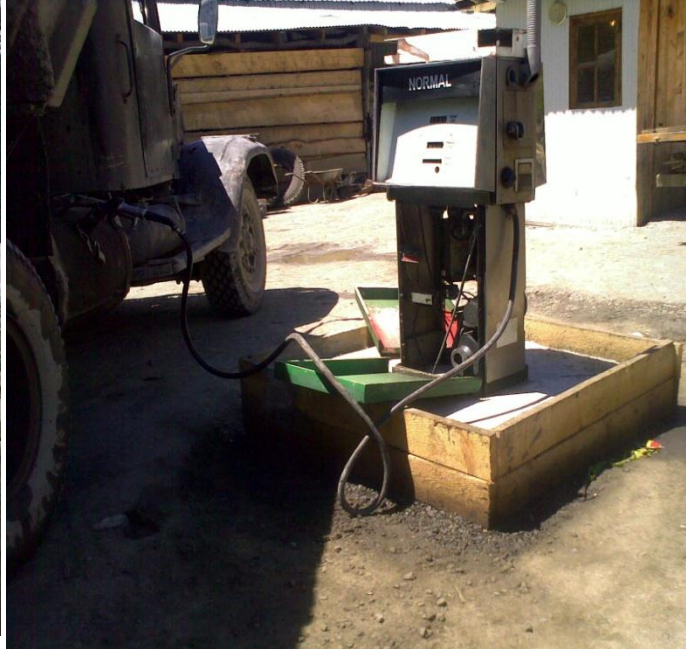
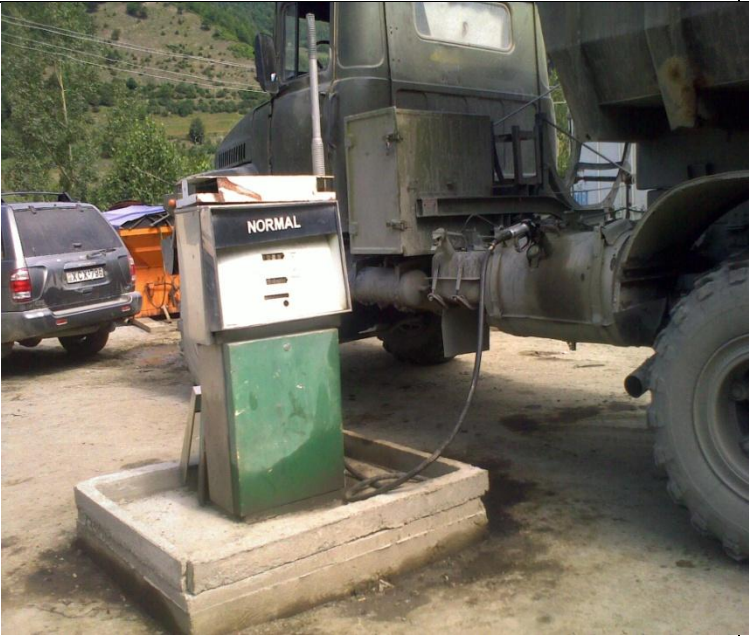
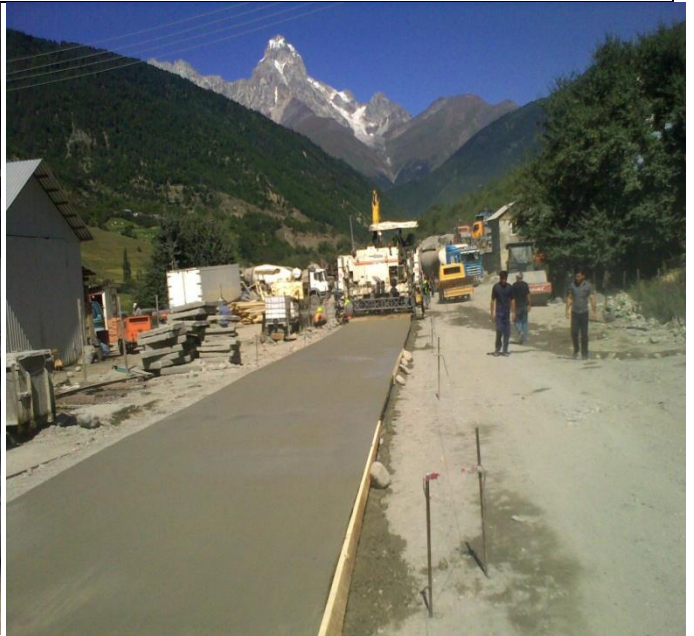
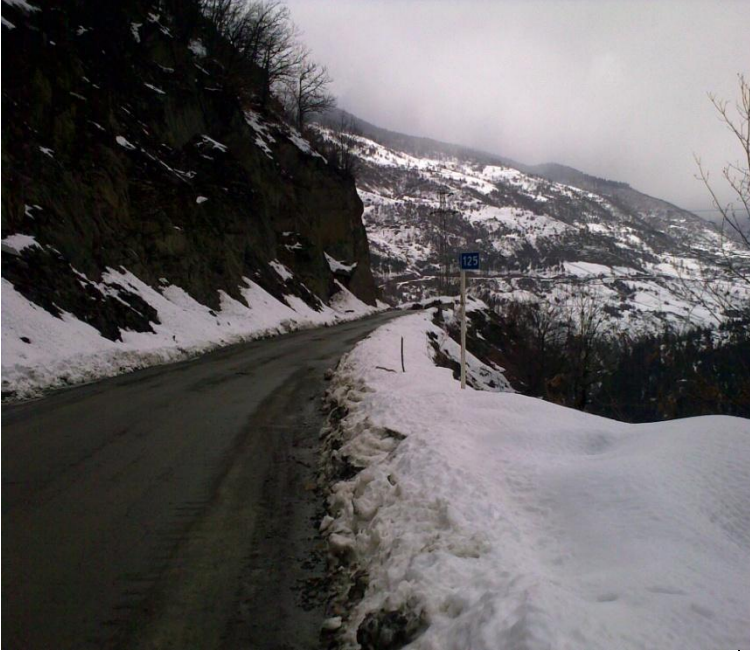
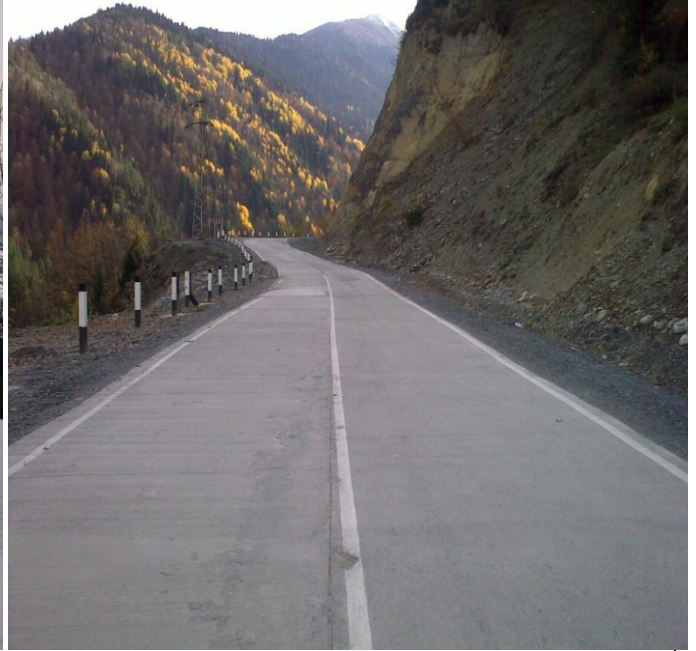
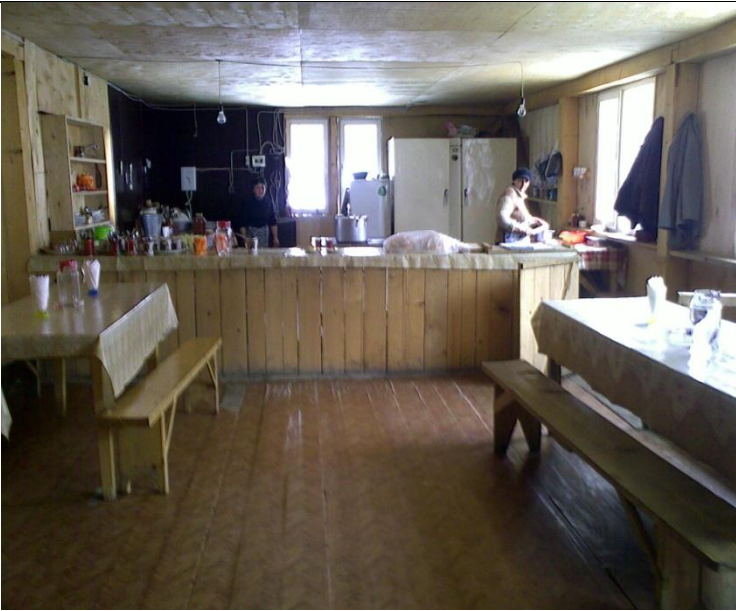
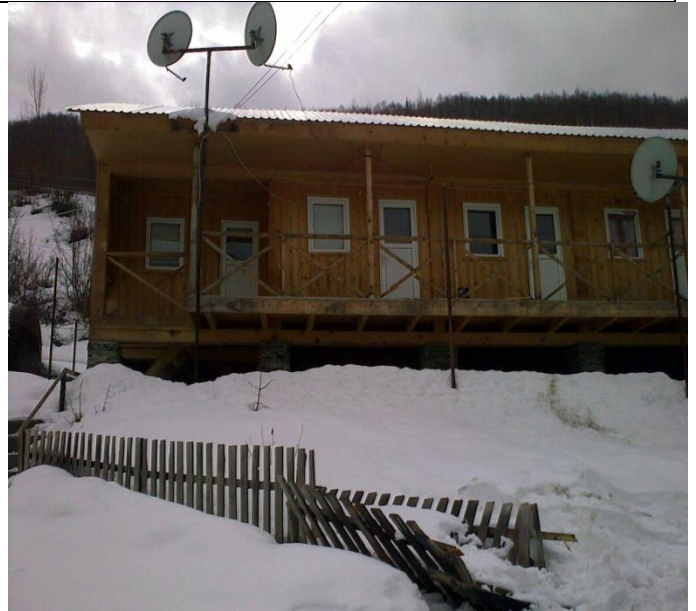
Reconstruction of section km 121-km 125 of the Secondary Road Zugdidi-Jvari-Mestia-Lasdili

2011.03.10 - contractor couldn't present license for excavation of borrow area on site. It should be arranged area around petrol filling appliance, namely arranging barrier and concrete bottom for preventing fuel leakage. Contractor was notified about the above-mentioned.

According to 2011.04.28 monitoring, the defects revealed during the previous monitoring hasn't been remedied and MDF supervisor and head of district were notified regarding the above-mentioned issue.
