Environmental Compliance Audit

September 2013

GEO: Sustainable Urban Transport Investment Program – Tranche 1

**Project: Rehabilitation and Reconstruction of Secondary Road Zugdidi-Jvari-Mestia-
Lasdili KM.74– KM.80, KM.89, KM.91 - 103 and KM.121-KM.125**

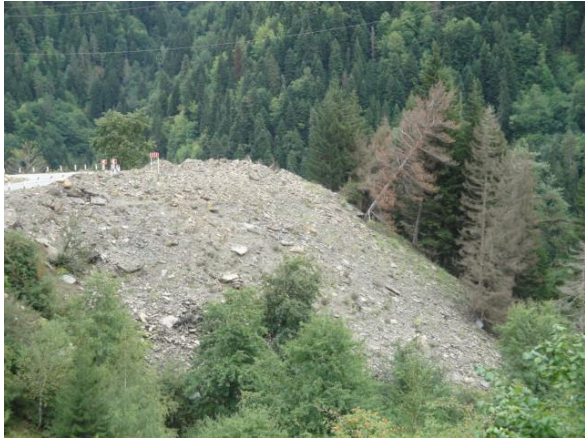
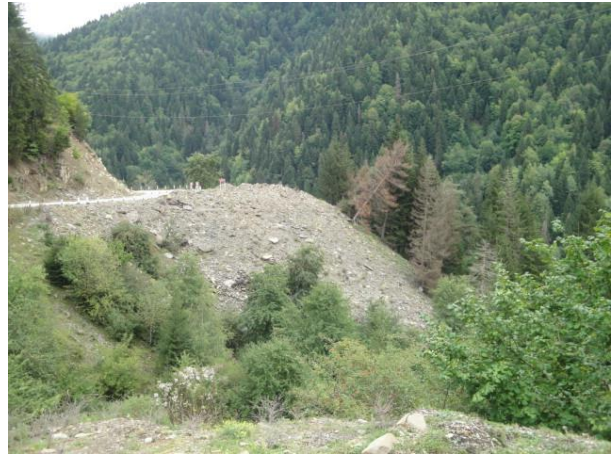
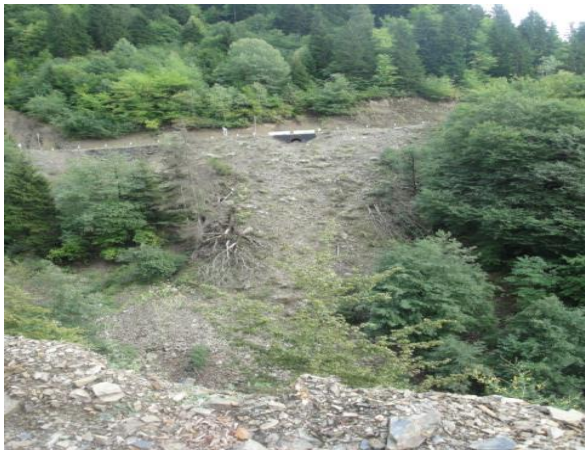
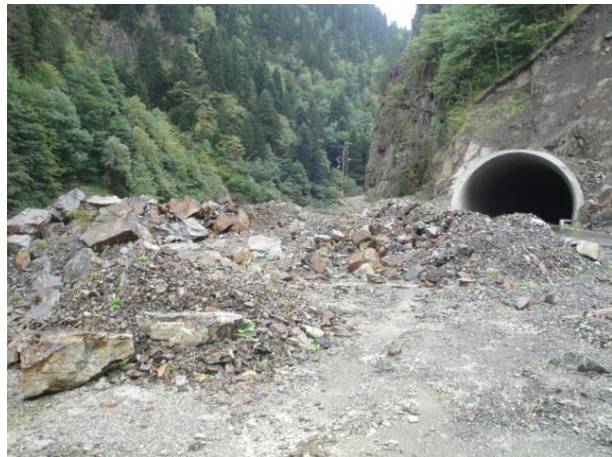
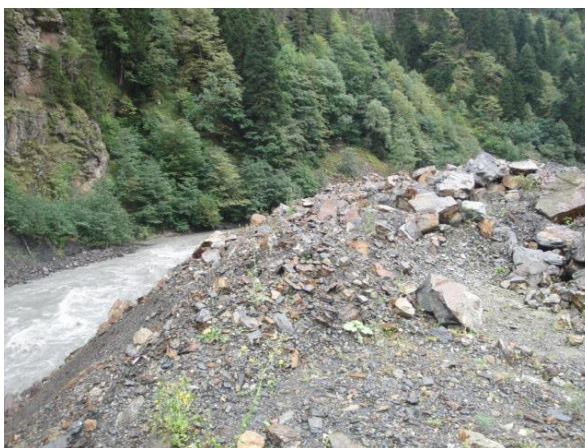
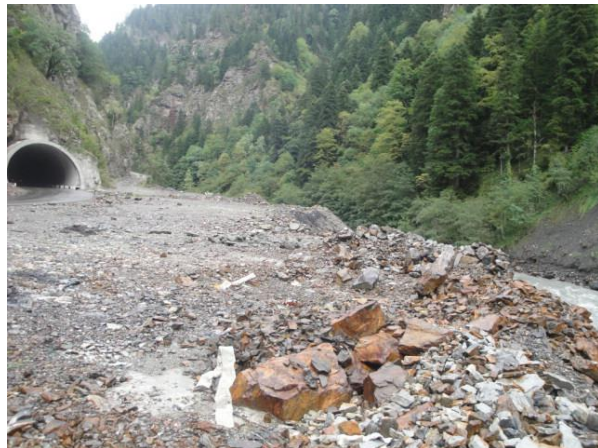
During the visual inspection of the construction site, the trace of large quantities of inert material poured at some places in the gorge of the river Enguri was obvious (See Fig. 1, 2, 3, 4, 5 and 6). It also should be noted that the amount of the inert material poured into the existing gully is much less than the amount of the waste predicted for the construction stage.

Proving that the inert materials fixed in the figures were originated during the road rehabilitation and the said waste was removed into the river Enguri gorge by the Construction Contractor is impossible.

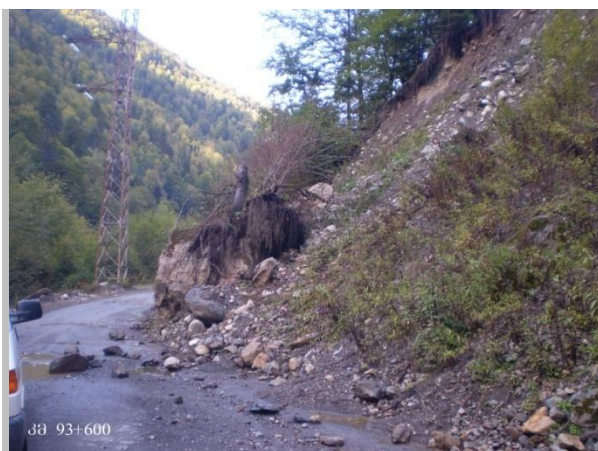
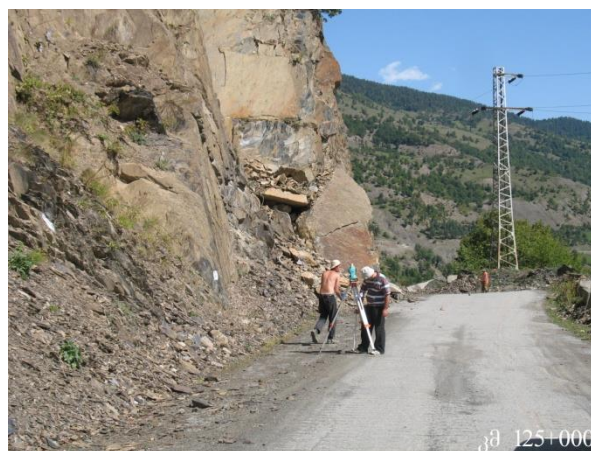
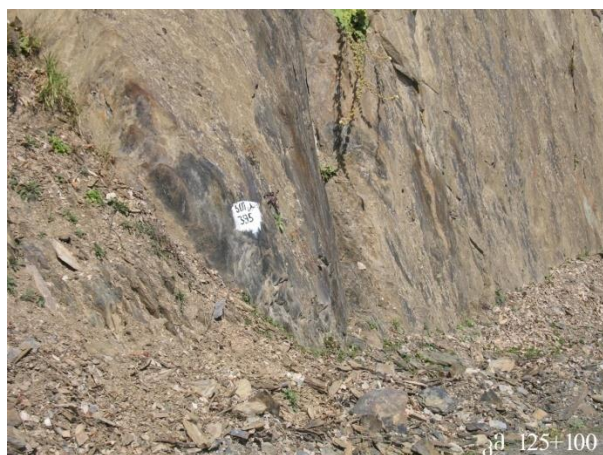
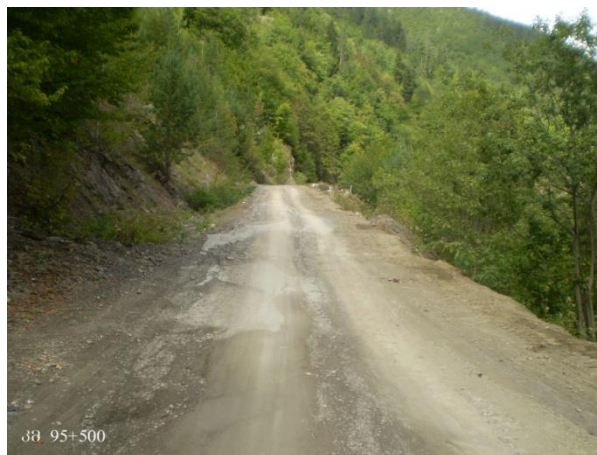
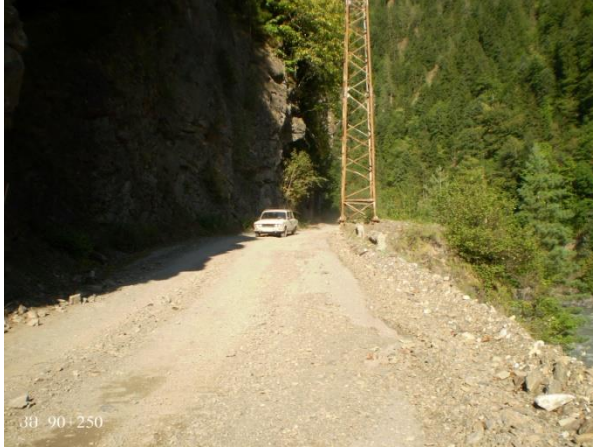
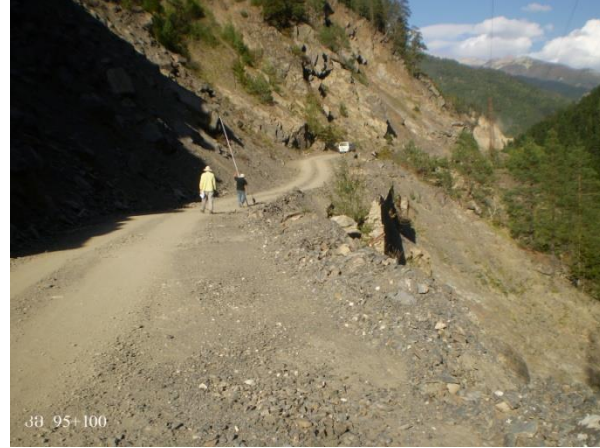
Large amounts of inert materials in the river Enguri gorge were fixed before the startup of the construction and rehabilitation works (See Fig. 7, 8, 9, 10, 11 and 12). The said inert materials were removed into the river Enguri gorge by the gangs charged with cleaning the road off the inert material removed from the slopes due to erosion. The inert material in the road was collected and poured into the river Enguri gorge. This was the case for several tens of years. Therefore, it is possible that the inert material presently fixed in the gorge is the result of several-year-long actions of the cleaning gangs.

The described practice of cleaning the roads off the inert material removed down the slopes is the case to present. Consequently, the amount of inert materials placed in the gorge of the river Enguri in an uncontrolled manner is increasing permanently.

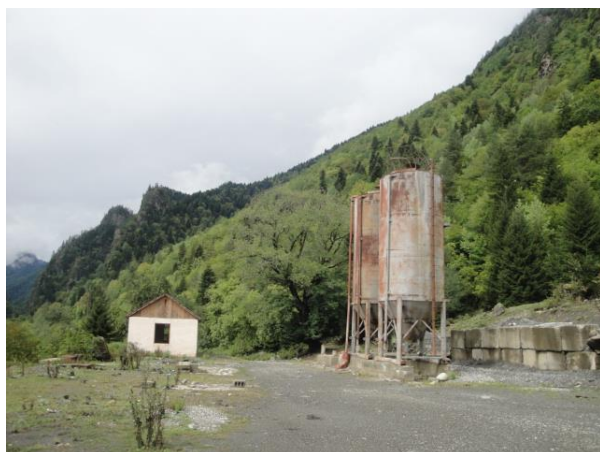
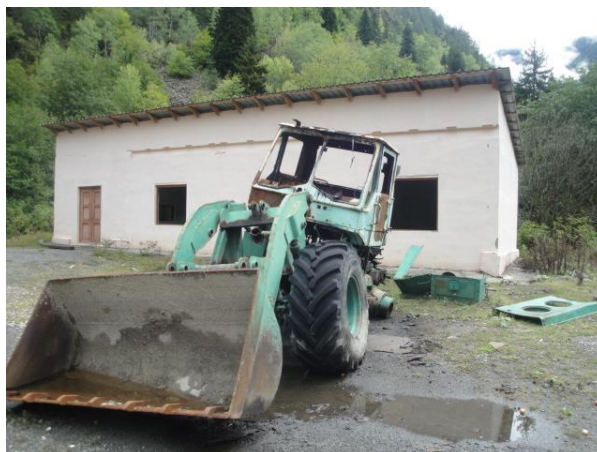
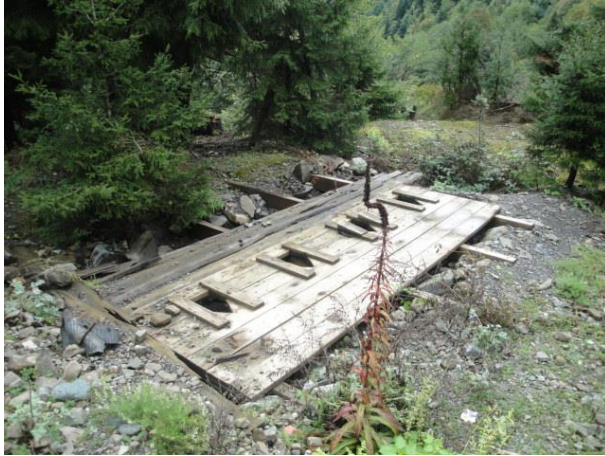
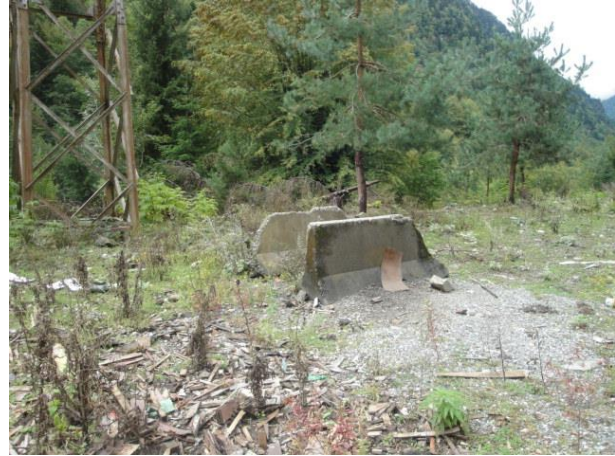
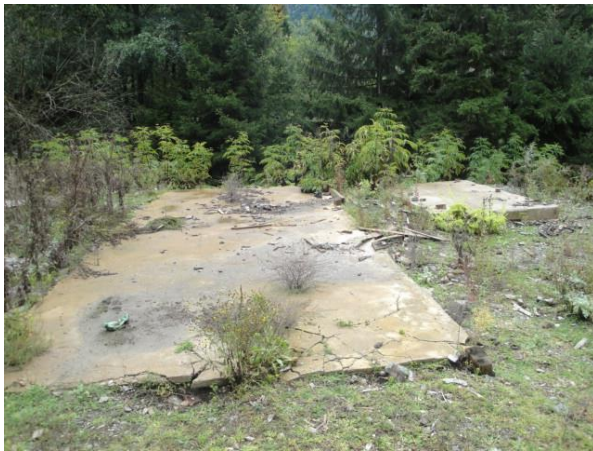
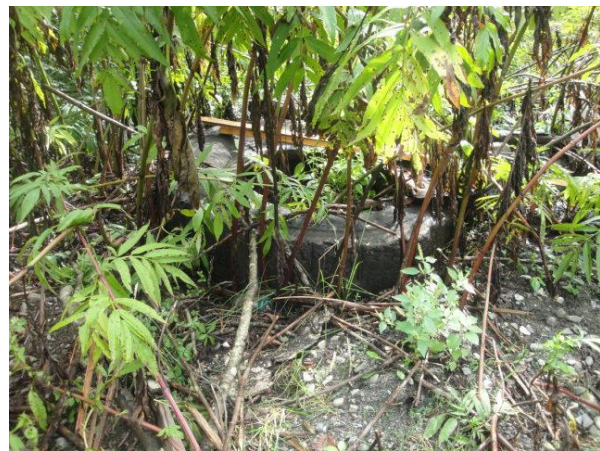
Existing situation: At present, the territory of the construction camp is abandoned without dismantling the camp or restoring its area. Over the territory of about 1000 m², there are two abandoned premises, concrete mixers, minor broken-down techniques; the dismantling of the toilet is not complete and there are foundations of some concrete buildings remained (See Fig. 13, 14, 15, 16, 17 and 18).

Correction action: The present owner of the territory must accomplish the full dismantling of the auxiliary facilities on the territory of the camp and area restoration.

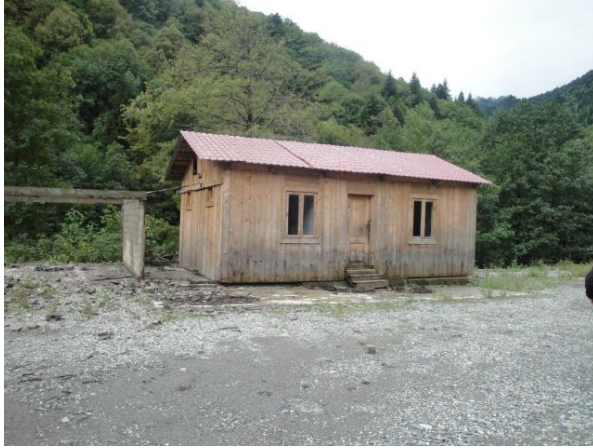
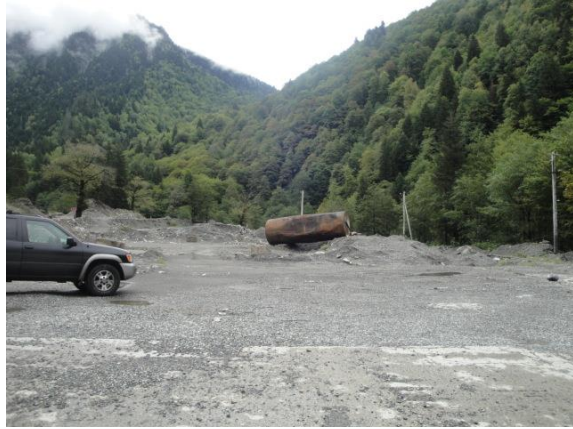
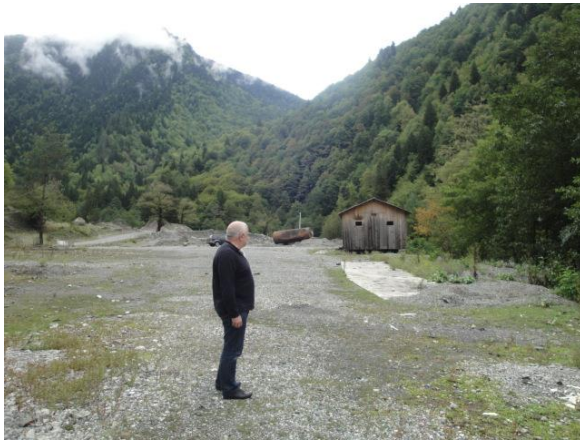
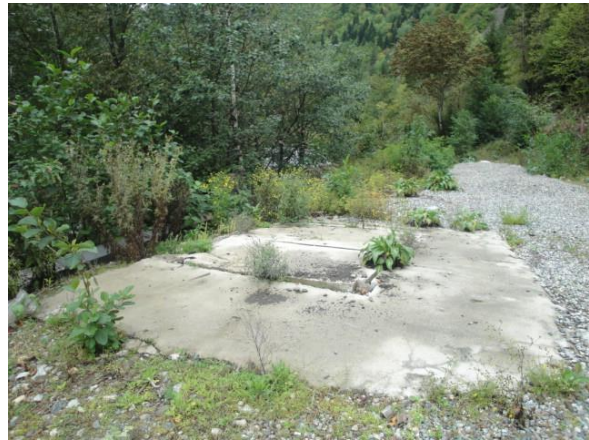
The borrow pit located across the river Enguri, KP 82 is no more used by the owner. A part of the existing infrastructure is removed from the territory of the pit. The buildings and premises are not dismantled (See Fig. 19, 20 21 and 22). In addition, the concrete foundations of some auxiliary buildings are remained.

Correctiv action: The present owner of the territory must accomplish the full dismantling of the auxiliary infrastructure on the territory of the camp and area restoration.

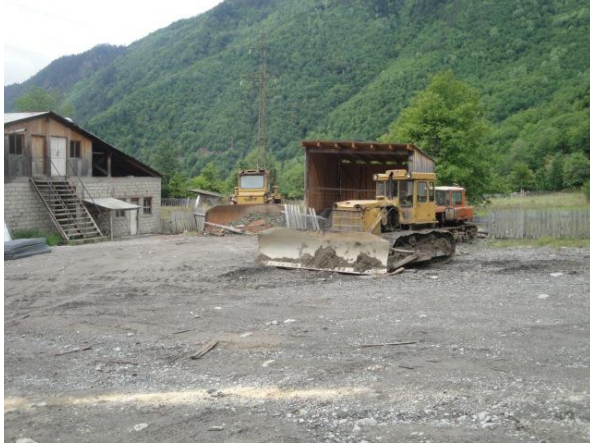
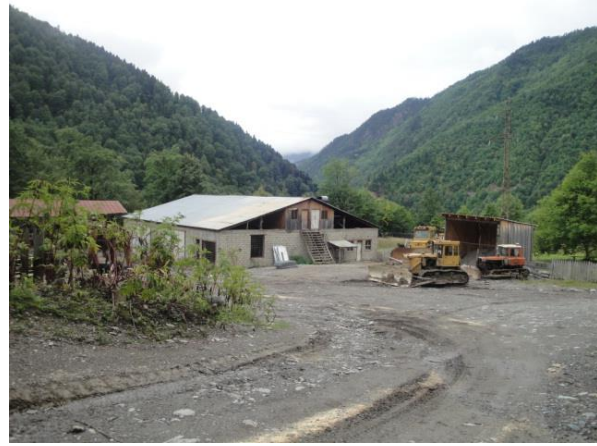
At present, the management of ARKEOPOLISI LTD. has finished the works and removed all the techniques from the rented area. As the area rented by ARKEOPOLISI LTD. was used before and is used to present as an entrepreneurship object, it needs no restoration (Fig. 23 and 24). The Lessor, the owner of the sawing plant has no claims to the company. The construction techniques in the figure below is the property of the sawing plant owner.

Fig. 23 and 24. The territory of the camp cleaned by ARKEOPOLISI LTD.

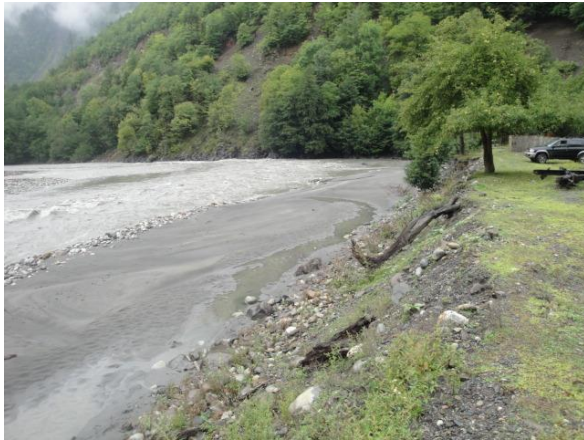
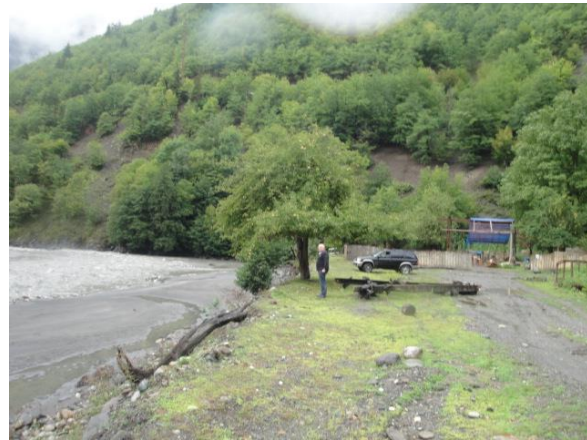
The sandpit in the river Enguri gorge, near village Ipari was owned by ARKEOPOLISI LTD. At present, the pit is not used by the company. The techniques are removed from the area, the auxiliary facilities have been dismantled and the degree of the area restoration is satisfactory (Fig. 25 and 26).

Fig. 25 and 26. Sandpit in the river Enguri gorge. KP 85

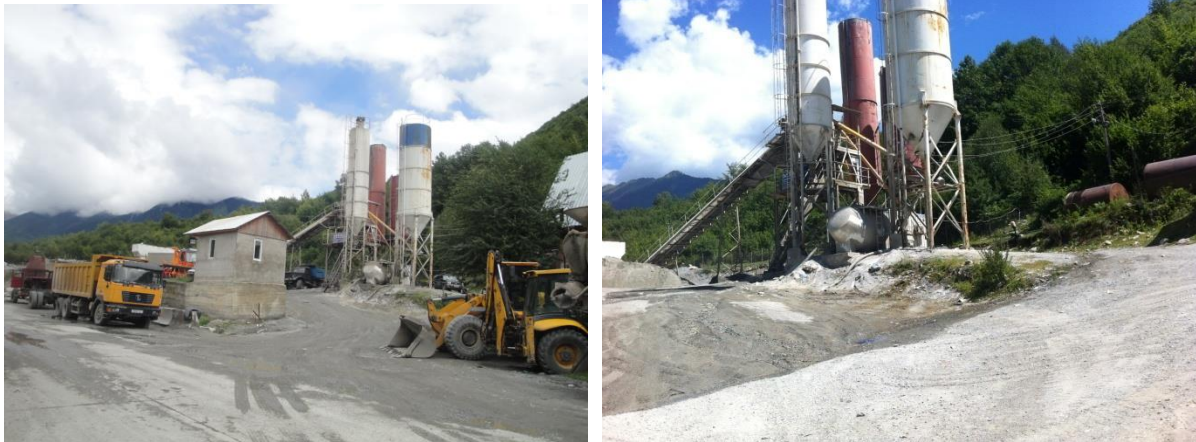
The owner of the construction camp in village Becho is ENGURI 2006 LTD. Despite the fact that Khaishi-Lasdili road rehabilitation project is complete, the company still uses this camp for another project realized in the region (Fig.27 and 28).

Fig. 27 and 28. Operating building camp of ENGURI 2006 LTD. and related infrastructure

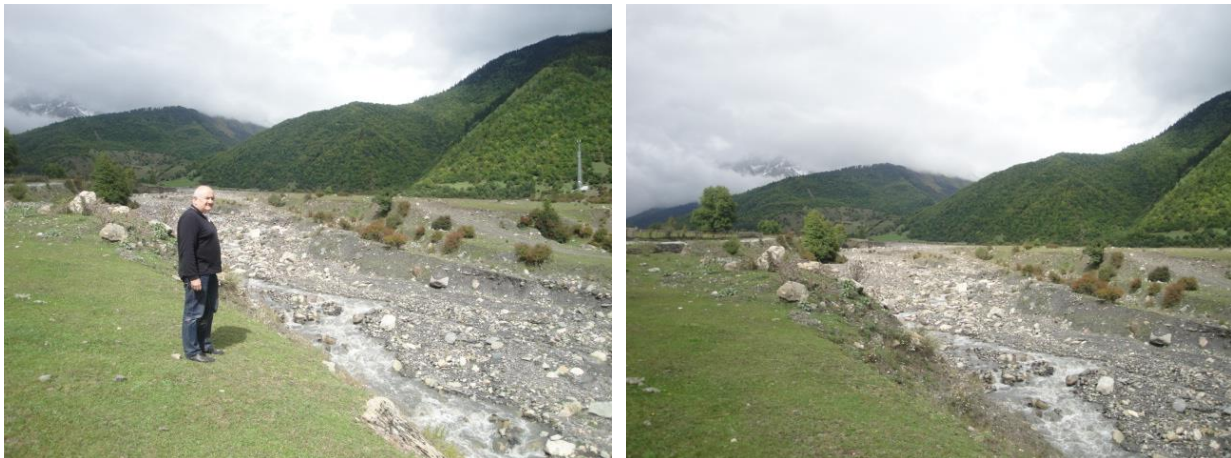
To quarry inert material, ENGURI 2006 LTD. used the borrow pit in the gorge of the river Dortla, 2 km from the construction camp. Since the project completion, the company has not used this pit. The techniques owned by the company and dismantled infrastructure is removed from the camp territory. The quality of the area restoration is satisfactory (Fig. 29 and 30).

Fig. 29 and 30. Restored inert material pit in the gorge of the river Dortla
