# Environmental Monitoring Report

Semestral Report  
October 2013

## GEO: Urban Services Improvement Investment Program – Project 1

**Georgia: Urban Services Improvement Investment Program (Tranche 1)**

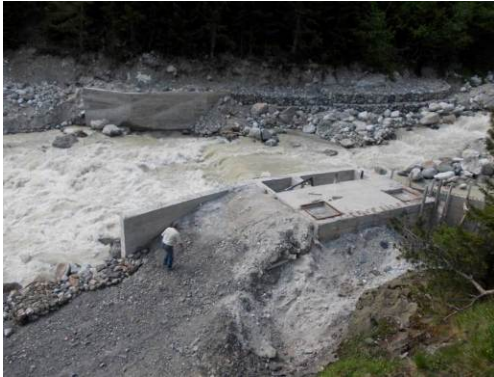
21. Site clearance and reinstatement after backfilling trenches remain partially completed; no protection zone (sanitary fence) was established at the intake works (Tyrolean weir).

MES 01 – no sanitary fence upstream to Tyrolean weir (access unprotected)

21.06	Fence to be installed at trenches; Intake to be fenced; Workers to wear helmets, gloves, vests.	RE	Corrected for a few sections only, most reinstatement pending.

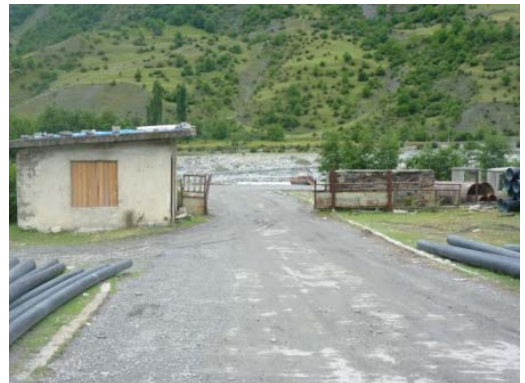
Entrance of equipment storage site

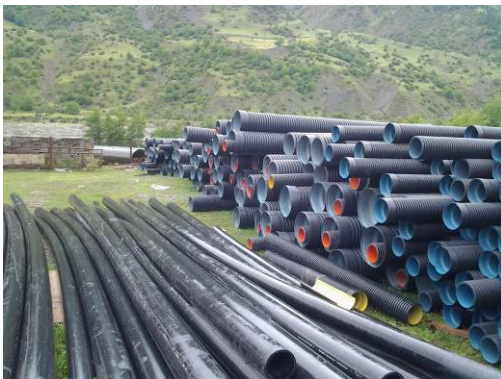
MES 01 - stored HDPE pipes

20.04	Establish temporary camps in consultation with the local authority; Ensure access and proper storage and cleaning of new camp at all times	RE	Corrected to some extent; camp cleaned and internal storage improved; however, pipe storage not corrected.

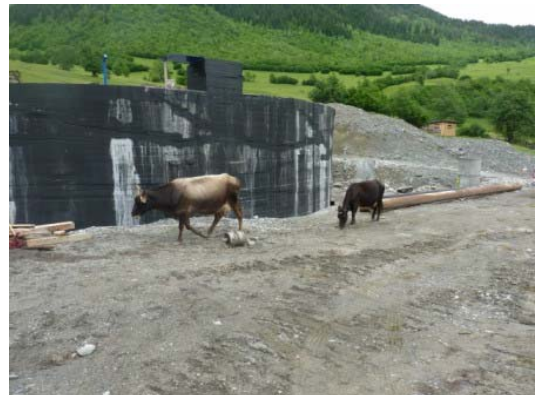
MES 01 - Reservoir area open access without fencing

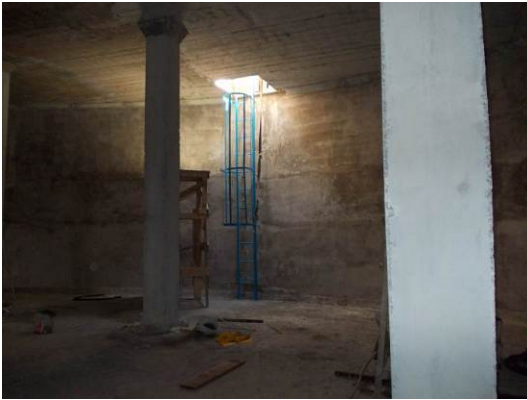
MES 01 – Wooden scaffolding used for plastering works – without protection

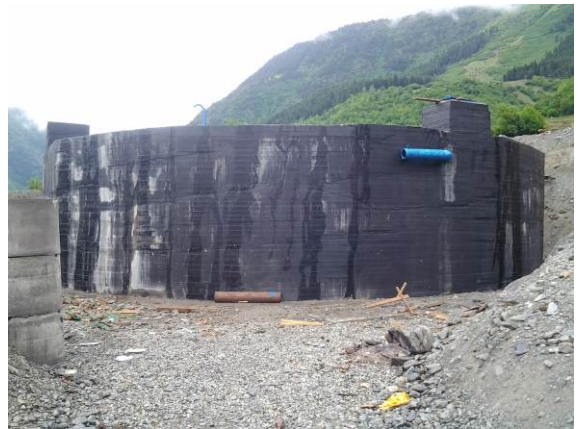
MES 01 – Backfill of reservoir pending leading to safety risks

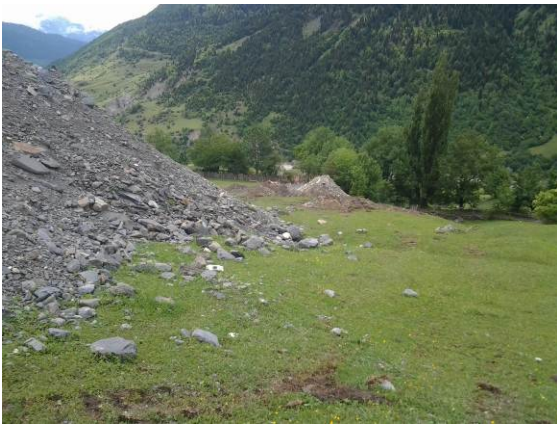
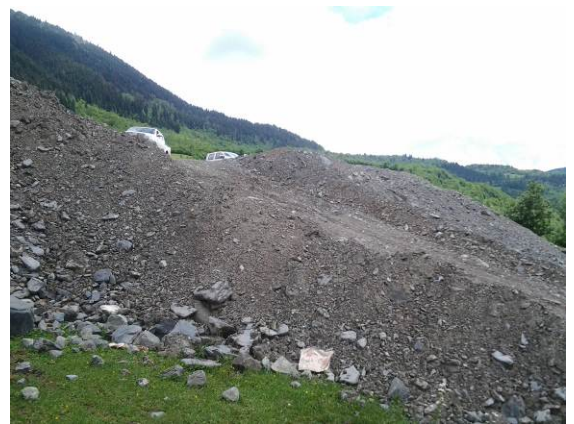
MES 01 – Excavation surplus from reservoir

<b>Nº</b>	<b>DATE</b>	<b>CORRECTIVE ACTION</b>	<b>ORIGIN</b>	<b>Status</b>
	13.04	Removal of earth/stones from reservoir site; Protection of workers inside reservoir (to use proper scaffolding and safety belts).	RE RE	Not corrected as at 30/6/2013. Not corrected as at 30/6/2013.
