GEO: Urban Services Improvement Investment Program – Tranche 2 (Mestia Water Supply Headwork)

Subproject 1: Mestia Water Supply Headwork

Compliance Environmental Audit Report

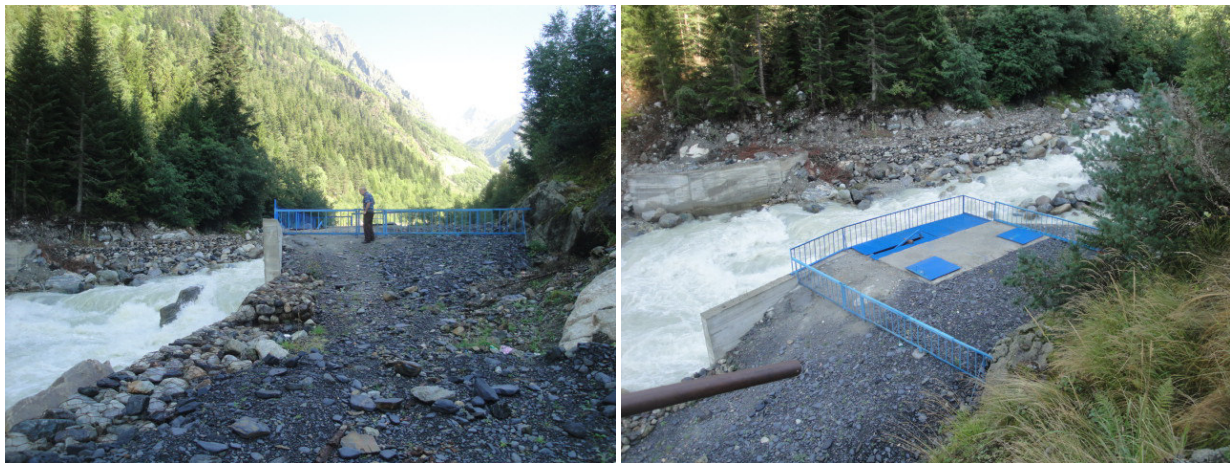
Figures 5, 6: Tyrolean Weir in Mestiachala River

24. Recovery works have been performed to a satisfactory level, the traces of construction waste could not be observed anywhere at the construction site, neither inert waste, nor municipal waste.

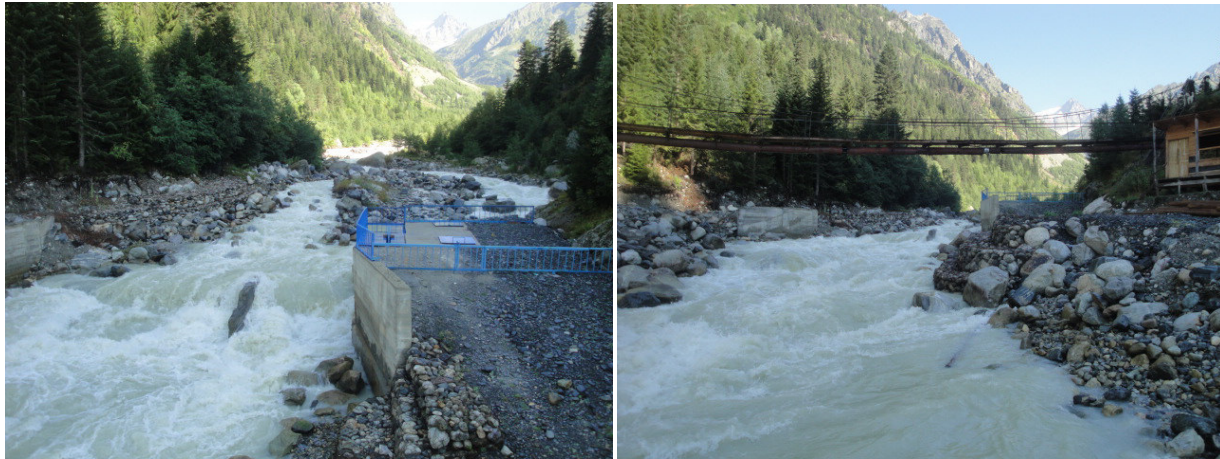
Figures 7 and 8: Embankment Structures

25. Restoration works on the territory adjacent to the water intake unit had been performed satisfactorily, following the implementation of embankment works on both sides of the river (**Figures 7 and 8**).

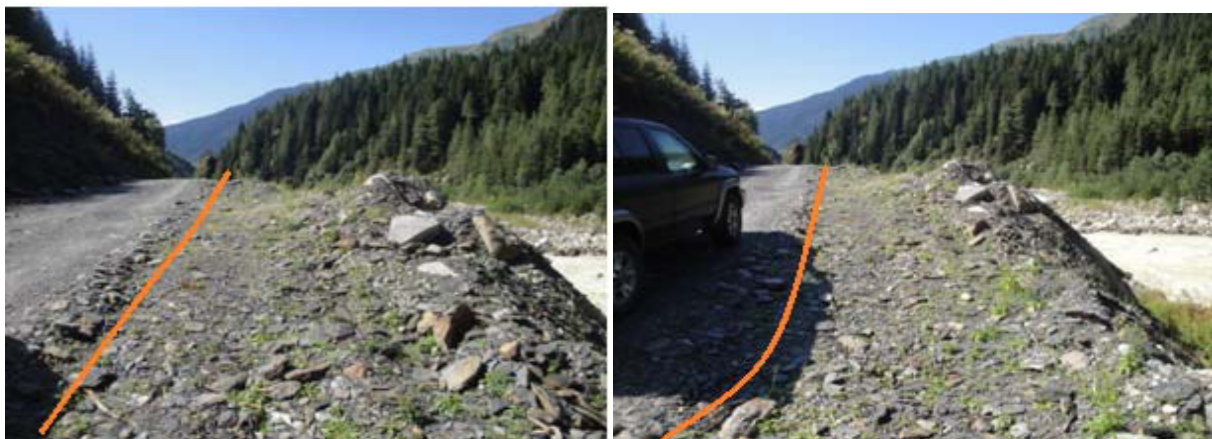
Figures 9,10: Restoration works performed on sandstone territory

26. On the mentioned section water main flows along the existing road large portion of which is also a “touristic path”. Due to natural conditions, on 6km sections of the mentioned road soil is represented by quite diverse soils. Here there are humus covered sections, as well as the sections covered by slates and sandstones. Restoration works have been performed satisfactorily and all sections of the water main have been restored adequately (**Figures 9,10,11 and 12**).

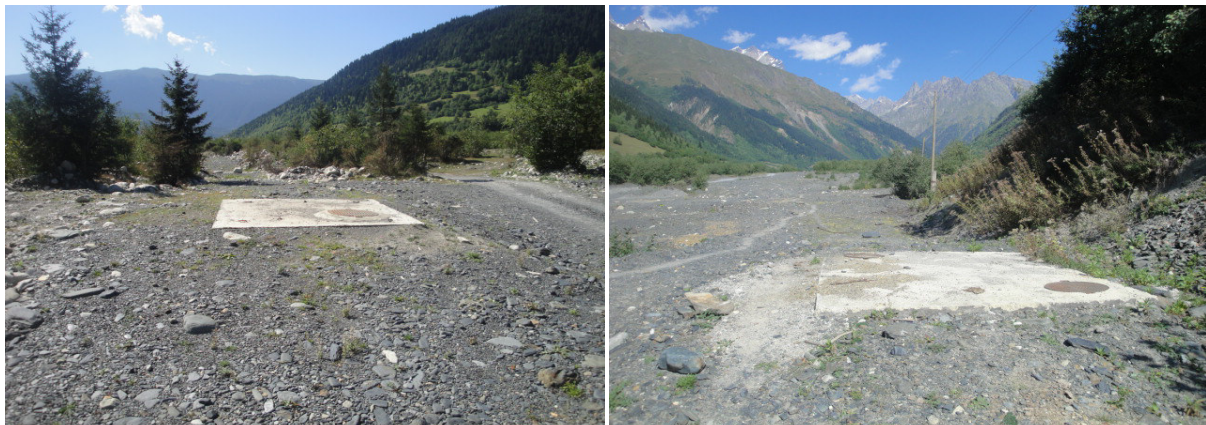
Figures 13 and 14: Restored landscape on the territories adjacent to the wells

28. No photos of the said territory were taken before the onset of the construction. Therefore, it is impossible to fix the adequacy of the restoration works to the pre-construction state. However, following the situation on the adjacent territories, we may conclude that the Restoration works on the territory adjacent to the wells have been performed to different degrees, predominantly to the satisfactory level(**Figures 13 and 14**).

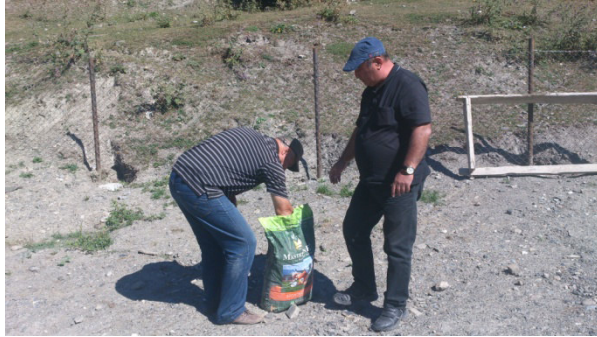
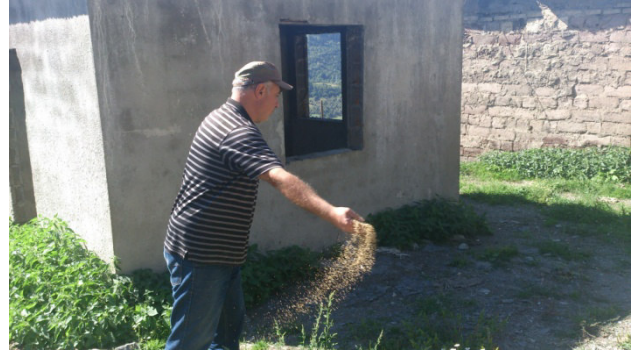
Figures 15 and 16: Grass Planting

29. On a small portion of a 6-kilometer section, before connection with the reservoir, the pipeline crosses pasturelands. Due to the absence of access roads to the mentioned section, it became necessary to cut about 4-5 meter corridor in order to place the pipes. The process of pipes installation has been completed.

30. Restoration works have not been performed on the mentioned section. As the Consultant have been informed, construction works ended the last on the mentioned section and the result of performed restoration works still cannot be observed visually. By the experts determine the characteristic grass species for this region and the company carried out to grass planting.(**Figures 15 and 16**).

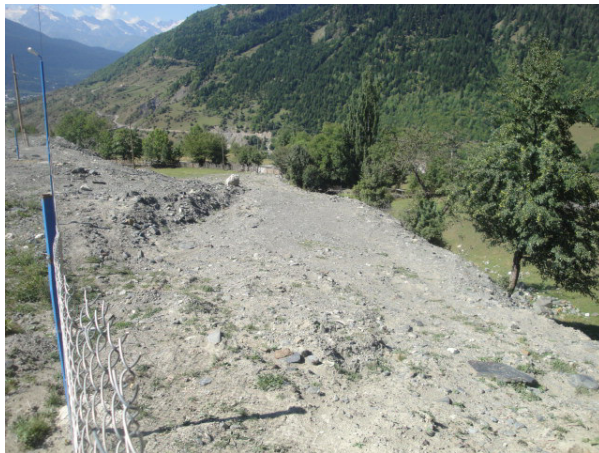
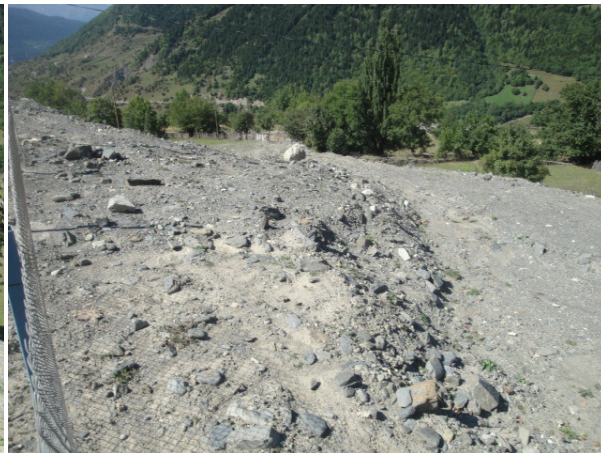
Figures 17 and 18: Unrestored territory adjacent to the reservoir

31. Due to the climatic conditions of Mestia, the monitoring of the quality of results of performed restoration works will be possible only in late spring, 2015. The period of elimination of deficiencies for the contractor has been set as one year. Respectively, it will be possible to determine the effectiveness of restoration works on the mentioned territory until the expiration of the period for the elimination of deficiencies.

- IX. If we do not consider the small section (on the territory adjacent to the new reservoir), restoration works have been performed satisfactorily. According to the explanation of contractor restoration works have been performed on the mentioned section, but it is impossible to visually see the result. Notably, there exists photo material about conducting restoration works on the mentioned territory;

32. **Recommendation:** Supervision Consultant shall carry out inspection in 2015 of the territory adjacent to the new reservoir in order to determine effectiveness of conducted restoration works.

#	Recommendation	Responsible for Audit	Implementation Terms	Implementation deadline	Responsible for restoration
1.	Determine the degree of effectiveness of restoration works carried out on the territory adjacent to the new reservoir.	UWSCG and Eptisa: Will carry out Inspection of the territory adjacent to the new reservoir in order to determine effectiveness of	The inspection in late spring, 2015.	Before defect liability period (July 2015)	Contractor

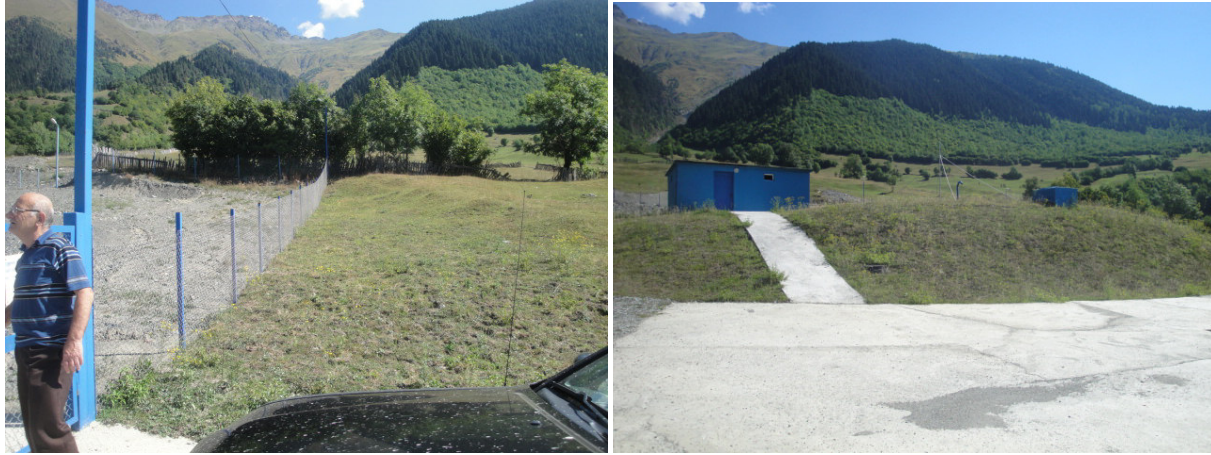
Figures 19 and 20: The territory of the new reservoir and internal concrete roads

34. The territory of the reservoir is confined. Reservoir access roads within the territory are made of concrete (**Figures 19 and 20**).

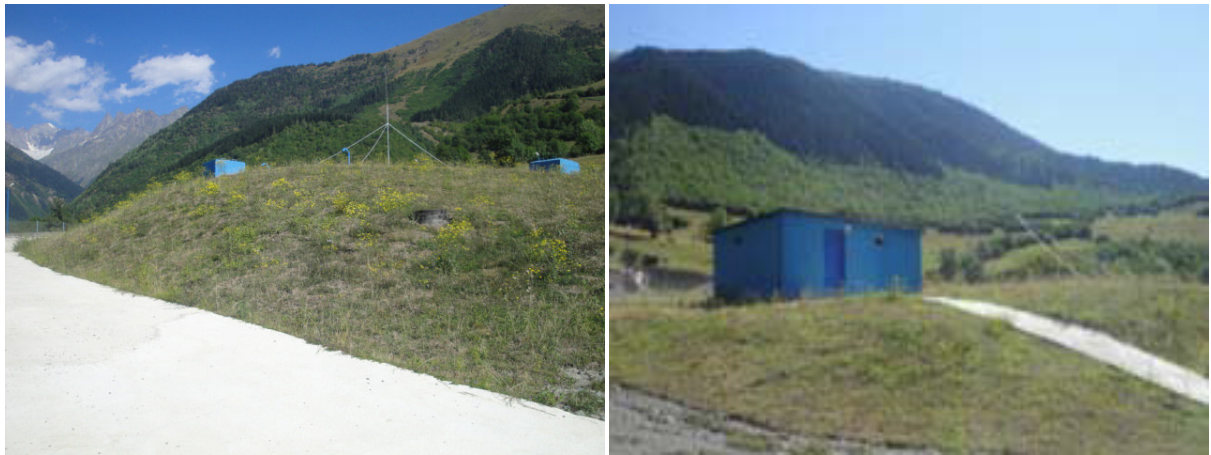
Figures 21 and 22: Reservoir territory

35. Restoration works have been performed well on the reservoir territory (**Figures 21 and 22**).

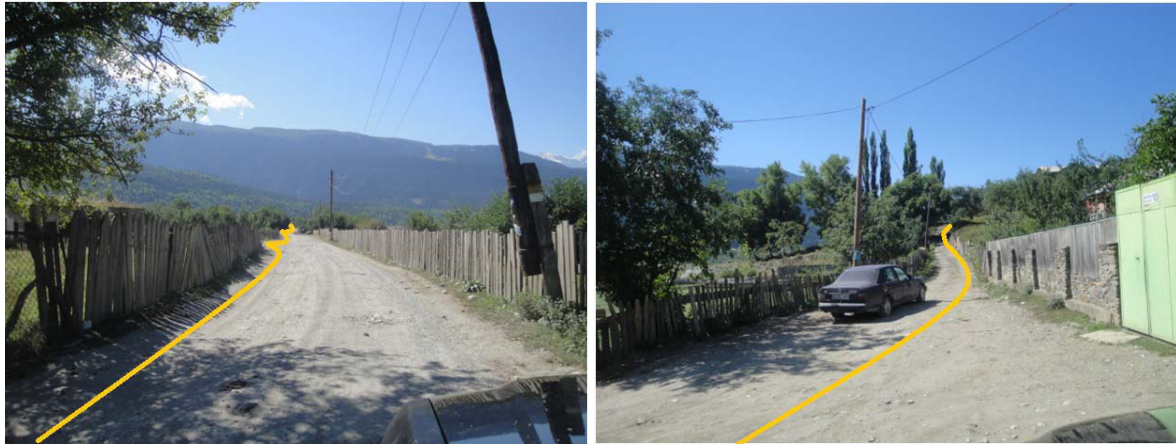
Figures 23, 24: Restoration works performed in settled areas

38. In settled areas the pipeline is mainly placed on unsurfaced internal roads (**Figures 23, 24 and 23**), although on small section pipeline passes along the asphalt-paved road (**Figure 26**). In both cases restoration works have been performed satisfactorily.

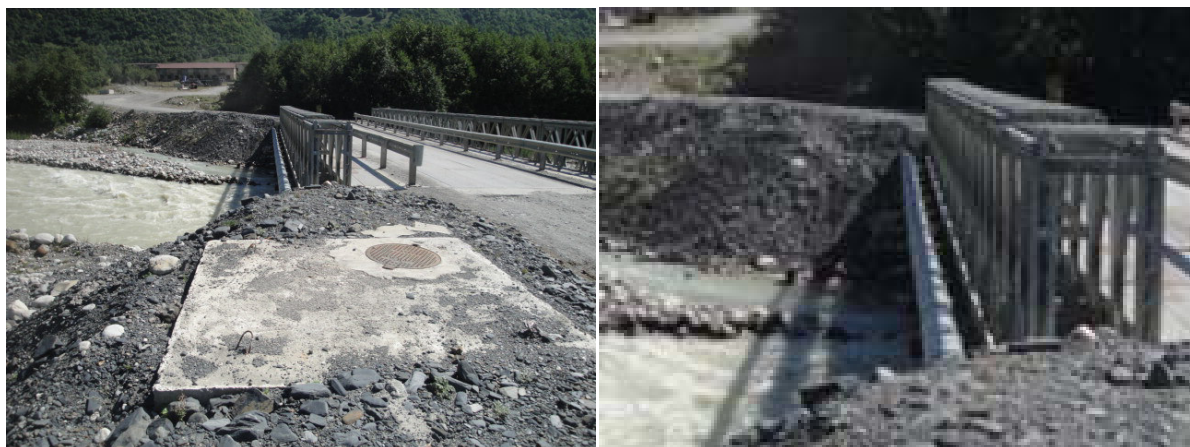
Figures 27, 28: Crossing River Mestiachala

39. The pipeline crosses River Mestiachala riverbed on the territory of the existing crossing bridge via an open method. The pipeline flows along the existing bridge (**Figure 25 and 26**).

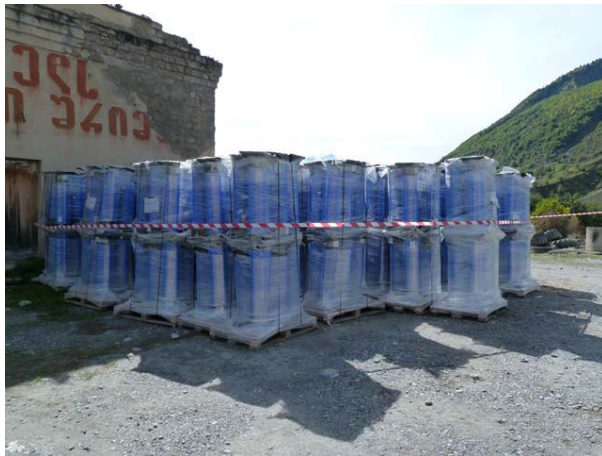
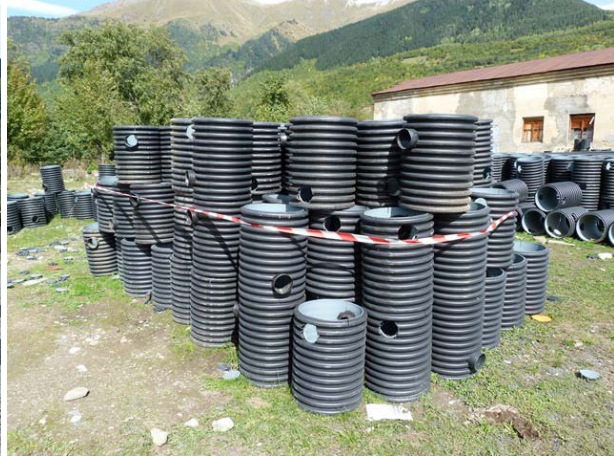
Figure 29, 30: Storage area

44. The mentioned construction camp is located in Mestia. No construction camps for the workers to live are used within the scope of the project. 60% of the employed workers within the scope of the Project are locals, while others live in the hired flats. The construction camps are only used to store the construction materials (figure 29, 30, 31 and 32).
