GEO: Urban Services Improvement Investment Program – Tranche 2 (Anaklia Water Supply and Sewerage Distribution Networks)

**43405-024 MFF-GEO Urban Services Improvement
Investment Project-Tranche 2**

**Subproject 1: Anaklia Water Supply and Sewerage
Distribution Networks**

Compliance Environmental Audit Report

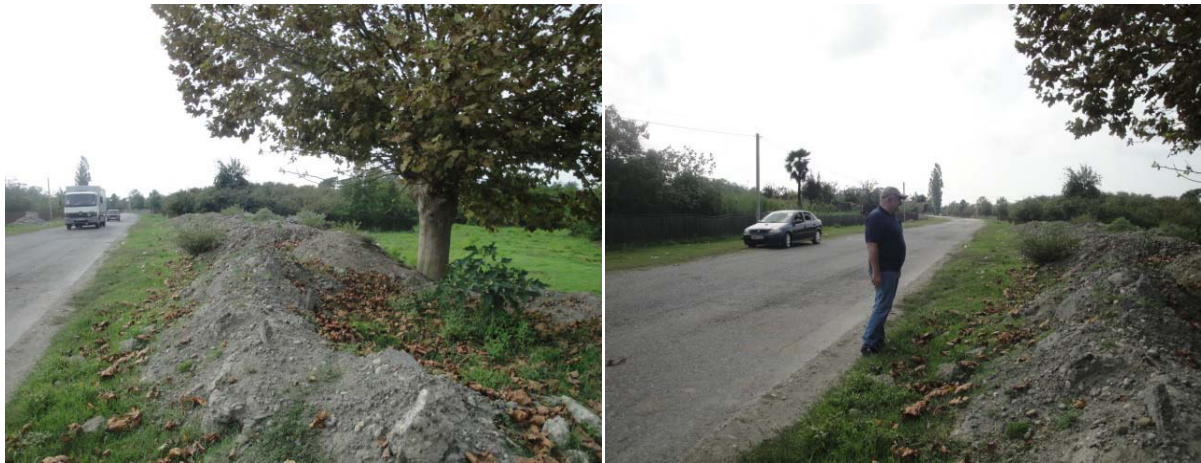
Figures 1, 2: Inert waste disposed along the road

- ✓ **Site 1** - The contractor had just placed inert waste on the mentioned site. Local authority representatives had not started yet the activities for leveling the disposed waste (**Figures 1 and 2**);

24. Contractor has disposed inert waste produced during the project implementation at places allocated by local authorities and subsequent responsibility for ultimate disposal of the mentioned waste is the obligation of the local authority. As can be seen from pictures local authority uses the inert waste derived during the project implementation for improving the territory adjacent to the Anaklia city central street. The territory adjacent to the street is being leveled and the boggy sections are being covered (**Figures 5 and 6**). On several sites works have been completed, although on several sites local authority or the companies hired by them have not yet started the implementation of works (**Figure 1 and 2**).

25. Recommendation: The draft audit report was shared with the Local Government and official letter was sent by UWSCG to the Local Government to improve the situation. Currently the transfer to the ultimate disposal place is being undertaken by the companies hired by the Local Government; Final verification of disposal places will be reported separately in the next EMRs.

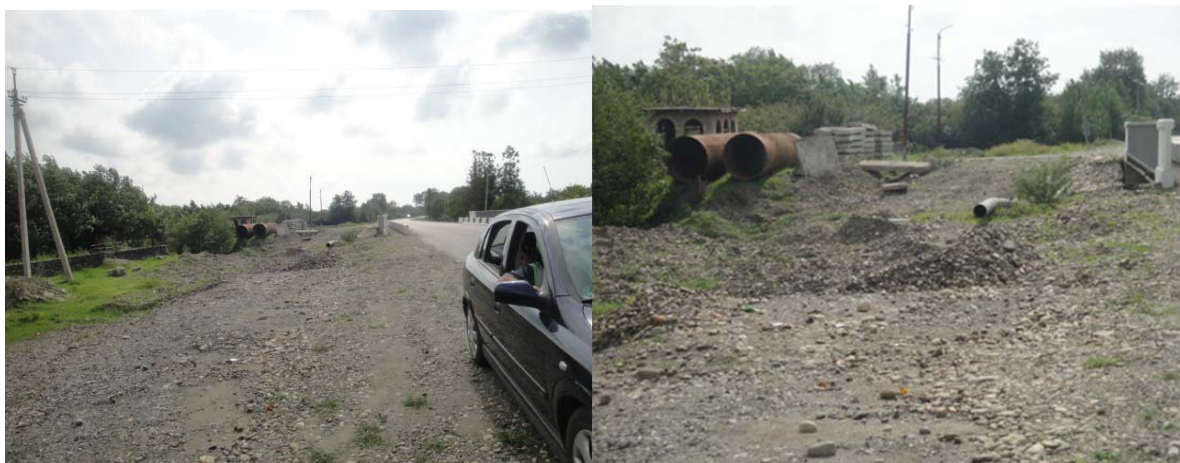
Figures 3, 4: Inert waste disposed along the road

- ✓ **Site 2** - The works of leveling disposed inert waste were underway (**Figures 3, 4**).

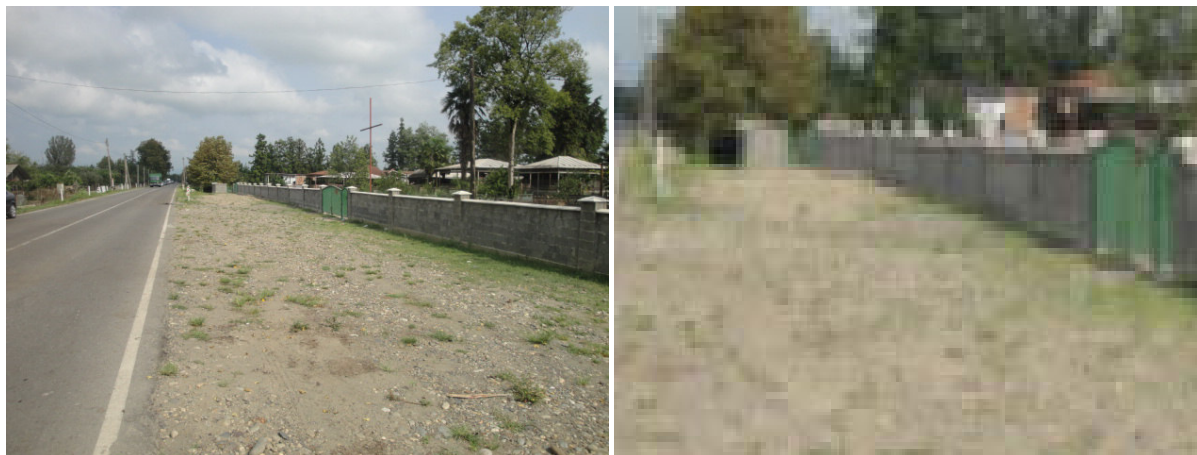
Figures 5 and 6: Final disposal of inert waste

- ✓ **Site 3** - On the mentioned site local authorities had already leveled the inert waste disposed by the contractor. According to the residents prior to performing the mentioned activities the cemetery access road was boggy and visiting cemetery was related to significant problems, especially during the rainy weather (**Figures 5 and 6**).

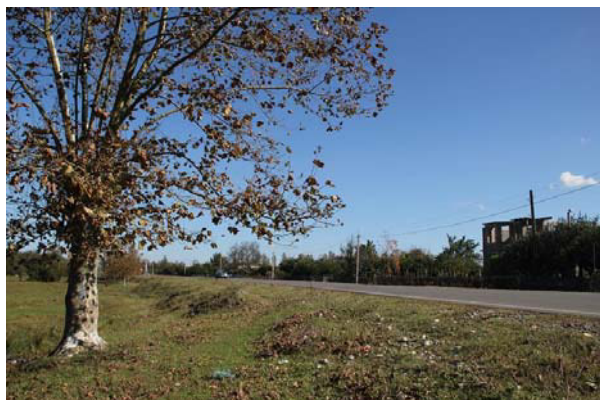
Figures7 :Territory is cleaned off the Inert waste

27. The municipality of the city of Anaklia planned the corrective action and the said inert waste was removed to Zugdidi municipal landfill from the said area. At present, the said territory is clean off the inert waste (Fig. 7).

26. After receiving the audit report, the Supervision Consultant applied to the municipality of the city of Anaklia in writing requiring the relevant department to submit the inert waste management plan and terms of the plan realization.

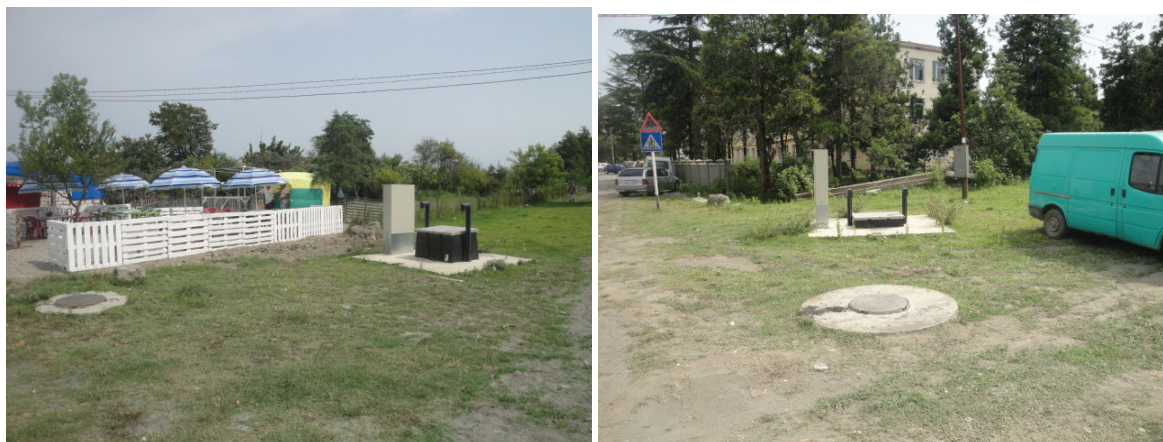
Figures 8, 9: Sewerage pumping stations and water supply wells

31. No photos of the said territory were taken before the onset of the construction. Therefore, it is impossible to fix the adequacy of the restoration works to the pre-construction state. However, following the situation on the adjacent territories, we may conclude that, as an example, the Restoration works on the territory adjacent to the pumping stations have been performed to different degrees, predominantly to the satisfactory level.

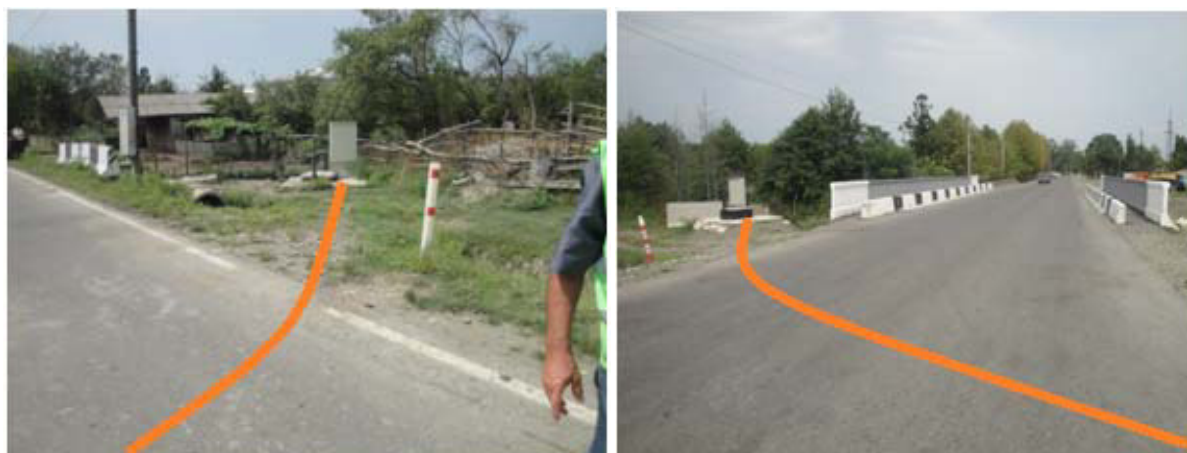
Figures 12 and 13: Restored asphalt layer set under another project

33. According to the design with the purpose of installation of water supply and sewerage pipes on many locations it was necessary to dig trenches on the motor road, mainly on Anaklia main street, respectively, it was necessary to damage the existing asphalt layer. During the audit the quality of damaged asphalt restoration works could not be determined, because new asphalt layer was set on the central road of Anaklia under another project, and this layer fully covered damaged sections of asphalt (**Figures 12 and 13**). The placed pipe track is shown in orange.

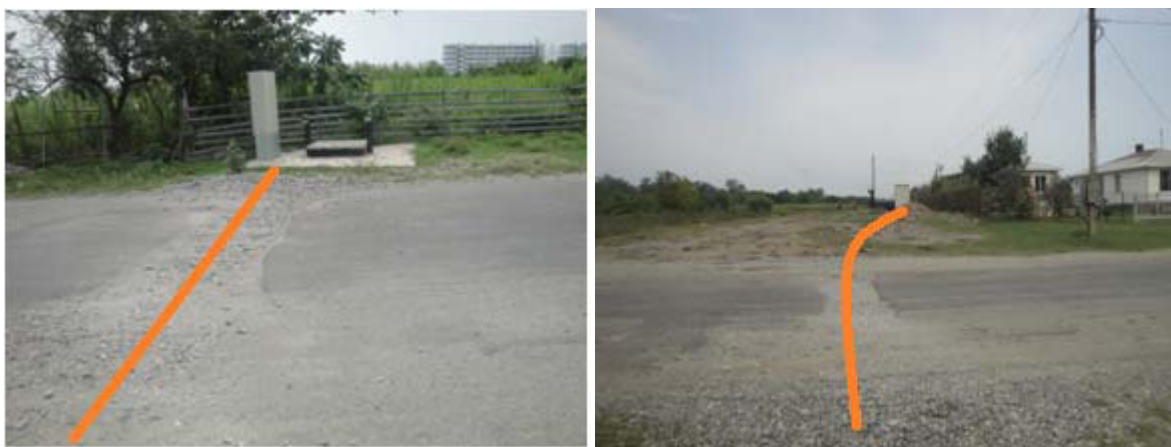
34. The degree of restoration of damaged asphalt layer on sections where new asphalt layer has not been laid under another project is unsatisfactory (**Figures 14 and 15**). The sections of asphalt restored to the unsatisfactory level can be found on the road leading to the new Public Service Hall.

Figures 14 and 15: Degree of unsatisfactory restoration of damaged asphalt layers

35. **Recommendation:** In case the laying of new asphalt on the mentioned section is not planned under another project contractor has to restore the mentioned section within one month from the receipt of audit report. Currently the restoration works as instructed by EPTISA for the 2 portions have been completed by the Contractor (as shown in pictures 20 below) and any further requirement for restoration will be reported in the next EMR.

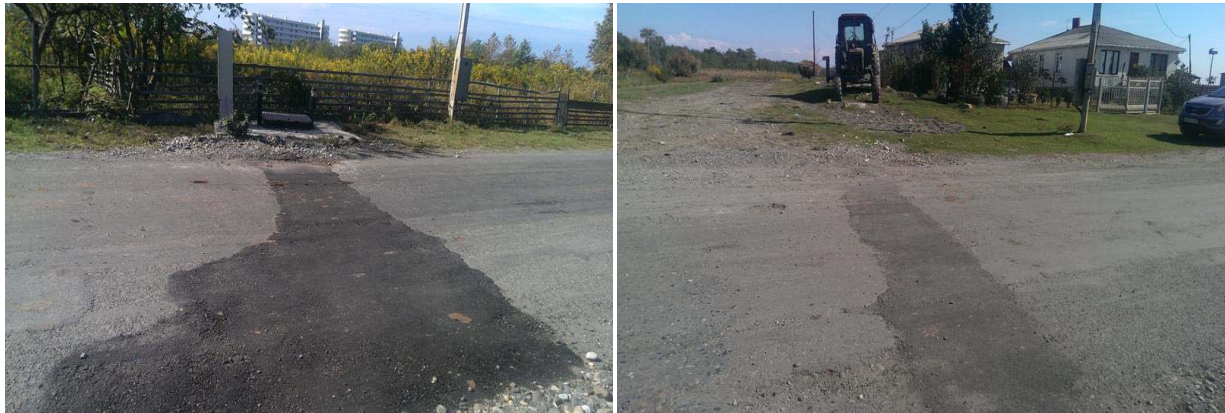
Figures 16 and 17: The restored road sections

37. Contractor accomplished the restoration works within the specified terms, and one month after the audit the corrective actions were also realized (Fig. 16 and 17).

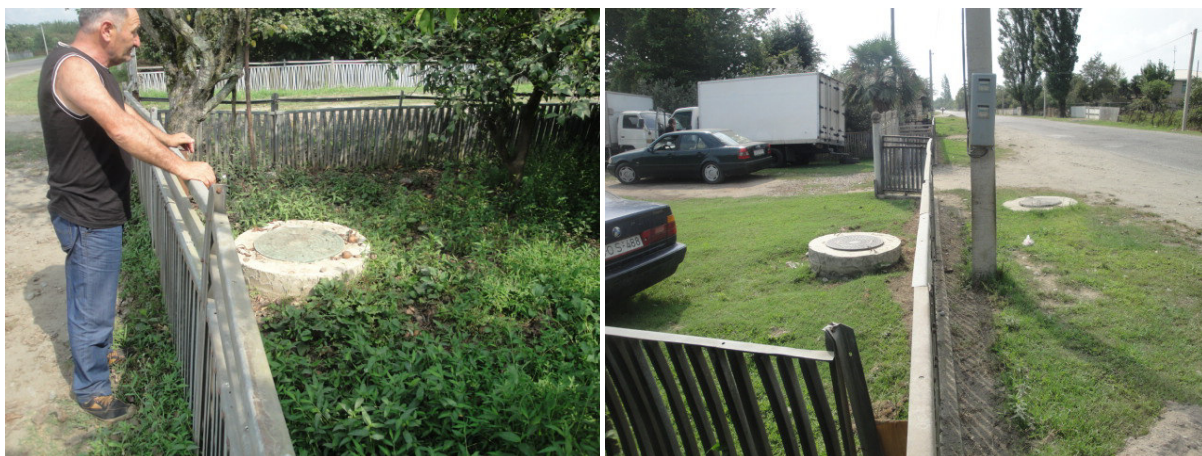
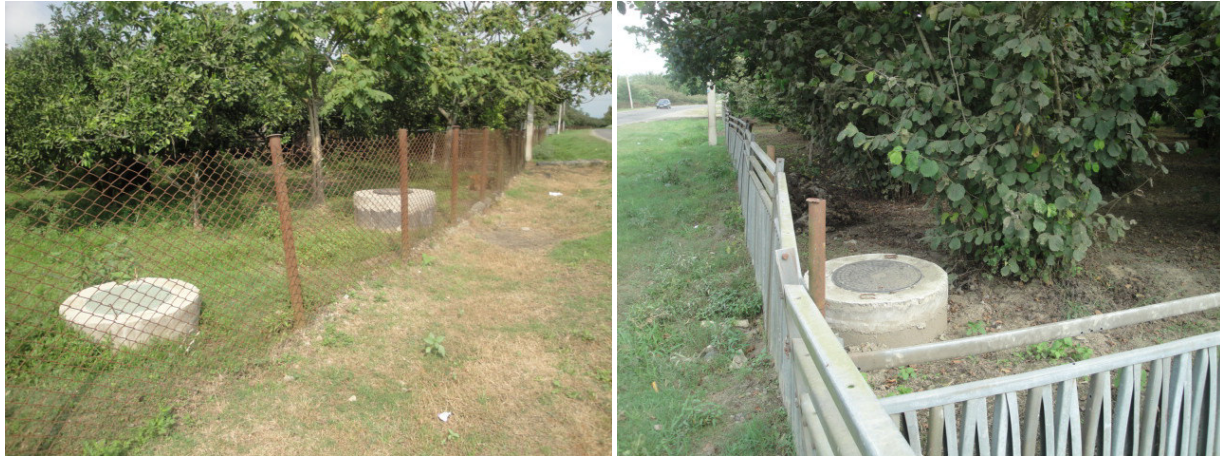
38. Furthermore, under the project the residents were connected to water supply, as well as sewerage system. During the audit the quality of the restoration works of the trenches dug for laying the pipes to up to forty families were inspected. At all those sections the consultant visited, the quality of restoration works was satisfactory(**Figures 18, 19, 20 and 21**).

Figures18, 19: Water supply and sewerage shafts located on private territories

Figures 20, 21: Water supply and sewerage shafts located on private territories

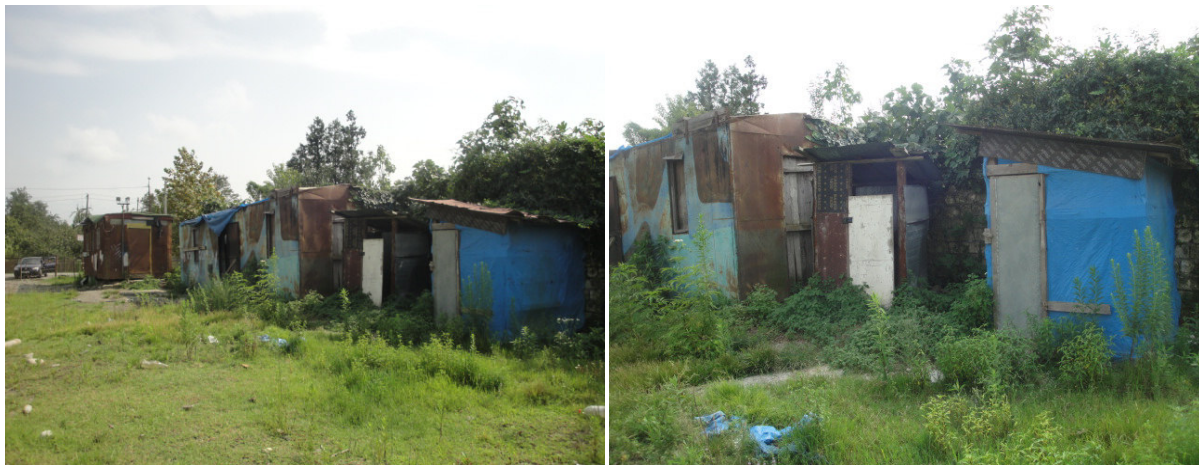
Figures 22 and 23: Abandoned utility structures on the camp territory

39. Construction camp of the contractor company was located on Ganmukhuri territory. Construction camp was closed on May 7, 2014. On the audit day construction equipment had been removed from the camp, although several wooden and metal light, small structures, as well as one wagon type structure (**Figures 22 and 23**) were remaining.

41. Recommendation: Based on the audit report and instruction issued by EPTISA, Contractor PERI carried out in Sept. 2014 the following corrective measures:

- ✓ Sewerage waste from the septic tank located on the camp territory pumped and transferred to the existing WWTP, and a septic hole filled with soil;
- ✓ All dismantling and removal of all sanitary structure from the existing territory, as shown in Figure 31

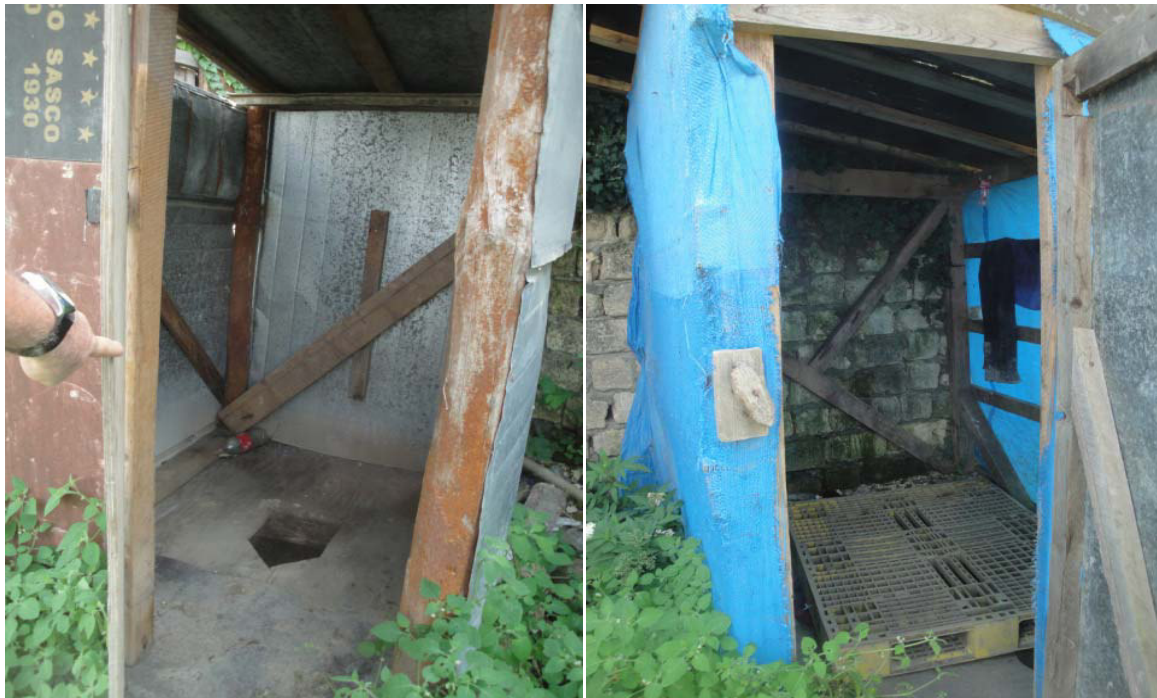
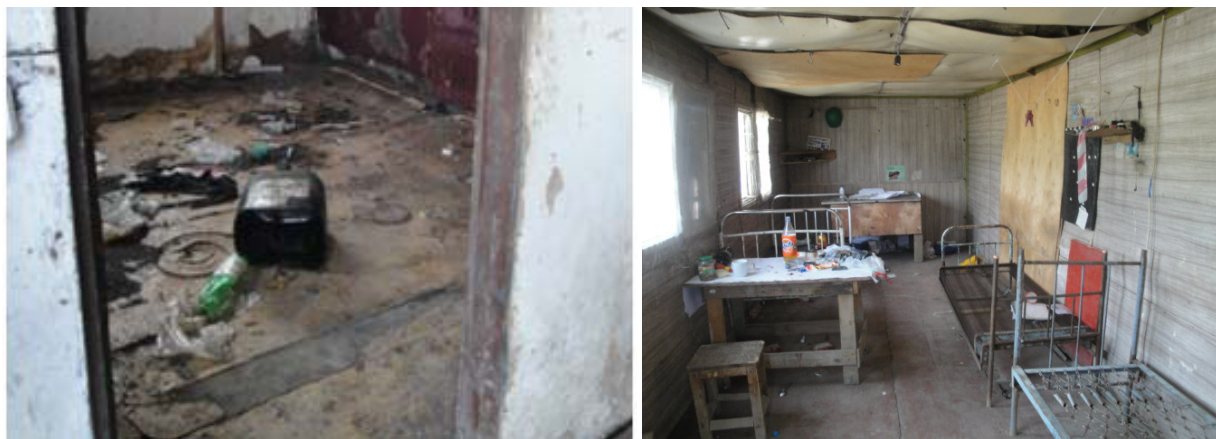
40. The mentioned buildings mainly had service function, and they were: toilet, bathroom, security guards room and warehouse facility (**Figures 24, 25, 26 and 27**).

Figure 24: Toilet**Figure 25: Bathroom**

Figure 26 27: Warehouse facility**Figure 30: Security guards room**

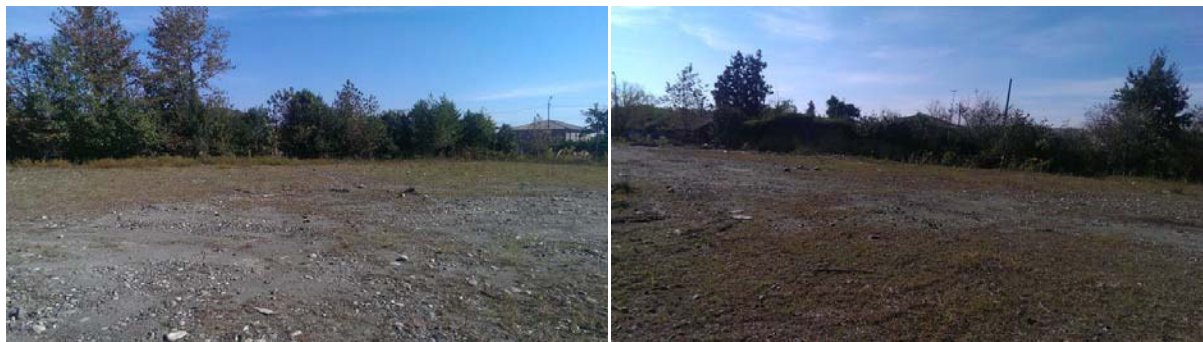
Figures 28 and 29: Restored camp area

43. Within one month from the audit, the small infrastructural buildings on the existing camp were totally dismantled and removed from the area, and the area was duly restored (Fig. 28 and 29).
