Belize
Municipal Development Project (P111928)
Climate Resilient Infrastructure Project (P127338)
Implementation Support Mission – August 8-12, 2016

Aide Memoire

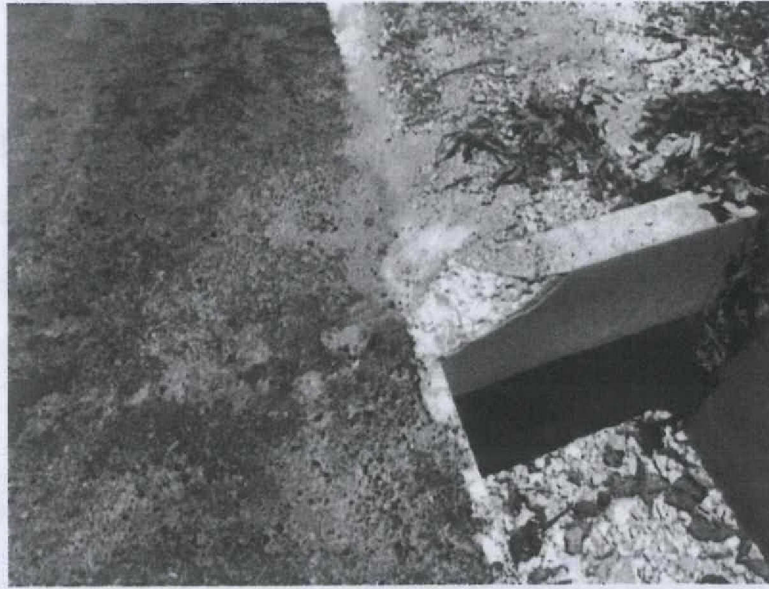
- Road work is ongoing, anticipated to be complete on schedule
- No sign of flooding or overflow from the effects of Hurricane Earl
 - All drains seem to be functioning well, tested by the rains of the category 1 Hurricane
- Debris in drain channels, will be cleaned fully after completion of chip seal roadwork
- Various driveway entrance curbs damaged, will be repaired following completion of roadwork (See photo below)

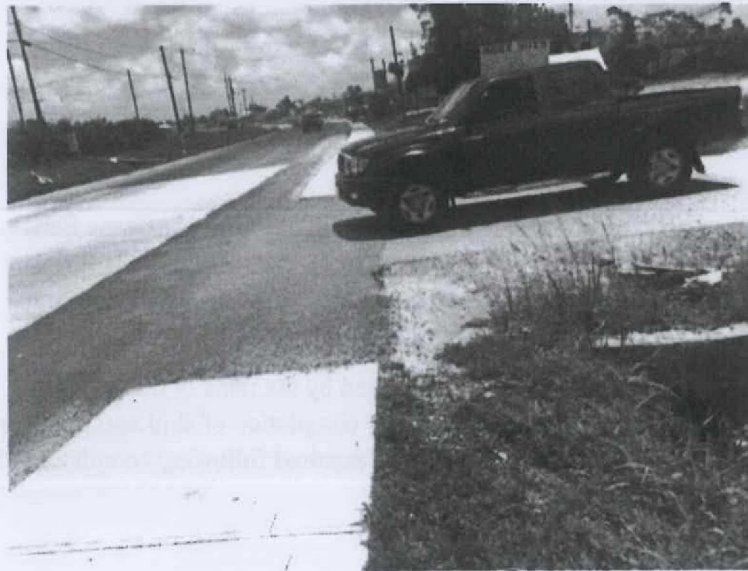
- At residential driveway entrances, due to the shallow drains, the drains are at risk of becoming clogged and flooding private resident. These areas should be well maintained to keep free of trash and debris.
- The outfall of the site drains to an existing street ditch that parallels Constitution Street, there is concern due to the increased flow of the new MDP project this may create water to overflow on the east side and flow over the road to the west side. This area should be monitored, an intervention may need to take place if this street continues to experience flow-over. (See photo below).

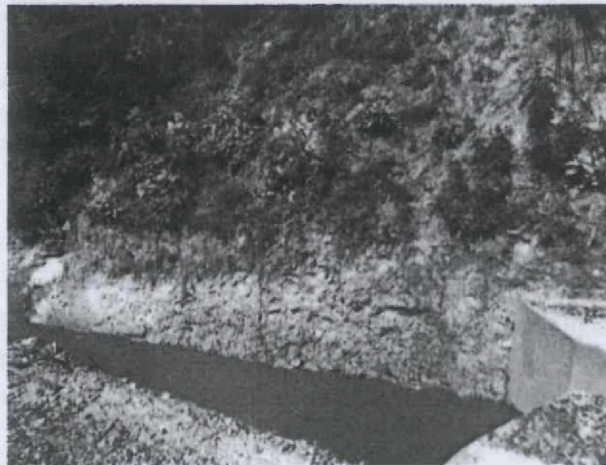
- Road work is ongoing, anticipated to be complete on schedule.
- Drainage is functional with no signs of overflow or flooding from Hurricane Earl.
- All ditches need to be cleaned and cleared of debris following completion of road works.
- The design called for grass lined ditches in some areas, these areas will be lined with concrete to make the ditch more resilient. Much of this is due to the increased slope of the drain and road causing higher velocities of water to drain downhill.
- Recommendation: Monitor the bottom of the hill where the drainage water velocity could be high to ensure it does not erode into the existing bank. There are already measures taken by the PIU to line the ditch between 1-2' with concrete to prevent erosion. (See photo below)

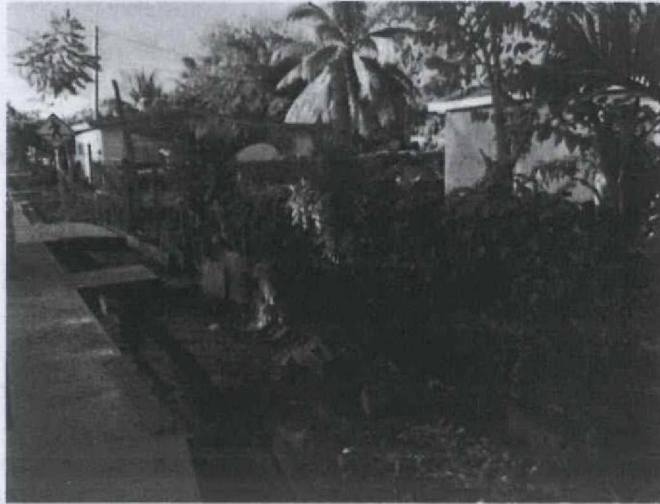
- Paving and markings are complete.
- Drainage is functional with no signs of overflow or flooding from Hurricane Earl.
- Area of concern: There seems to be signs of flooding at the bottom of the hill where the site drainage system ties into the existing system. There were signs of flooding in this area on the previous visit prior to MDP project tie-in, which indicates this is a previously flood prone area. The PIU team to follow-up to see if the MDP project has increased the flood risk, there seems to be no impact from the MDP project. (See photo below)

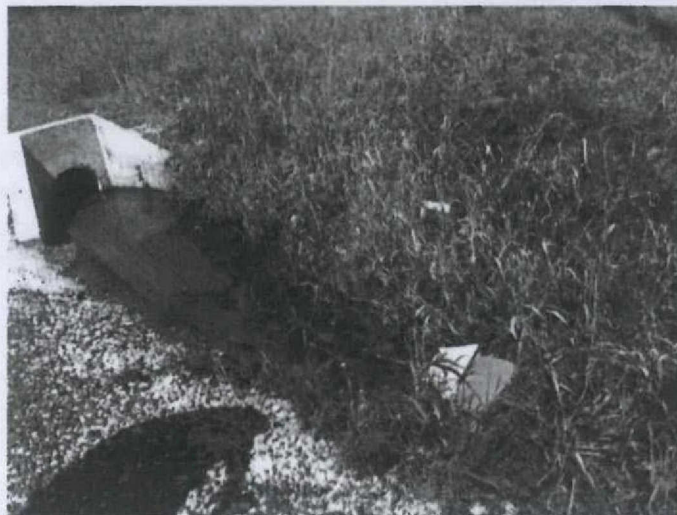
- Road work is ongoing, anticipated to be complete on schedule.
- Drainage is functional with no signs of overflow or flooding from Hurricane Earl.
- Design at this Lucille Street location calls for grass lined ditches. Trash and debris are present in ditches and will need to be maintained. (See photo below) See follow-up clarifications (Maintenance Plan).
