## **Environmental Monitoring Report**

# **Highlands Region Road Improvement Investment Program – Tranche 2.**

Mendi – Tambul Road Sub-project.

## **Mendi to Tambul ROAD SUB-PROJECT ENVIRONMENTAL SAFEGUARDS MONITORING REPORT**

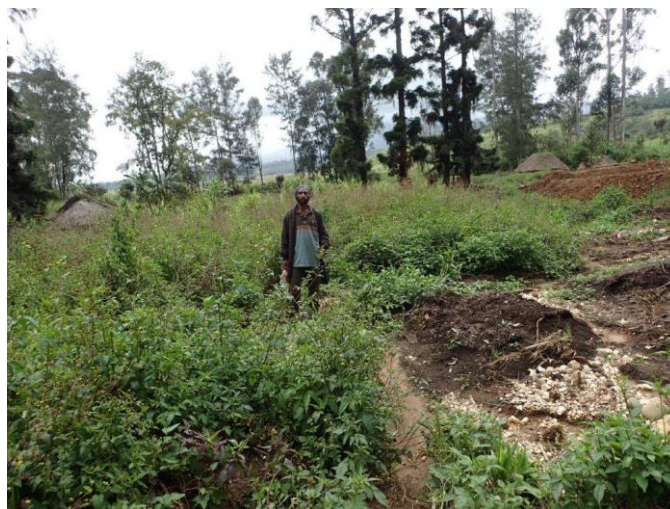
## List of Figures

Figure 1 : Sedimentation on food gardens at Chainage 19+

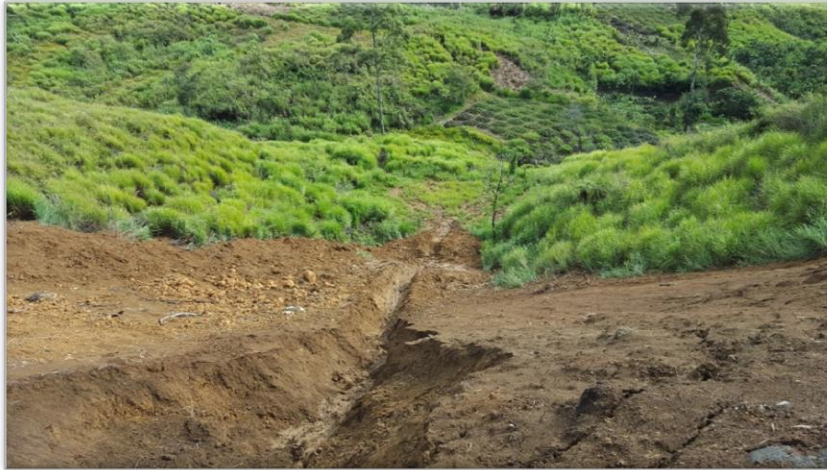
30. The wastes generated from construction works are of three main types namely, overburden from construction site and quarry sites, camp wastes and hazardous material. The over burden generated from road sides was dumped in designated areas after reaching agreements with relevant land owners. There were several requests from land owners to dump road wastes into their land and level the grounds. In such cases, the contractor supplied waste material to land owners at free of charge. However, there have been few cases where road waste allowed roll-down slopes damaging gardens and streams (Figure

2). Chainage 51+167, In another case at chainage 19+100, the contractor dumped waste at the door-step obstructing the movement of households. The contractor has been instructed to resolve such issues immediately where the outcome has been unsatisfactory. The contractor has been notified to correct this issue on 20<sup>th</sup> September 2016.

Figure 2 : Dumping of Road side waste at Chainage 51+167

6	PPE materials inadequately supplied to local workers		
7	Road waste material not disposed properly. Damage to vegetation and gardens i.e. chain 51+167; 41+500	Notice of violation issued to contractor on 20 <sup>th</sup> Sep 2016	Will be monitored in first quarter 2017
8	Extraction of materials at Ande River turned stream water murky chainage 44+446

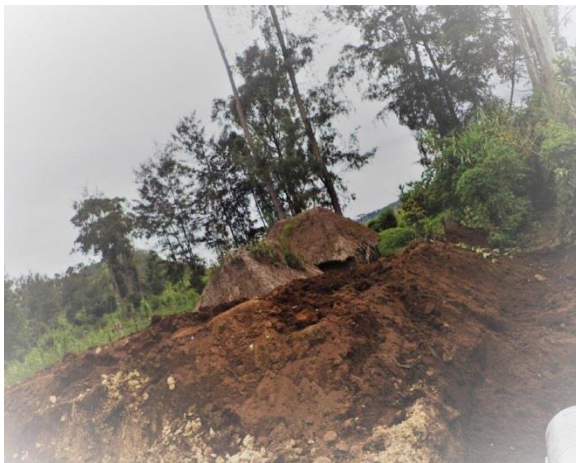
Figure 3 : Road overburden obstructing a house

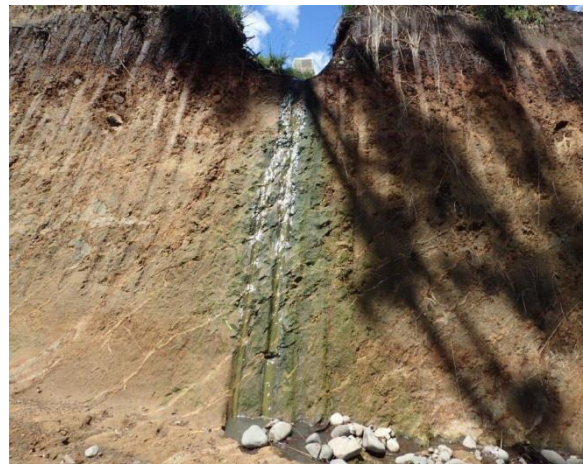
Figure 4

24. Ande camp has new facilities for the employees where the worker facilities are at a higher level. The two areas of non-compliance with CEMP are the disposal of waste water and solid waste management. As stated in paragraph 21, the grey water is diverted to a natural stream feeding into Ande River which is non-compliance. Kitchen and workshop waste is dumped or is burnt which is non-compliance. The CAR details are in Appendix 3.

Figure 4: Grey water discharge at Ande Camp

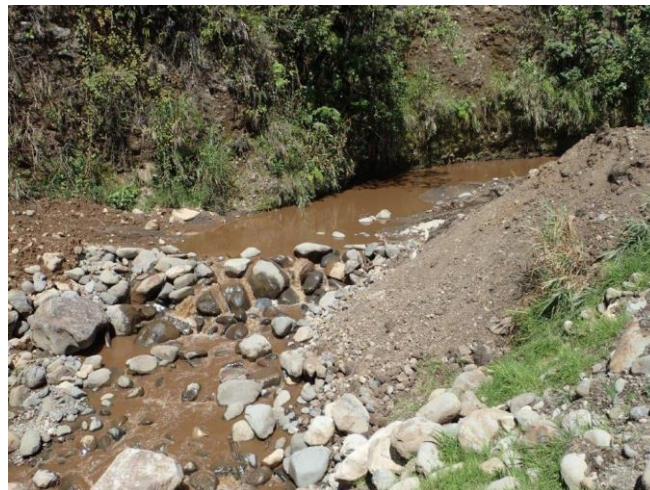
35. The environment damage from the 2 quarries at Ekari (Ch 55+530) and Kagul (Ch 13+000) were evident where waste material followed a free-fall. It was not possible to minimize this damage due to the location of the quarry in a hilly landscape. The damage was to the adjacent land where forest stood including edible pandanus and ficus damaropsis. The quarry operation at Ande River caused the deterioration of water quality (Figure 5). However, the river water became normal after the completion of material extraction.

Figure 5 : Dirty water (low quality) at Ande River due to material extraction

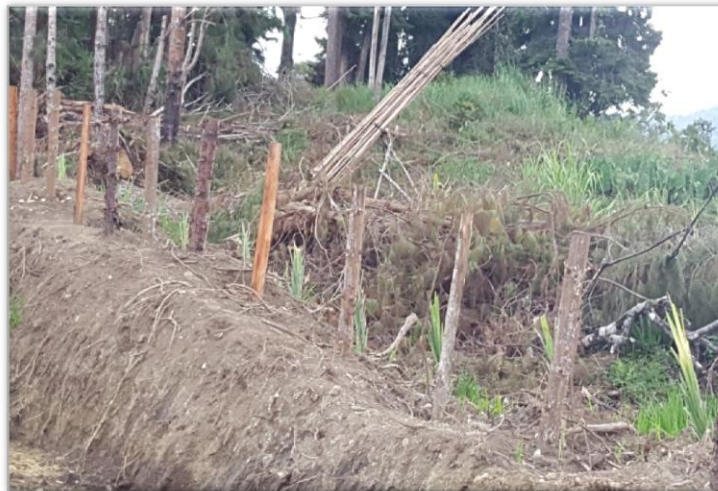
39. The contractor is currently preparing a re-vegetation plan for implementation after the completion of road works. This plan will be reviewed by ESSU before rolled over to implementation. In the meantime, community by itself has planted trees in chainage 16 who have been educated by contractor staff (Figure 6).

Figure 6 : Tree replanting at Enep village

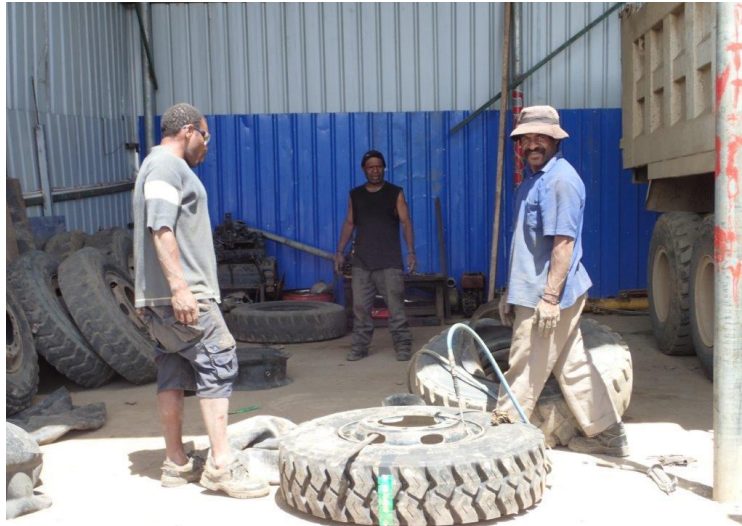
41. All construction workers are required to be present on their respective stations until 6.00 pm. The employees are advised not to engage with affairs of the community. The employees were advised on camp rules including the prohibition of removal of fauna, flora and fuel wood from the local forest areas. There had not been any social issues or concerns by locals against the employees during the reporting period. The entrance to camp and yards are controlled by private security guards where entry of any unauthorised person into these premises is not permitted. Each employee was issued with personal protective equipment (PPE). However, during inspections, it was obvious that the employees were not wearing PPE items (Figure 7). The contractor has been instructed to make it compulsory for all its employees to wear PPE whilst at work (see Appendix 3 for CAR). The matter will be monitored aimed at an appropriate solution.

Figure 7 : workers at Ande camp without safety PPEs

- The order placed by the contractor for the supply of PPE equipment and baseline equipment to collect environmental data has not arrived yet. Accordingly, workers do not have PPE equipment and the baseline environment data has not been established;
