# **PNG: Highlands Region Road Improvement Investment Program (Project 2)**

## **Mendi to Tambul Road Sub-project**

### **ENVIRONMENTAL SAFEGUARDS MONITORING REPORT No.1**

**(January to June, 2016)**

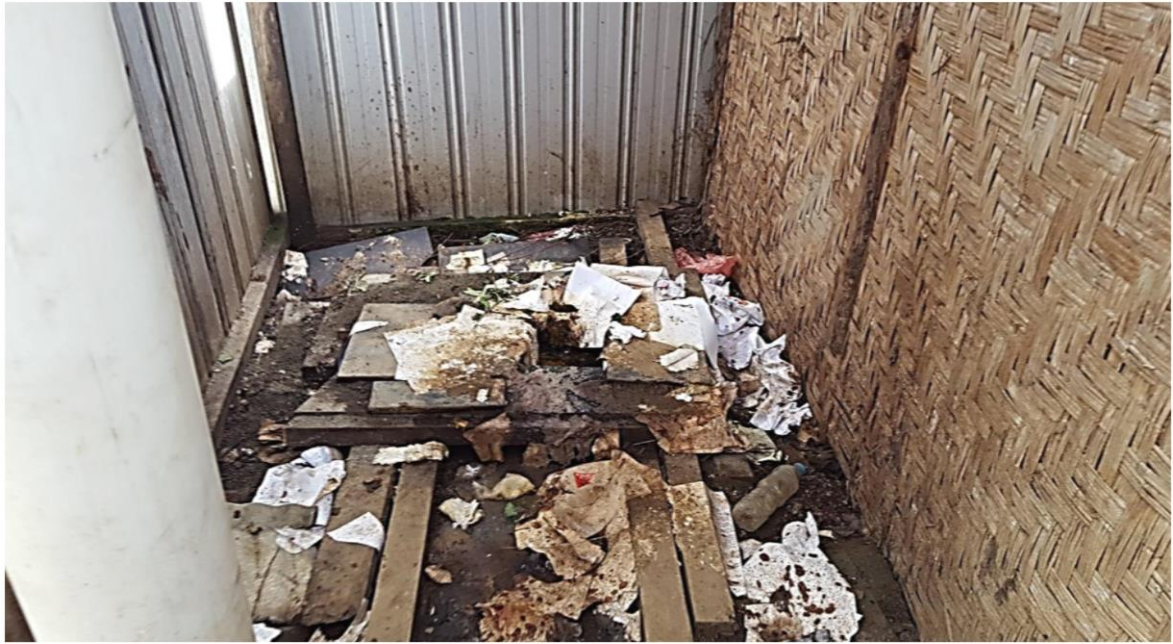
**Photo 1 Toilet used by local Employees at Mopa Camp**

28. It has been highlighted by CSC, HRMG and PIU that proper accommodation for the national workers should be built with safe drinking water, kitchen facilities with septic toilets. The toilets at Mopa camp do not meet with the requirements as seen in Photo 1.

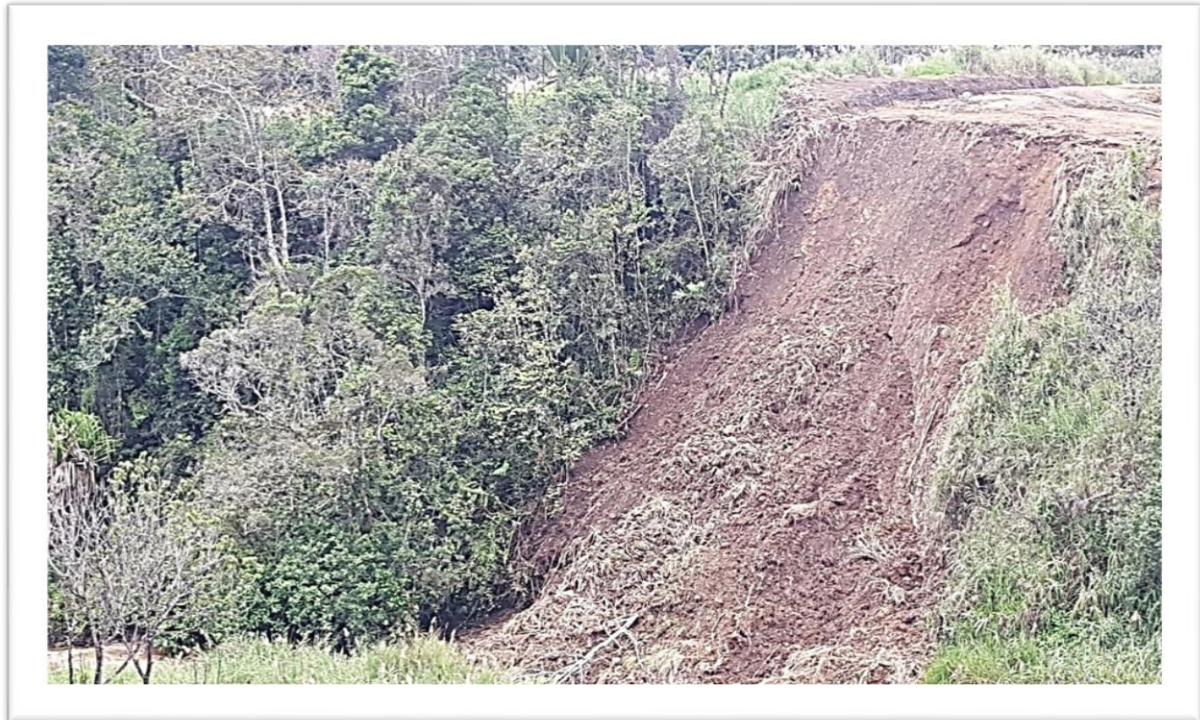
dump road wastes into their land and level the grounds. In such cases, the contractor supplied waste material to land owners at free of charge. There have been a few cases where spoil rolled down the slope of the road onto gardens and streams (Photo 2). Also a few reports on waste dumping damaging gardens of land owners have surfaced. The contractor has been instructed to resolve such disputes.

**Photo 2 Dumping of Road Spoil at Ande River in Tambul**

40. On reporting of such impacts, the contractor changed its behaviour and dumped wastes in designated areas where there would not be any harm to the local population and their assets. The dump sites were levelled off and adequate drainage provided upon pointing to the contractor by HRMG staff and the community. The timber off cuts, iron cuts and other material were collected and disposed by the contractor in designated sites.

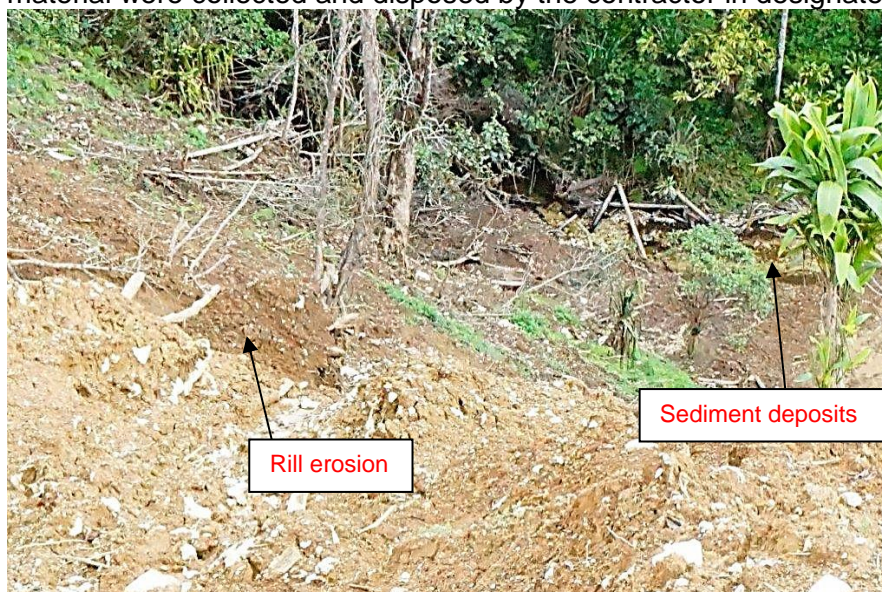
**Photo 3 Dumping Quarry Spoil in Streams near Alu Quarry, Komeal**

41. The wastes generated from quarry sites were used to fill depressions at the request of relevant land owners. All material disposed did not have any impacts on the community and no reports from the community were received regarding this. There was an observation where Alu quarry spoil washed down into streams (Photo 3) although there was no complaint from the community.

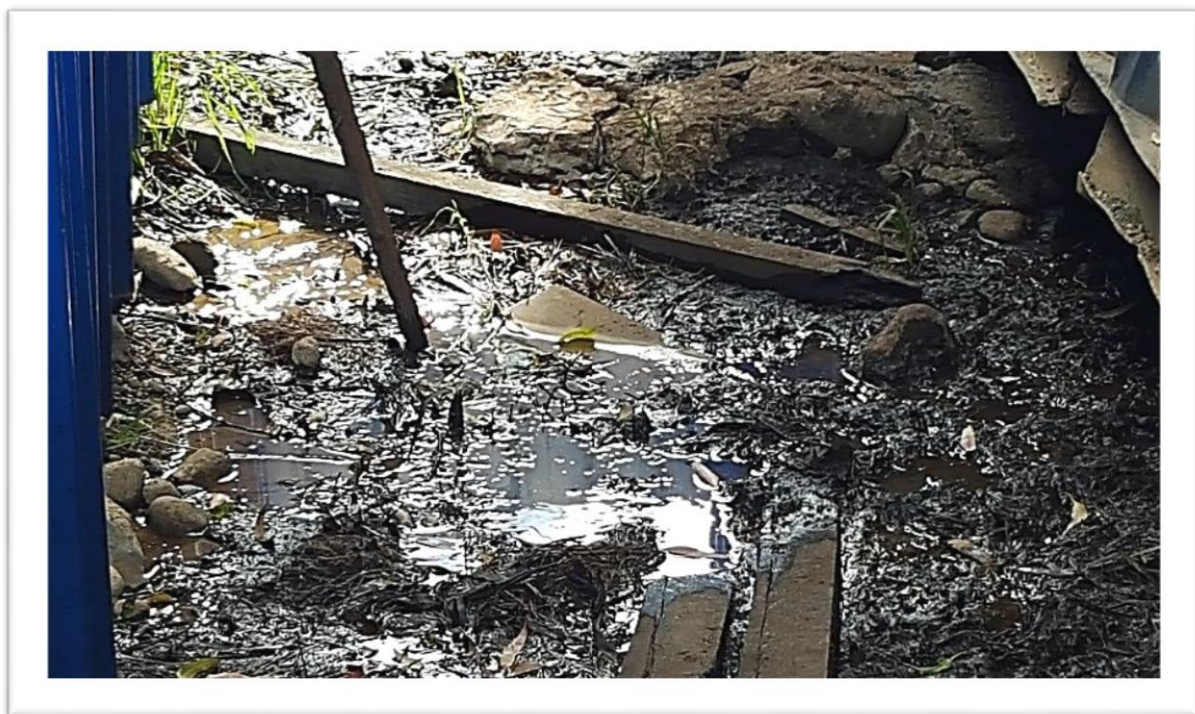
42. The hazardous wastes generated from construction works were the bitumen, paints and lubricants. All such materials were contained in contractor's yard with controlled entry to people. There was no report of any injury or life impairment to community members from hazardous wastes disposal. There was an incidence where bitumen leaked from the bitumen burning plant. The contractor on reporting impacts quickly cleared the area and made it safe for the people. Minor leakage of fuel and lubricants from the camp were removed by the contractor without creating adverse impacts on the environment (Photo 4).

**Photo 4 Lubricant and Oil Leakage at Ande Camp**

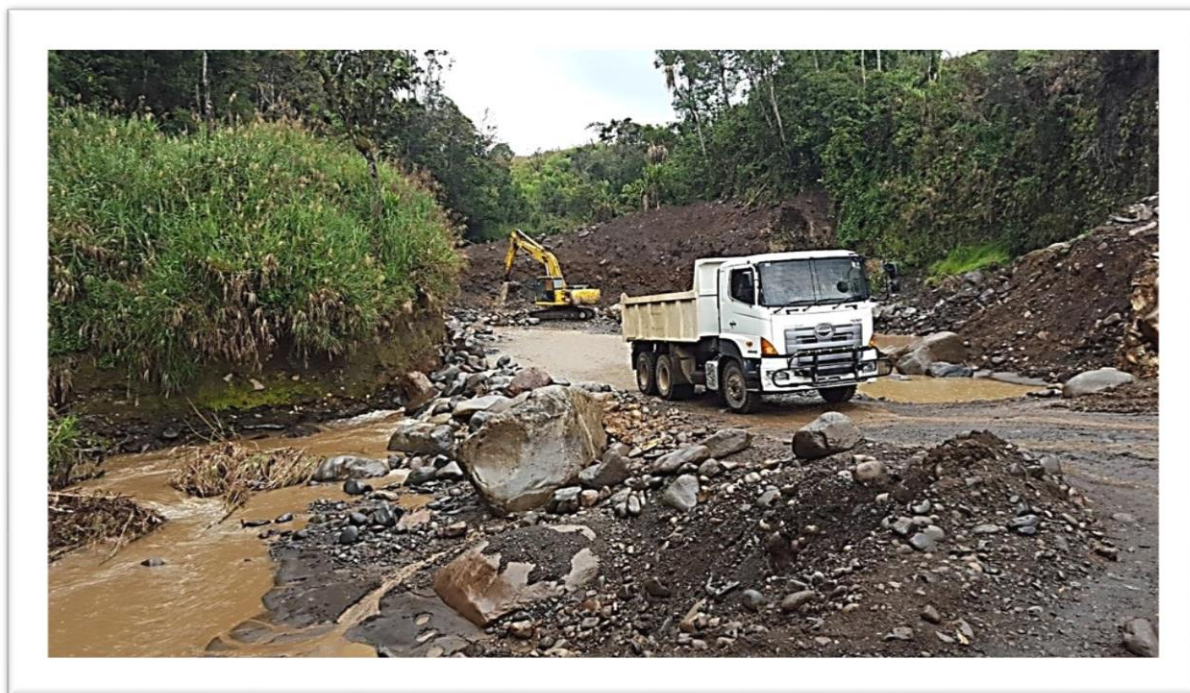
45. The environment damage from the 2 quarries at Ekari (Ch. 55+530) and Kagul (Ch. 13+000) respectively were evident where spoil material cascaded down the slope. It was not possible to minimize this damage as the quarries are on hilly landscape. The damage was to the adjacent land where forest stood including edible pandanus and *Ficus damaropsis*. The quarry operation at Ande River caused temporary discolouration in water quality (Photo 5). However, the river water was clear after the completion of material extraction.

**Photo 5 Materials Extraction at Ande River**

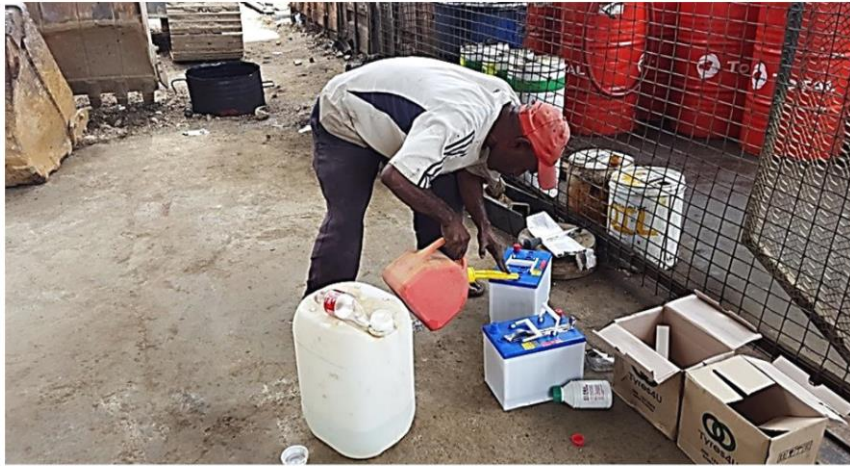
**Photo 6 Employee at Mopa Camp filling battery water without PPE**

54. Most of the employees do not wear such equipment during working hours. The contractor has been instructed to make it compulsory for its employees to wear PPE whilst at work.

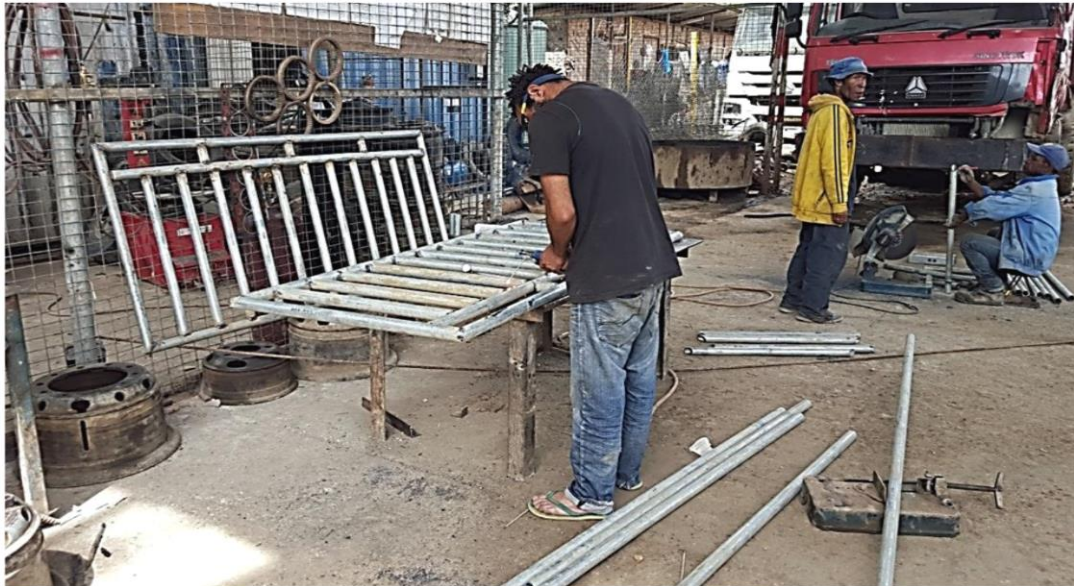
**Photo 7 Welder without Safety Boot and Hand Gloves**
