Semi-annual Report

PNG: Highlands Region Road Improvement Investment Program (Project 2)

Kotna to Lampramp Sub Road Project

ENVIRONMENTAL SAFEGUARDS MONITORING REPORT

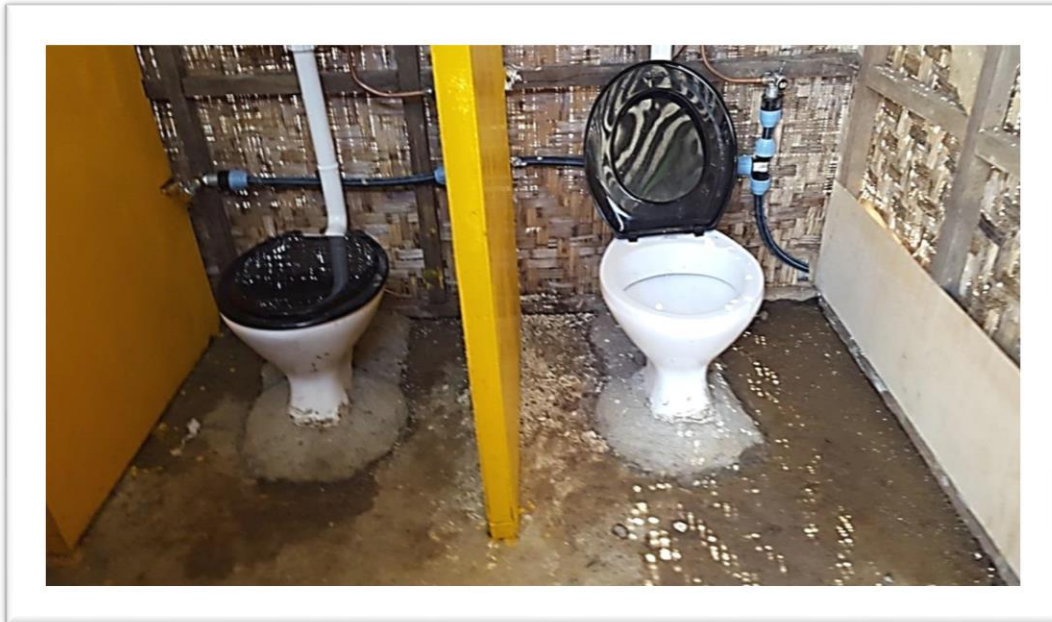
27. The Tigi camp yard is used for the storage of construction equipment and material stockpile. The camp was fully fenced where the contractor employed local security guards for the protection of machinery and equipment as well as for the control of visitors. The camp provided offices, staff accommodation, equipment storage, kitchen facilities and toilets. Tigi camp is the only camp in tranches 1 and 2 that has provided septic toilets for local employees (Photo 1).

Photo 1 Septic toilet at Tigi base camp

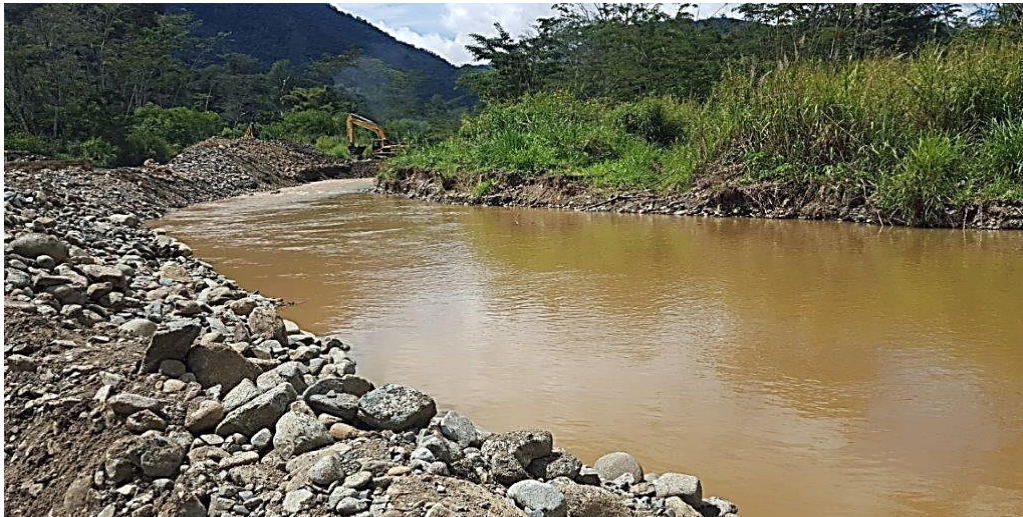
33. There are several streams and rivers that are located within the construction zone. Although the water quality of streams and rivers along the road section was not measured before the construction works began, observations revealed lowered water quality in the Angel River where a river-based quarry is in operation (Photo 2).

34. Also, dumping of road wastes along the river caused pollution of river water. The water quality was also found to be low in several other streams in the mountainous section due to excessive run off from landslides along the alignment. The water quality deterioration is mainly due to sediment load. The impacts are temporary as water quality will improve after the completion of works. The contractor has been advised to provide adequate water quality mitigation measures in future. It has also been agreed that the contractor conducts baseline water quality measurement prior to work commencing in other areas.

Photo 2 Turbidity in Angel River from material extraction

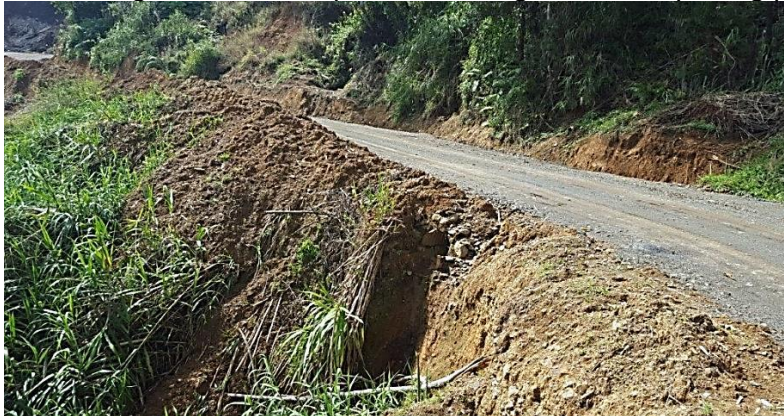
41. The dumping sites have been agreed with the clan leaders. In addition, spoils were placed on land and levelled off as requested by several land owners. In such cases, the contractor supplied waste material to land owners and did levelling off free of charge. In few cases, the material has been rolled down the slope of the road alignment thus damaging natural vegetation and streams. Photo 3 shows rolling of road wastes down the slope of the road which is non-compliance.

Photo 3 Construction Spoil Rolled Down from slopes above

43. After the reporting of such impacts (see photo 3&4), the contractor was found to have changed its behaviour by dumping wastes in designated areas without causing any harm to the local population or their assets. The dump sites were levelled off and adequate drainage provided upon pointing to the contractor by HRMG staff and the community. The timber off cuts, iron cuts and other material were collected and disposed by the contractor in designated sites.

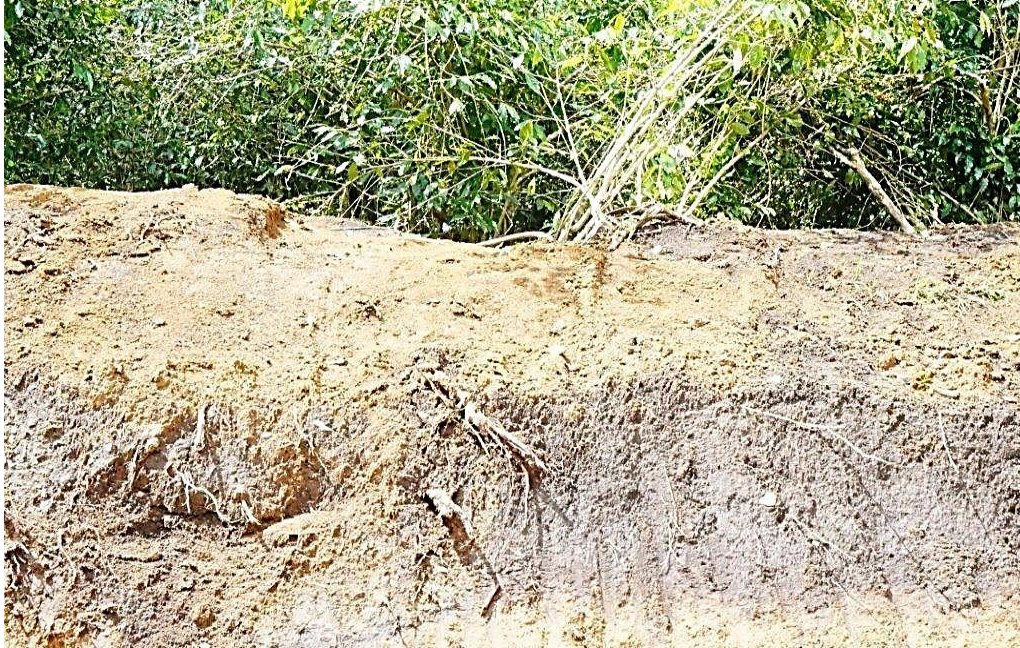
42. The road waste dumped on coffee gardens near 17 km does not comply with the CEMP (Photo 4). The contractor has been advised to deal with this case and to provide compensation to respective land owners, if required. The contractor has supplied the CAR where it agreed to fix the problem during the next reporting period.

Photo 4 Spoil placed on Coffee Gardens at 17 km

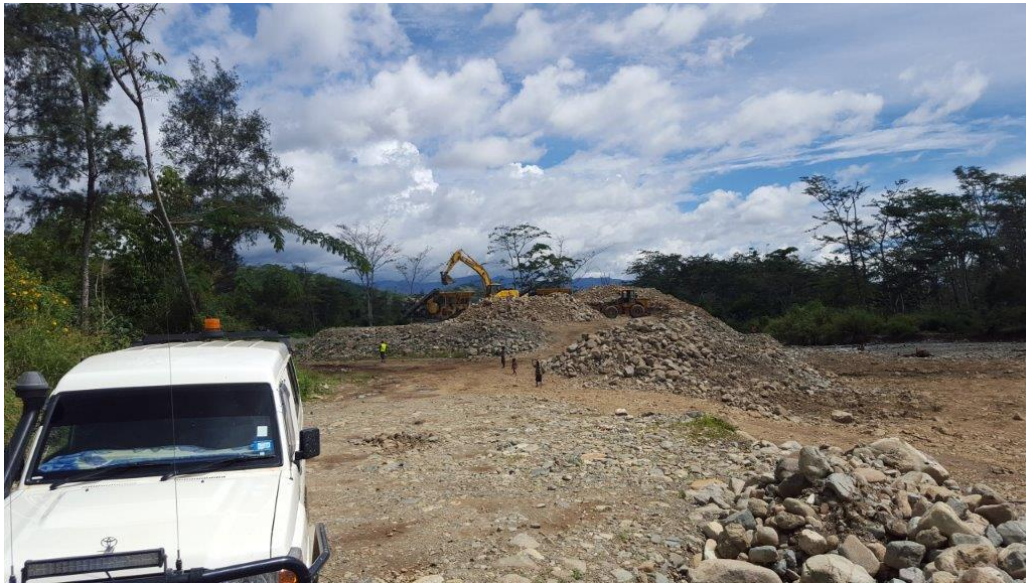
Photo 5 Gravel Extraction at Angel River Quarry

48. The environmental impact from the 2 river quarries on the downstream was evident as the turbidity level was very high during material extraction. The impacts were obvious as the excavator was working in the middle of the river. As a result, many people living downstream were affected by way of their washing and laundry. A non-compliance report has already been delivered to the contractor who has responded with a CAR in order to rectify the damage (Appendix 3).

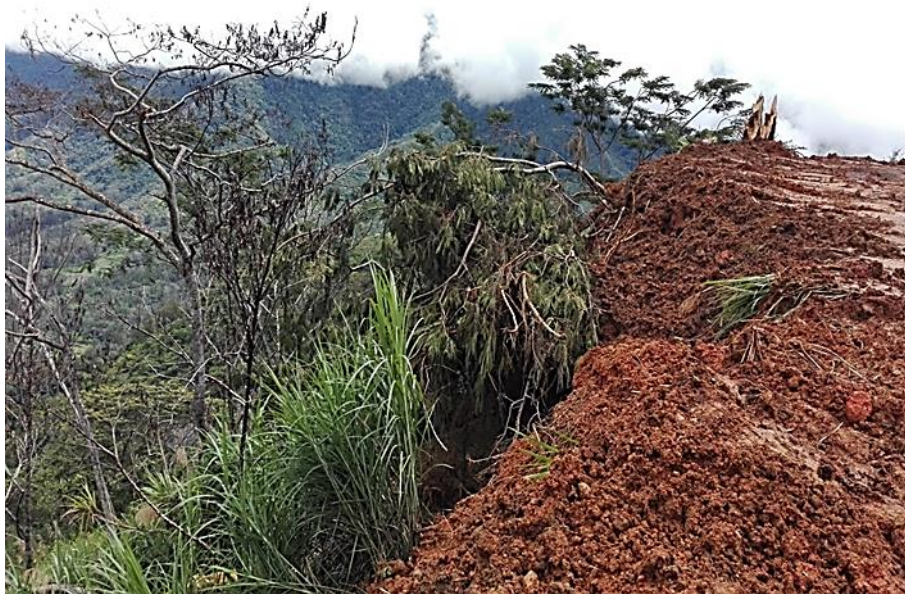
49. A number of trees were removed from the Right-of-Way to pave the way for road construction. Many trees were removed in accordance with the resettlement plan where APs have already been compensated for. In the meantime, there were other trees removed in order to pave the way for construction works. The actual number removed is unknown as there had not been records kept by the contractor who had been advised to correct this issue through proper record keeping. This will be monitored. The contractor will provide seedlings to people along the alignment for planting in order to replace what is being destroyed.

Photo 6 Damage to Natural Vegetation resulting from road spoil dumping

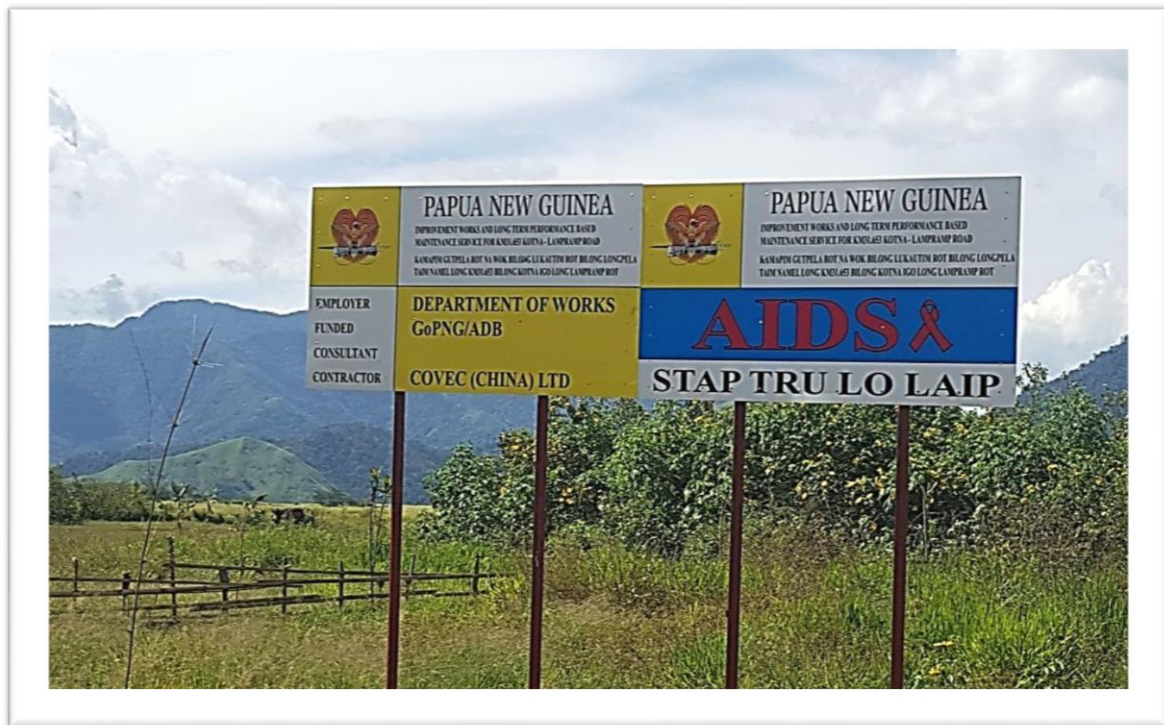
54. The contractor has prepared a HIV/AIDS and STDs control plan. This had been submitted and cleared by the ESSU. The contractor implemented the Plan where the progress was recorded in monthly reports. The Plan was implemented by two workers trained by the Provincial Aids Control Unit. All workers were provided with basic HIV/AIDS training by the HSO on several occasions and they were also issued with condoms. Training program for the community was also conducted on 25th May 2016 where 110 members received the training. In addition, two sign posts were erected to convey vital information to the public about HIV/AIDS (Photo 7).

Photo 7 HIV/AIDS Sign Post along Road Alignment at Lampramp

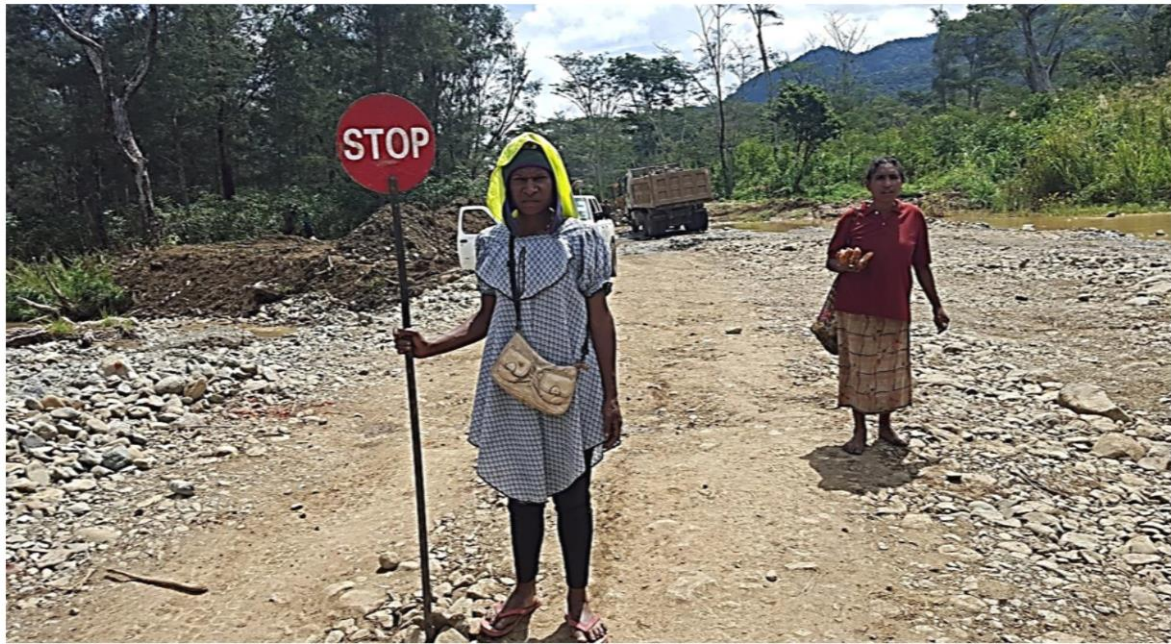
Photo 8 A woman employee at work
