Highlands Region Road Improvement Investment Program – Tranche 2.

Kotna – Lampram Road Sub-project.

HIGHLAND REGION ROAD IMPROVEMENT INVESTMENT PROGRAM – TRANCHE 2

Kotna to Lampramp ROAD SUB-PROJECT ENVIRONMENTAL SAFEGUARDS MONITORING REPORT

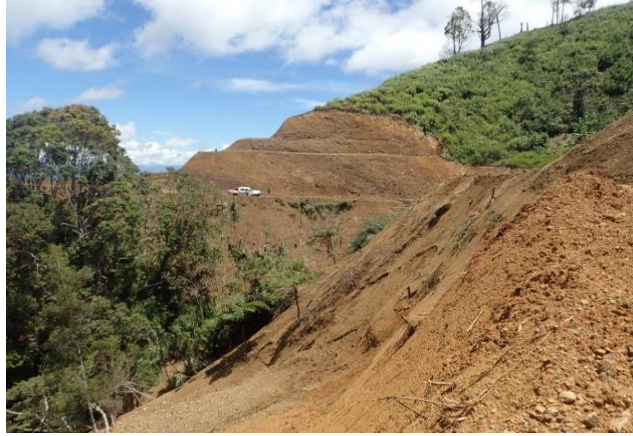
27. Soil erosion and sedimentation was generated during the review period in sections where clearing and grubbing as well as cut and fill occurred. It was high especially in the section that traverses over the hilly landscape that generated substantial amount of cut and fill. Although the contractor has adopted various methods such as drains, gabion baskets, cutting benches to slow down erosion and providing line drains, the occurrence was high that escaped large volume of soil into the vegetation and subsequently into water ways. Examples are at chainage 11+900, 12+600, 12+800, 13+400, 13+800 and 15+200. In areas with moderate slopes, the control measures were adequate to minimise soil erosion.

Figure 1: Poor Construction Practices near Km11

29. The contractor has been issued with Corrective Action Request (CAR) on 5th August 2016 in respect of soil erosion and sedimentation control. Details are presented in Appendix 3.

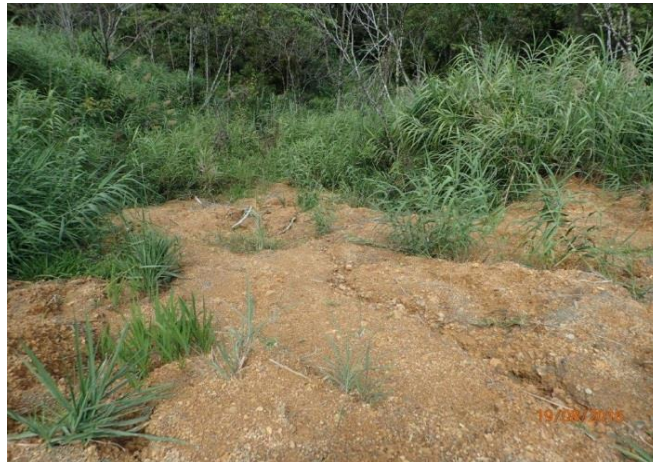
28. Sedimentation has occurred in streams, agricultural lands and on other pathways even though the contractor utilized a number of measures to reduce sedimentation. One of such measures is to prevent discharge of sediment laden construction water or materials directly into the rivers and surface water. All such construction waters have been diverted to lock-and-spill drains. In some cases, drains diverted sediment-laden run off water away from natural forest area but the scale of loss was so high that did not bring about effective sedimentation control.

Figure 2 : Sedimentation around Km10

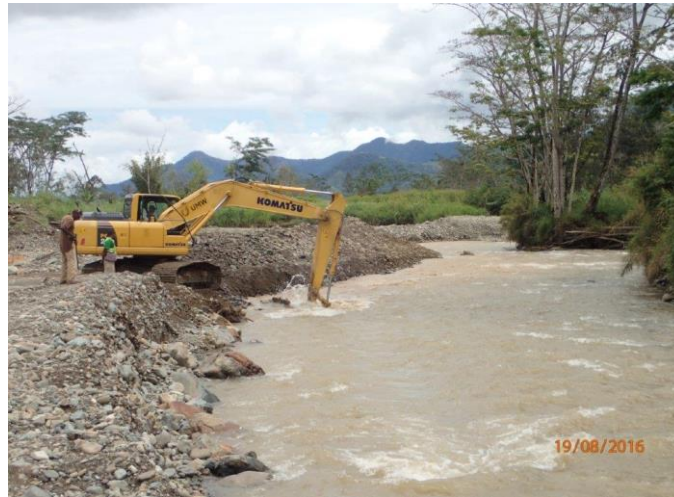
30. There are several streams and rivers that are located within the construction zone. Although the water quality of streams and rivers along the road section was not measured before the construction works began, observations revealed lowered water quality in the Muka River where a river-based quarry is in operation (Photo 2). However, the impact of lowered water quality is temporary as it returned to normal after extraction is suspended.

Figure 3 : High-turbidity in Muka River result from material extraction

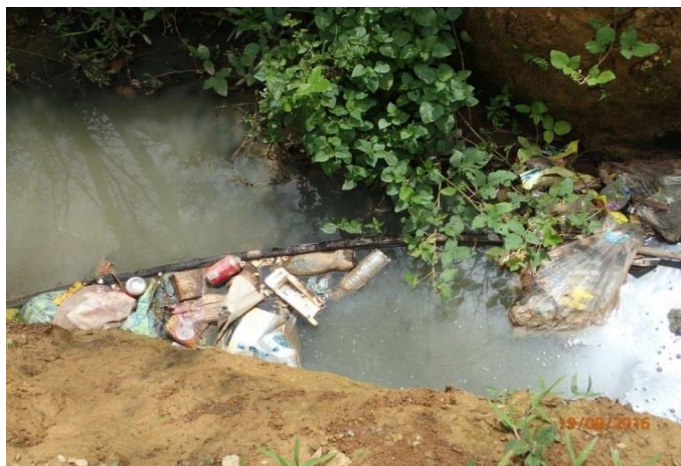
42. Although much of the camp waste generated in the kitchen has been dumped in a pit near 18 km, site inspections revealed littering around camp (Photo 4). The contractor has been advised to clean rubbish and dump it only in the pit. The contractor continued to provide compensation by way of an agreed fee to the land owner for the temporary use of land for rubbish disposal.

Figure 4 : Accumulated waste in a stream near camp site.

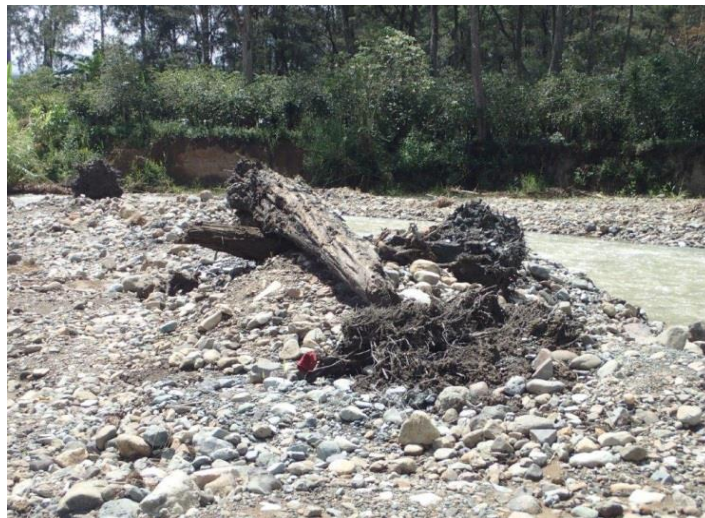
Figure 5 : Muka River bank erosion triggered by gravel extraction

45. The environmental impact from the 3 river quarries on the downstream was evident as the turbidity level was very high during material extraction. The impacts were obvious as the excavator was working in the middle of the river. As a result, many people living downstream were affected by way of their washing and laundry. A non-compliance report has already been delivered to the contractor who has responded with a plan to rectify the damage (Appendix 3).

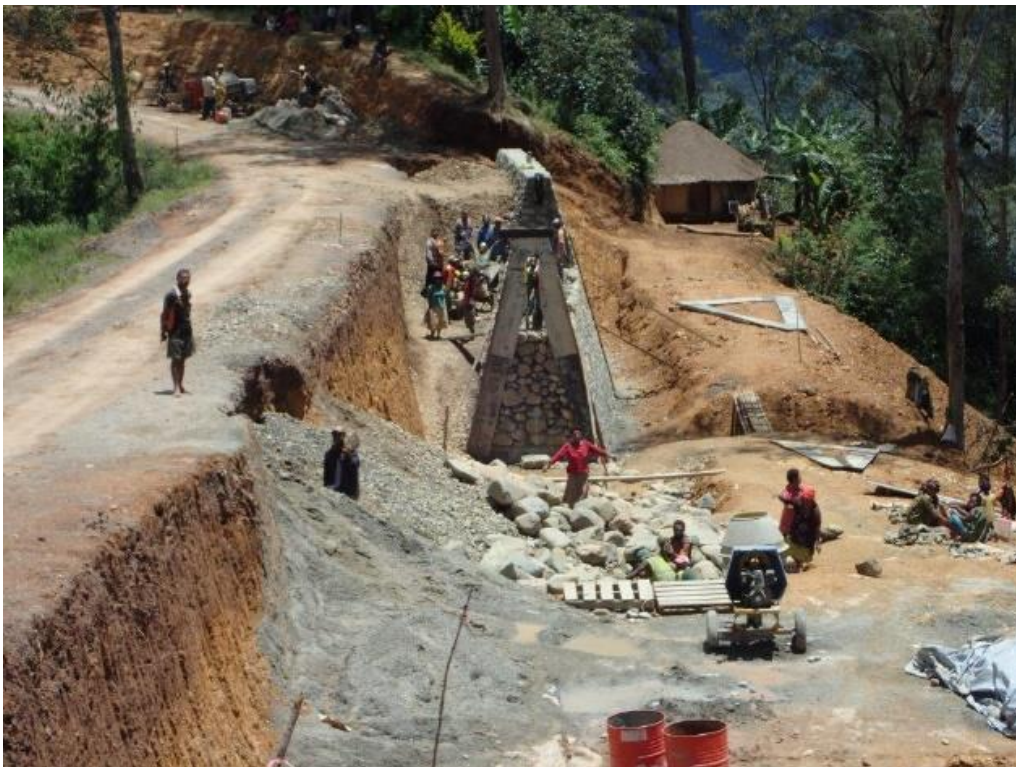
Figure 6 : Women employees on site
