Environmental Monitoring Report

Project Number: 39176-044
Bi-Annual Report
January 2017

AZE: Road Network Development Program – Project 4

Four Bridges Improvement Project Ganja Region,
Agstafa District Roads: R 24 and Y-05-08

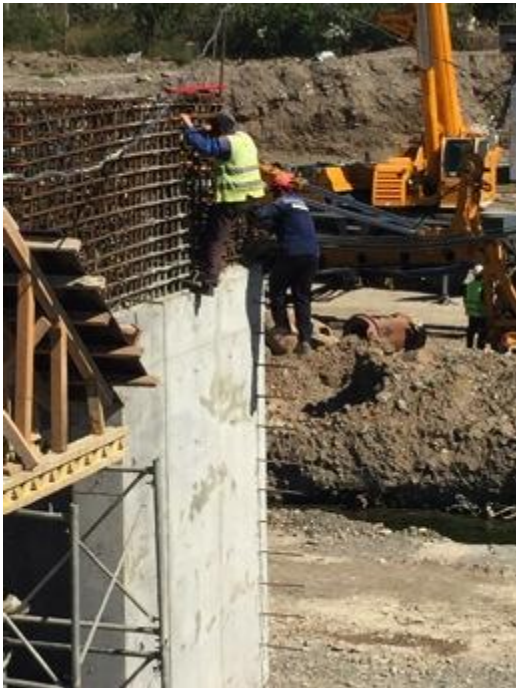
Item	Comment	Action	Responsibility	Schedule	Progress - December 2016
1.

<p>Lack of PPE working at height. No suitable ladder.</p>	<p>1. Staff should be informed that harnesses must be worn when working at height.</p> <p>2. Suitable ladders need to be provided.</p>	<p>1. KBT HSE Team</p> <p>2. KBT Site Manager</p>	<p>1. At the time of incident.</p> <p>2. Throughout construction period.</p>	<p>Ladders and scaffolding at some locations is still not adequate.</p>

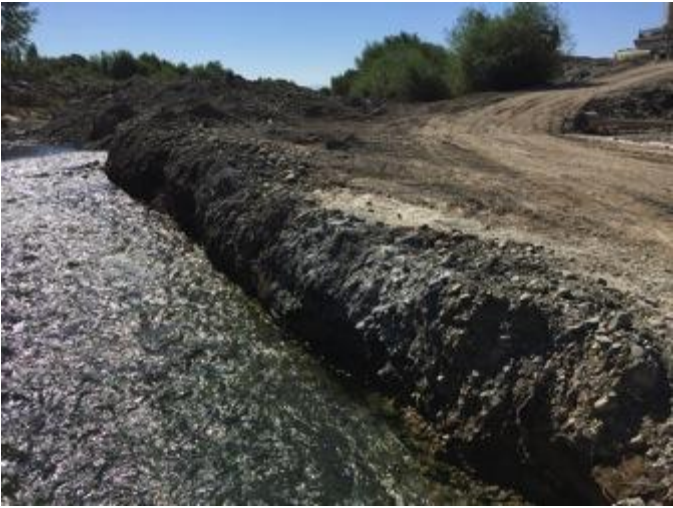
<p>2.</p>

<p>Concrete sludge washed out into Agstafa river.</p>	<p>1. Concrete mixers should not be washed out in rivers.</p> <p>2. Training to be provided to staff.</p>	<p>1. Mixer operators</p> <p>2. KBT HSE Team</p>	<p>1. Throughout construction.</p> <p>2. Periodically throughout construction.</p>	<p>There was no evidence of mixers being washed out in the Agstafa river. However, according to the Engineers EHSM concrete mixers had been washed out into the Kur river.</p>
<p>3.</p>

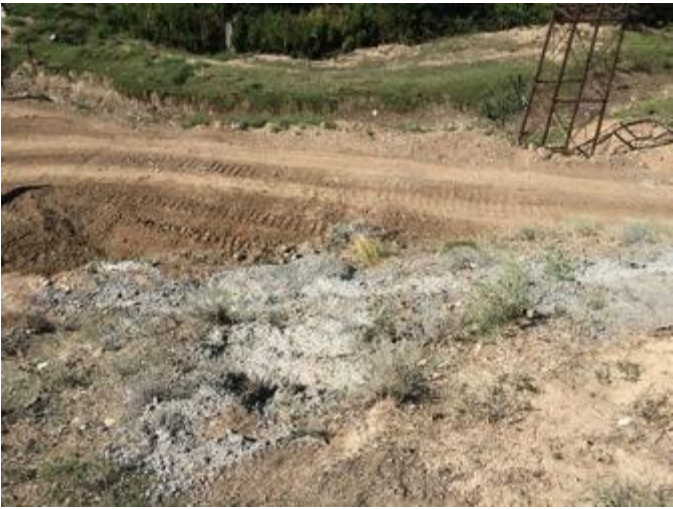
<p>Concrete sludge washed out on open land.</p>	<p>1. Concrete mixers should not be washed out on bare soils.</p> <p>2. Training to be provided to staff.</p>	<p>1. Mixer operators</p> <p>2. KBT HSE Team</p>	<p>1. Throughout construction.</p> <p>2. Periodically throughout construction.</p>	<p>Concrete mixers are still being washed out on bare soils at most of the construction sites (see Table 12 below).</p>

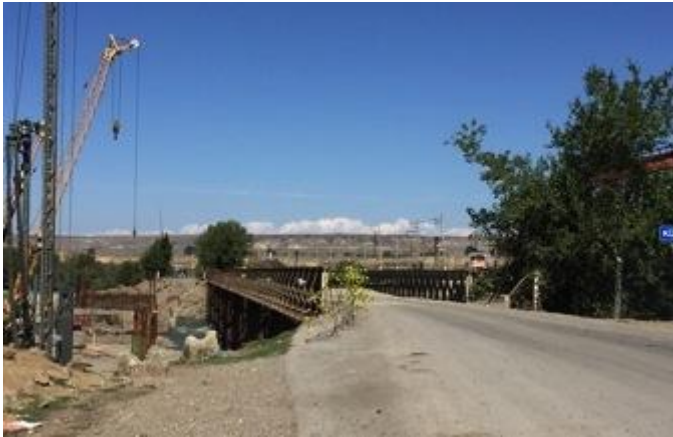
4.

<p>Lack of safety barriers and warning signs on approach to Bridge 2.</p>	1. Construct suitable safety barriers and provide warning signs.	1. KBT HSE Team	1. Throughout construction period.	Safety barriers are still not adequate in several locations (see Table 12 below).
5.

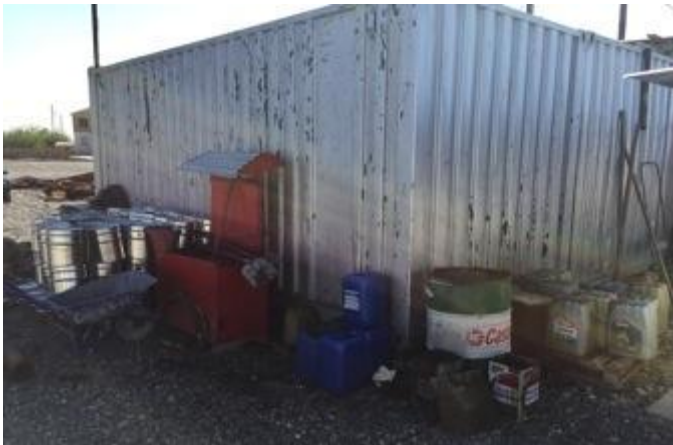
<p>Poor storage of oils at construction camp.</p>	1. Provide bunding for hazardous liquid storage.	1. KBT site manager.	1. During the next reporting period.	This area has now been bunded, although the height of the bund should be increased.

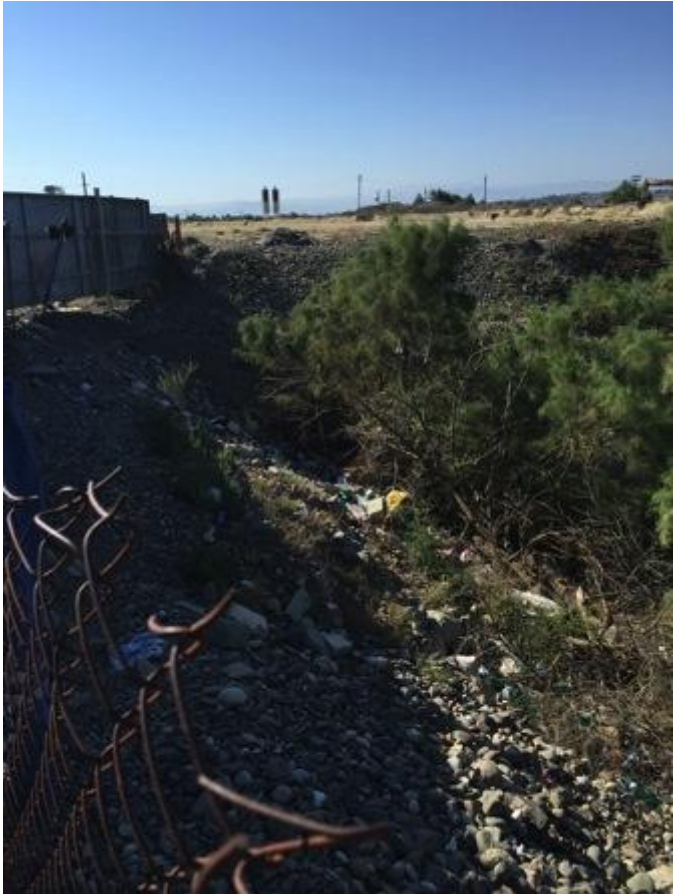
6.

<p>Waste behind the construction camp.</p>	1. Clean up waste materials.	1. KBT site manager.	1. As soon as possible.	Lots of waste materials are still present (see Table 12 below).
----	---	------------------------------	----------------------	-------------------------	--

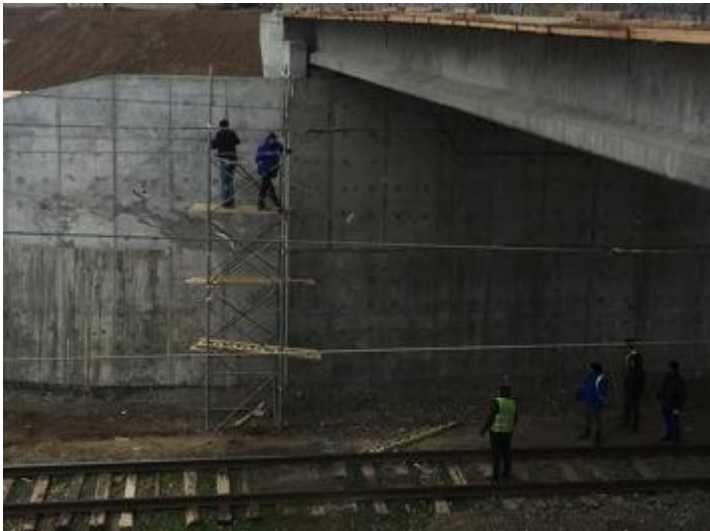
Item	Comment	Action	Responsibility	Schedule
1.

<p>Inadequate PPE and dangerous scaffolding and ladders.</p>	<p>1. Ensure that adequate PPE is used by staff at all times, including the use of harnesses.</p> <p>2. Provide suitable quality and safe scaffolding and ladders for access to heights.</p>	<p>1. KBT site manager to ensure scaffolding, ladders and PPE is provided.</p> <p>2. KBT HSE Manager to provide regular PPE toolbox sessions to staff.</p>	1. 15 th January, 2017

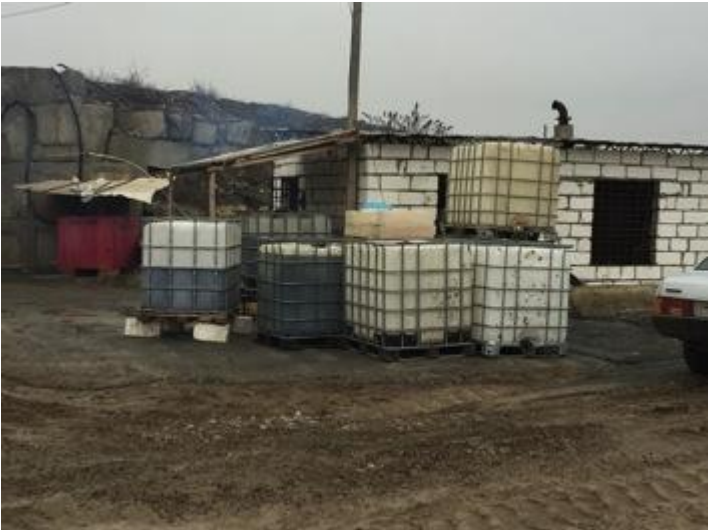
<p>3.</p>

<p>Plasticisers and oil tanks are still not banded.</p>	<p>1. Ensure all hazardous liquids are stored within impermeable bunds capable of containing 120% of the volume of the largest container in the bund.</p>	<p>1. KBT Site Manager.</p>	<p>1. 15th January, 2017</p>
-----------	---	---	-----------------------------	---

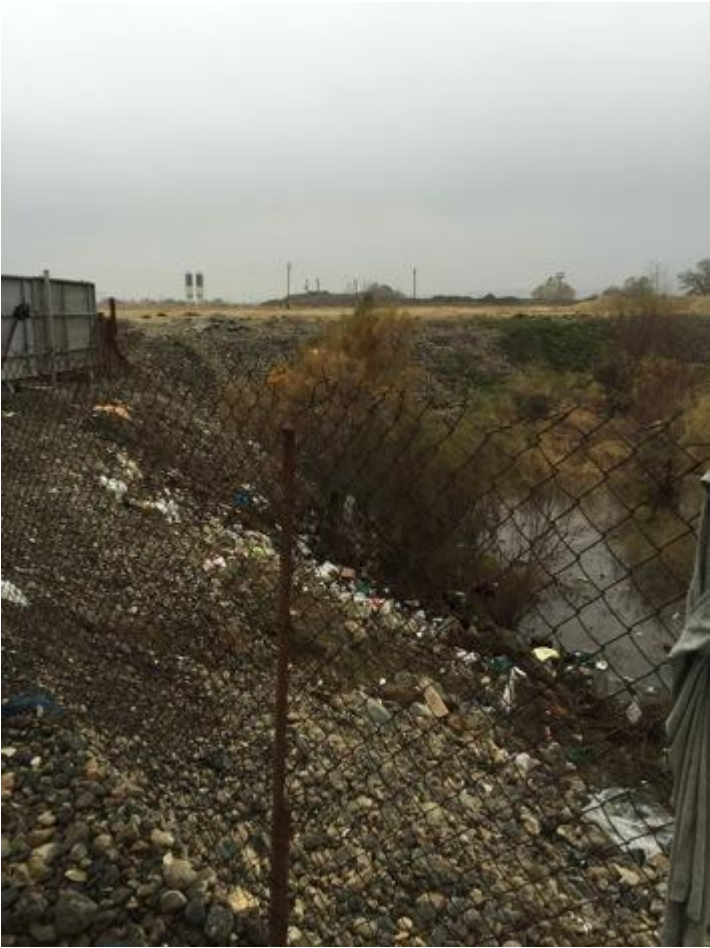
<p>4.</p>

<p>Waste materials scattered behind construction camp.</p>	<ol style="list-style-type: none"> 1. Remove waste materials from this area. 2. Erect signs prohibiting waste from being dumped in this area. 	<p>1. KBT Site Manager.</p>	<p>1. 15th January, 2017</p>
-----------	---	---	-----------------------------	---

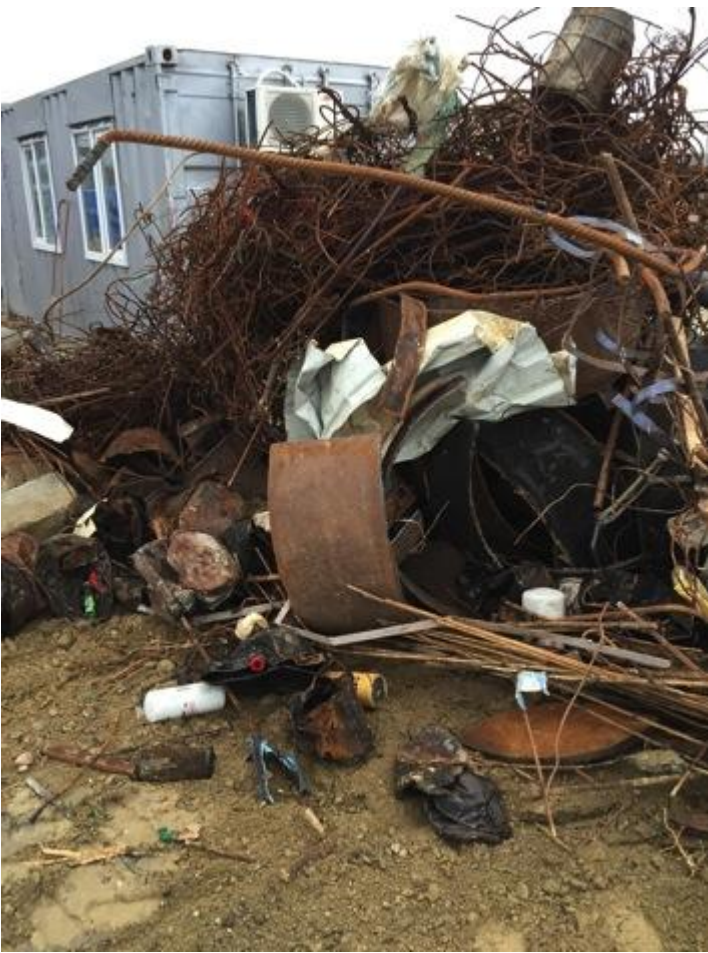
<p>5.</p>

<p>Hazardous waste is dumped on open ground and mixed with non-hazardous waste at the construction camp.</p>	<ol style="list-style-type: none"> 1. Provide suitable containers for hazardous waste at all work-sites. 2. Provide toolbox training for staff in waste management. 3. Separate all hazardous and non-hazardous wastes. 	<ol style="list-style-type: none"> 1. KBT Site Manager to provide waste containers. 2. KBT HSE Manager to provide toolbox training. 	<ol style="list-style-type: none"> 1. Waste containers - 15th January, 2017. 2. Training – once every two weeks from 15th January, 2017.
		<ol style="list-style-type: none"> 1. All fire extinguishers and fire fighting equipment should be inspected on a regular basis. 	<ol style="list-style-type: none"> 1. KBT EHS Manager to inspect extinguishers. 	<ol style="list-style-type: none"> 1. 15th January, 2017

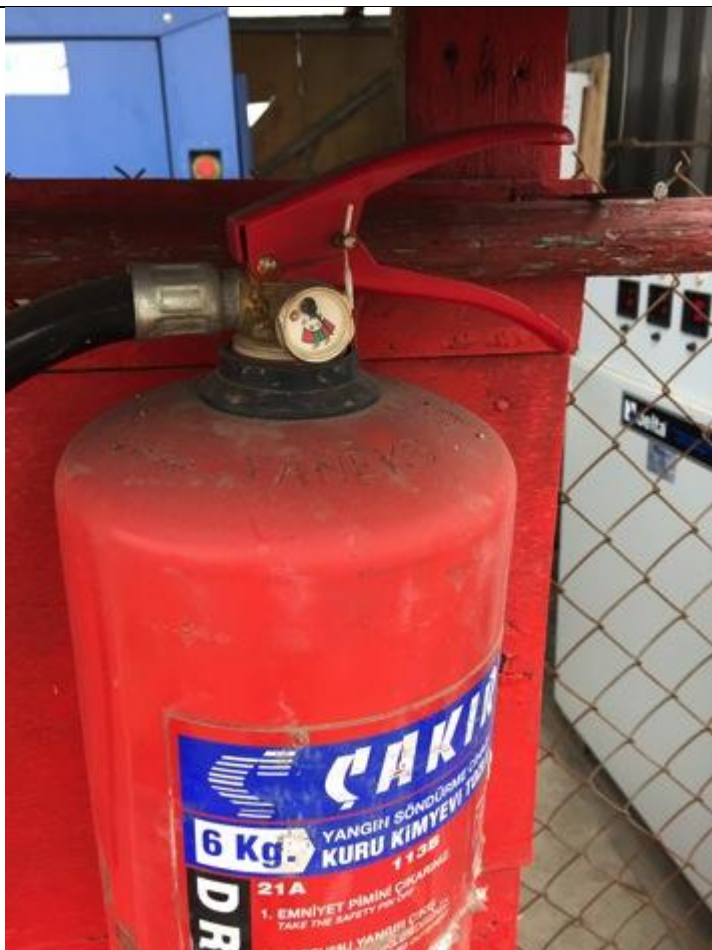
Fire extinguisher with low pressure in the construction camp.

2. Low pressure extinguishers should be replaced.

2. KBT Site Manger to replace extinguishers.

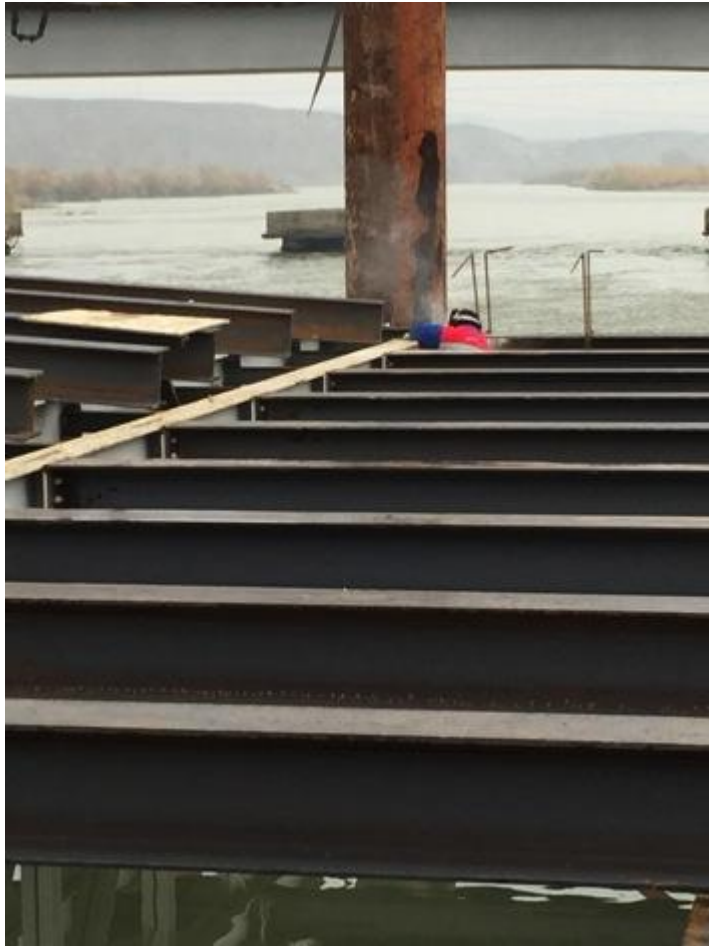
Welder working above the Kur River without suitable PPE.

1. All workers working in the vicinity of the Kur River should be wearing life vests.

1. KBT HSE Manager

1. 15th January, 2017
