VOROTAN CASCADE OF HYDROPOWER PLANTS

404MW Vorotan hydro cascade in Armenia
Dam and civil structures survey and monitoring plan
December 2015

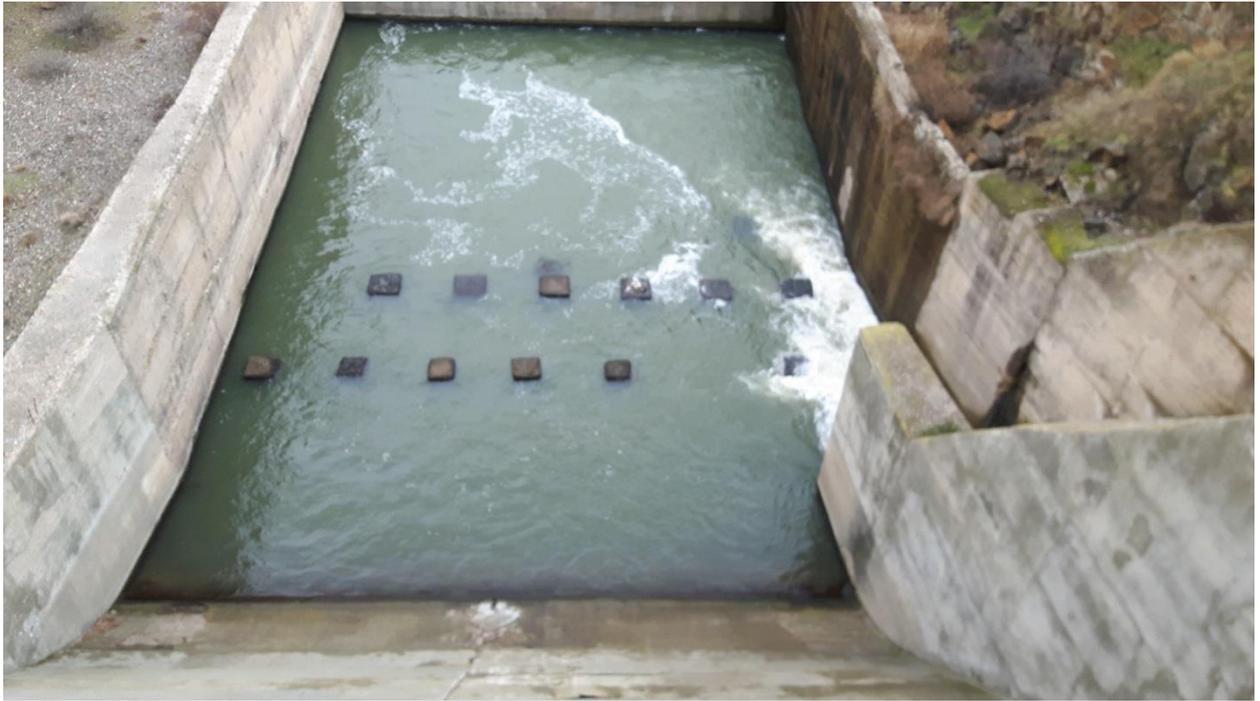
There is only very little information on the dam which consists of a few sections and a plan. There is no specification of the dam or foundation material. Regarding the condition of the concrete dam it was noticed that some of the baffle blocks in the stilling basin were missing. These should be replaced and the other blocks rehabilitated as these baffle block reduce the length of the hydraulic jump and are therefore required for effective energy dissipation.

There is a gallery through the dam and there appears to have been grouting below the dam in the rock foundation. It was not possible to see the dam condition due to missing lighting system inside the gallery.

- The baffle blocks in the stilling basin need to be repaired and reinstated where they are missing.
- Study of condition of geodetic measurements points and prescription of improvements or preparing of design and methods for periodic measurements, tracking the stability of the Dam.

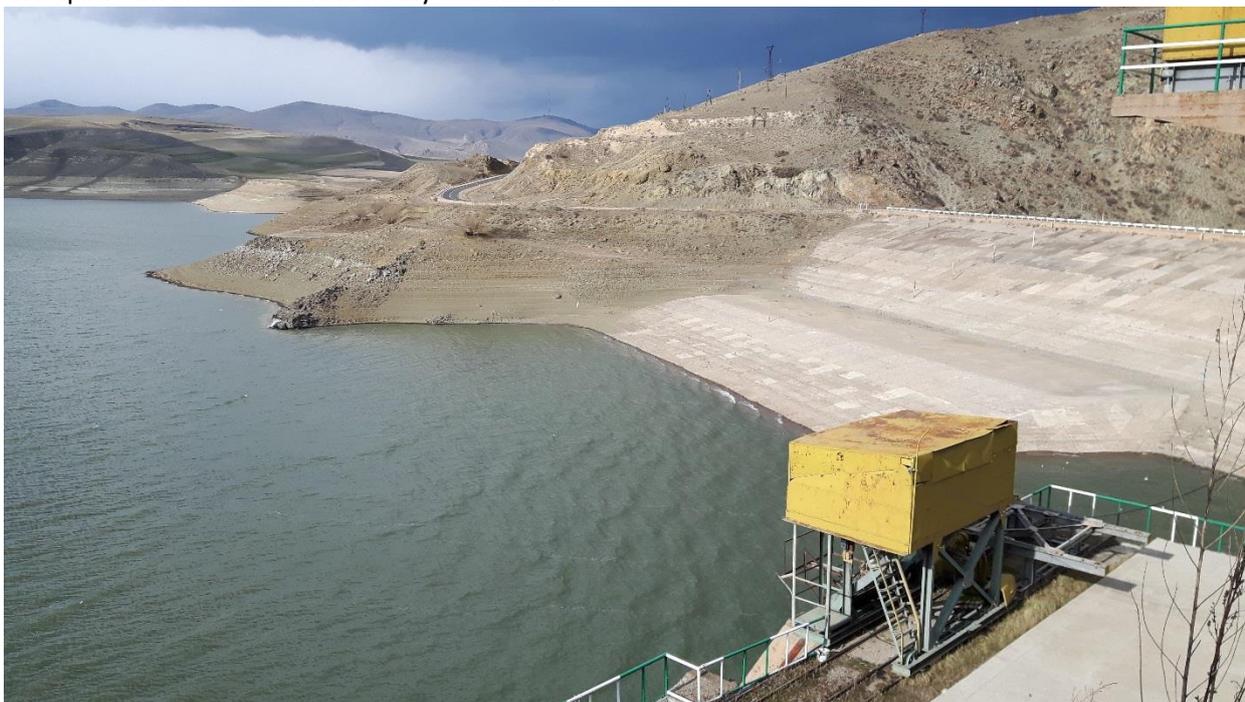
The actual condition of Tolors dam seems stable, but there are some concerns whether the dam meets revised stability criteria. The 2000 report quotes an excerpt from a report by the Hydro design Institute completed in 1998. The report concluded that the slopes of the dam do not meet earthquake criteria and that this could be achieved by flattening the slopes both on the upstream and downstream side, by the addition of 345,000 cubic meters of fill. The effect of this additional fill on the side slopes has been considered but its effect on the stability of the dam cannot be conclusively established.

There is a piezometers system and geodetic net with bench marks and measure points on the site. The level of filtration waters is measured by using of piezometers system and respective records are carried out. The piezometers are in good condition except two-three of them, which are blocked with stones and need to be repaired.

- The side slopes of the dam appear to be quite shallow; however this may be due to the quality of material used to construct the dam. A better understanding of the dam materials and foundation conditions needs to be achieved in order to perform a stability analysis of the dam including seismic loads. This will help confirm the additional 345,000 cubic meters of material calculated by previous studies.

- Construction activities for implementation of new piezometers to be considered.
- Expert investigation of the design and actual condition of Tolors Dam concerning seismic stability. Preparing of report with conclusion for the Dam condition and solution for improvement.

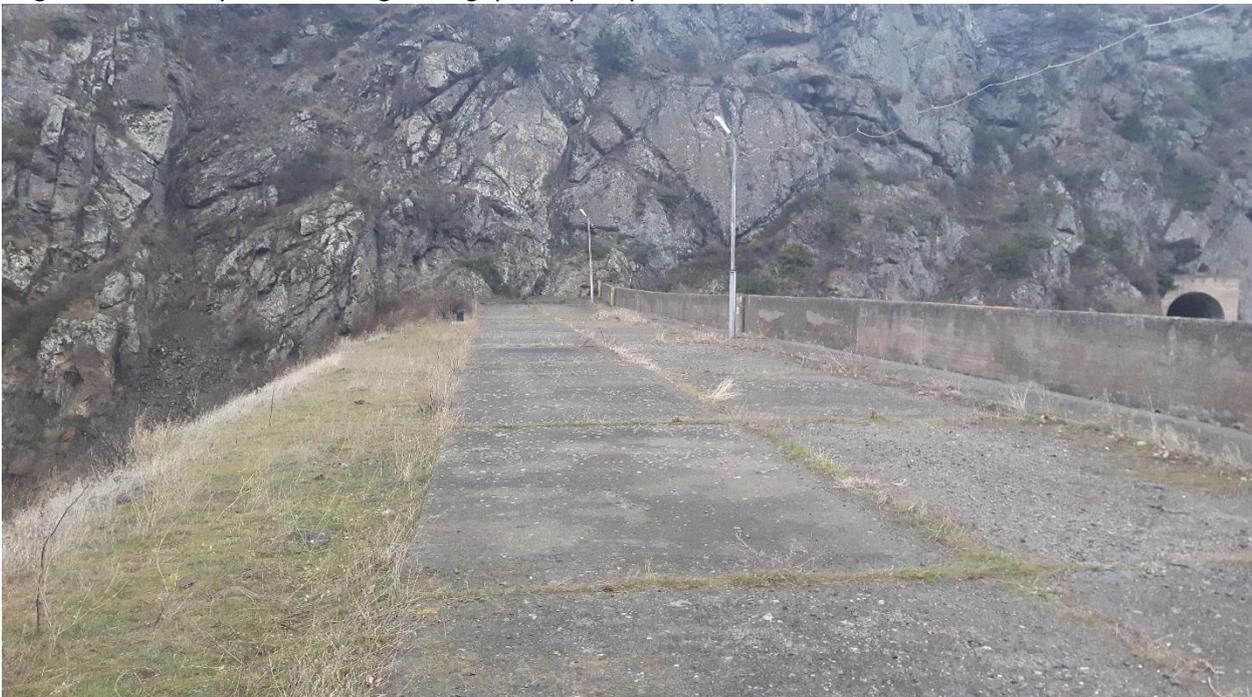
As with Spandaryan and Tolors no monitoring is being carried out and most of the instrumentation has fallen into disrepair. Settlement has been monitored annually from 1972 to 1998 and the monuments have not moved more than the allowable criteria. However this appears to have stopped

in recent years and it is important that the recording is restarted. There is some vegetation, which needs to be removed and the stone protection re-graded.

- Vegetation downstream of the dam should be removed. Covering the external slope with geotextile or geomesh could prevent future vegetation grow.
- Detailed study of the condition of piezometers and prescription for replacement of the inactive once. Installation of new (additional) piezometers.

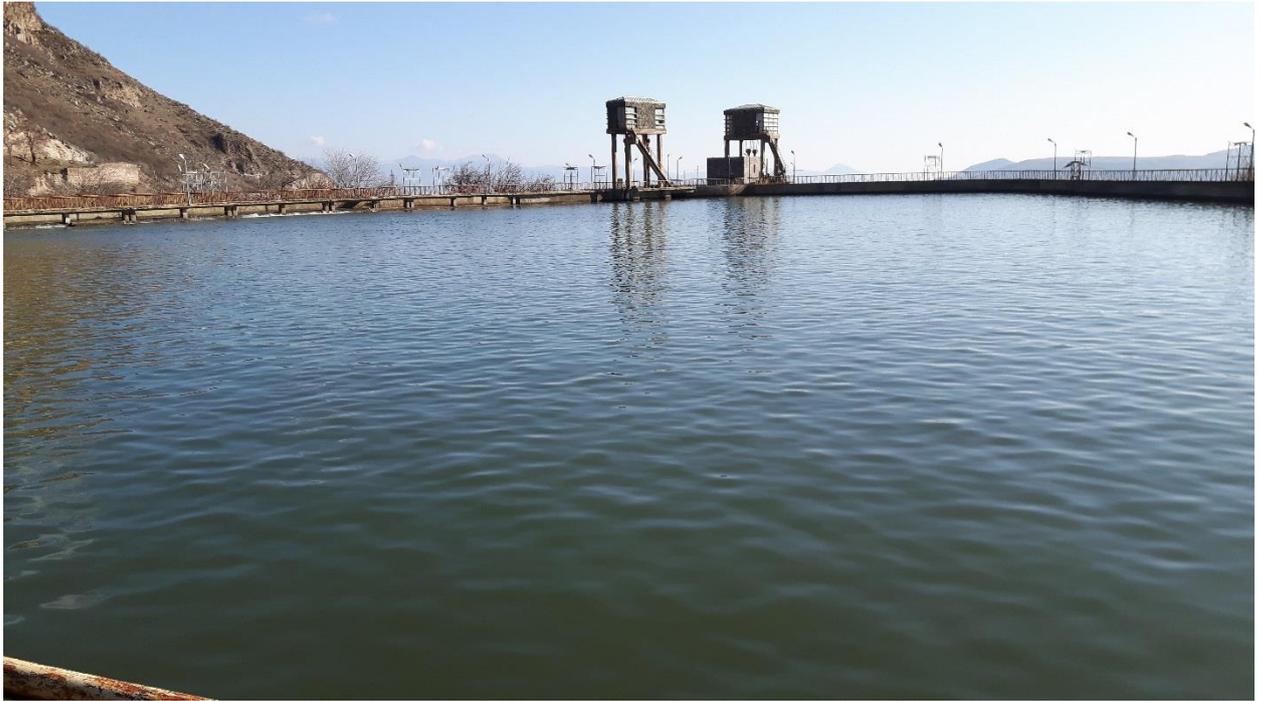
The DRP appears to be in good condition but there are many defects on the external plaster – torkret that should provide protection of the main concrete structure. There are many structure damages and defects on the concrete staircases and towers for the gates and walkways.

Some leaks from the temperature joint are visible and need to be repaired. Detail study of the leaks source should be carried out.

- Expert investigation of the actual condition of Tatev Daily Regulation Pond concerning residual strength of the construction and seismic stability and comparing with the design of the facility. Preparing of report with conclusion for the Dam condition and solution for improvement.
- Study of condition of geodetic measurements points and prescription of improvements or preparing of design and methods for periodic measurements, tracking the stability of the Tank.
- Starting the periodic geodetic measurements.
- Rehabilitation and maintenance of the external plaster – torkret as well as to the building structures, stairs and walkways. This will include dewatering of the pond and must be planned well in advance.
- Detail study of the leaks source to be arranged and leaks to be fixed.
