Targeted Environmental Assessment Temporary Sewage Treatment System Caracol Industrial Park (PIC) Northern Haiti

Submitted: January , 2014

**PARC INDUSTRIEL
DE CARACOL**

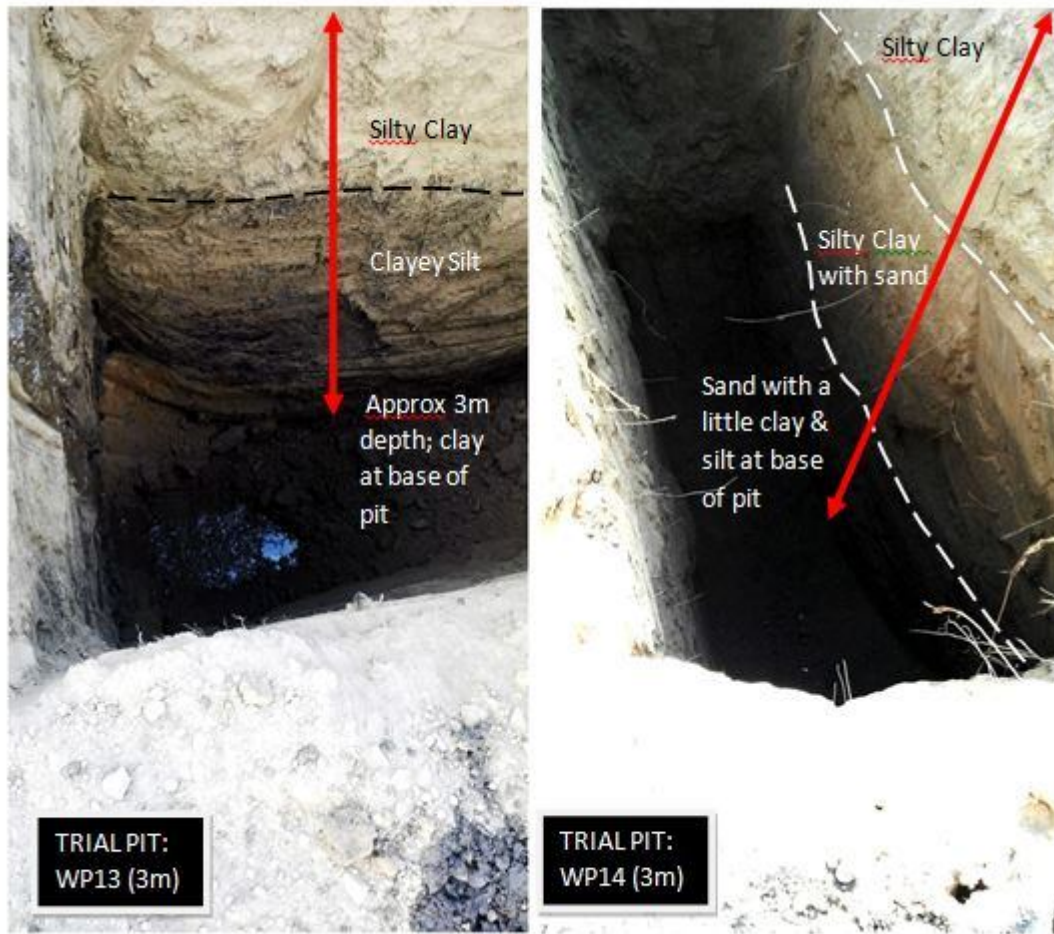
During the site reconnaissance on December 06, 2013 the surface soil encountered at the WWTP indicated a soil with moderate to large clay content at surface and extending to at least 3 m below soil surface as evidenced by the mechanical trial pit at WP13 (see Figure 3 and 4 below). Water was added into WP13 and the level of seepage observed. This was not a percolation test done to specifications, but simply an on-site observation of the behavior of introduced water on the soils in the unsaturated zone near the WWTP. Another trial pit WP14, advanced to approximately the same depth, 50 m to the south-west of WP13, and adjacent to the drainage field, penetrated silty clays, with silty clayey sand at the base (Figure 4). No water was introduced into this trial pit.

Figure 3 - Trial Pits: WP13 (Left) and WP14 (Right). No Groundwater Was Encountered In The Trial Pits.

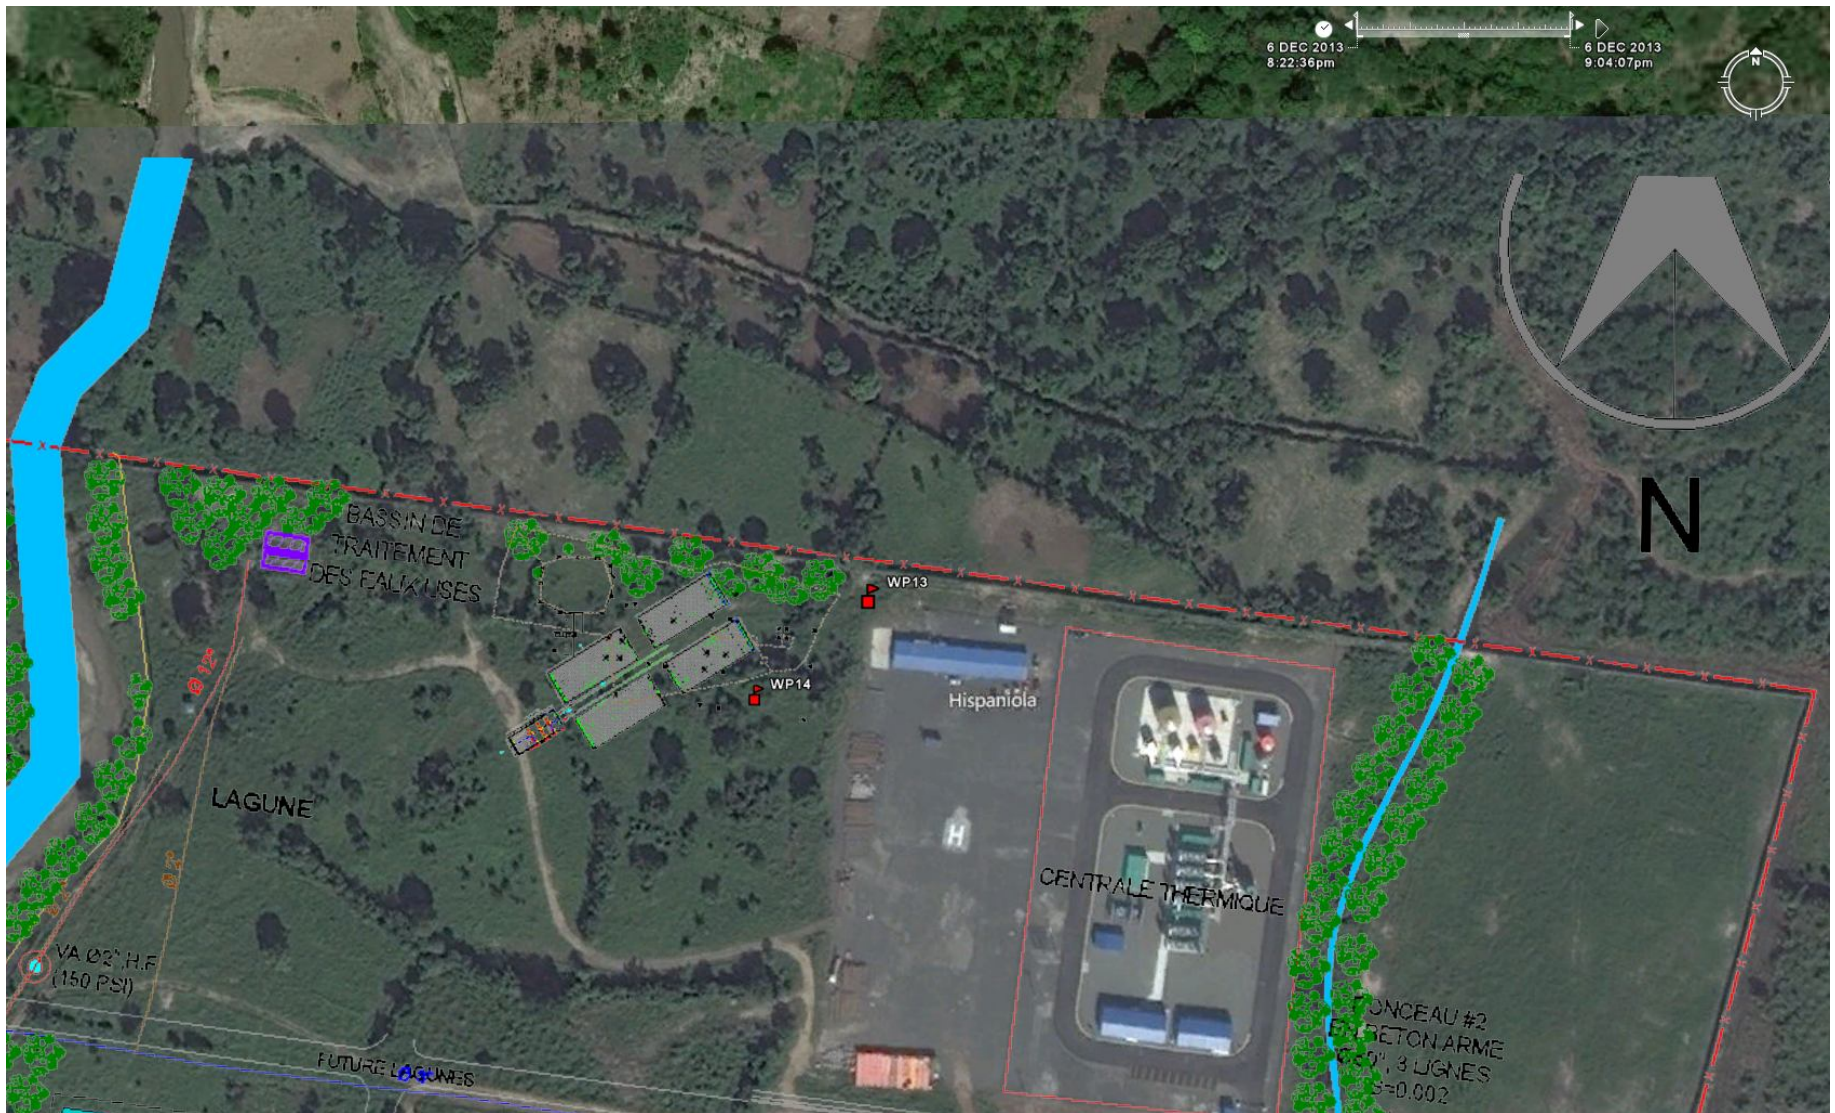
FIGURE 4 - TRIAL PIT LOCATIONS ON 06 DEC 2013 (WP13 AND WP14). THE LOCATION OF THE WWTP#2 IS ALSO SHOWN BASED ON DRAWINGS SUBMITTED.

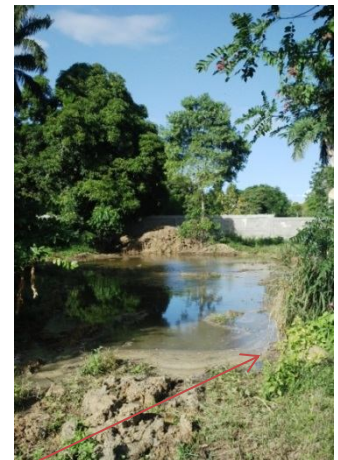
Significant ponding was observed in the vicinity of both WWTP#1 and WWTP#2. Several stagnant surface ponds (Figures 6 - 12) of liquid were observed just west of the existing infiltration basin and extending approximately 100m east inside the north perimeter concrete wall. The source of the surface water/liquid was diverted treated effluent from the infiltration pond for WWTP #1.

Figure 6: Showing ponding on land between pond and plant

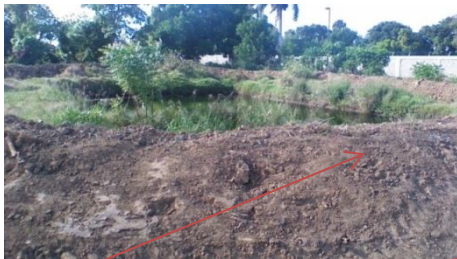
Figure 7: Showing infiltration pond with fresh soil at edges

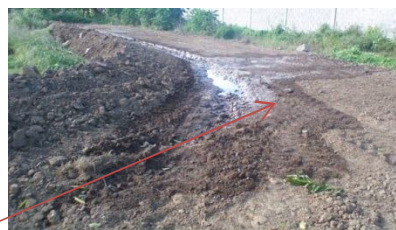
Figure 8: Ponding in the area of the driveway

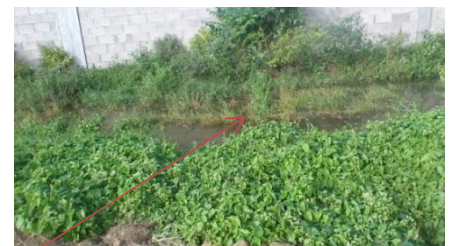
Figure 9: Ponding inside of the PIC perimeter wall

The evidence presented at the site suggested that these ponds inside the boundary wall have been present for at least a few continuous days to possibly weeks as the vegetation adjacent the ponds was verdant and lush. Further, evidence outside the northern boundary wall of the PIC suggests that the seepage there (Figure 10) has persisted for some considerable period of time. The seepage is limited to the areas in close proximity to the existing holding ponds and proposed WWTP drainage gallery. Based on the above evaluation, the capacity of the receiving soils to accept discharged water is likely to be exceeded and as a consequence the likely creation of a perched saturated zone above the pond/in situ soil zone. The possible explanation for the ponding/seepage at surface probably is likely caused by a laterally expanding perched groundwater mound emanating from the clarifying basin. As the water slowly percolates from the infiltration pond it creates a subsurface perched groundwater mound around the pond that will expand laterally as downward percolation is restricted.

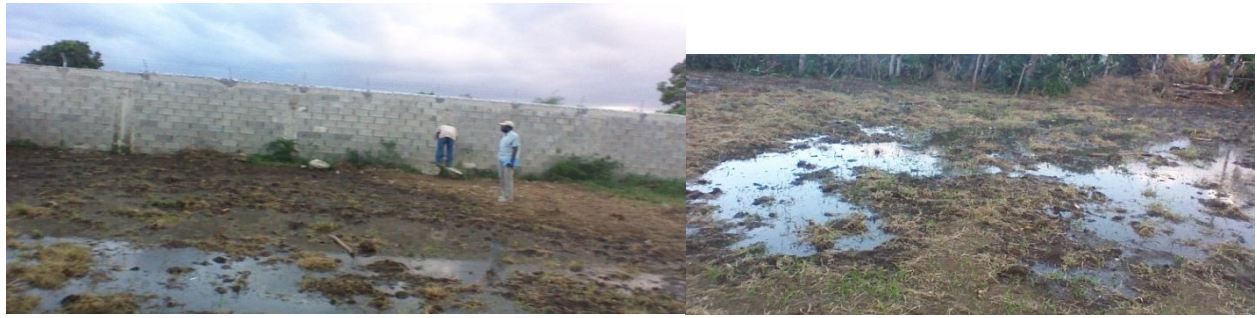
Figure 10: showing ponding outside PIC perimeter fence

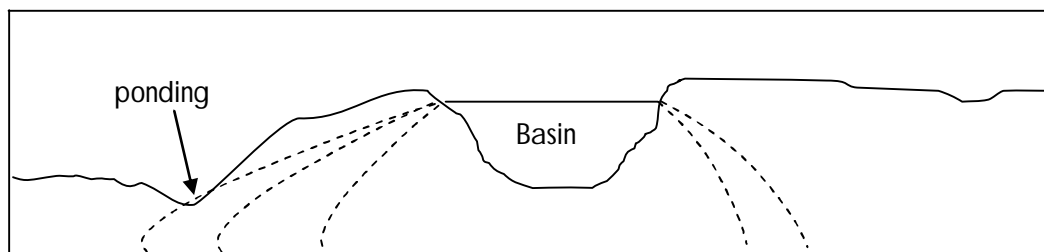
Figure 11 - Schematic Representation Of Possible Cause For Seepage North Of Clarifying Basin As The Perched Groundwater Envelope Expands From The Pond Intersects Ground Surface

As the perched groundwater mound expands from the pond and it intersects with any ground surface lower than the expanding mound the surface will become saturated and eventually surface ponding will occur. As the principal direction of subsurface flow would most likely be to the north, the presence of the ponds and surface seepage along the northern wall fits with this lateral expansion of the perched groundwater mound adjacent the infiltration basin. Figure 11 explains diagrammatically what is possibly occurring at the site. As more and more effluent is released to the infiltration pond and as downward percolation is restricted the pond will over-top occasionally and flow at surface and fill any low lying depressions as well. This is also likely to have occurred at the PIC.

4. The site surface seepage conditions identified during the site reconnaissance visit is likely due to the fluid from the infiltration pond flowing toward the river, the point of lowest hydraulic potential. The solid variability subsurface is possibly limiting the percolation pathways due to predominance of clayey soils resulting in effluent emerging or saturating the upper soils leading to ponding.

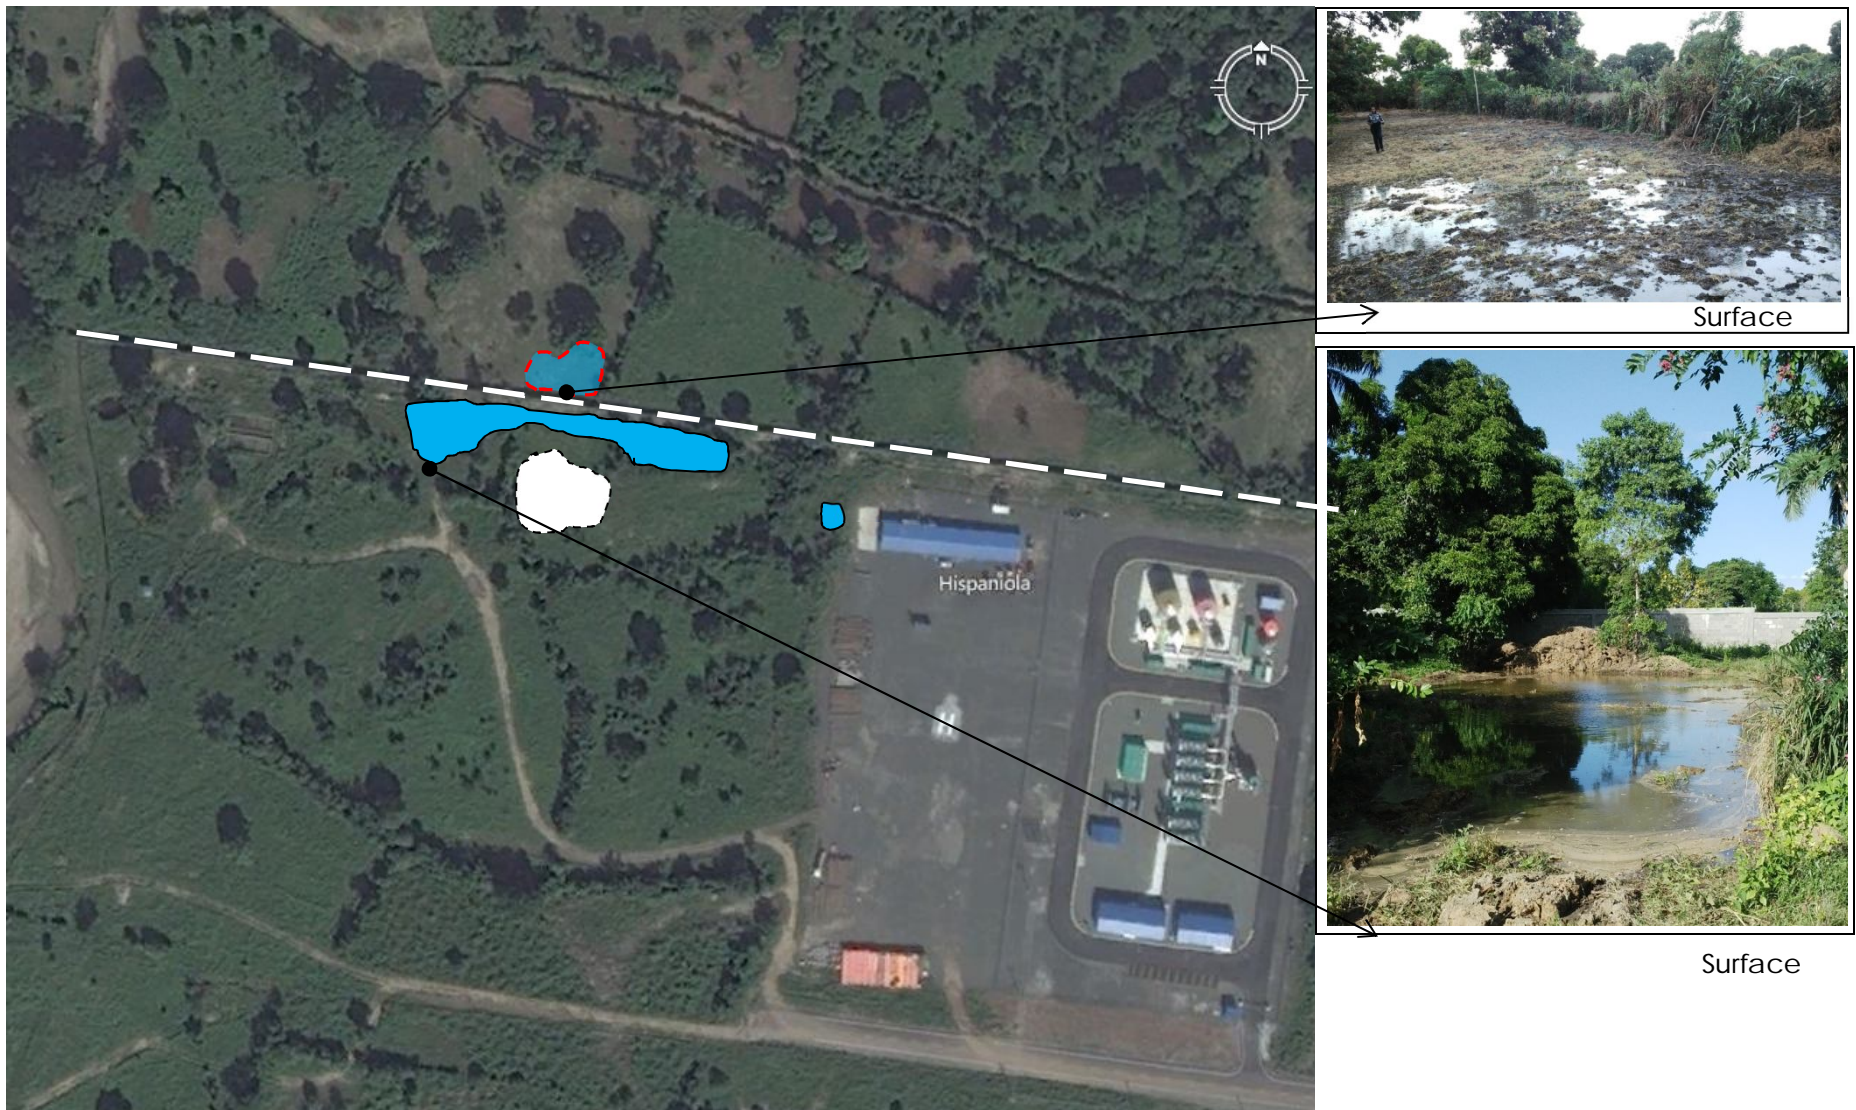
Figure 12 - Observed surface ponding north of WWTP site on 06 December 2013. Photographs to the right of main image show images taken inside the PIC perimeter fence (bottom right image) and outside (top right image).

3. Install an effluent filter in the septic tank if it wasn't already included.
4. Phytump by planting a row of poplar trees and other types of vegetation that establish a dense root mass and take up large quantities of water. Poplar trees when mature can transpire 114-1140 litres of water per day out of the ground. This could be used to control surface seepage. To promote evapotranspiration and soil dewatering, plants such as poplar, could be considered to promote phytopumping (Figure 16) in the areas between the infiltration pond and the northern boundary wall.

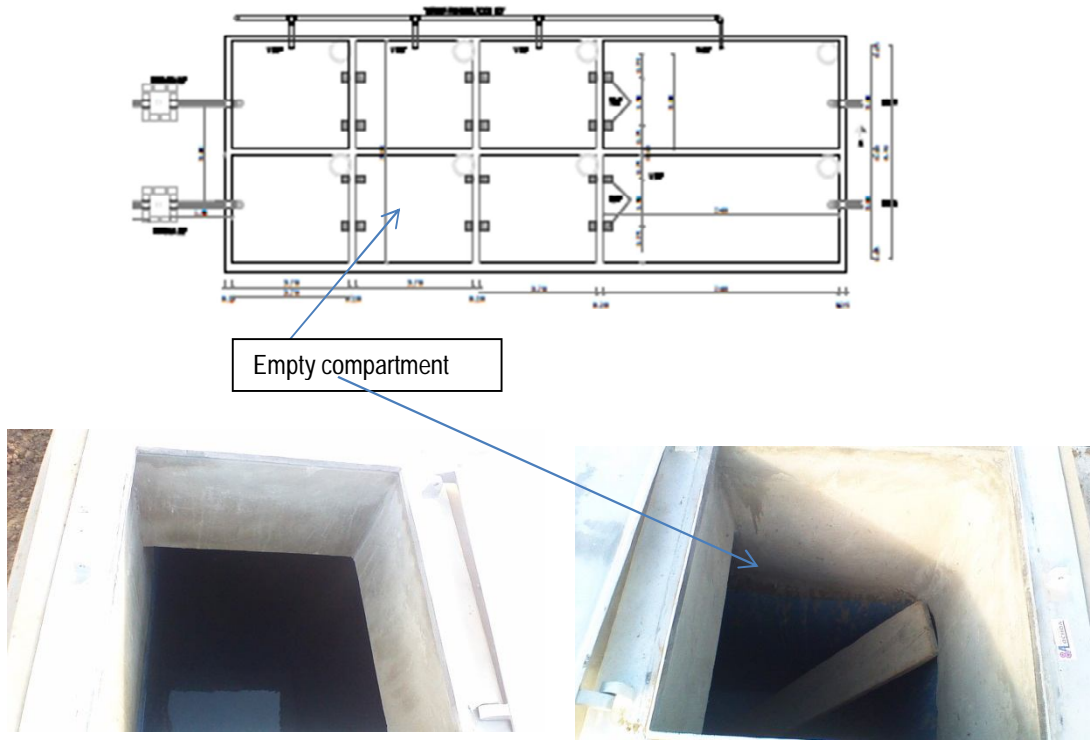
The second wastewater treatment plant had recently been completed and was being tested by the contractors Estrella at the time of the site visit. The test was not occurring as planned as the water used to fill the system was observed in seven (7) of the eight compartments. One compartment was empty.

Figure 13: Septic tank at WWTP#2 with unfilled compartment

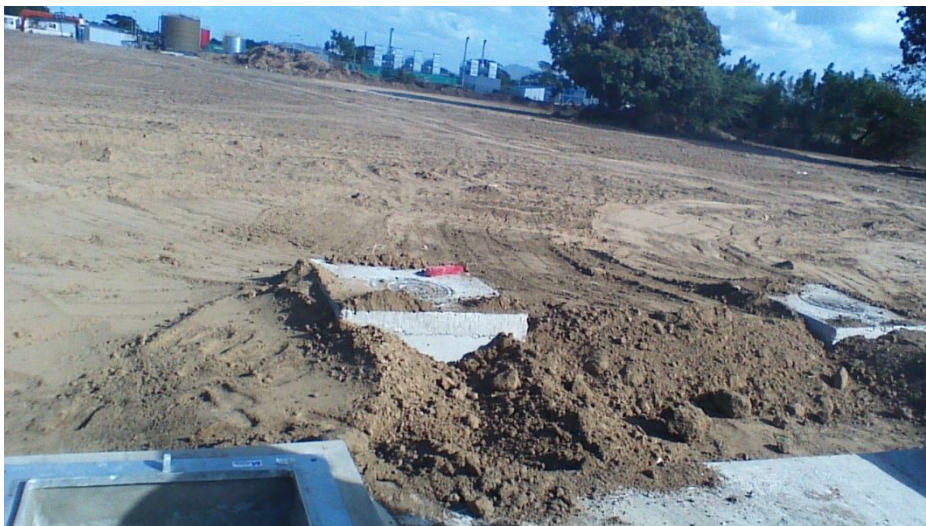
Figure 14: Showing completed drainage gallery viewed from the septic tank at WWTP#2

The drainage gallery site was very dusty, with significant amount of fugitive dusts. The workers on site were using their handkerchiefs to protect themselves from inhaling the particulates. The Consultant recommends wetting of the site to reduce fugitive dust levels. Workers should be provided with the necessary personal protective gear such as dust masks.

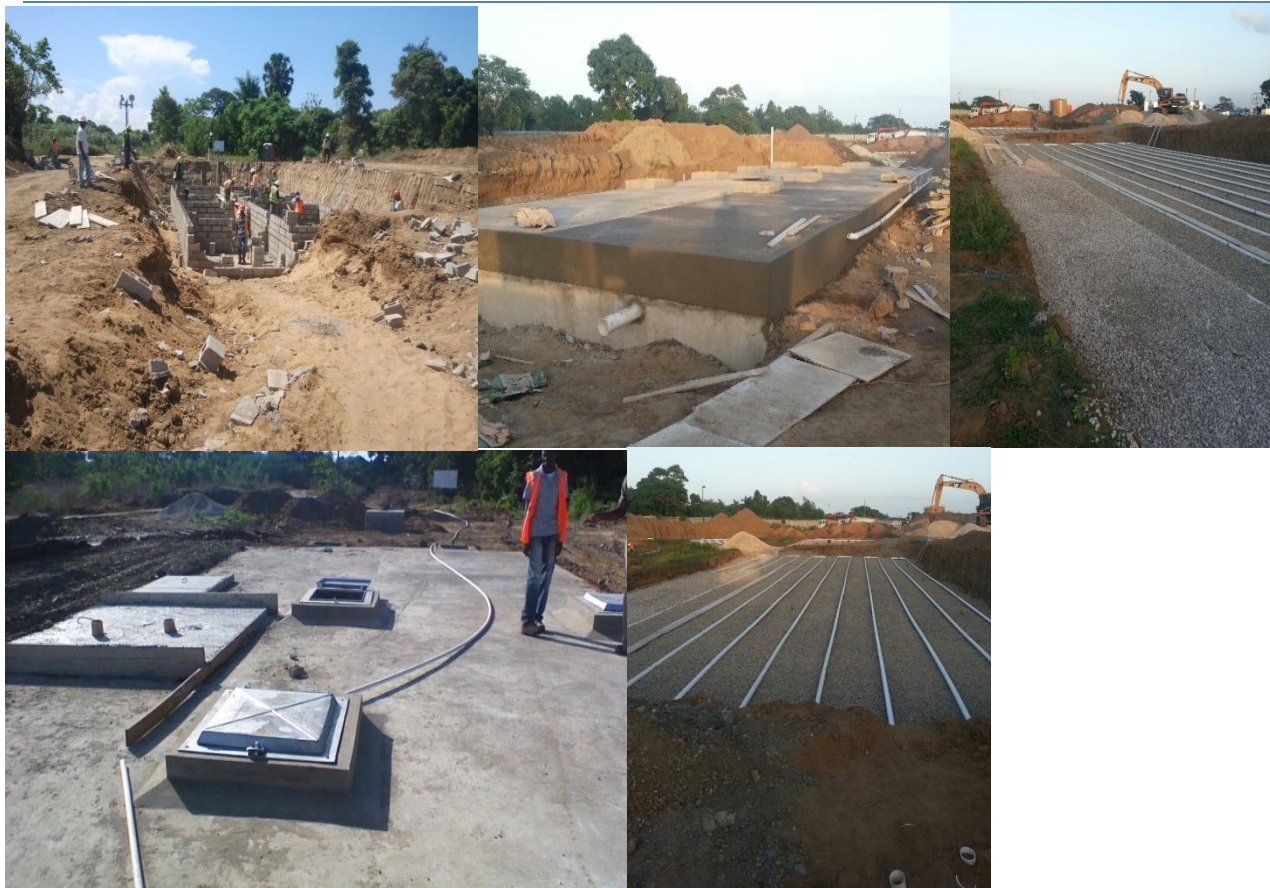
Figure 15: Views of the Septic Tank and Drainage Field at WWTP#2 during construction (IDB)
