FINAL REPORT HERITAGE IMPACT ASSESSMENT

METRO CORRIDOR-I AND II AGRA

Prepared for:
Lucknow Metro Rail Corporation
December 2019

HERITAGE IMPACT ASSESSMENT (HIA): OF PROPOSED METRO CORRIDOR- I AND II AND ITS THE HERITAGE RESOURCES OF AGRA INCLUDING THE TWO WORLD HERITAGE PROPERTY OF TAJ MAHAL AND AGRA FORT

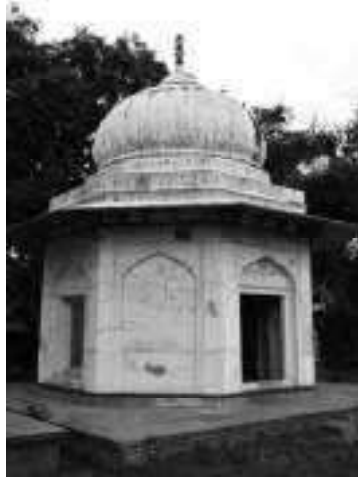
Plaster cracks on exterior surface

The interior wall plaster is deteriorated and there are plaster cracks on exterior surfaces. The tomb and original gravestone are in good condition.

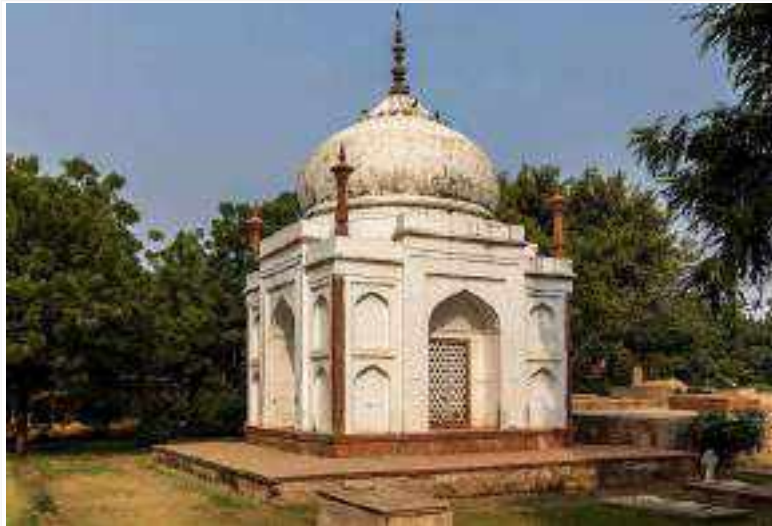
The square tomb with bulbous dome is an unknown tomb of some Englishman. The tomb is in stable condition. Only the stones of the plinth of the tomb are in deterioration. There is blackening on wall exterior plaster surfaces.

Unknown square tomb structure

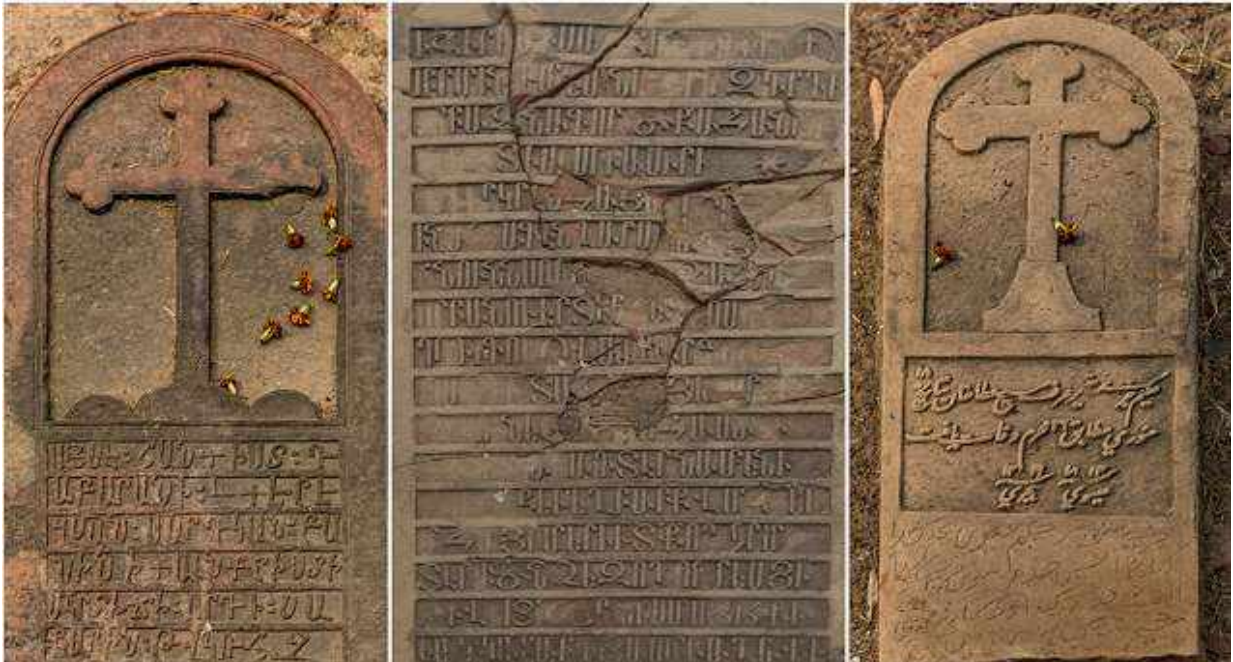
Few of many inscriptions on the gravestones which are found all across the complex. Some of them are damaged.

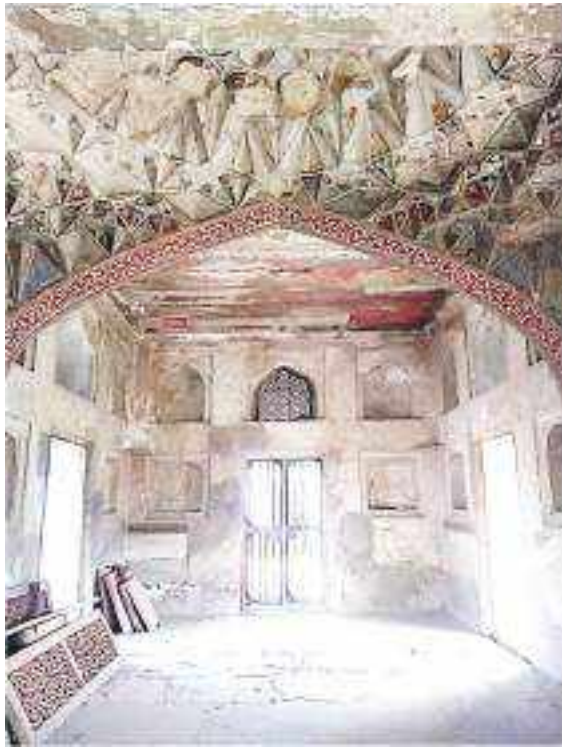
Decorative features in the interiors of pavilions showing sign of deterioration

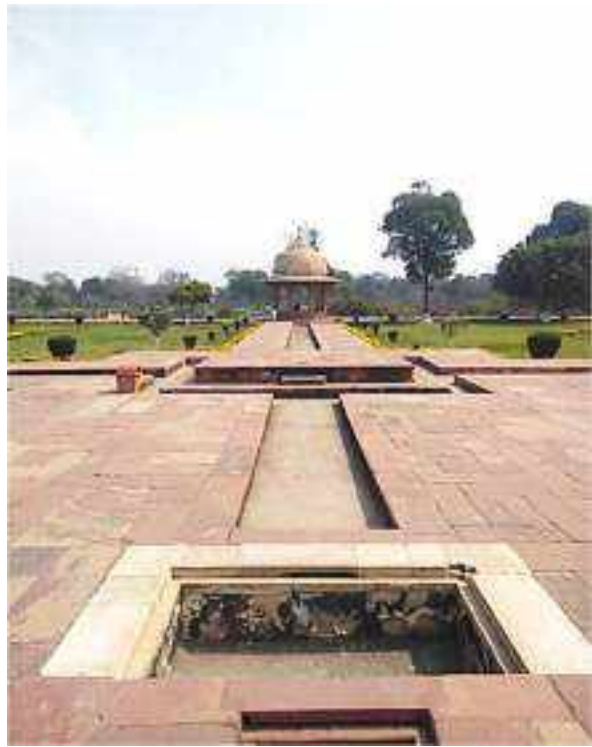
Condition of terraces are stable. There are signs of stone deterioration in patches all over.

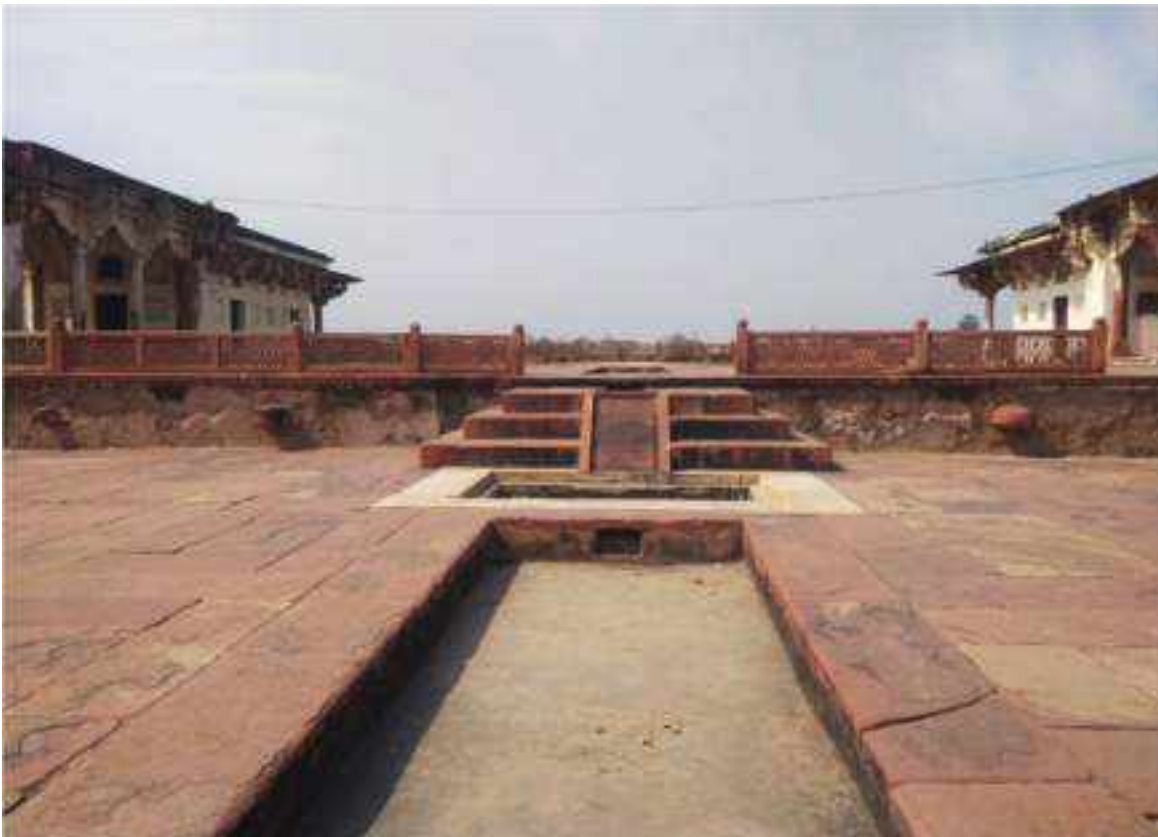
Condition of terraces of charbagh are stable. Signal storey houses are also in stable condition. There are signs of stone deterioration.

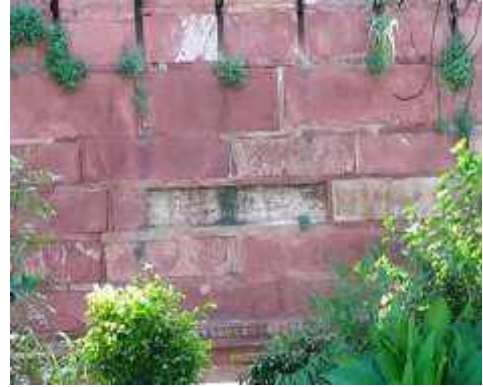
Figure 23: Loss of Cladding

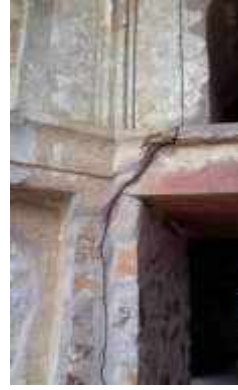
Figure 25: Vertical Crack

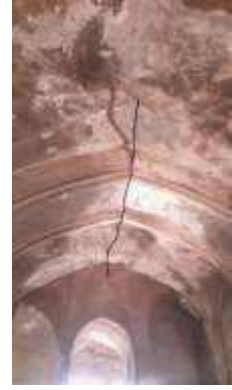
Figure 26: Horizontal Crack

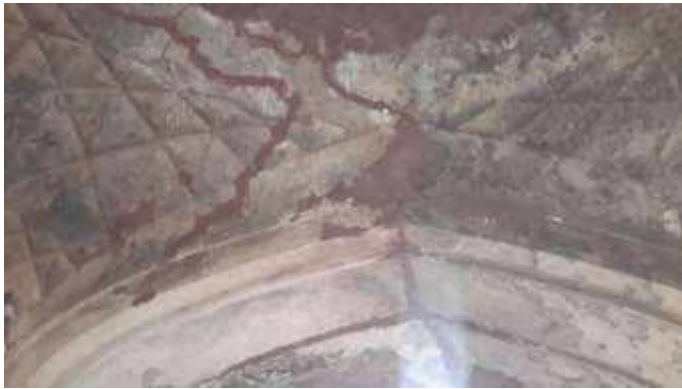
Figure 27 Cracks in the ceiling

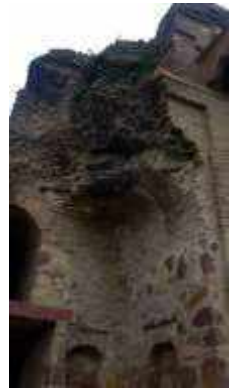
Figure 28: Vegetation Growth and structural damage

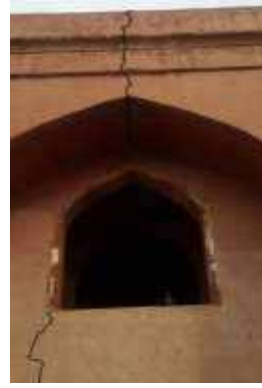
Figure 30: Vertical Crack

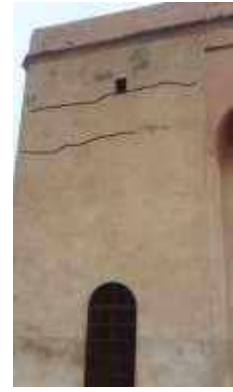
Figure 31: horizontal crack

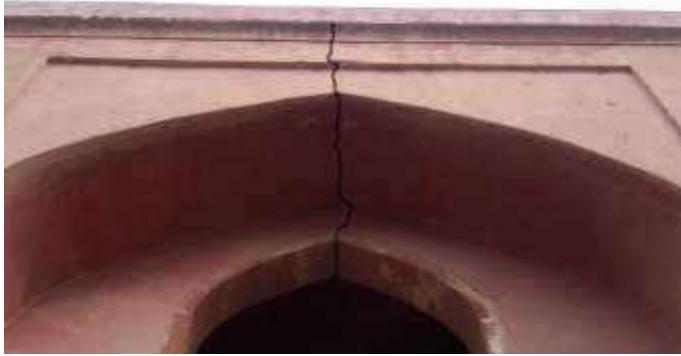
Figure 32: Structural crack

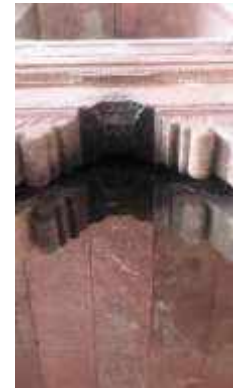
Figure 33: Soot formation

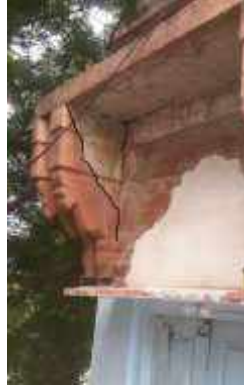
Figure 38: Structural Crack

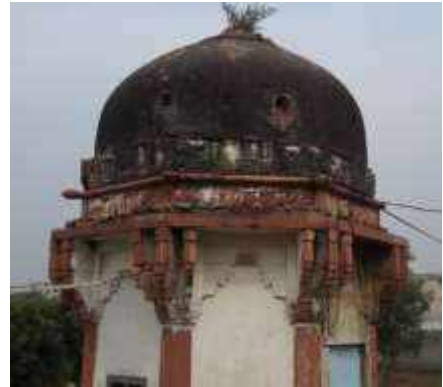
Figure 39: Vegetation Growth

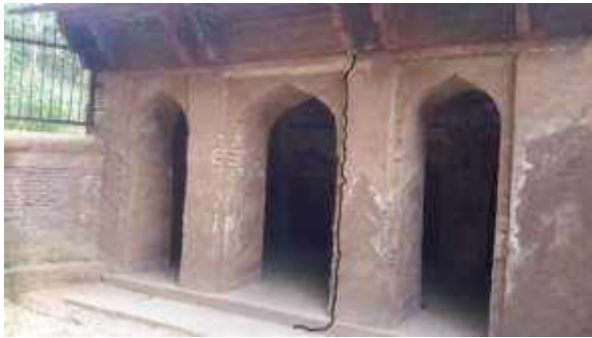
Figure 41: Vertical cracks

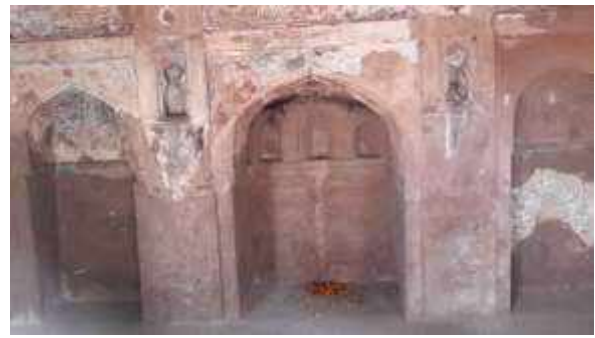
Figure 42: Plaster Delamination

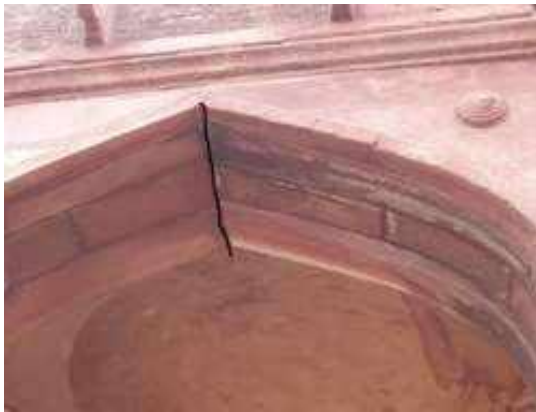
Figure 46: Structural Crack

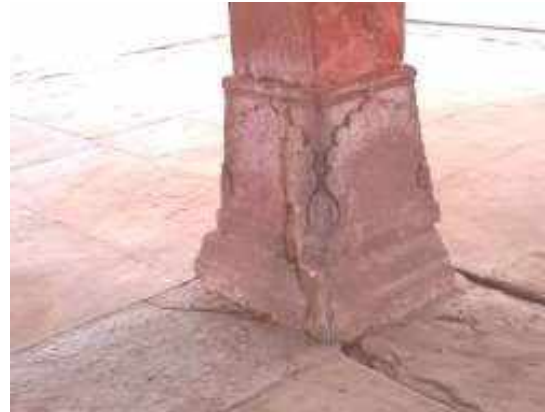
Figure 47: Wind Erosion

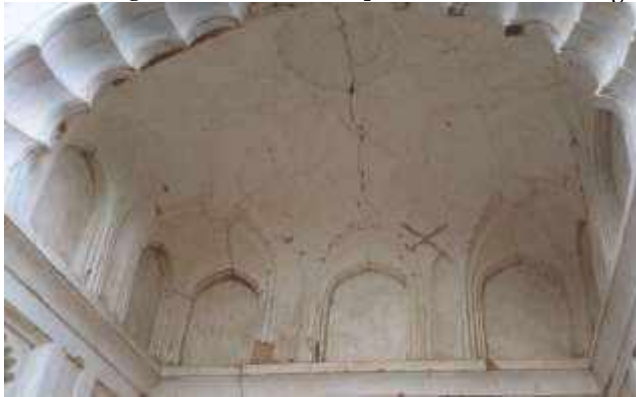
Figure 51: Structural Crack

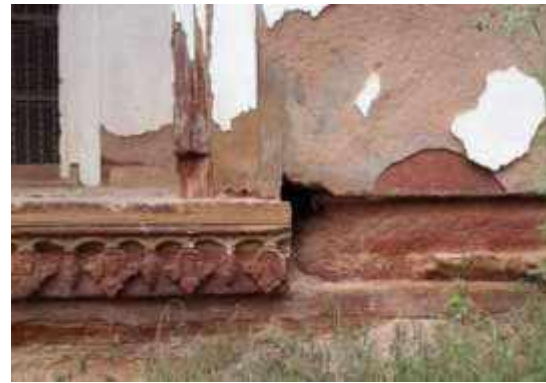
Figure 52: Openings at Base

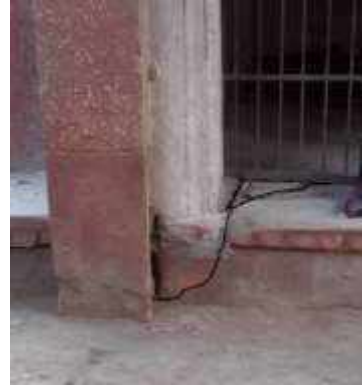
Figure 56: Horizontal Crack

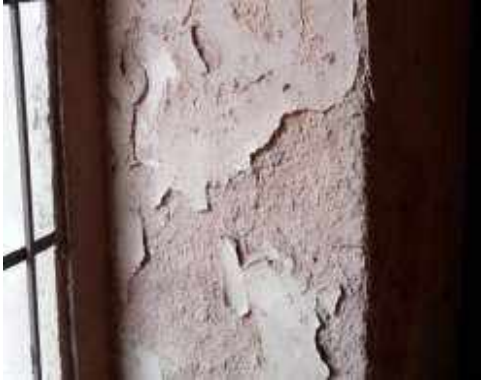
Figure 57: Plaster removal
