Government of Zambia

# Environmental and Social Audit Report and Remedial Action Plan for Ten Dams in Zambia

Additional Financing Irrigation Support Development Project (P102459 & AF-P172140)

April 16, 2020

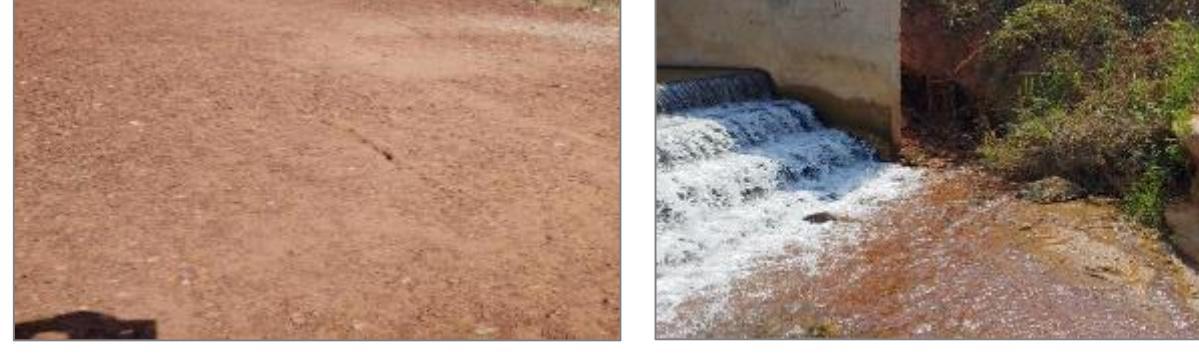
Code	Aspect	Concern/non-compliance	Risk
Constru	ction Remediati	ion Phase	
SFA-1	Structural safety	Crest tension cracks probably due to settlement of the embankment fill caused by sponging and seepage along the toe of the dam.	Dam failure through slips - downstream community safety.
SFA-2	Structural safety	Piping of water down the side of the emergency spillway as settlement shears vertically down the side, causing erosion.	Dam failure through eventual undercutting of the spillway - downstream community safety.
SFA-3	Structural safety	The tight turn of the channel below the emergency spillway into the main river channel, which is likely to result in channel erosion on the bend.	Undercutting of the emergency spillway.

Tension crack on the embankment crest. Seep

Figure 8-4. Incipient structural failures due to poor construction (Katembula).

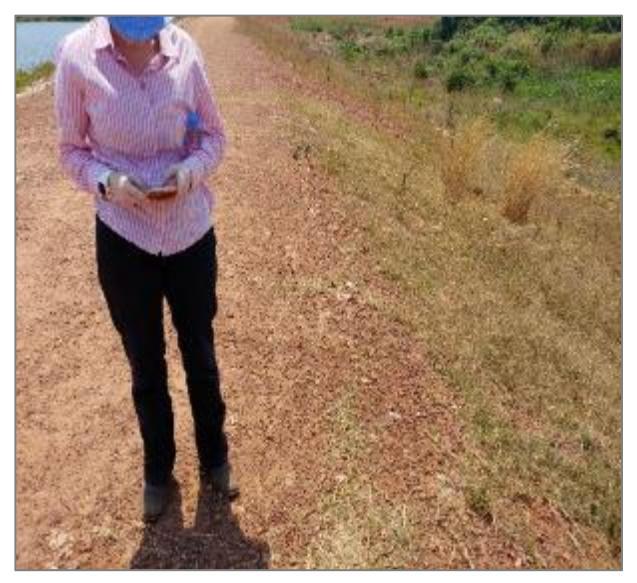
Some naturally occurring grass cover on the downslope embankment. No topsoil evident (November 2019).

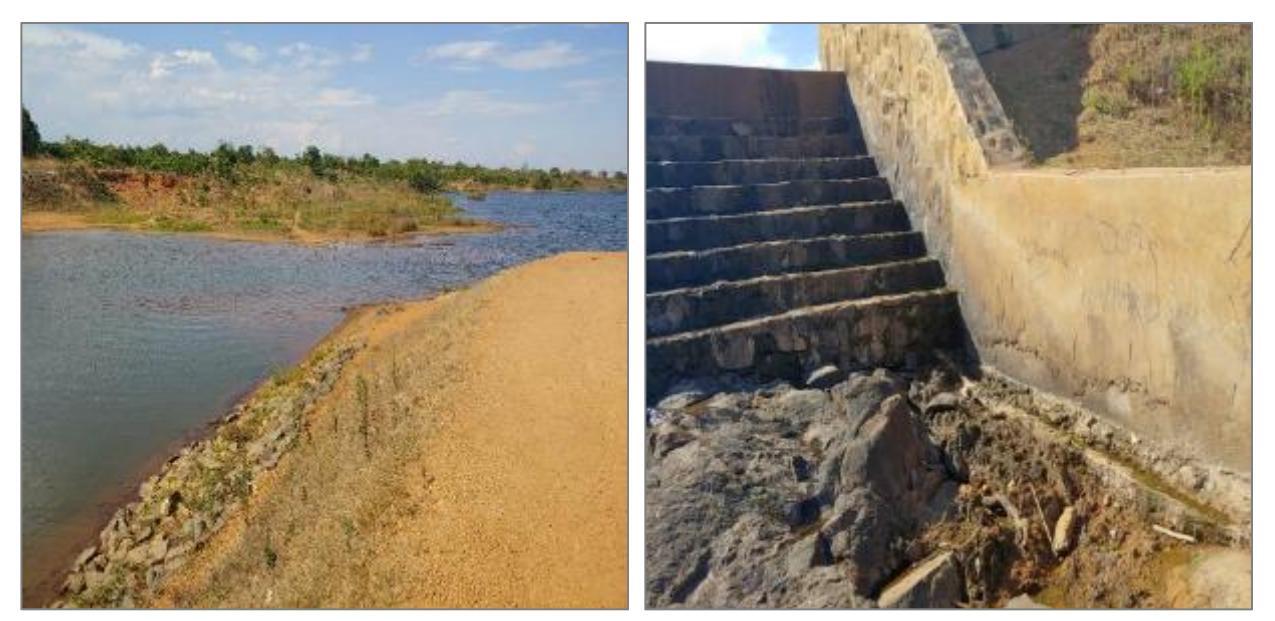
Restricted throat to the main spillway.Erosion at the base of the spillway abutments.Figure 8-9. Dam safety issues at Chibalashi Dam due to poor construction.

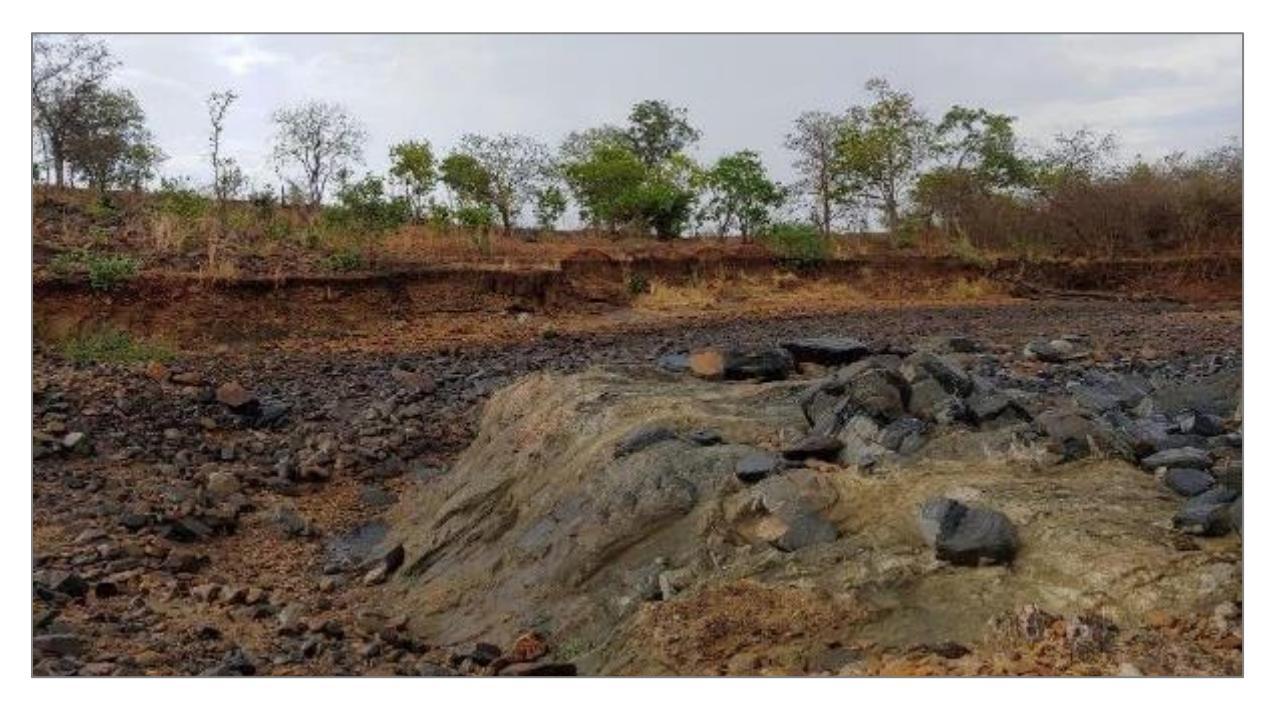
Code	Aspect	Concern/non-compliance	Risk
		the main wall although no gullying evident. Mild tension cracks that have occurred may be due to poor material selection or poor foundation preparation.	
SFC-3	Downstream erosion	Flood erosion of the spillway return Throwing flow to the left and causing vertical slopes of 4–6 m. All eroded slopes to the channel are unstable.	Could possibly affect a small settlement 50 m downstream, causing land loss.

Figure 8-13. Rock bar below Chikowa Dam deflecting to the left hand side of the channel towards downstream settlement.

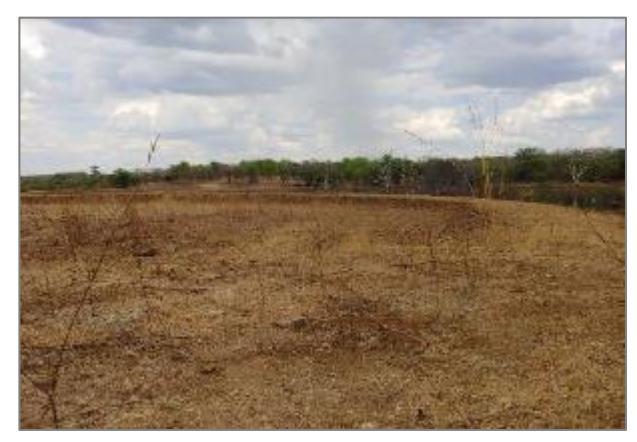
Little grass cover on the hemispheric dam wall.

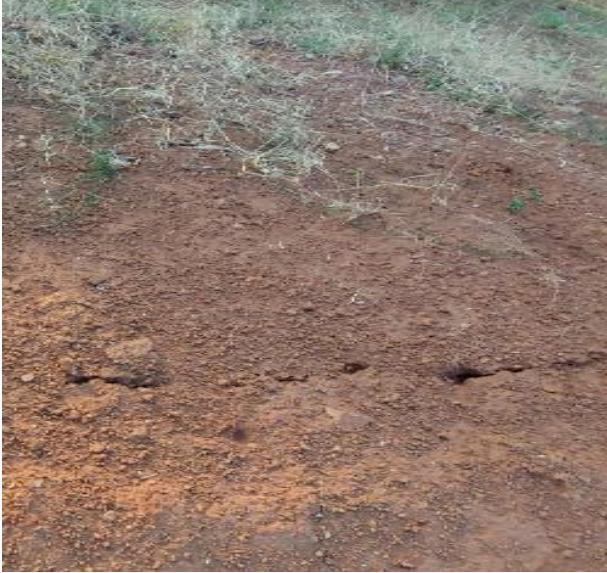
Downstream view of low flow pipe. Valve chamber still Tension crack on the downstream slope (November 2019).

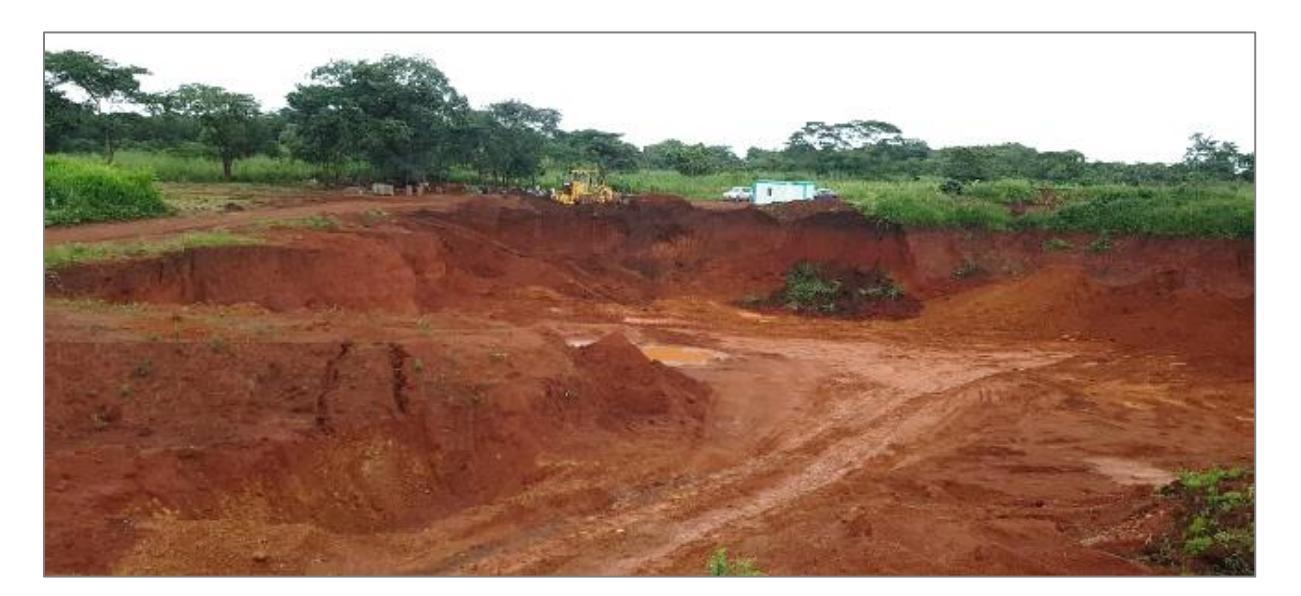
Figure 8-18. Borrow area above Kanyika dam on the right abutment. Note project office in the background.

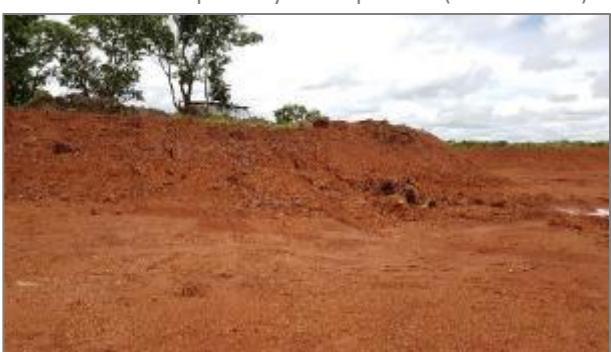
Borrow area excavation in spillway forebay showing loose rock layers (March 2018).

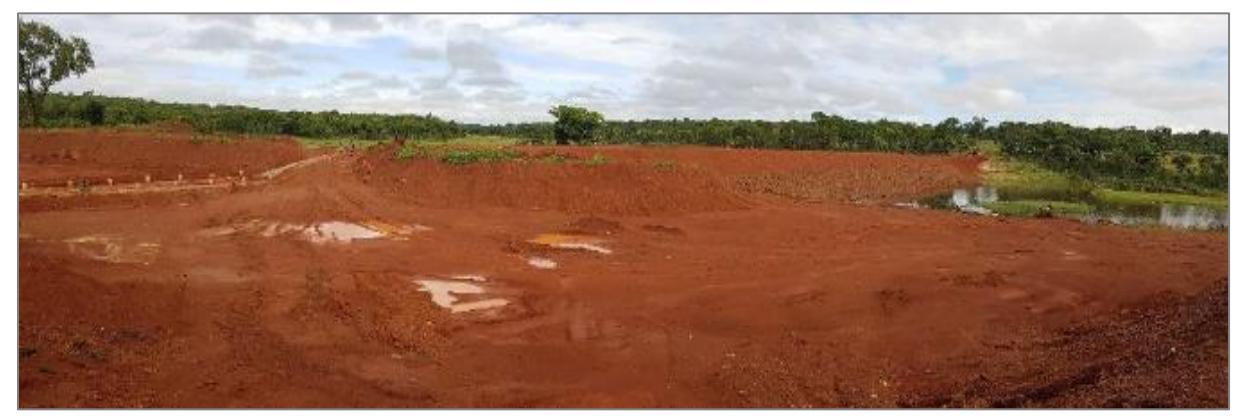
Figure 8-27. Borrow area at the spillway (March 2018).

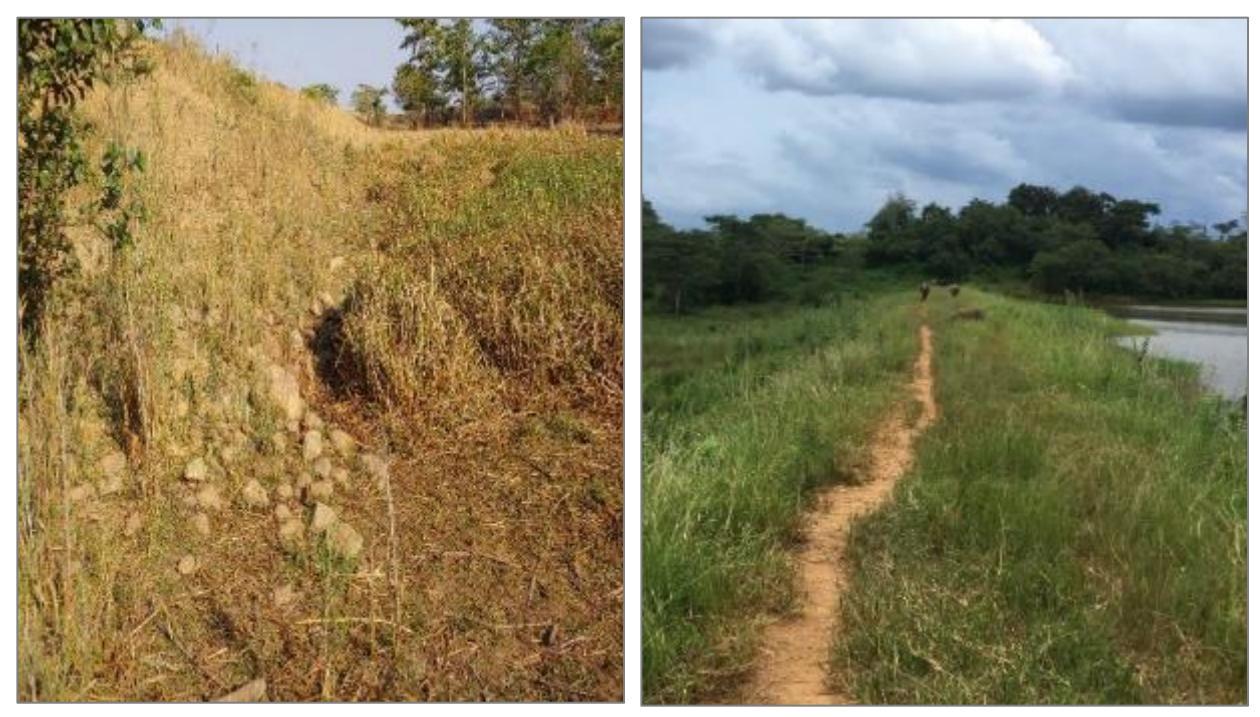
Reeds on the downstream embankment (November Livestock use of the embankment (March 2018). 2019).

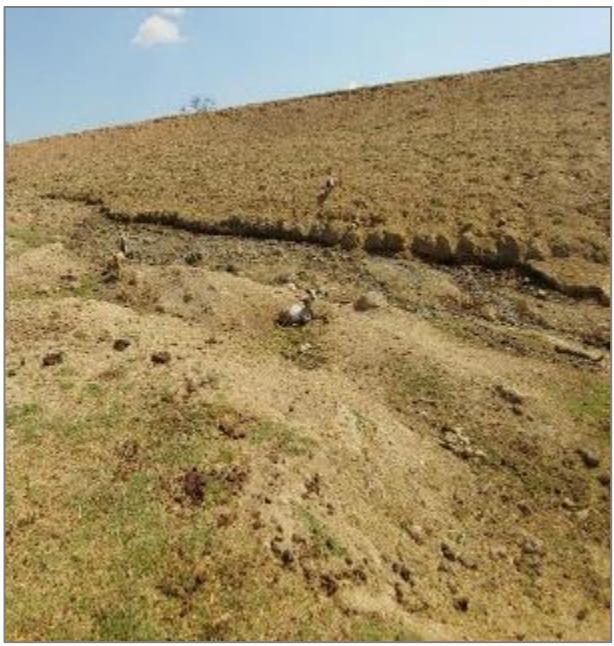
Erosion of the cam embankment partly cause by livestock.

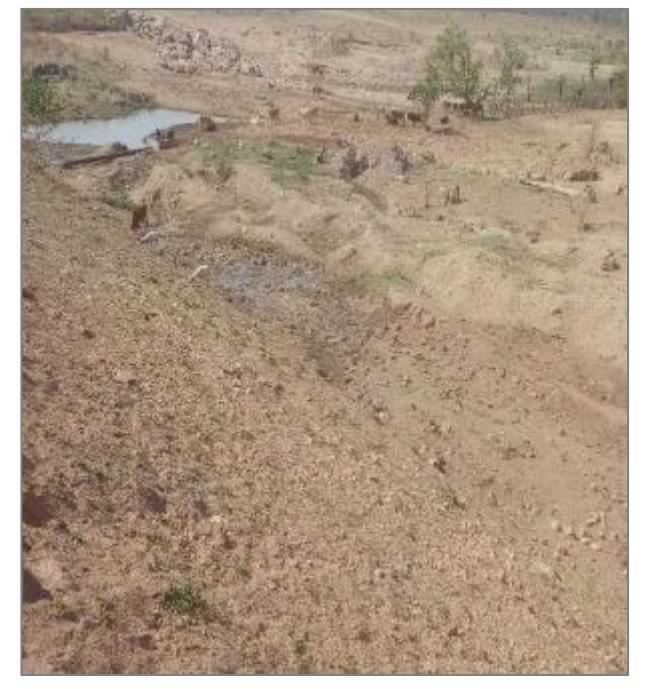
Toe seepage and livestock damage.

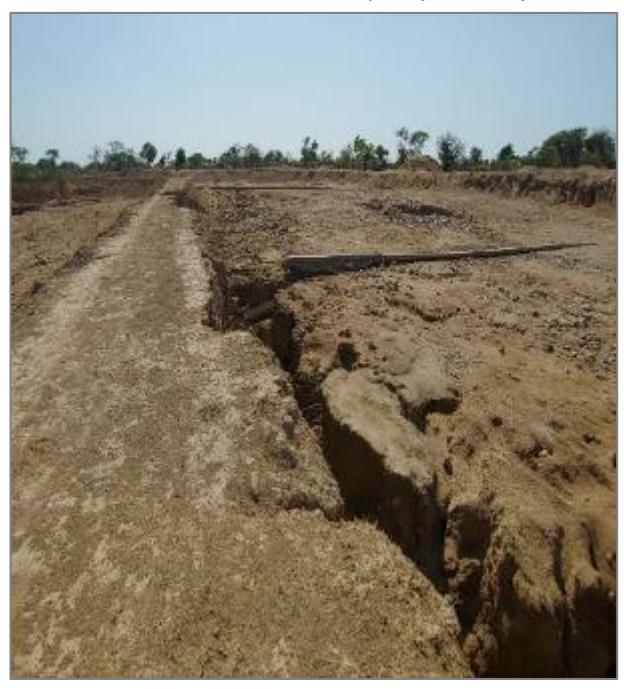
Failed downstream drop weir.

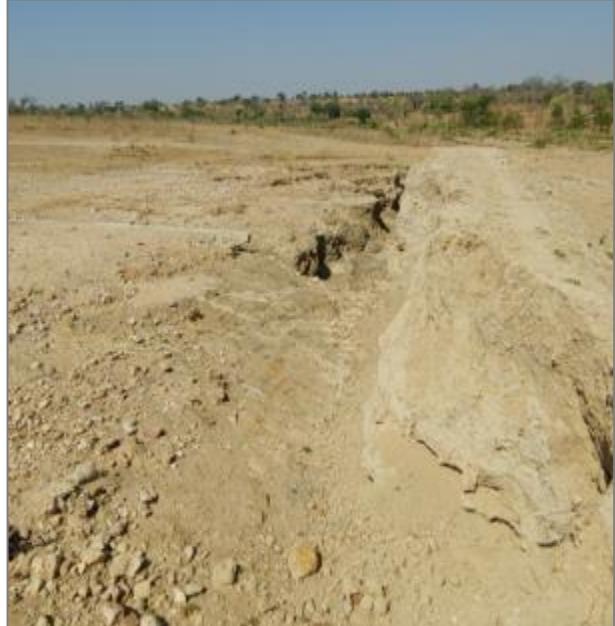
Gullying in the return channel.

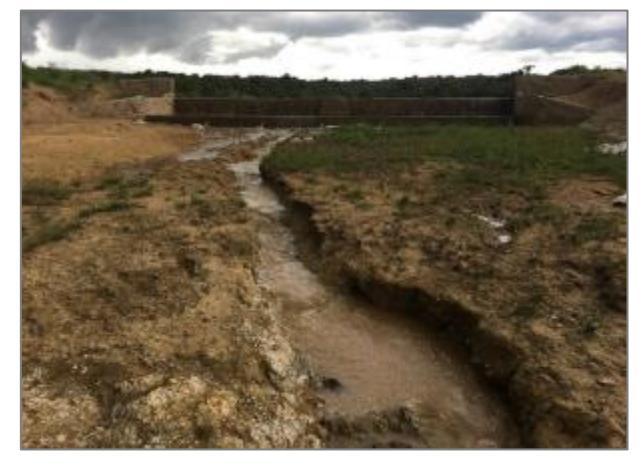
Concrete causeway (November 2019) in the dry season. Gulleying in spillway channel (March 2018). Note cattle presence and gulley eroding back to the spillway.

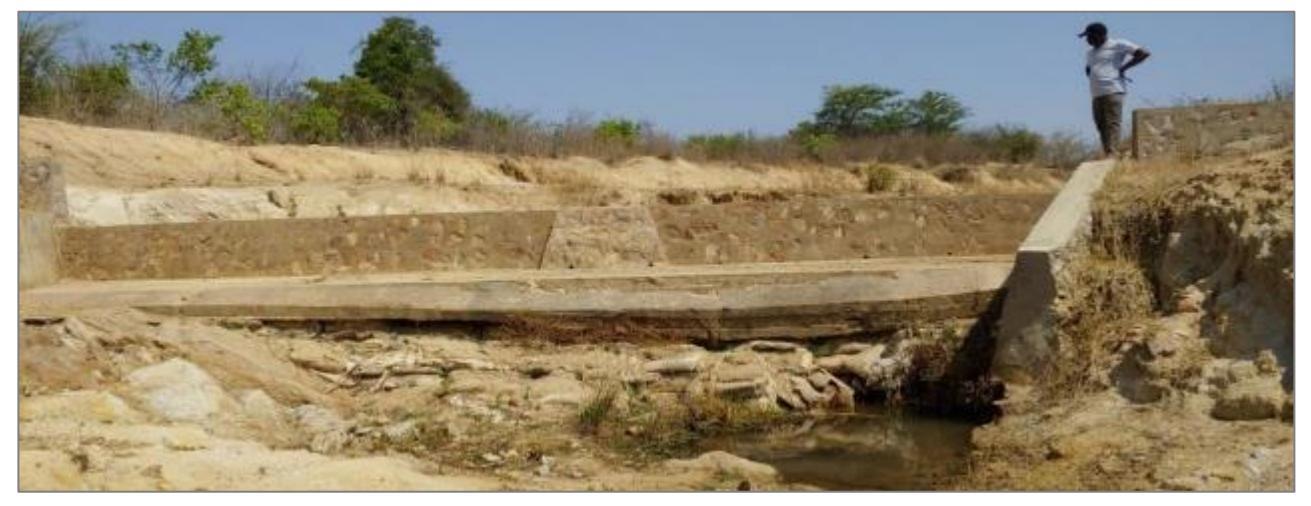
Second drop weir (November 2019). Undermining evident.
