Initial Environmental Examination

Report
June 2017

VAN: Cyclone Pam Road Reconstruction Project - Additional Financing

Prepared by Ministry of Infrastructure and Public Utilities for the Vanuatu Government and the Asian Development Bank.

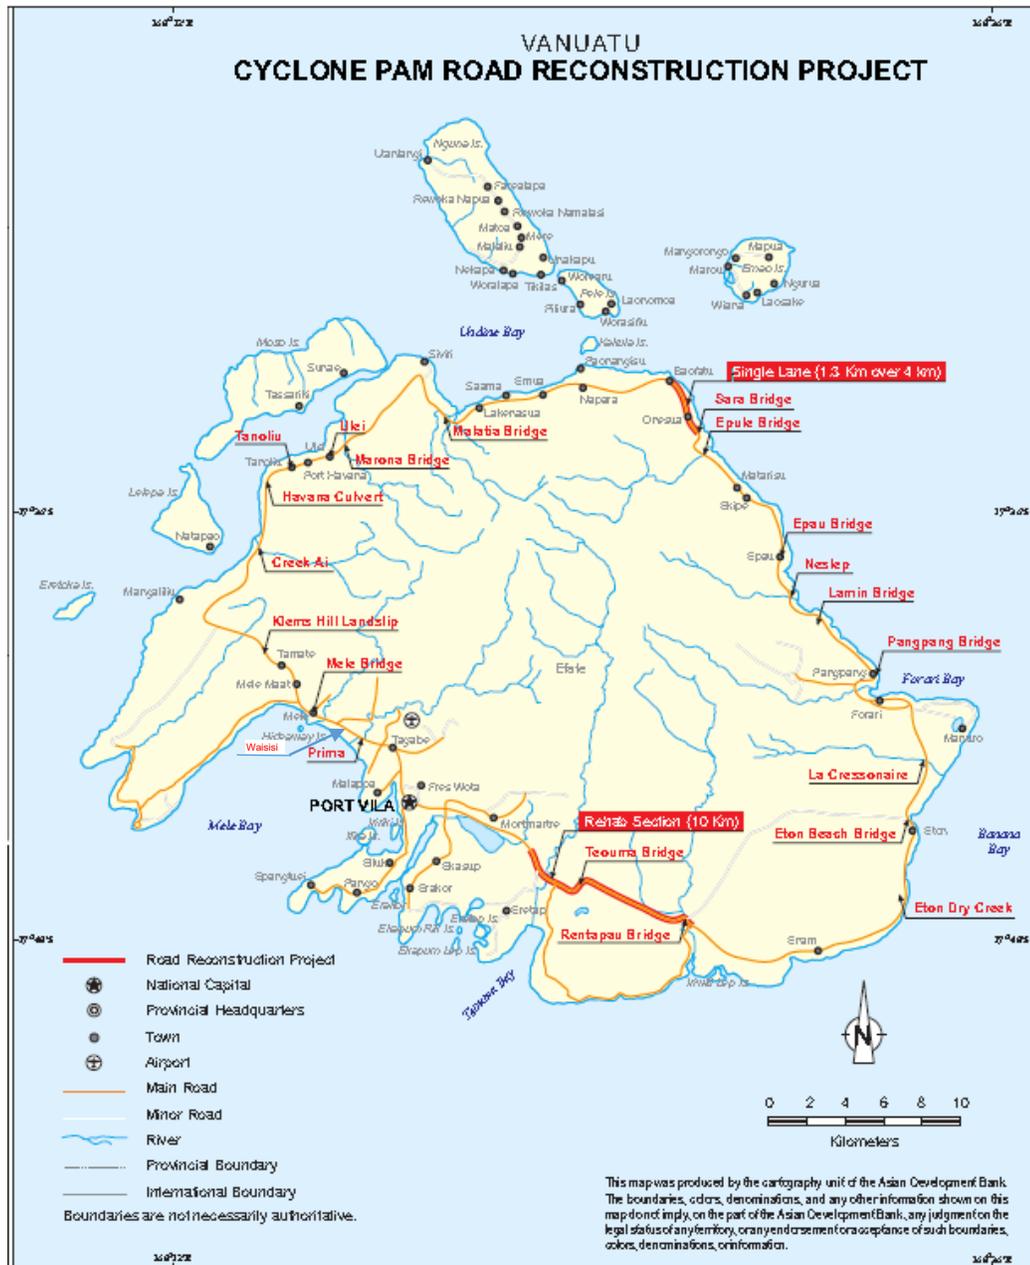
Figure 3-1 Subproject locations

42. There are six subprojects in Phase II of the Project. The locations of each are shown in **Figure 3-1**.

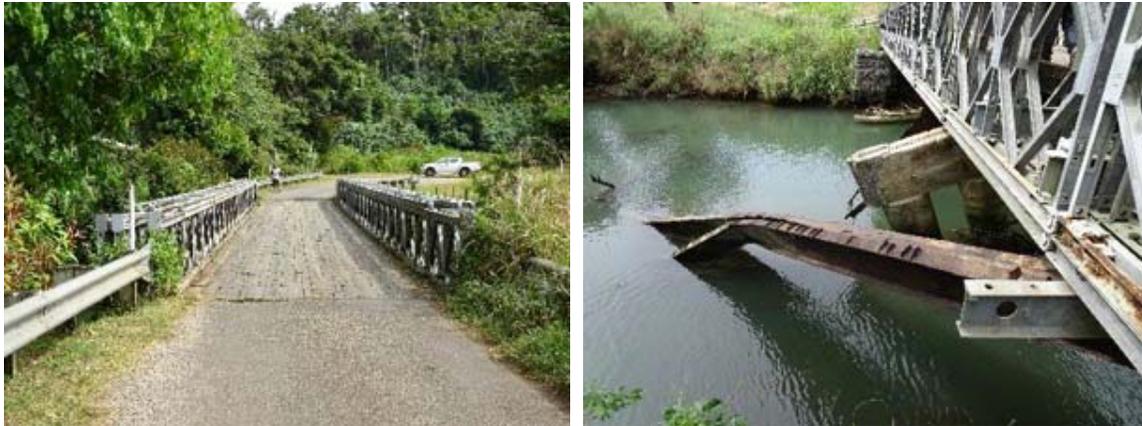
Plate 3-1 Epule bridge

52. Local villagers report that the bridge was overtopped by floodwaters to a depth of about 1 m following TC Pam but receded after approximately one hour. The local villagers further report that the bridge is overtopped about twice a year.

53. It is noted that the original bridge subsequently collapsed in 2015 as a consequence of TC Pam and the partial remains of the centre pier and sections of steel beam are still visible above the waterline at the northern end.

60. Epule Bridge was ranked as priority site No.20, during Phase I, due to low traffic volumes, and the limited damage sustained in TC Pam. However, given its criticality to ring road connectivity and its age and condition, PWD requested that a new bridge be provided.
61. The options for a new bridge at Epule focussed primarily on an improved road alignment. Different structure types were considered (refer Appendix B of the feasibility study report), and an Eastbridge type through truss was determined. The bridge will be a 48 m lone, two-lane structure on a 25-degree skew to the river.
62. Each alternative alignment option involves some land use outside of the existing corridor. The option agreed achieved an improvement in design speed, but minimised the land area required to be leased for use.

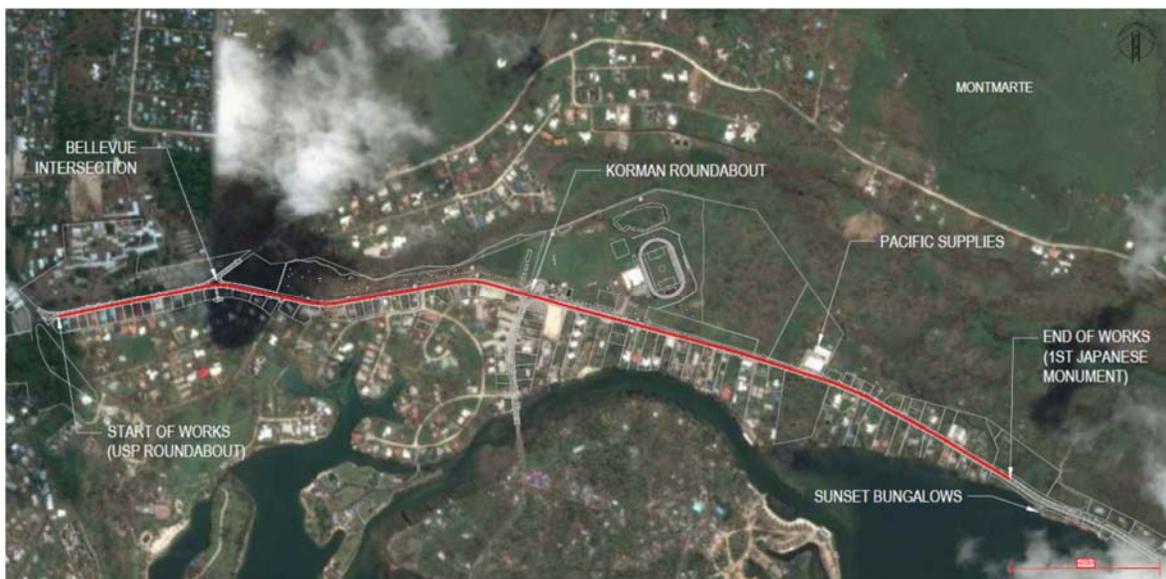
Figure 3-2 Tassiriki Road – Section 1

54. One of the major subprojects of the Phase II works is the Tassiriki Road upgrade (RD04). This proposed improvement starts at the roundabout adjacent to the University of South Pacific (USP) and ends at the second Japanese (JICA) Monument on the Efate Ring Road. The subproject consists of two sections:

- > Section 1 – Road Improvement – Approximate length of 2.7km
- > Section 2 – Reseal of Existing Road – Approximate length of 3.3km

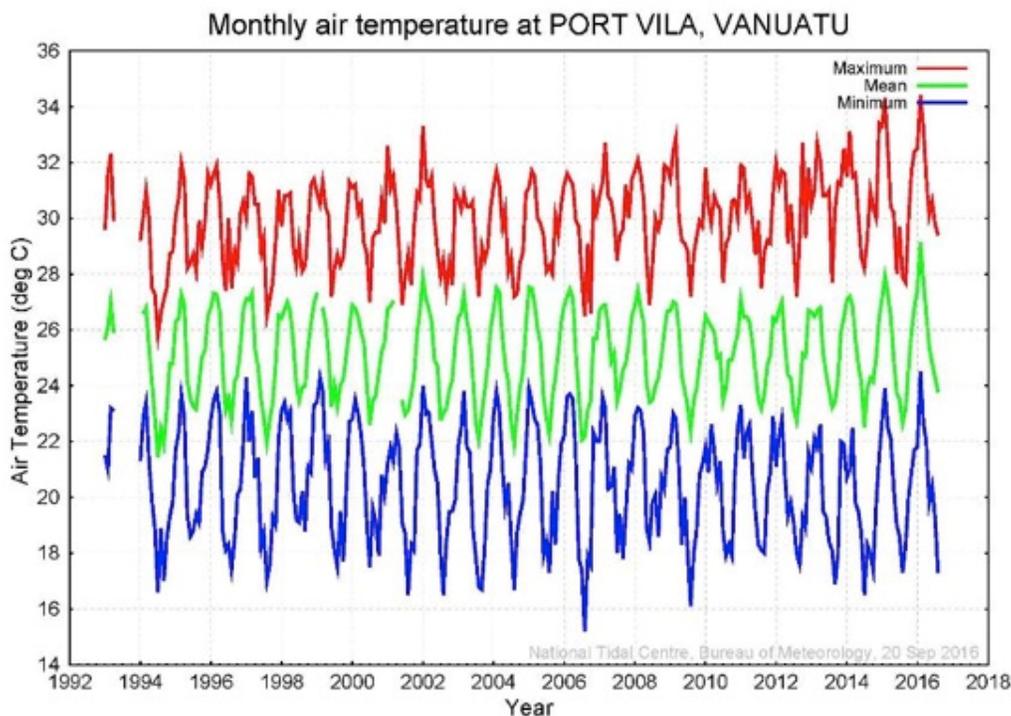
Figure 4-1 Monthly air temperatures in Port Vila

90. Temperatures do not vary greatly throughout the year, given its geographical position near the equator. Air temperatures in Port Vila,³ in the south west of Efate, vary between an average of 23°C in August and 27°C in February. Monthly maximum, mean and minimum temperatures from 1992 to 2016 are illustrated in **Figure 4-1**. Temperatures are not collected on other areas of the island (Republic of Vanuatu, 2014).

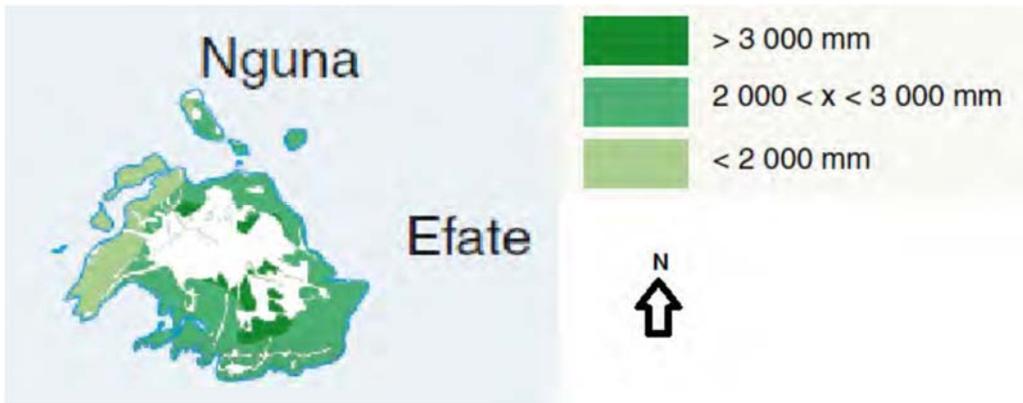
Figure 4-2 Rainfall pattern

91. Rainfall distribution patterns across Vanuatu is determined by seasonal wind flow, topographic features (i.e. rain shadow effects) and the South Pacific Convergence Zone (SPCZ). During the wet (hot) season, rainfall is higher on the south east, the windward side. On Efate, annual rainfall ranges from 2400-3000 mm on the east and is almost half that amount on the leeward/west side. The wettest month in Vanuatu is usually March and the driest month is August (Government of Vanuatu, 2014).

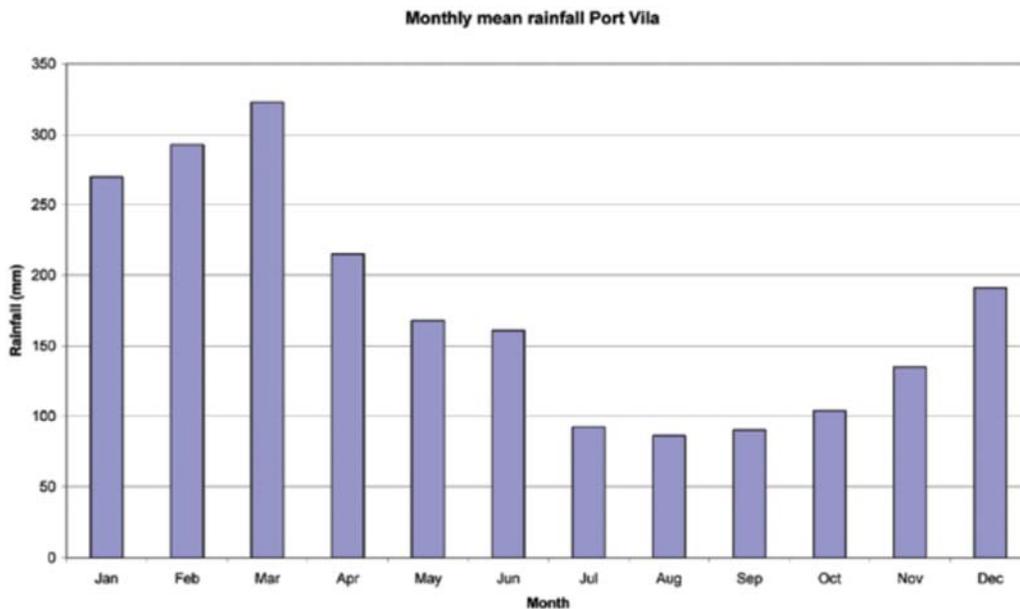
Figure 4-3 Mean rainfall, Port Vila

92. Mean rainfall in Port Vila, in the south west of the island) is presented in **Figure 4-3**. The wettest month in Vanuatu is usually March and the driest month is August.

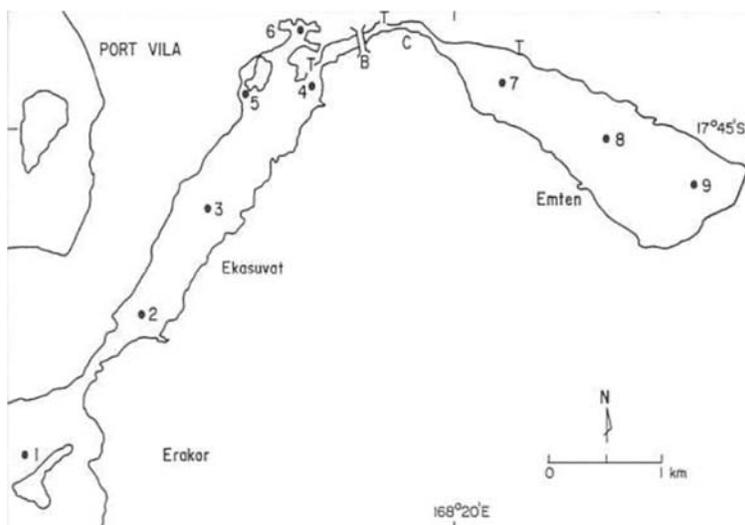
Figure 4-4 Water quality monitoring sites in the Erakor lagoon system

102. The general layout of the Erakor Lagoon system is shown in **Figure 4-4**. There are two lagoons, Ekasuvat, a 178 hectare, 10.7 m deep lagoon that has an entrance to the ocean at the southern end, and a second outlet that leads to Emten Lagoon, a 219 hectare, 6.4 m deep lagoon. There are no significant fresh water river tributaries to the lagoons and the watersheds to each are rather small, 327.5 hectares and 1,542.5 hectares respectively.

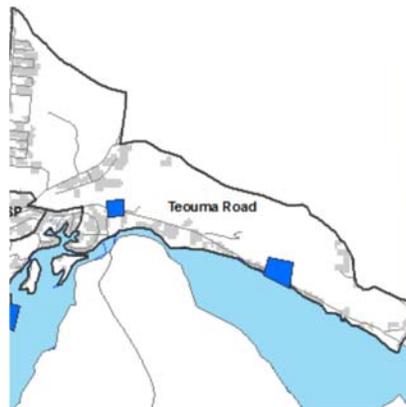
Figure 4-5 Location of flash-flooding “hotspots “

108. The recent UN Habitat Report on Climate Change Vulnerability (Treadle, 2015) listed two areas of flash flooding identified during community consultations which are both found in the drainage catchment of the Tassiriki drainage catchment area. No information was reported on the length of time that flooding remained and any transport access was restricted (see **Figure 4-5**).

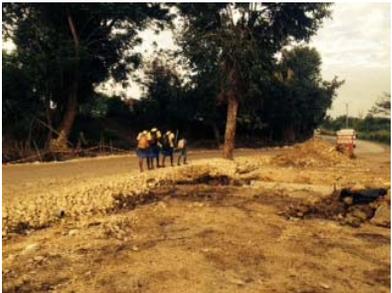
<p>The geology of the area is mixed alluvium over remnant limestone reef. The soils along the creek are sandy from upland areas surrounding a lowland wetland over peat wetland soil mainly downstream of the road. The catchment makes up an area of approximately 175 Ha. The presence of significant amounts of the upland sandy soils has led to sedimentation in the creek bed downstream. The site is presently under construction.</p>	<p>The impact area has been highly modified with human intervention with weed infestation, bamboo stands and vines and significant amount of solid waste dumped in and around the waterway. There are scattered large lowland rainforest trees which suggest a significant wetland rainforest or open canopy forest was present downstream.</p> <p>From field inspection the water quality appears excellent with no turbidity issues. The water flow is strong and appears to be groundwater under pressure from fissures in the underlying limestone geology below the culvert under construction. Upstream the surface water flow appears to have been effectively stopped by the current construction activities.</p>	<p>The area has scattered settlement on the upland side of the road with a broken unsealed access road leading to a low standard housing area approximately 50 metres upstream on the eastern side.</p>

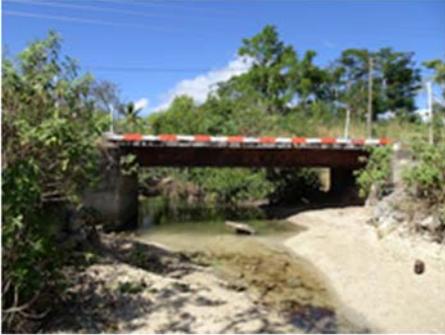
Saama Culvert	<p>Steep gradients both upstream and downstream of culvert that flows to the sea approximately 150 m downstream. Evidence of sheet flow over the road</p>	<p>A highly modified environment made up of secondary vegetation and various weeds. Bull rushes and other introduced reed species dominate on either side of the road restricting flow into the culvert</p>	<p>The site is approximately one km from the nearest village and is relatively isolated.</p>
Tanoliu Bridge	<p>Located adjacent to the coast The Sanoa Marine Protected Area (community-led initiative) is nearby. The bed material is sandy and the dominant flows are tidal.</p>	<p>There are mangroves present upstream but the immediate vicinity of the bridge is highly modified due to the proximity of the village also upstream</p> <p>Fauna species associated with mangroves present in large numbers (e.g. fiddler crabs, mangrove crabs, mudskippers, hermit crabs) are present in Havannah bay which is adjacent to the bridge and approximately 20 metres from the fringing beach.</p>	<p>Residence situated north-east of bridge. A bench is located south-west of the bridge for use as waiting area for busses. For people travelling and commuting from the adjacent offshore islands. Anecdotal evidence from two consultations was divided as to whether mangroves are exploited in the area upstream for charcoal production.</p>

68. Options investigated for Saama were to simply line the inlet channel to the existing single cell pipe culvert, or to replace the culvert with larger pipes. The increased pipe culvert option was considered to effectively address the site requirements, at a low capital and maintenance cost and therefore was

selected by PWD. A single 1200 mm diameter pipe will be installed to replace the existing and road side drains will be concrete lined.

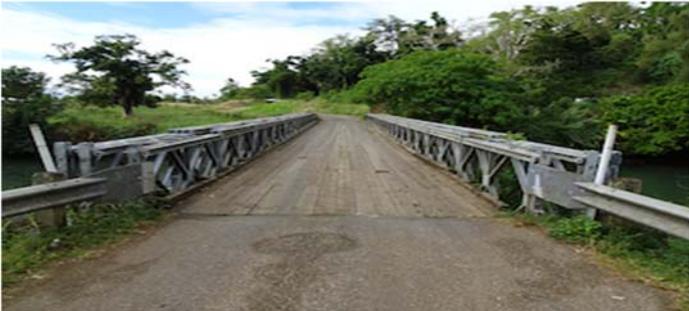
<p>Epule Bridge</p>	<p>Epule crosses a relatively long estuarine river that is relatively approximately 10-15 km in length and deep enough for the use of kayaks and canoes. The geology at the bridge is recent up- lifted limestone but further tream the source is in the older limestone.</p> <p>The channel is dominated by tidal flows with very good water quality. There was no evidence of sedimentation in the channel.</p>	<p>The area is well vegetated both up and downstream of the bridge.</p> <p>The coastal side of the bridge has mostly cleared and grassy vegetation which is highly modified with many weed species. Inland, there is more private land there are planted gardens along the northern side of the river by the residence and further upstream.</p> <p>The river supports a diverse ecosystem of endemic salt and estuarine fish and crustaceans such as eel fish and estuarine shrimp.</p>	<p>There is a residence to the immediate northeast that rents out kayaks and does river tours. The village population is scatterd in private houses on both sides of the river which are all relatively close to the bridge</p> <p>There is fenced off private land on either side of the bridge along the river which is fenced using barbed wire.</p>
