Assessment of the Effects and Impacts Caused by
Hurricane Joaquin
The Bahamas

Hurricane Joaquin was among the 25 hurricanes and tropical storms that have hit The Bahamas in the last 25 years, and the 10th hurricane of the 2015 hurricane season, reaching category 4 for an extended period of time over the Bahamian islands. It severely damaged islands in the southeast, central, and northwest Bahamas on its path from 30 September to 2 October, 2015. The extent of damage varies according to the amount and duration of rainfall, storm surge, the path of the storm, and other factors such as the location of the settlement, number and type of buildings in the area, the terrain, and prior conditions.

The Ministry of Finance of the Government of The Bahamas requested the Inter-American Development Bank (IDB) for an assessment in terms of damage, loss, and additional cost caused by hurricane Joaquin. The IDB requested the assistance of ECLAC for technical assistance in the assessment of the effects and impact of hurricane Joaquin. The team then made recommendations to guide a resilient reconstruction process by using the five pillars of disaster risk reduction, thereby contributing to the red

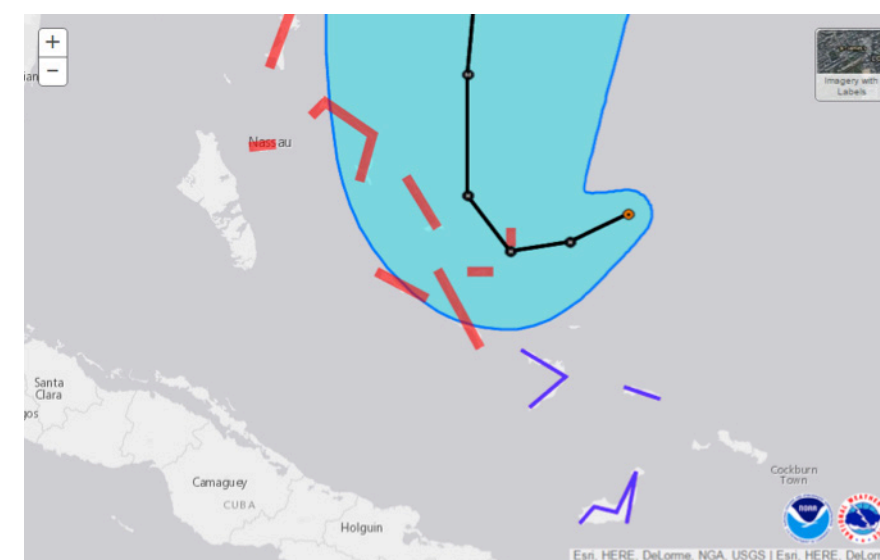
Map 1- Trajectory of hurricane Joaquin
30 September, 5:00 p.m. AST

On Wednesday 30 September, tropical storm Joaquin was upgraded to hurricane and at 5:00 p.m. the government of The Bahamas issued a hurricane warning for the central Bahamas, including Cat Island, the Exumas, Long Island, Rum Cay and San Salvador (Map 1). Another hurricane warning was issued for the northwestern Bahamas (Abacos, Berry Islands, Eleuthera, Grand Bahama and New Providence). Additionally, a tropical storm warning was issued for the southeastern Bahamas (Acklins, Crooked Island, Long Cay, the Inaguas, Mayaguana and the Ragged Islands) and Andros Island. The Category 3 hurricane showed maximum sustained winds of 115 mph (185 km/h) and was located 90 miles (145 km) East of San Salvador and 170 miles (275 km) east of the central Bahamas.

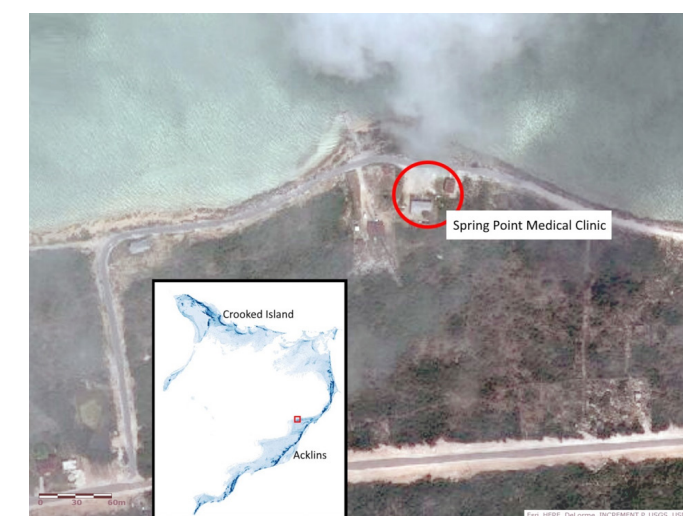
Figure 1- Spring Point Medical Clinic

The health centre is located close to the ocean (Figure 1) and as a result suffered from major flooding. The roof incurred damage because of high wind resulting in loss of shingles, causing leakages through the roof. The generator was destroyed because of water damage; and all vaccines and insulin were lost. The storage facility sustained major flooding, causing destruction of all medical supplies that were stored before the hurricane. The well water was contaminated with saltwater intrusion; however, there was no faecal contamination. Furthermore, the doctor's government residence sustained damage due to flooding.

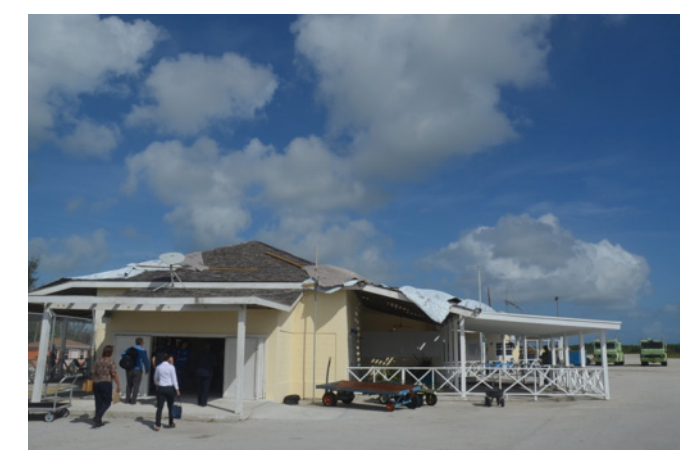
Photo 1- San Salvador Airport

The terminal buildings located in Acklins, Crooked Island, Long Island (Deadman's Cay) and San Salvador are all similar, airports consist of a runway and neither have guidance or communication systems. The terminals are single-story structures of reinforced concrete and masonry. The hurricane produced damage in all terminal buildings, but they are partially recovered and all presently functioning. In Rum Cay there was no building terminal.

Runways of all five airports inspected are clear of debris and functioning, but require repairs. They show insufficient previous maintenance unrelated to hurricane Joaquin. The costs of these repairs have not been estimated due to lack of information regarding their design parameters and their estimation could be part of a comprehensive infrastructure development master plan. The total damage to airports in Acklins, Crooked Island, Long Island and San Salvador is estimated at \$1,771,964.

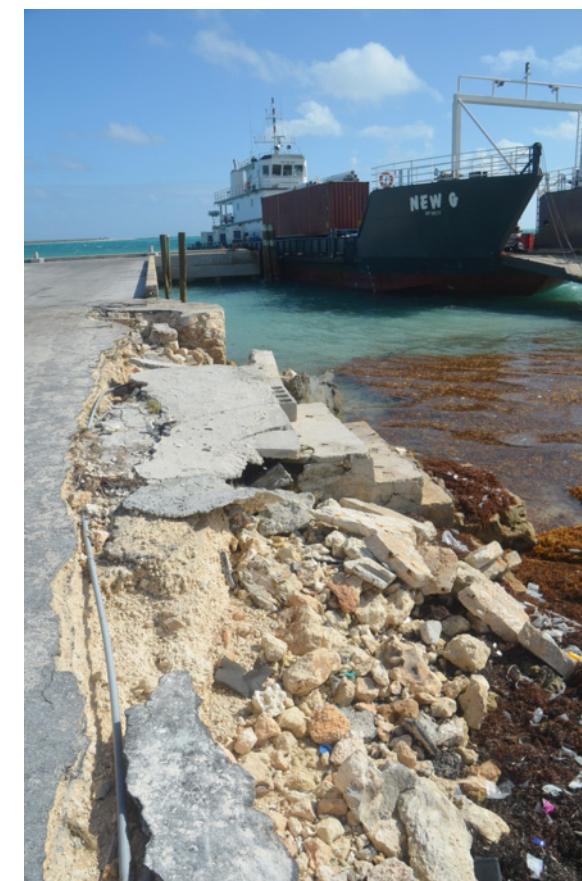
Photo 2- Damage to a dock on Long Island

Dock structures showed important damage before the hurricane due to insufficient maintenance and to previous disasters. The structure of docks is comprised of wooden piles with concrete and wood platforms. Some docks were destroyed or severely damaged and cannot be utilised. Their repair must be carried out as soon as possible given their importance as support infrastructure for the reconstruction process; as well as a means to recover the economic activities of the islands. Photo 2 shows how extensively docks were damaged.

A larger effort should be made in order to assure adequate port infrastructure and port security. The quality of the port infrastructure is required in order to reduce transportation and operation costs.

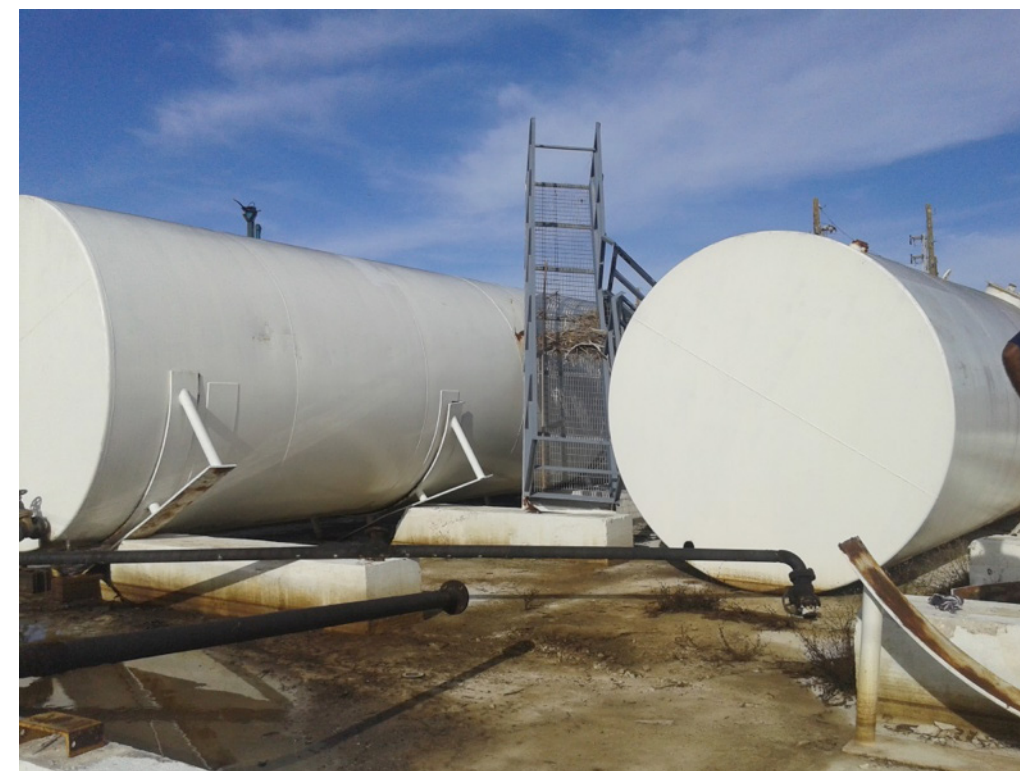
Photo 3- Damage to fuel tanks

Another effect of the storm surge on the Landrail Point Power Station was the dislocation of two 25,000 gallon tanks used for the storage of diesel. The tanks were ripped from their concrete bases, and an estimated 7,000 to 10,000 gallons of diesel leaked out through a pipe that had become disconnected. Soil sampled from a drainage area nearby the tank was found to be contaminated with diesel, as evidenced by the presence of strong fumes which were noted by the disaster assessment team. This spill warrants further investigation, to determine the extent of soil contamination, possible options for remediation, and potential danger to the water table. The tanks themselves are salvageable, but will require a crane to be put back into place.
