Environmental Monitoring Report

Bi-Annual Report
June 2016

AZE: Second Road Network Development Investment Program – Project 2

Construction Supervision of the Alat-Astara Highway

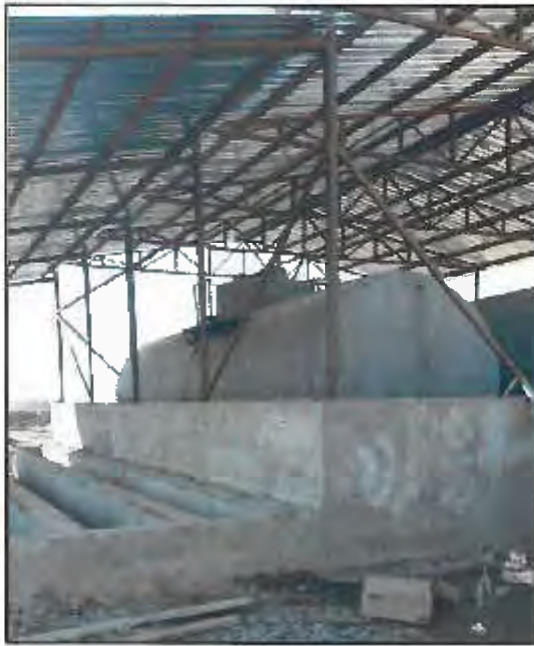
Figure 4. Bounded Fuel Tank inside Construction Camp

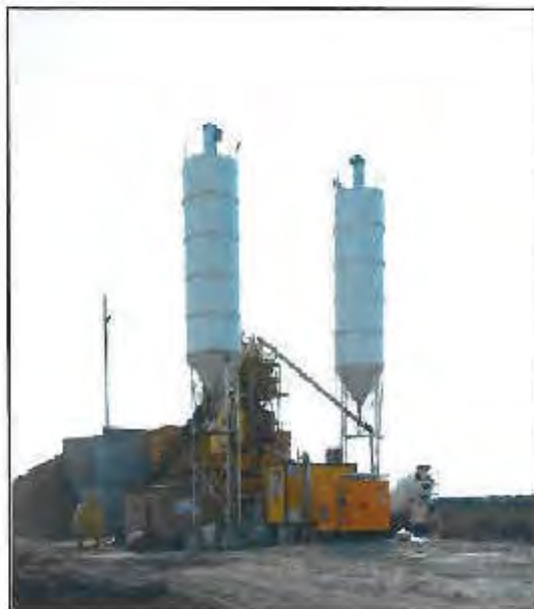
Figure 5 Concrete batching plant inside Camp

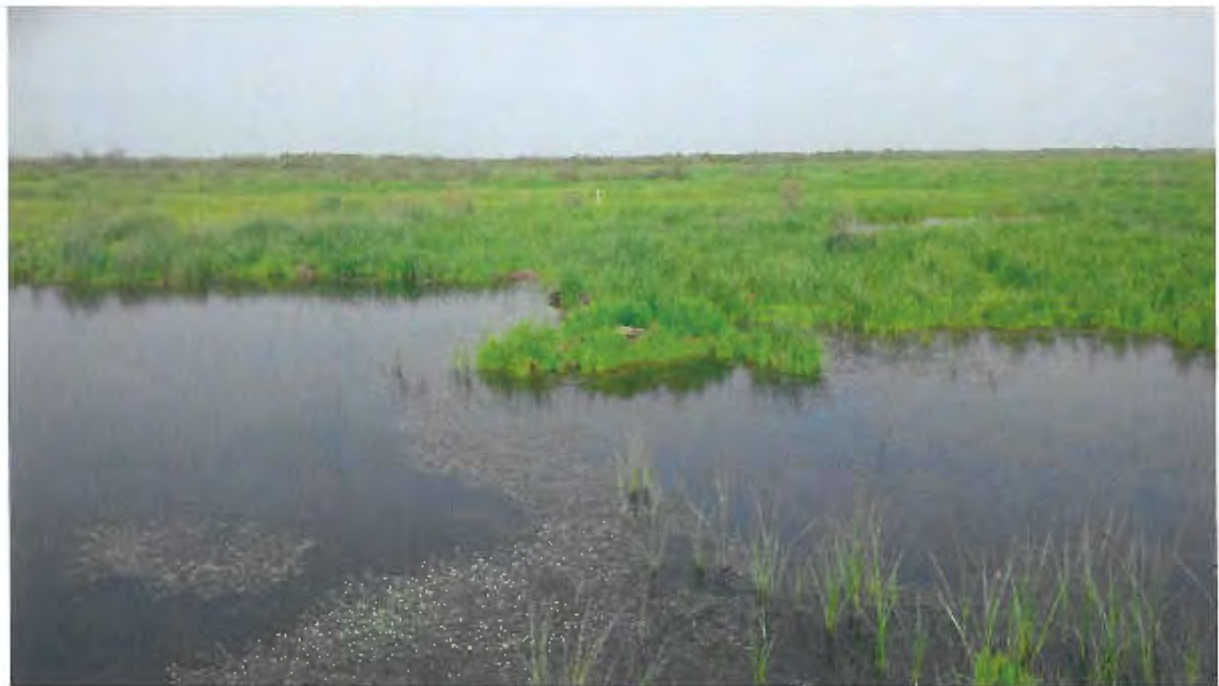
Figure 2. Reed-bed habitat at Akchala. This is the microhabitat type typically used by *Emys orbicularis* at the study area. Photo by Luca Luiselli

7. Transects surveys were carried out in the reed-bed vegetation habitat type at Akchala (Figures 2 and 3). These transects consisted in slow-walking throughout the habitat, in order to directly observe turtles and eventual other aquatic fauna randomly encountered. When a given turtle individual was observed, its behavior, data and hour of observation, and precise site of observation were recorded. Total surface of this area was 15,000 ha.

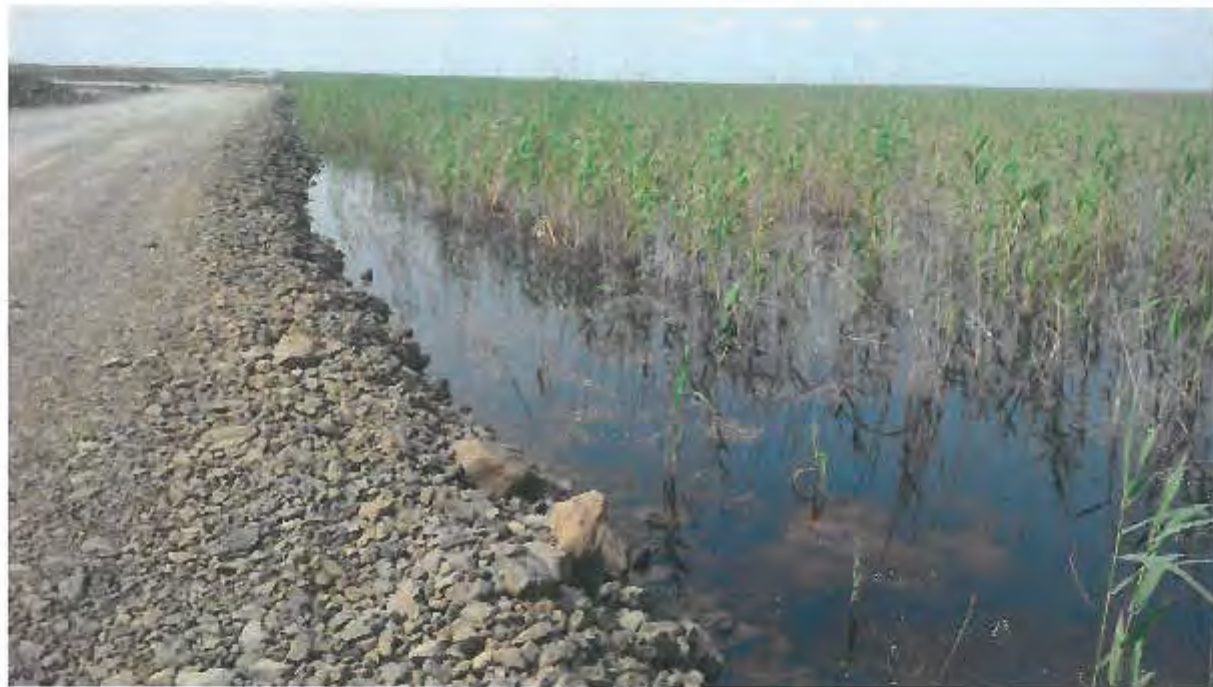
Figure 3. Road construction at the reed-bed habitat type in Akchala. Photo by Luca Luiselli

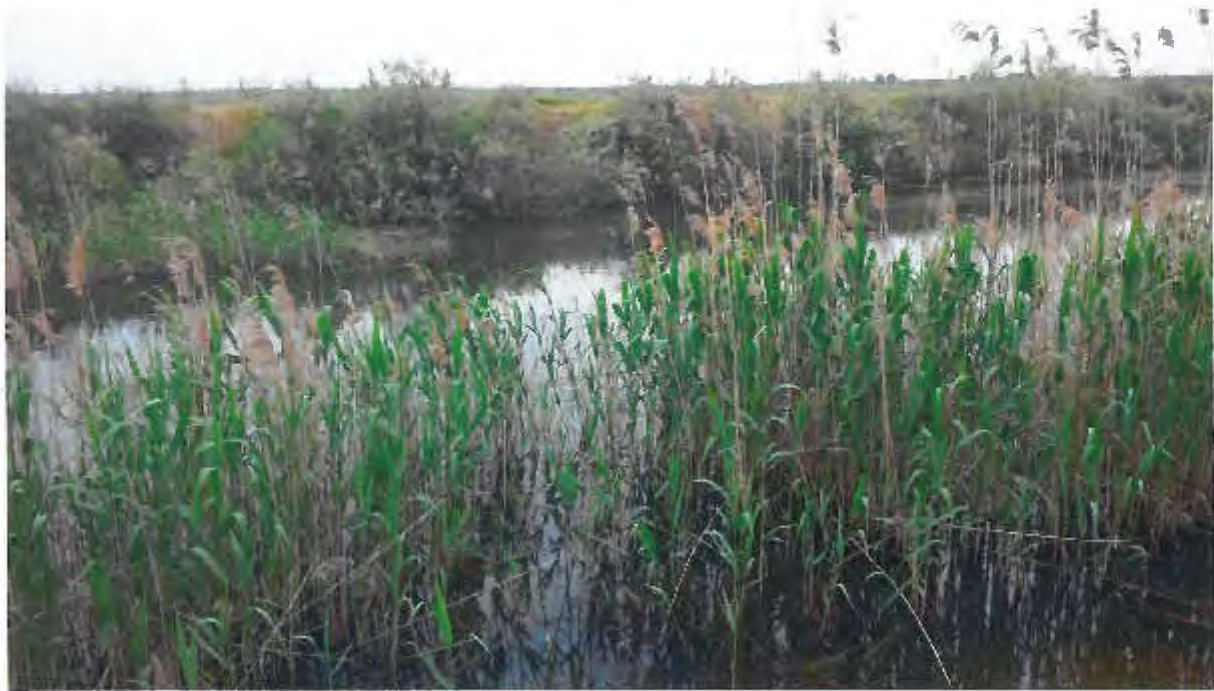
Figure 4. Water channel habitat type at Mahnudchala wetland. Photo by Luca Luiselli

9. Open water habitat type, including both drainage channels (Figure 4) and a lake (Figure 5), was studied at Mahnudchala wetland. The vegetation at this site was similar to that at the reed-bed site, but with least vegetation density and with more current water. Overall surface of this wetland was 8,000 ha.

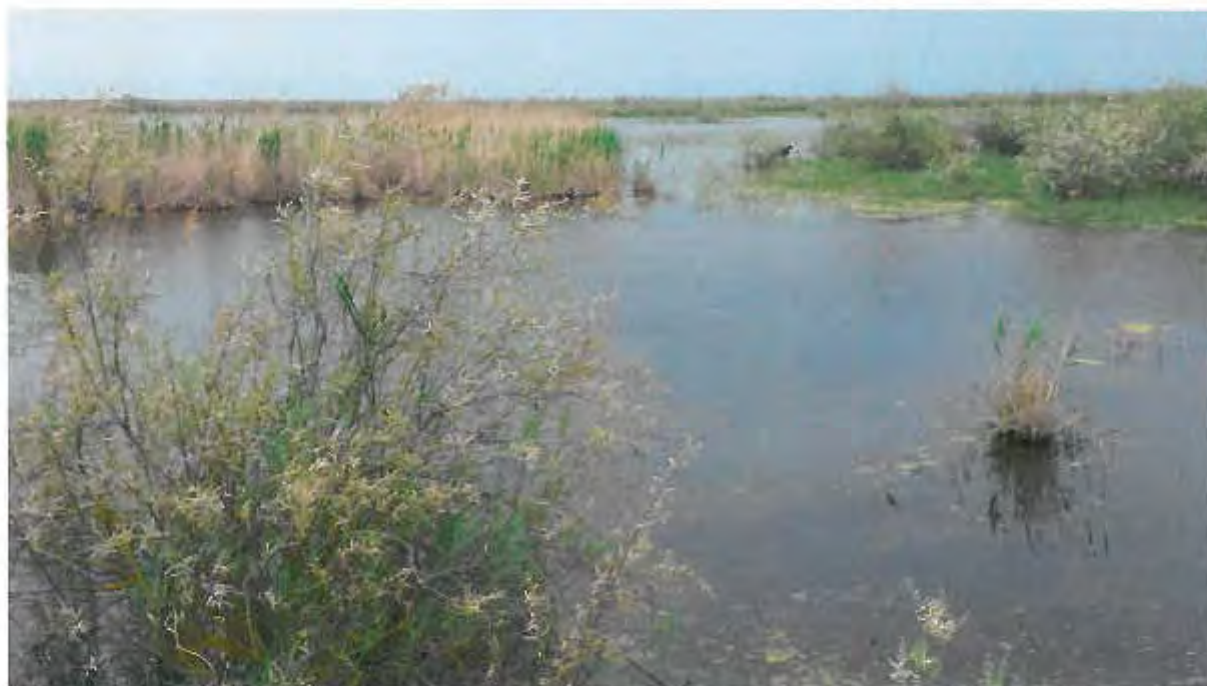
Figure 5. Open water habitat type at Mahnudchala wetland. Photo by Luca Luiselli

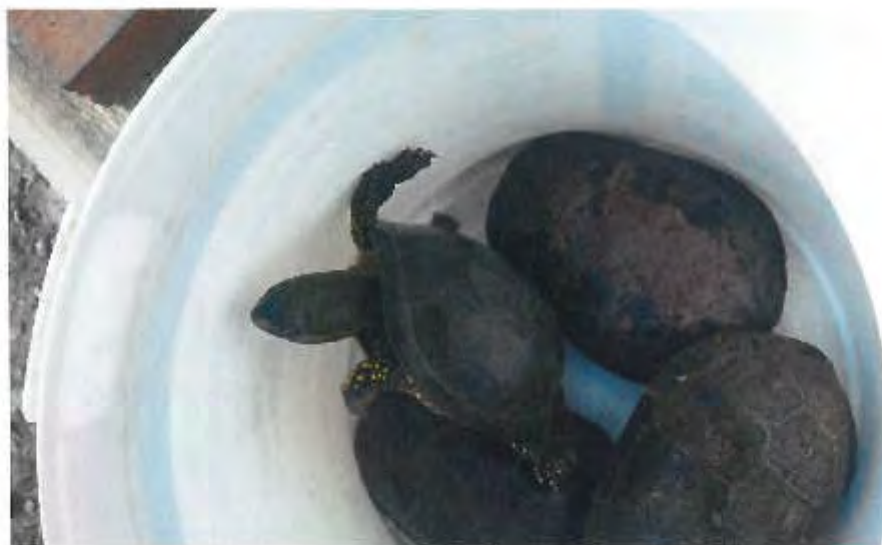
Figure 6. Several live turtles, just captured and carried to the laboratory for further examination. Photo by Luca Luiselli

15. When it was possible, turtles were also captured (Figure 6) and carried to the laboratory in order to study their morphometric characteristics, their age (via count of the annual annuli growth on the dorsal shell), and in order to allow them to defecate. Feces do contain remains that may allow the turtle expert to analyze the dietary preferences of the population under study. Although these biological data are not directly relevant for the Turtle Action Plan, they are important from the purely scientific point of view and in any case may convey important data that can be useful for eventual future management/relocation programs.

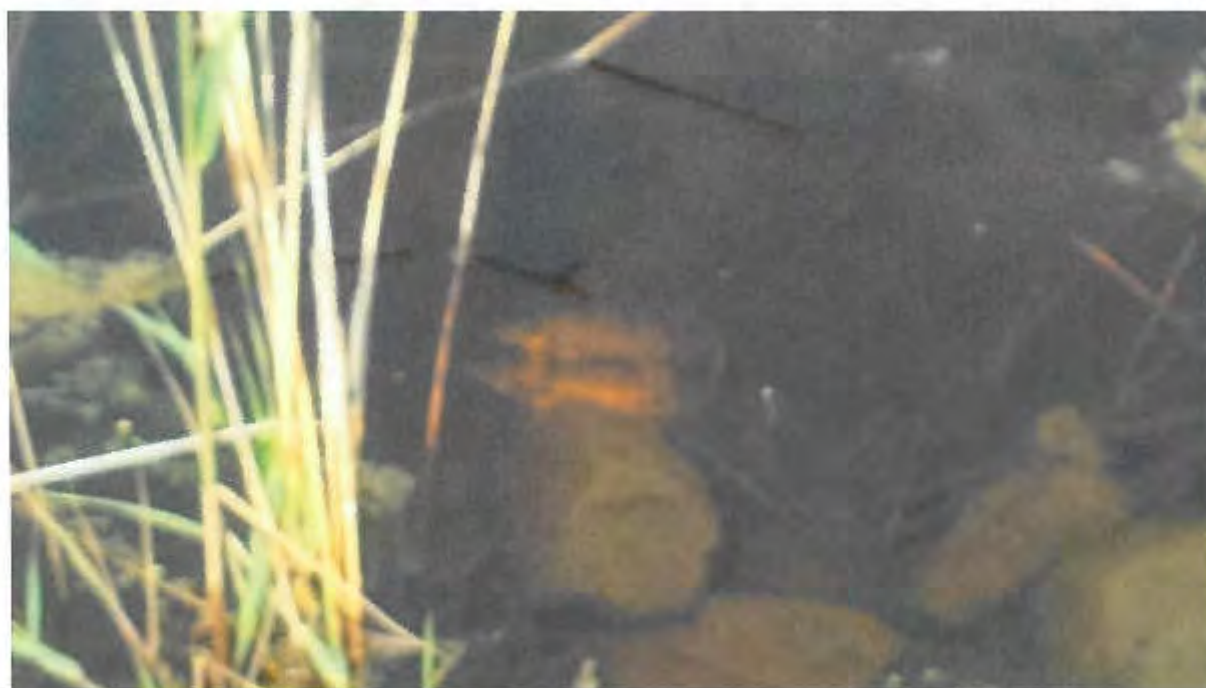
Figure 7. A mating pair of *Emys orbicularis* recorded in the wild, hour 1037 am, at site with coordinates 300366.630 N 4349930.574 E, about 3 meters aside the road construction operations. Photo by Luca Luiselli

17. This habitat type appeared extremely good for turtles, and suitable for their reproductive activities. The highest turtle activity was observed between km 103.200 and 103.900, with two mating pairs observed on 26 April 2016 (Figure 7).

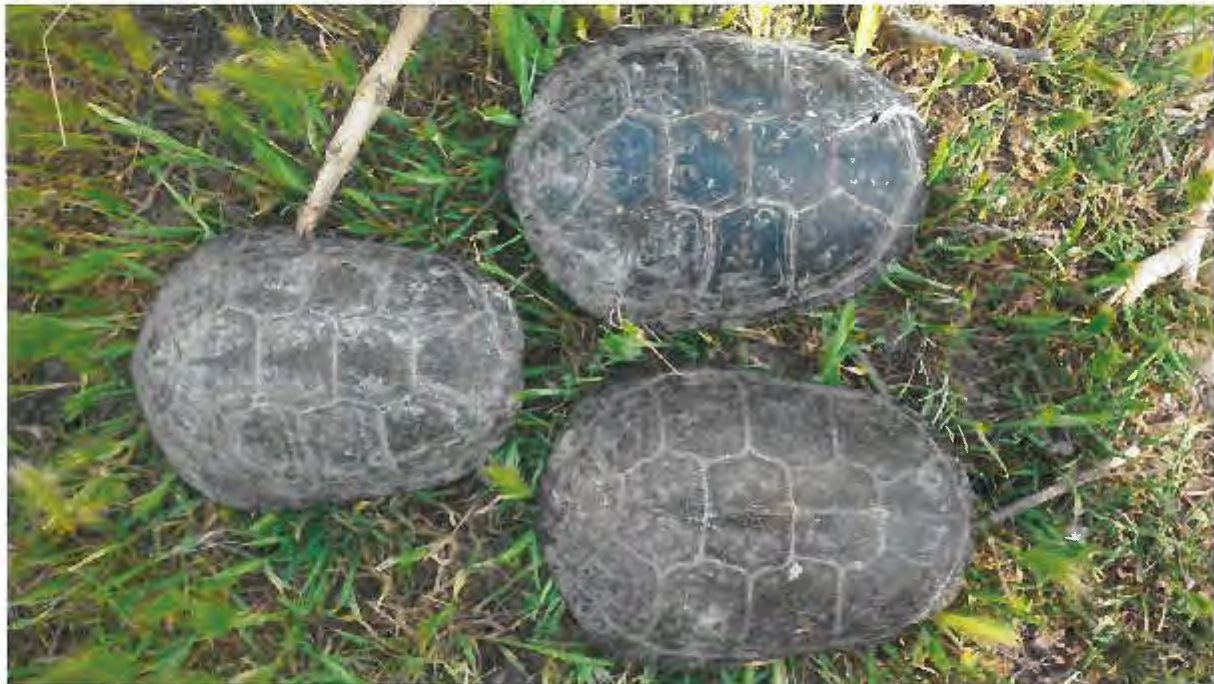
Figure 8. Shells of three dead *Emys orbicularis*, observed in the vicinities of a fishing net at the open water habitat. Photo: Luca Luiselli

18. This habitat also appeared very good for turtles, with some individuals encountered alive during our field transects, and 7 specimens (3 males, 2 females and two broken shells of undetermined sex) were found dead in the vicinities of a fishing trap (Figure 8).

40. Another main threat is represented by fishing nets, that can kill a considerable number of individuals within short time intervals, in the open water habitat. For instance, 7 individuals were found killed at a fishing net station on 28 April 2016, at Mahnudchala (L. Luiselli and A. Taylor original observations).

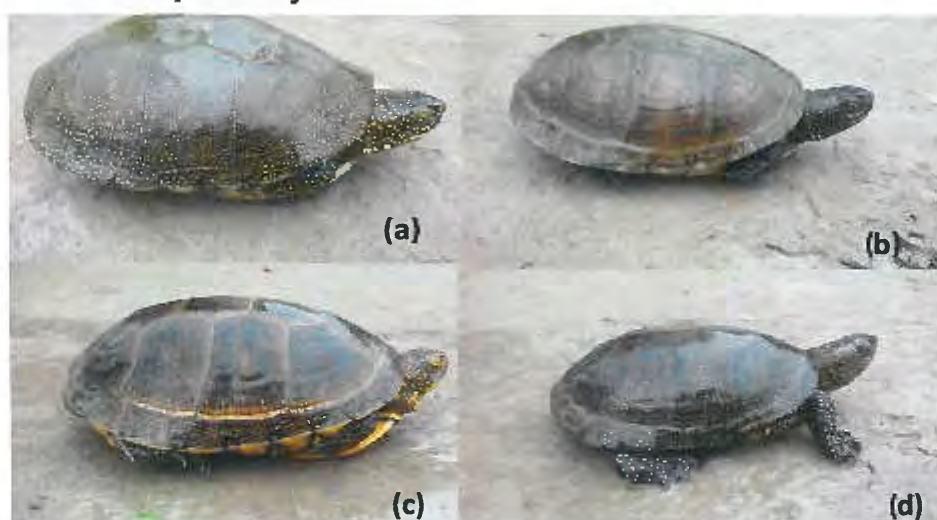
Figure 10. Example of the identification book for the turtles of Akchala wetland. All photos by Luca Luiselli.

33. In addition, the turtle expert has been creating a detailed identification book for all the encountered/captured specimens of *Emys orbicularis* (Figure 10). Each individual is measured, photographed lateral, back and dorsal, in order to create a reference book for eventual management plans in the future. Since the field surveys of the turtle leader are short-time, it would be recommended that such a type of work for identification of turtle specimens in the area could be prolonged also by eventually purposely hired personnel.

34. It should be remarked that each individual turtle is easily identifiable via the patterns of yellow marks on the carapace, either visually or through dedicated image discriminations software that aid this kind of biological analyses on population demography of wild animals.

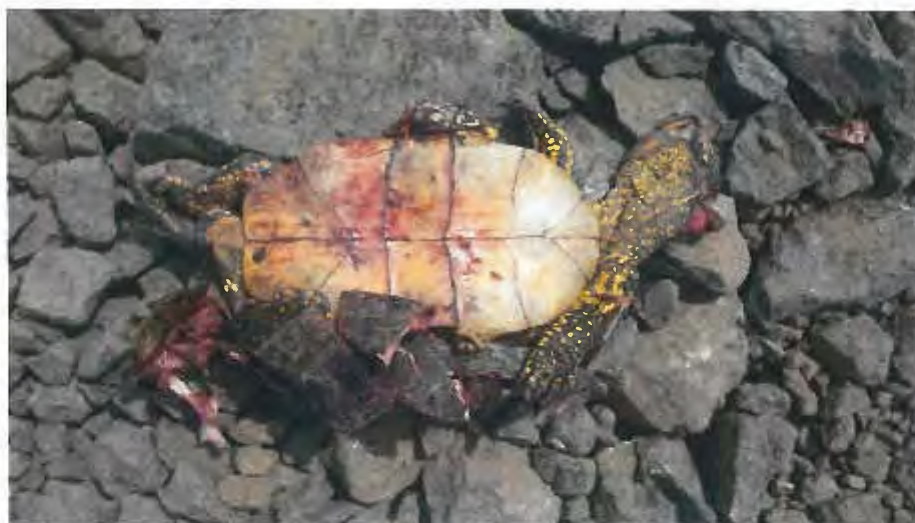
**Figure 11. A female turtle squashed on the road, at the Akchala site.
Photo by Luca Luiselli**

38. Road-killing has been already observed at the site (Figures 11 and 12), and may become a serious issue in the next months if some management activities will not be implemented.

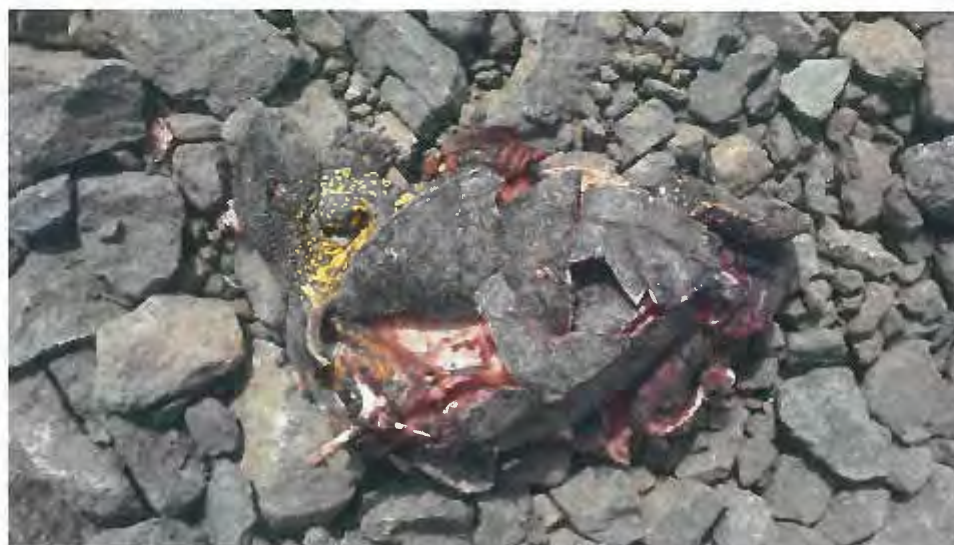
**Figure 12. A female turtle squashed on the road, at the Akchala site.
Photo by Luca Luiselli**

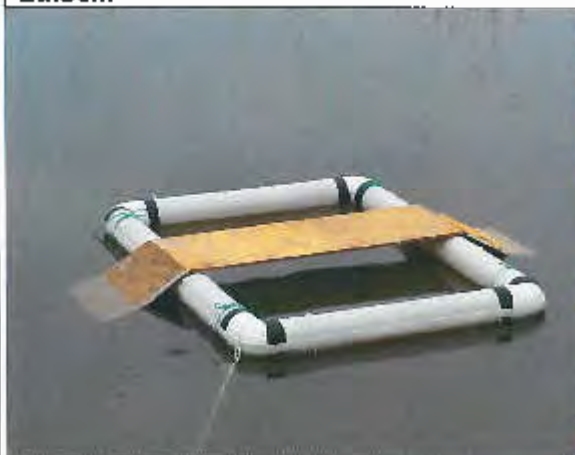
Figure 14. Example of a 'basking trap' that can be used for sampling freshwater turtles. This type of trap has been used with good success in capture rate of *Emys orbicularis* in Italy. Photo by Luca Lulsell

64. A combination of two types of traps for turtles is suggested in this habitat type: basking traps (Figure 14) and baited hoop traps (Figure 15). It is strongly advised to use a combination of the two traps in order to maximize the success of capture for turtles residing in the surroundings of the construction works. Indeed, it should be noted that it is not possible to capture a reasonable number of individuals just by hand, because these animals escape quickly in the water and are also very cryptic, thus being difficult to spot even by experienced turtle hunters.

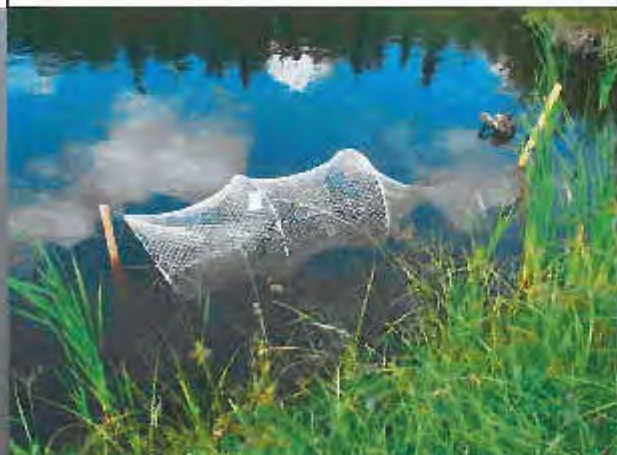
Figure 15. Example of a baited hoop trap, that works very efficiently with carnivorous freshwater turtles such as *Emys orbicularis*. Photo by S. Hecnar
