# Environmental Due Diligence Report

November 2018

## BAN: SASEC Chittagong–Cox’s Bazar Railway Project, Phase 1 – Tranche 2

Construction of Single Line Dual Gauge Railway Track from  
Dohazari to Cox’s Bazar via Ramu, Bangladesh

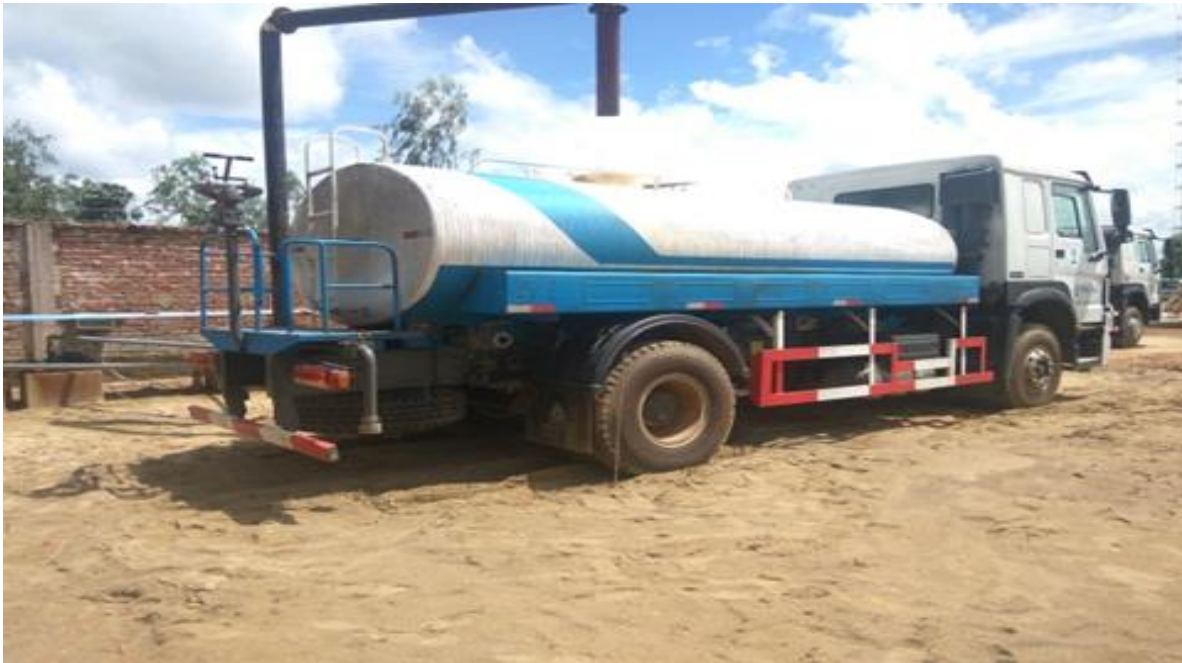
51. In Lot 2 Napitkhali camp was seen to have their own watering truck. A similar truck is expected to be kept at the Ramu Base camp.

**Figure 2: Until recently, the only water sprinkling truck at Napitkhali camp.**

50. Results and Findings: In Lot 1 Dohazari base camp and adjacent bridge site, a watering truck is yet to be deployed. At Dohazari bridge site the muddy conditions are more of a problem than dust at this stage. The site safety person agreed to work on improving the conditions to comply with the EMP. At the Harbang base camp the main facility is still under construction, and at B # 79 camp sprinkling of water is done by a handheld pipe since the camp area is not very

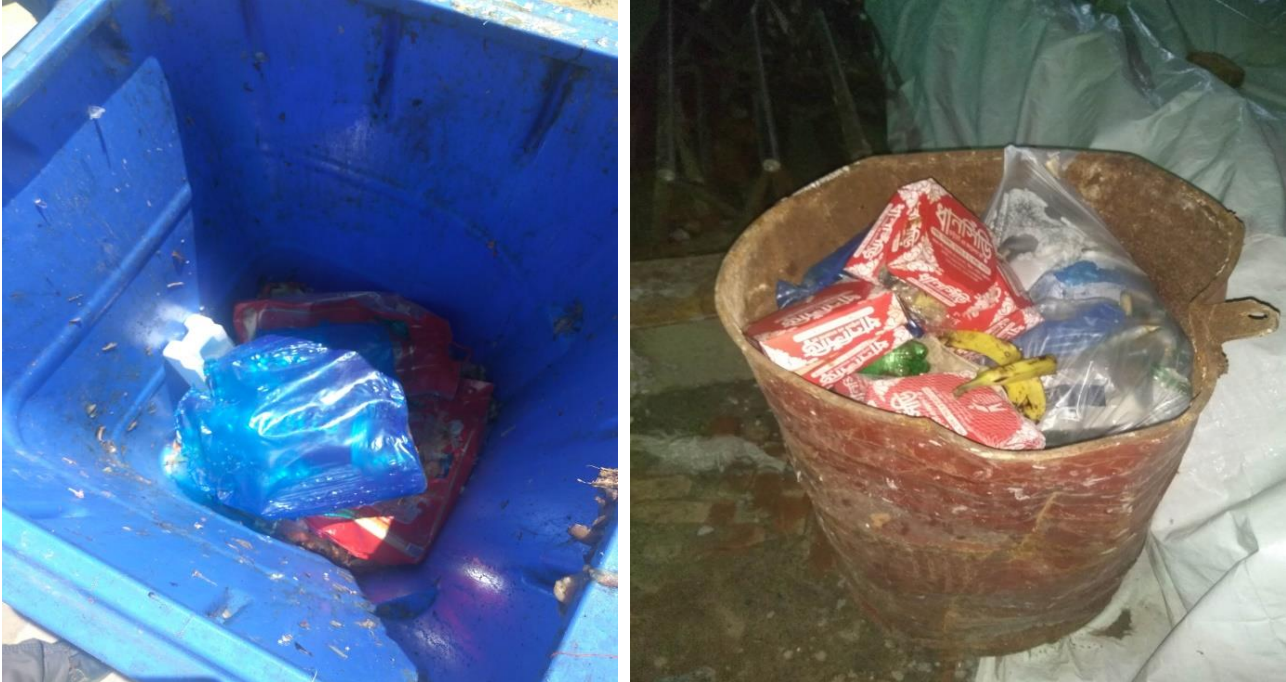
52. In lot 1 inspection of waste bins were conducted at Dohazari base camp and Bridge # 79 camp. Both camps give their waste to municipal waste collectors. But no camp has waste log book to quantify waste so it is advised to the all designated people to maintain a book where everyday waste generation will be logged. The health and safety managers at Dohazari, B # 79, Napitkhali and Max Lab of Lot 2 were advised to segregate the biodegradable and plastic waste - an important waste management practice.

53. Initially, no waste bins were seen at the Harbang campsite. According to the contractor the waste bins will be installed when the facility will be fully operational. The site incharge was instructed to immediately place waste bins and start a waste log book. Within 2 days the site manager complied with the instruction and two bins were placed for plastic and biodegradable wastes.

**Figure 3: Bins at B # 79 camp and Napitkhali camp**

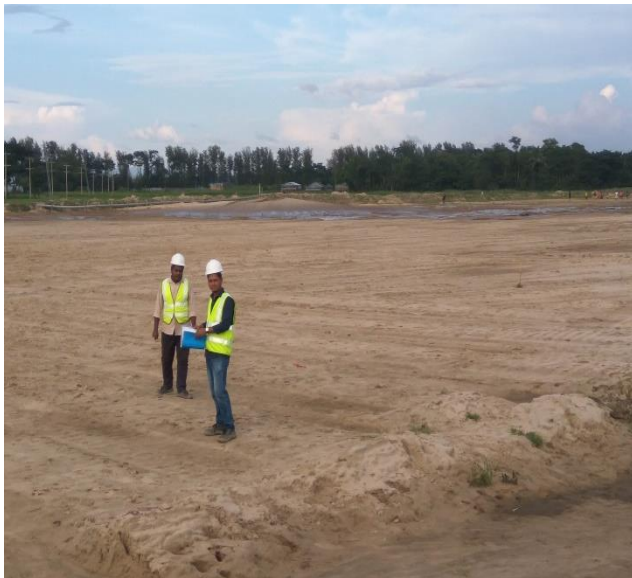
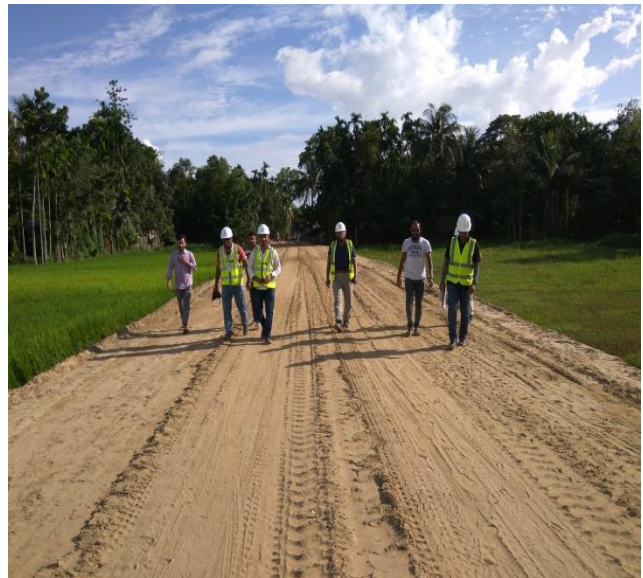
54. Earthwork has not commenced fully but temporary stockpile of topsoil has been observed in Lot 2. Construction of trench to avoid siltation on adjacent agricultural land around the site is on-going. No issues have been observed on this site. Back filling activity has been observed at Cox Bazar station area, no accidental spillage seen on the dredge sand pipeline.

**Figure 4: Sandfilling at Cox Bazar Station yard and Access road for B # 124**

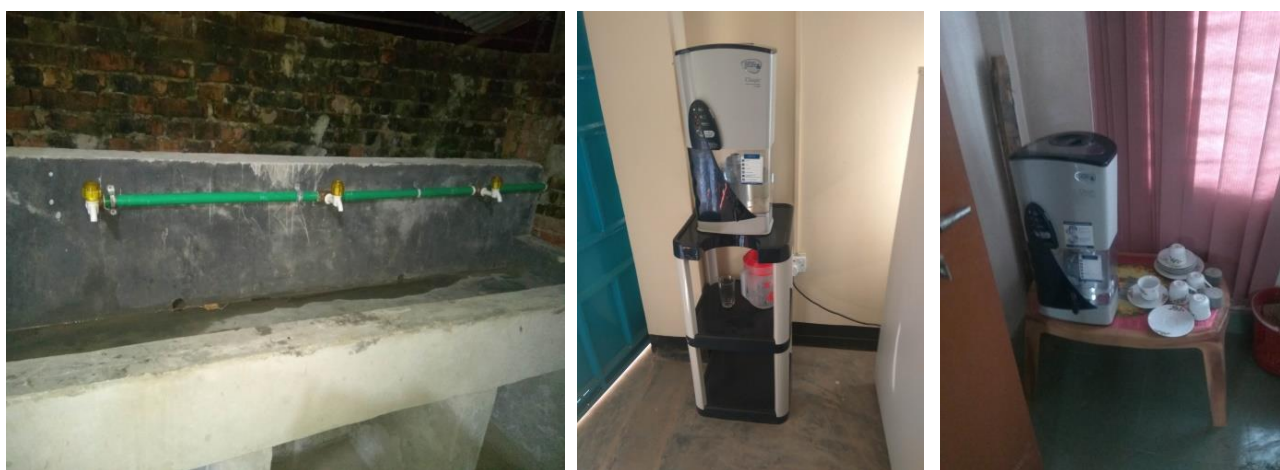
62. In Lot 1, this area needs to be improved though the camp construction is still ongoing at Dohazari and Harbang. In Lot 2 adequate measures has seen (supply of potable water, water filter etc) at Napitkhali camp and Lab, the Ramu base camp is still under construction.

**Figure 5: Drinking water facility at B # 79, Dohazari camp and Max Lab.**

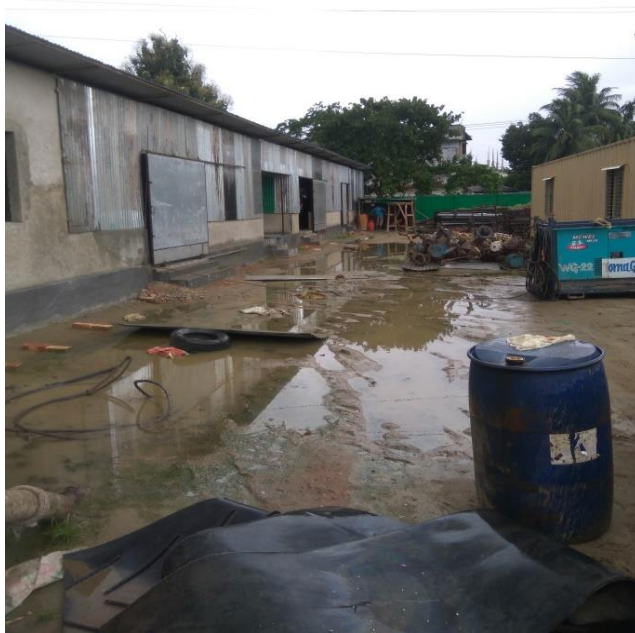
64. In Lot 2 some stagnant water was observed at the camp sites at the drainage facility. The site safety incharge was advised to regularly clear the drain way. All the people live in the camp were given mosquito net and aerosol spray can.

65. In Lot 1 Dohazari base camp, B # 79 camps also reveals stagnant water in drain system, but the drain network is not totally completed till now. At Harbang the drainage structure just started. Inspection finds people who live at camp are given mosquito net and coil. No vertically suspended trye were found at any sites which could be a source of stagnant water and harbor mosquito. Similarly, no empty boxes were found left open.

**Figure 6: Water logging situation at Dohazari Base camp and Napitkhali Base camp.**

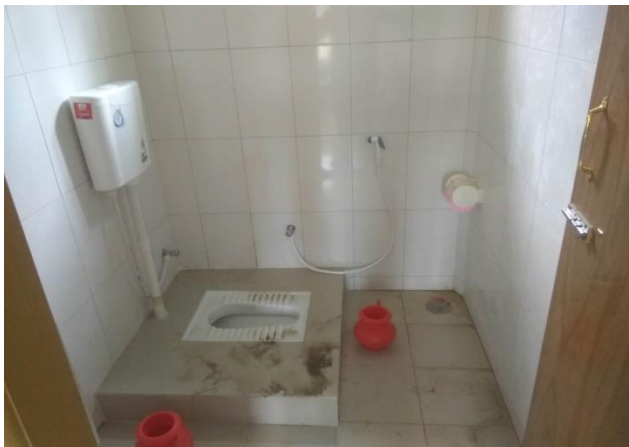
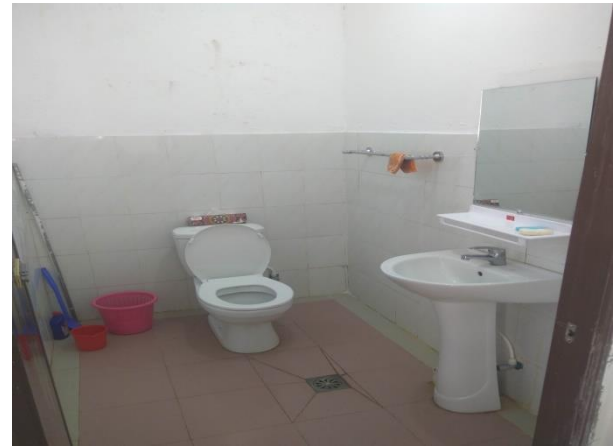
66. In Lot 1 Dohazari Base camp and B # 79 camp has toilet facility but MBEC is instructed to make some change in style in compliance with Bangladeshi custom. The Harbang base camp still has no latrine since their main building is under construction.

67. In Lot 2 Napitkhali camp has good toilet facility also found it in Max Lab in Ramu.

**Figure 7: Dohazari base camp and Napitkhali camp**
