# Addendum to the Environmental Impact Assessment

## SRI: Mahaweli Water Security Investment Program

Tranche 1 and 2  
Upper Elahera Canal Project

Annexes 1 to 4

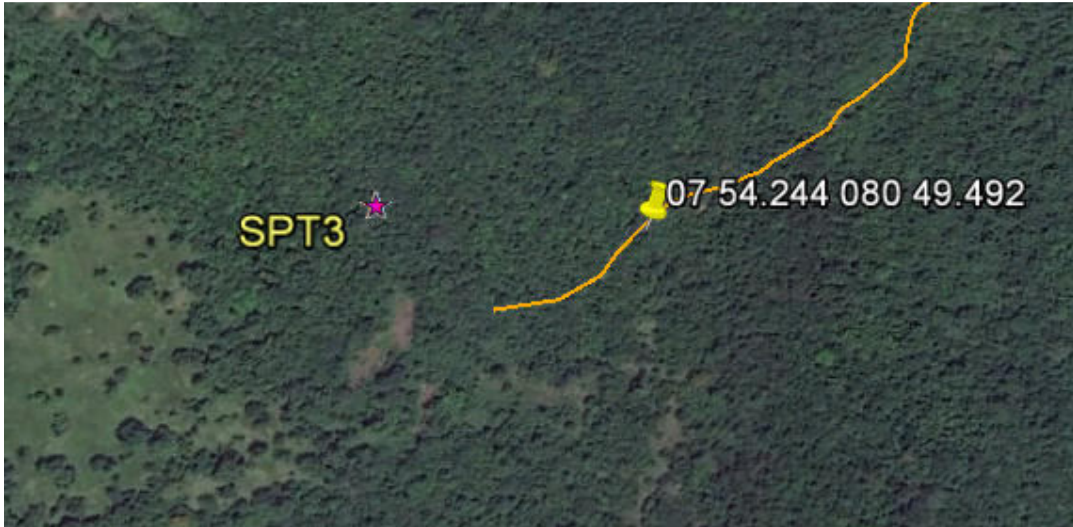
**Last 200 m of the Proposed Access to the Southern Portal of Tunnel 3 (SPT3)**

The latter part of the proposed road traverses through a good forest patch that will require felling a considerable number of trees. If the road can be turned from the point marked in the figure below (GPS N 07° 54.244; E 080° 49.492) and thus traversing a degraded area, mostly scrubland, it is possible to save some trees and wildlife habitat.

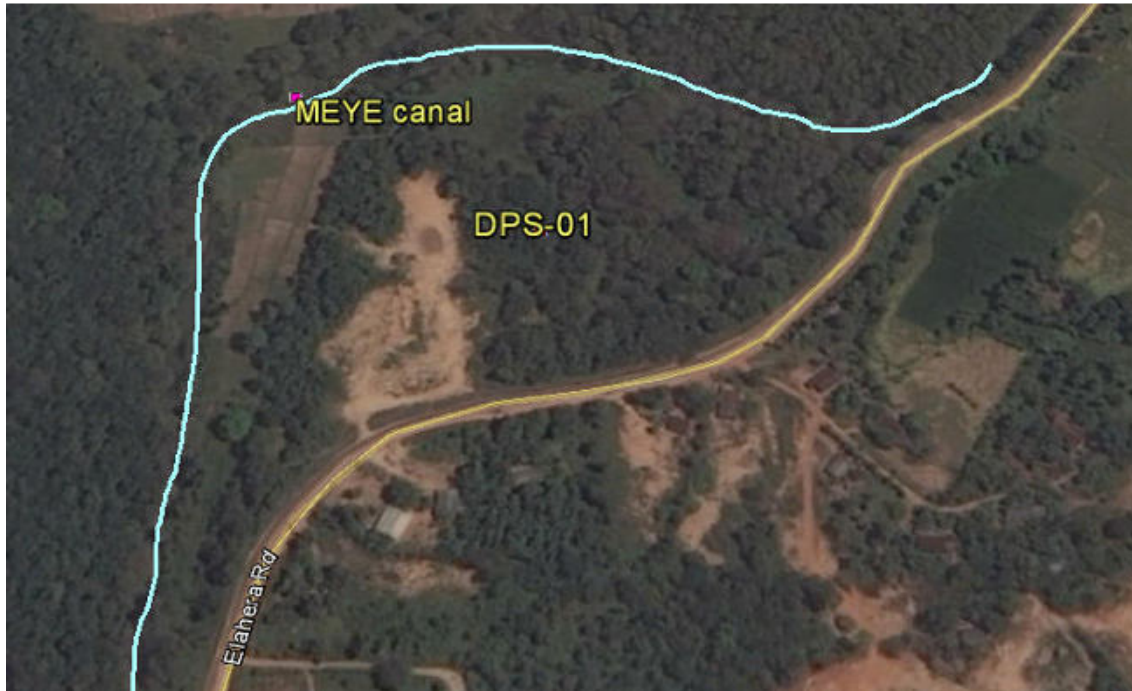
**Proposed Permanent Disposal site and Location for Crushing Plant (DPS1)**

As shown in the figure below, the location is associated with sensitive areas such as a main road, a residential area and MEYE canal, and hence appropriate mitigation measures are required. Updated EMP and conditional approval of EIA by CEA/DWC described general migratory measures. However, the adequacy of the borrow site needs to be verified.

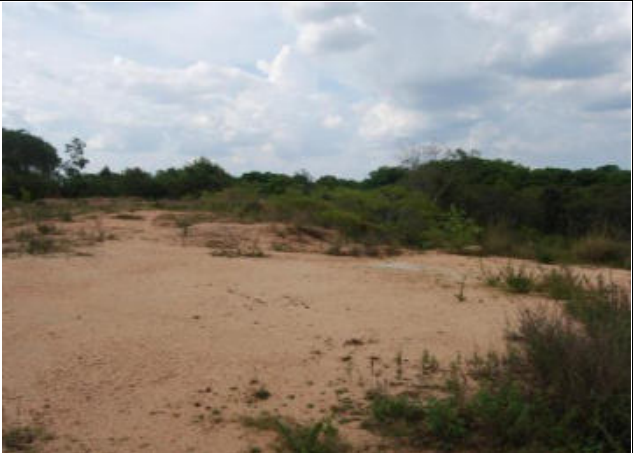
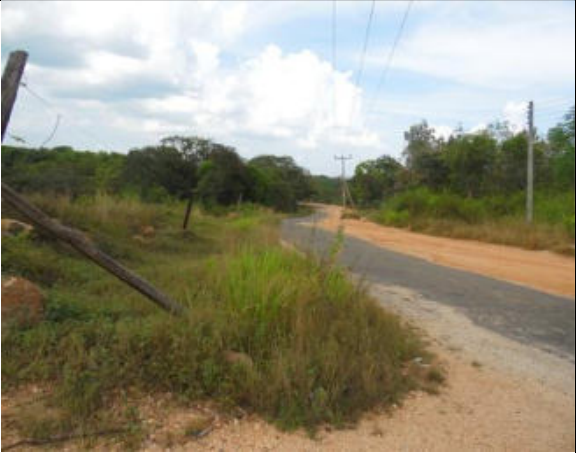
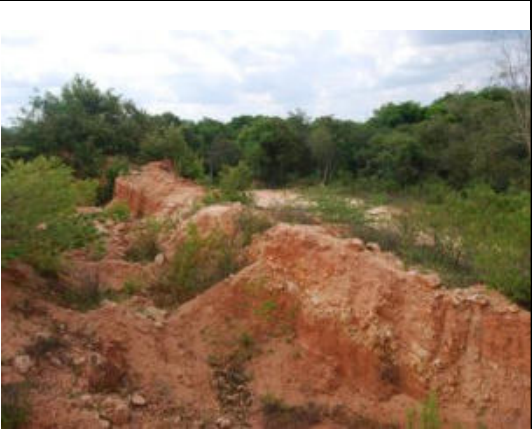
Photo 1	Photo 2	Photo 3

Present land use	Elephant fence and road at the eastern boundary of the site	Old borrow pit

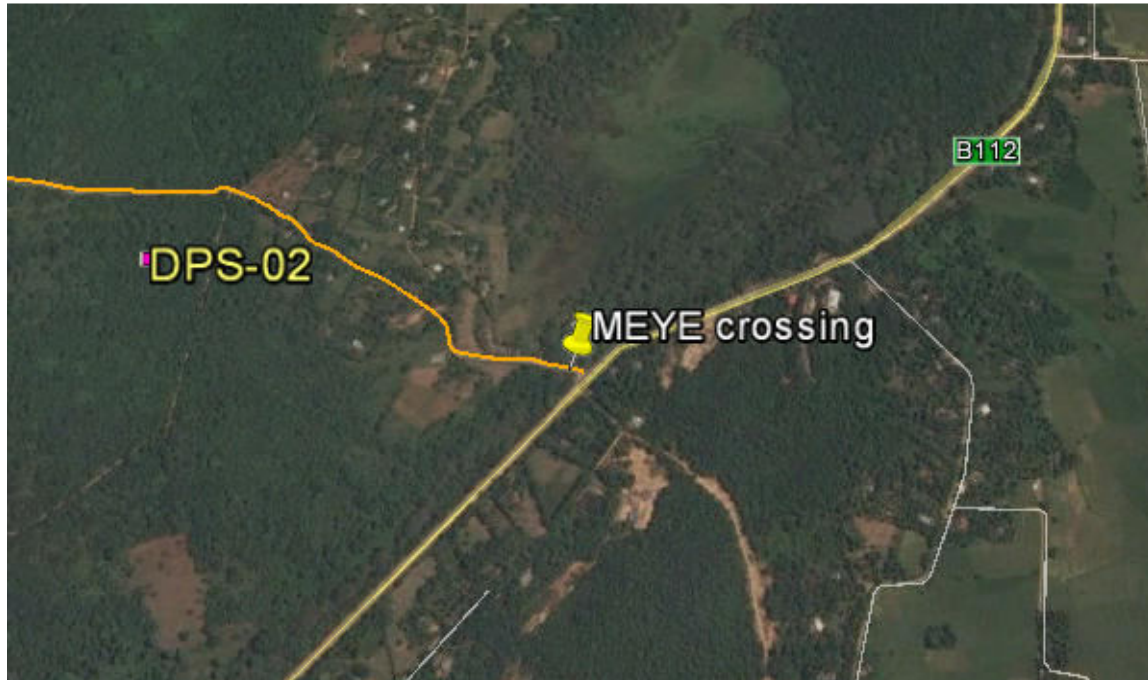
**Proposed Access to the Temporary Disposal Site (DPS2)**

The identified area is in disturbed habitat with scrubland, and it is close to human settlements and cultivated areas. Still the location falls within the Elahera - Girithale sanctuary area within the elephant fence. Hence, mitigatory measures to be followed as per updated EMP and conditional approvals of CEA/DWC, to avoid disturbances to the existing wildlife and surrounding habitats.

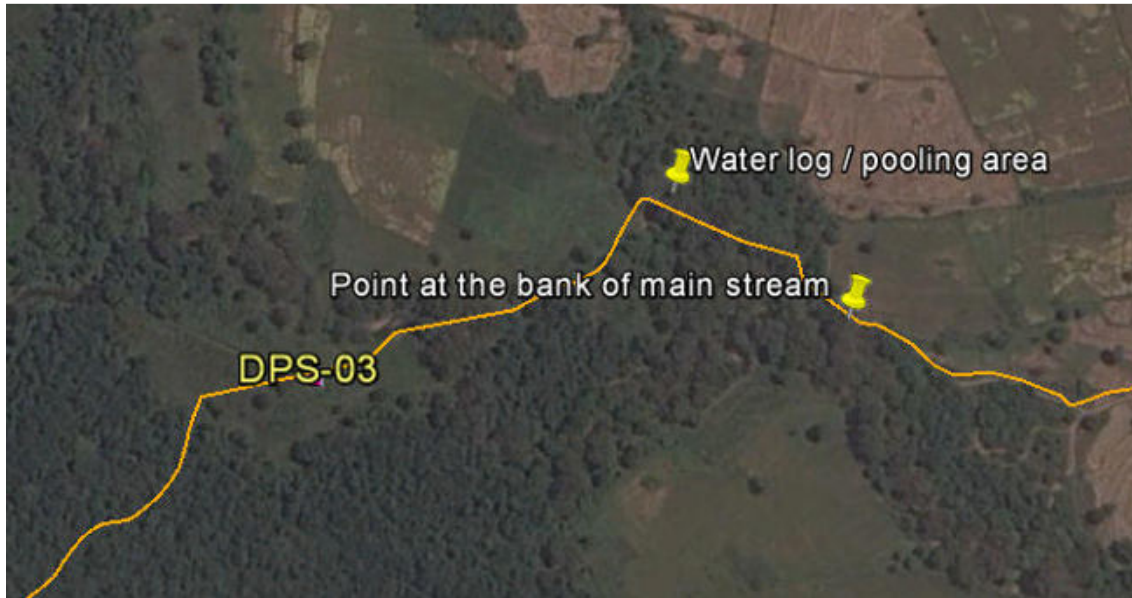
**Proposed Access to the Temporary Disposal and Batching Plant (DPS3)**

The area is associated with a good stream network and the bank of the main stream and water logged area is close to the access to DPS3. Since the batching plant is to be installed here, precautions need to be taken to avoid waste water discharges to the natural stream network. Further, dust and sedimentation impacts could be significant during the construction stage, hence appropriate mitigation actions will need to be taken.

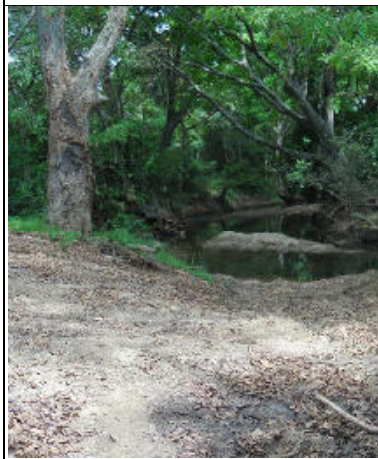
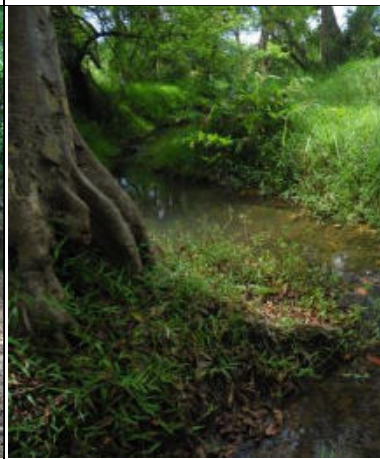
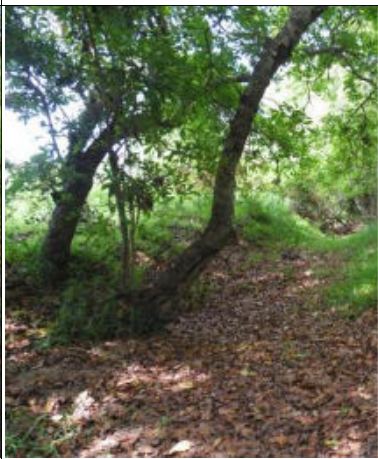
Photo 1	Photo 2	Photo 3

Main Stream crossing along access to DPS 3 and closer to batching plant	Small stream crossing found along access	Water pooling area during rainy season

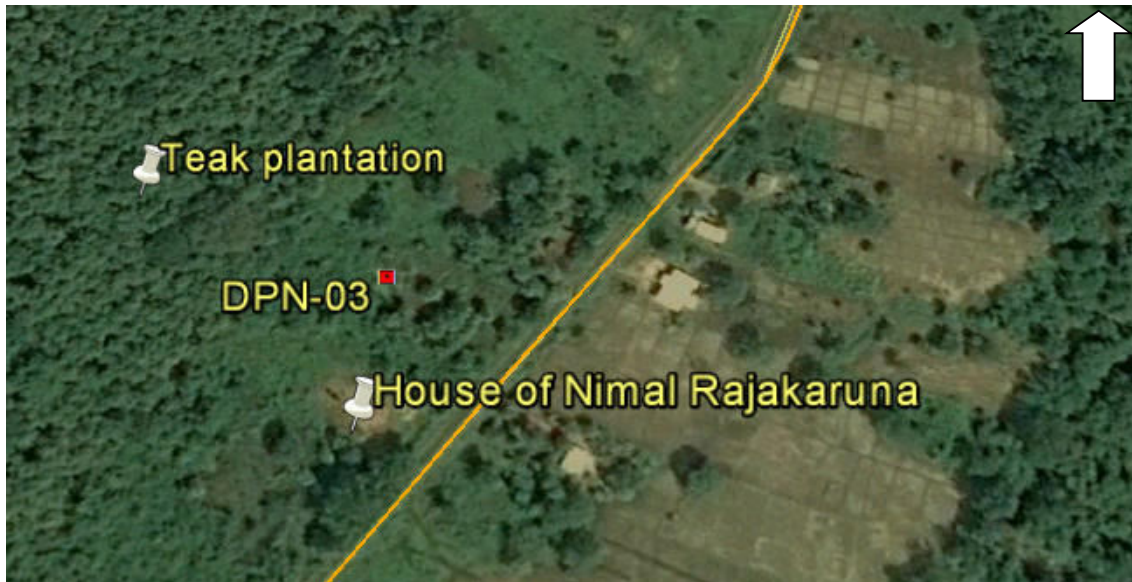
Land Uses in the Proposed Area

As shown in the following diagram, the proposed area is associated with human settlements and a main access road and hence appropriate mitigation measures will need to be followed. The Volume 2 Updated EMP describes general migratory measures. The proposed disposal area is very close to the house of Mr. Nimal Rajakaruna, which might cause disturbances to his daily life.

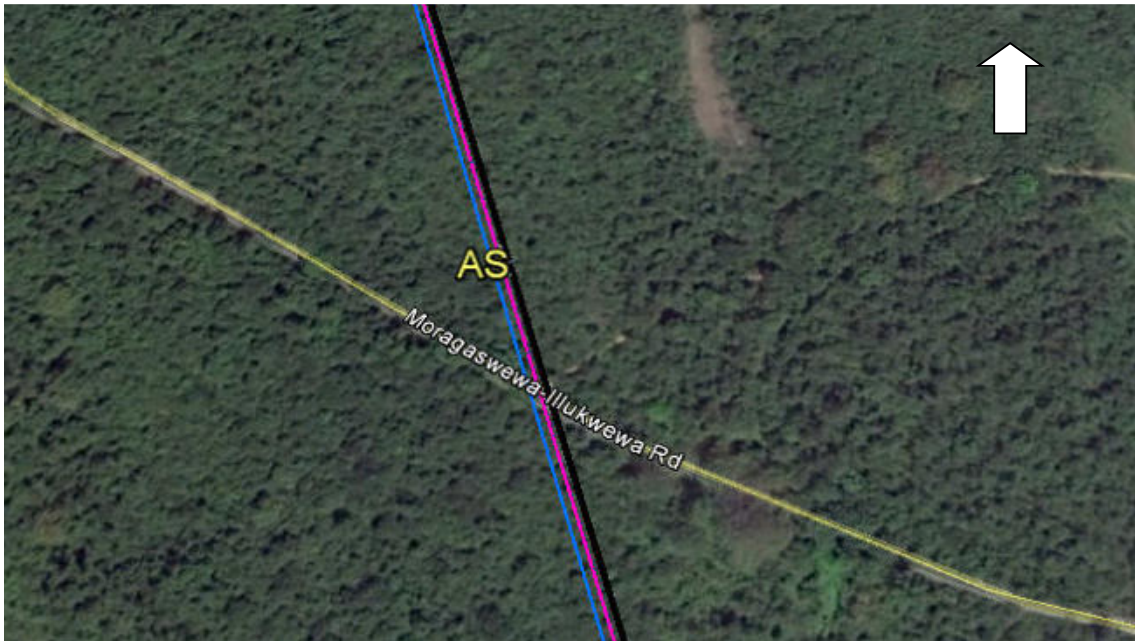
**Proposed Access Shaft (Temporary Ventilation shaft) (AS)**

As shown below, the location is associated with sensitive habitats such as a main road leading to tourist hotels and forest within a protected area. Hence appropriate mitigation measures need to be followed. The Volume 2 Updated EMP and conditional approval to EIA by CEA/ DWC describes general migratory measures.

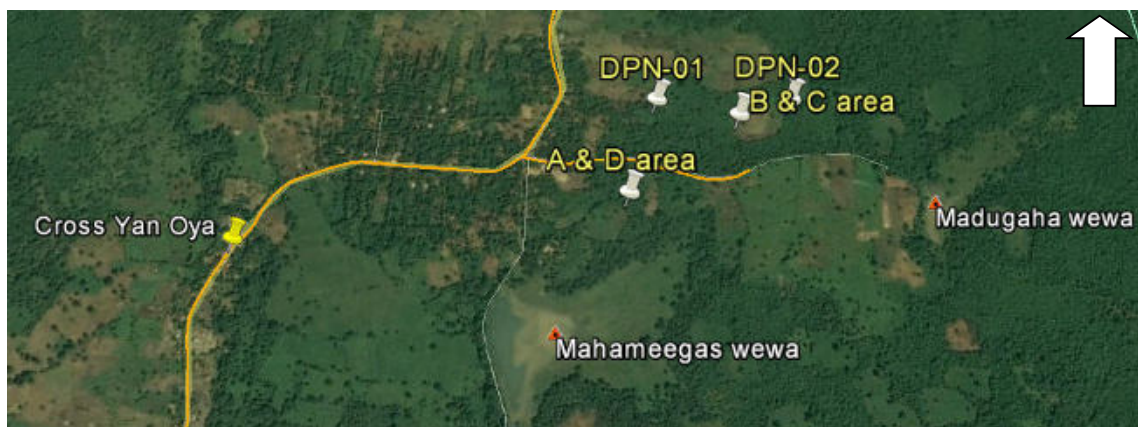
Land Use in the Proposed Area

As shown below, the proposed area, including the access road is close to human settlements, temple etc., and so appropriate mitigation need to be followed. The Volume 2 updated EMP and conditional approval or EIA by CEA/ DWC describe general migratory measures. The proposed location for the facilities is an already disturbed habitat due to clearing lands for seasonal cultivations.

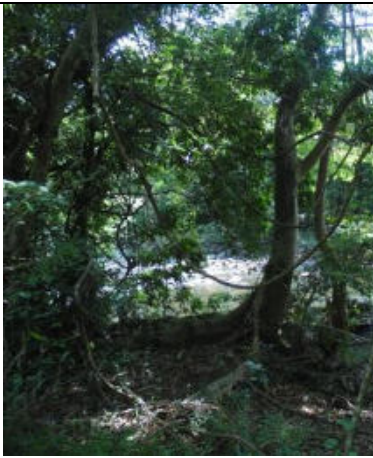
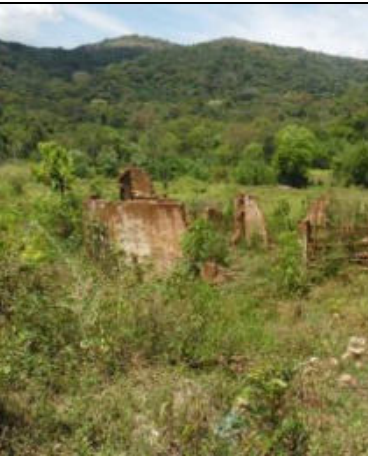
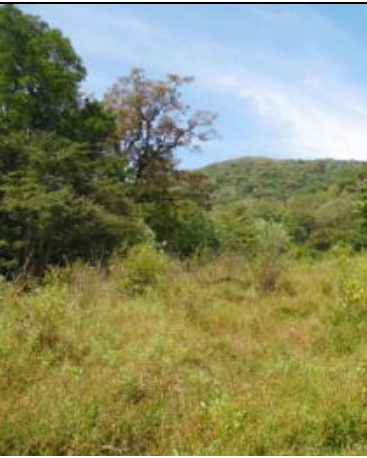
Photo 1	Photo 2	Photo 3

Kambarawa stream located closer to at DP3	Area identified for DP3	
Photo 4	Photo 5	Photo 6

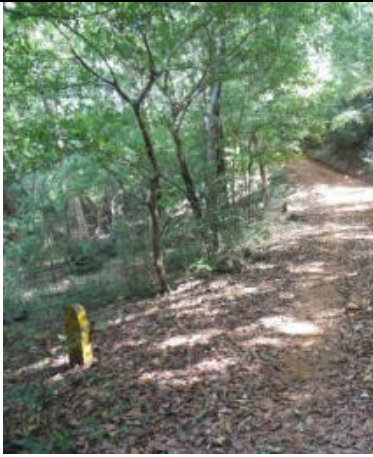
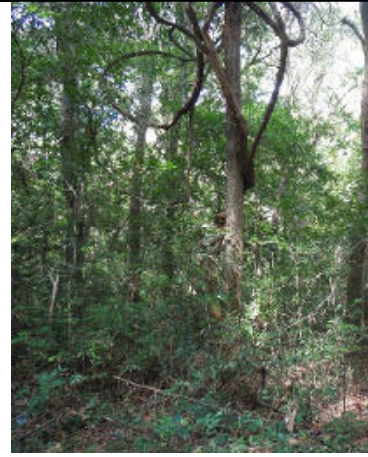
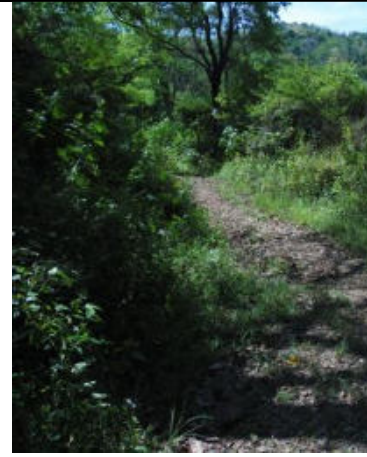
Existing road section "e"	Forest to be cleared for new road section "f"	Existing road section possible to be linked via Kambarawa Oya instead of cutting new road section "f"

2. Road section “e” is an existing jeep track, which need more rehabilitation to allow for the passage of construction vehicles. This area is within the Knuckles buffer zone. There are 4 stream crossings noted along the road section, and the Kambarawa Oya flows by the side of the road. Hence, road rehabilitation work needs adequate mitigation to maintain the stream flows, especially considering peak flow during rainy season.

4. The new road section of about 2 km is traversed through a primary forest patch starting from the end of road section “e” within the Moragahakanda reservoir reservation. The land comes under the jurisdiction of Forest Department and lies within the buffer zone of Knuckles conservation forest. The proposed trace will traverse hilly terrain which might cause erosion towards Kambarawa stream.
