PAKISTAN: New Bong Escape Hydropower Project Environmental and Social Issues Compliance Report (October to December 2012)

Environmental and Social Issues Compliance Report

Quarterly Report

October 01, 2012 – December 31, 2012

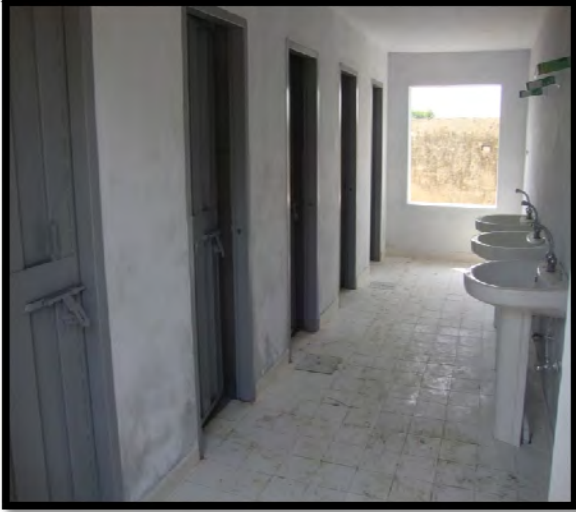
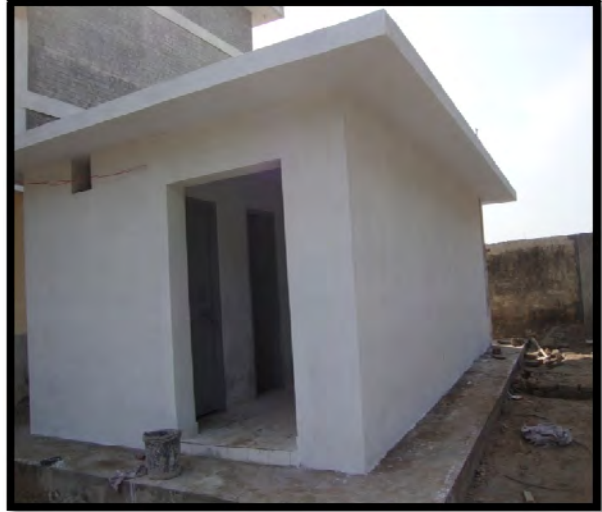
9. As CSR activity 5 washrooms is have been constructed in government girls school Village Lehri, which is basic requirement of the school. Following are the pictures of constructed Toilets.

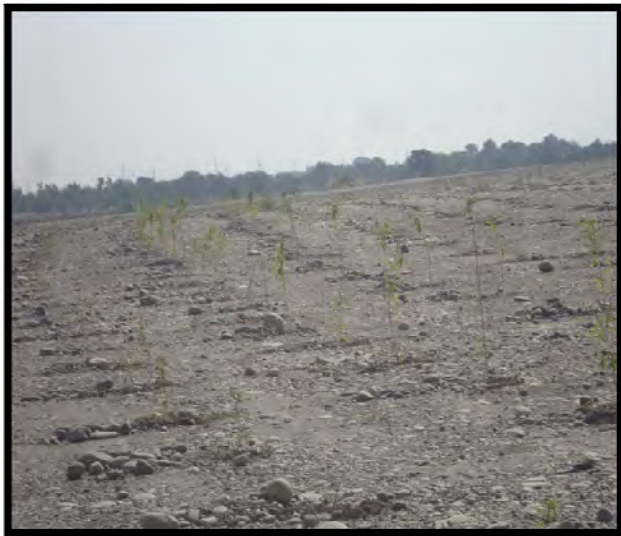
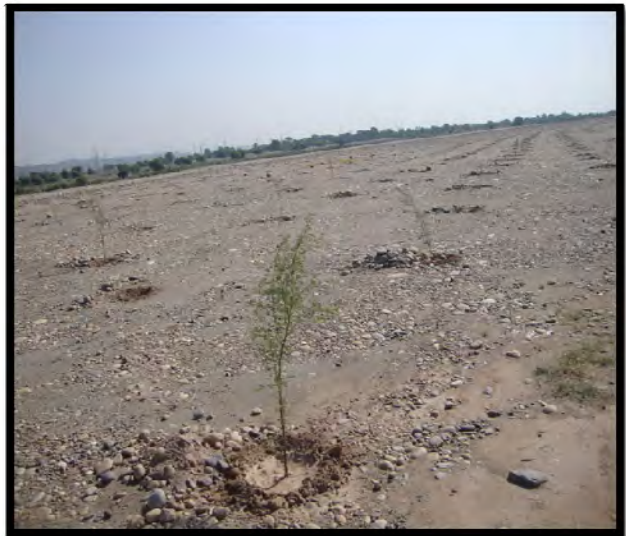
10. As part of obligations under the IEE, Plantation at flood protection dike has been completed. Total 14,000 plants have been planted at flood protection dike. Maintenance of plants is in progress following are the pictures of plantation.

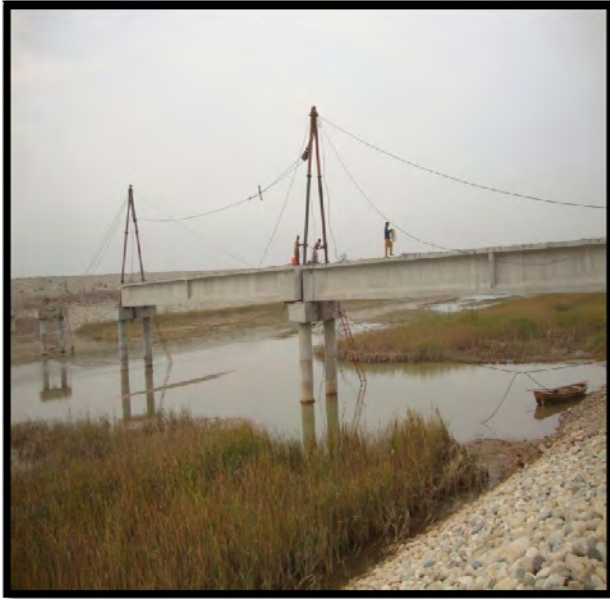
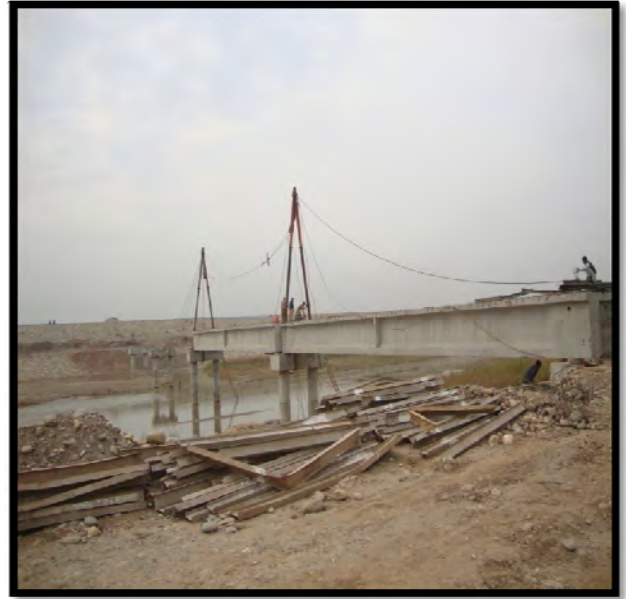
11. As CSR activity, Construction of bridge for community access at the location of RD 4+600 is in progress. As CSR activity, filling of ditches of play ground and graveyard of LEHRI village

has been completed, Approximately 200 dumpers have unloaded there, Picture are below.

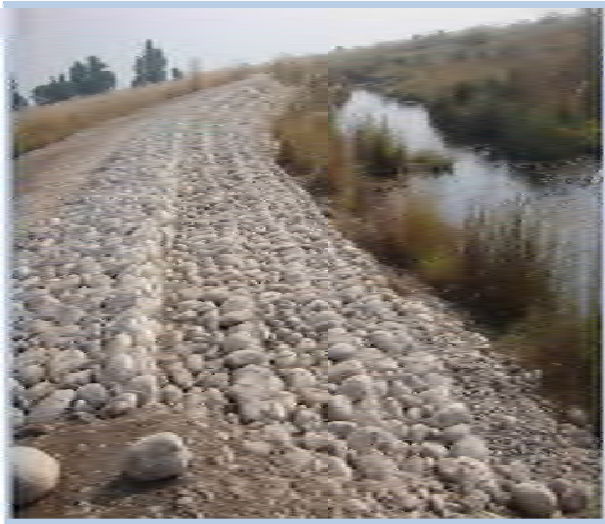
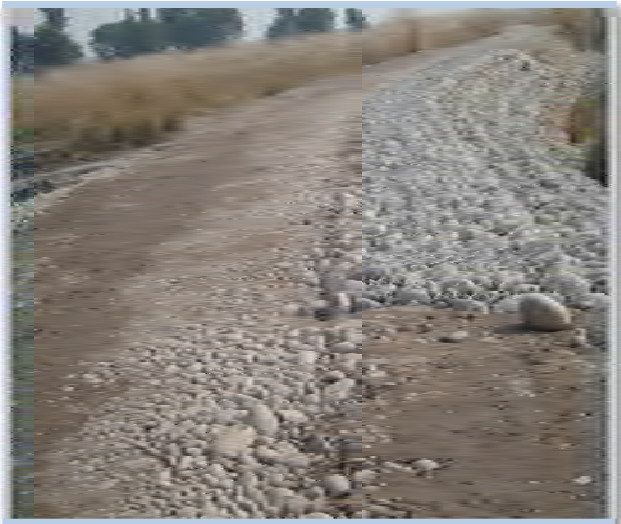
12. As a CSR activity, repairing and gabion placing work of LEHRI village graveyard dyke has been completed.

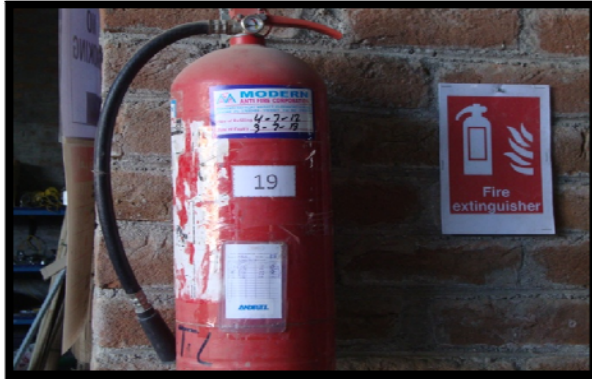
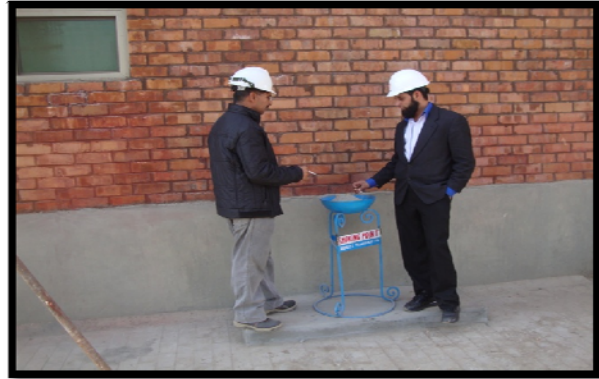
5. Smoking zones are arranged at different locations at project site, Further smoking zones placed at erection bay and inside the office building have been removed and placed outside the building to avoid any fire hazard.

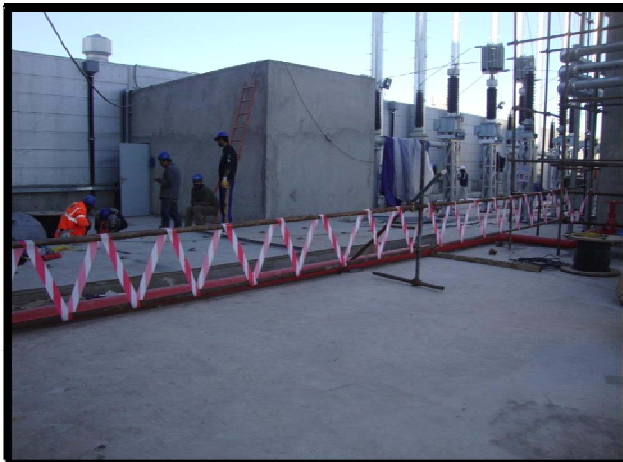
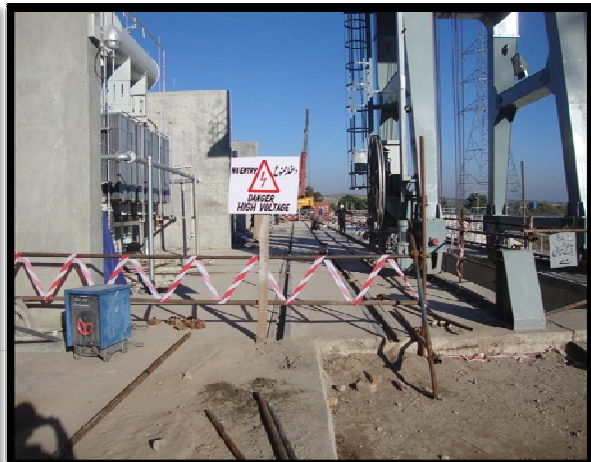
9. Energized areas are properly guarded with hard railing to check the entrance of irrelevant workers or staff in the area to avoid any electric shock hazards. Safety signs have been installed on both sides of entrance inscribed in Urdu and English languages to create awareness among the workers at site. Further the area is fully secured by deploying guards on both sides of transformer deck.

Entrance in the Energized area is prohibited with hard barricades and sign inscribing “high voltage and no entry” are displayed.

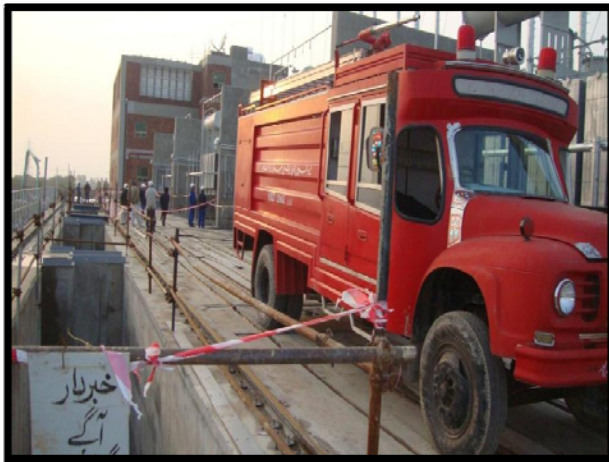
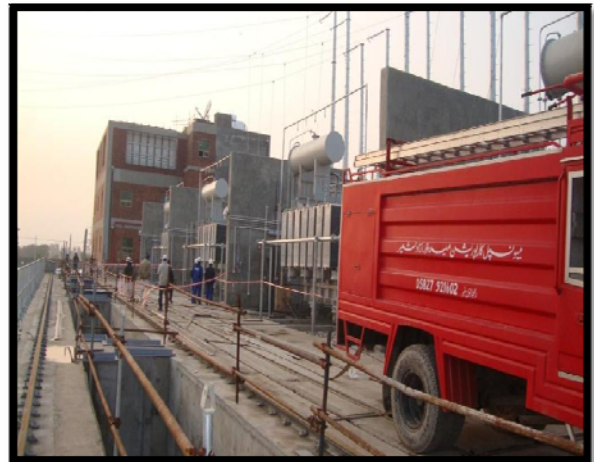
14. To avoid any fire hazard during the testing phase of transformers a fire tender was called at site. Keeping in view the severity of the fire hazard a fully equipped fire tender with well trained fire fighting team was arranged at site during the energizing of step up transformers. Photographs are attached below.

Fire tender ready to face any emergency at transformer deck.

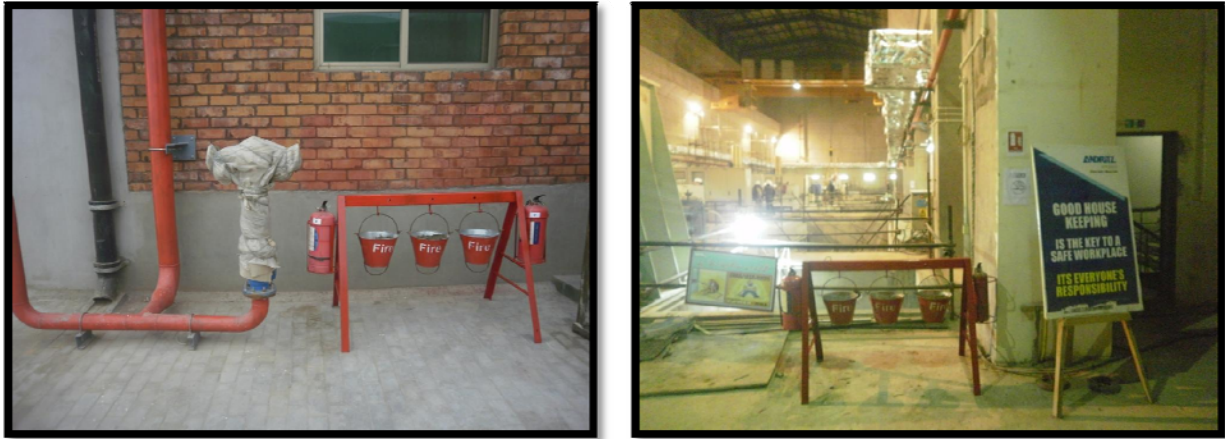
18. A safety update is issued on “Fire Extinguishers and its Use” and is displayed at notice boards and all important locations to create awareness among the workforce. It is attached as “**Exhibit 14**”.
19. Fire stands fully equipped with sand buckets and fire extinguishers have been arranged at site at prominent locations at fire prone locations to face fire emergency. Moreover a firefighting team has been nominated & deputed at site to face fire hazards. Photographs

Photographs shows the Fire stand at different locations

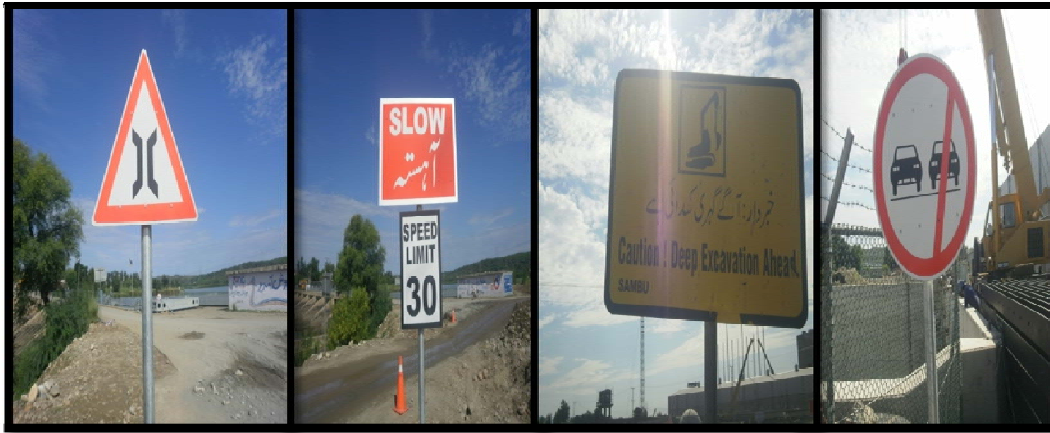
9. Community complaint register (CCR) has been placed on the Project Site along with the placement of sign board. As per MM recommendation, the Contractor has inserted all telephone complaints in CCR to follow up the complaints.
10. All complaints on CCR have been addressed and resolved by the Company through Contractor.
11. Necessary road safety sign boards have been affixed to communicate to the community about the temporary diversion road.

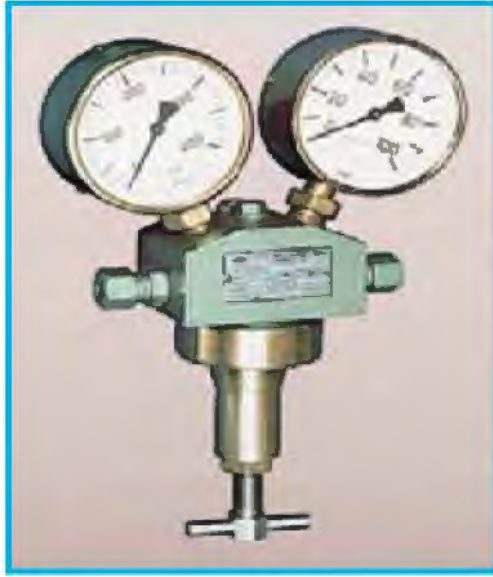
ویلڈنگ ٹارچ اور ٹینک کے درمیان اچھی قسم کا بیک پریشر والو
Pressure Valve (Back) لگا ہونا چاہیے تاکہ بیک فائر
نہ ہو سکے اس والو کو روزانہ چیک کرتے رہنا چاہیے۔

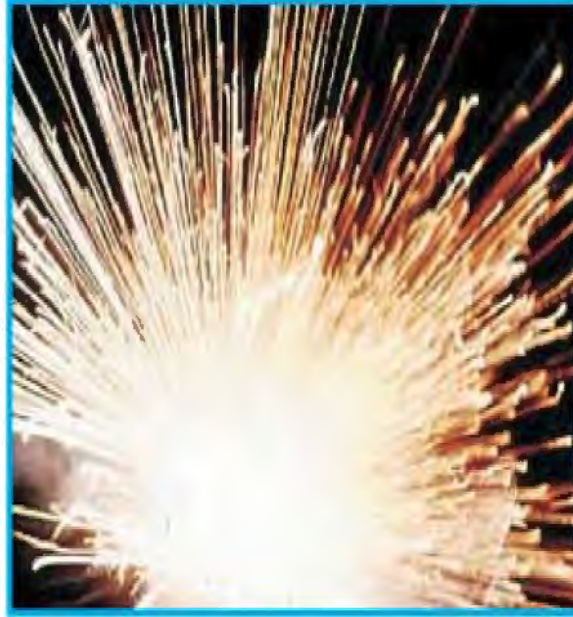
اگر نوزل کسی وجہ سے بند ہو جائے تو دھماکہ ہو سکتا ہے۔ لہذا نوزل کو
کبھی بھی بند نہیں ہونے دینا چاہیے اس کو پگھلی ہوئی دھات یا پینٹ میں
نہیں ڈبونا چاہیے۔

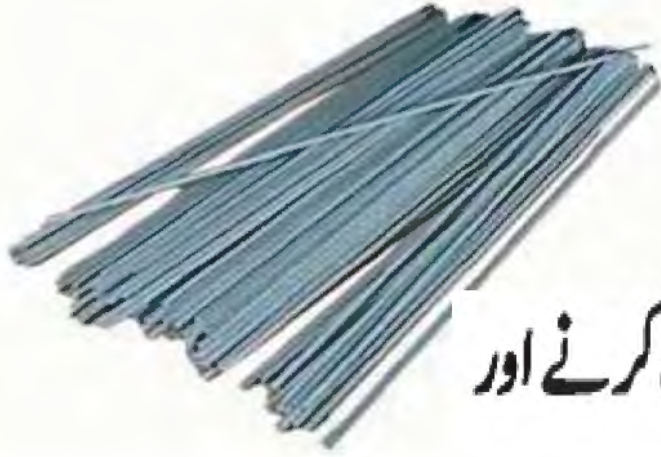
ویلڈنگ راڈ کو جکڑنے والے ہولڈر کو بار بار صاف کرنے اور
کنسنے سے گرم ہونے کا احتمال کم ہو جاتا ہے۔ جب ہولڈر استعمال
نہ ہو رہا ہو تو اسے ایک غیر موصل کیل یا ہک پر لٹکا دینا چاہیے۔

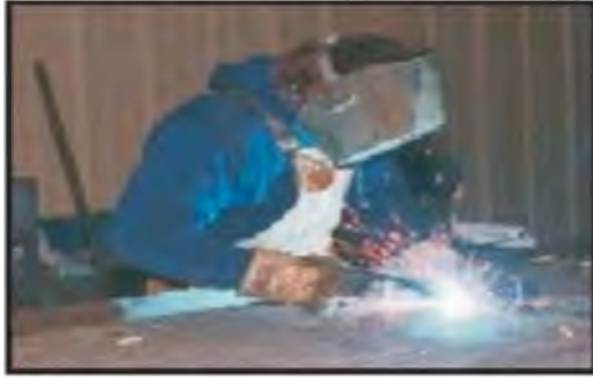
اس عمل کے دوران ایک برقی الیکٹروڈ (ویلڈنگ راڈ) کے ذریعے مطلوبہ دھات کے درمیان برقی شرارہ پیدا کیا جاتا ہے اس

دوران درجہ حرارت 4000 سنی گریڈ تک پہنچ جاتا ہے جس سے دھاتی حصے پگھل کر جڑ جاتے ہیں۔ ویلڈنگ راڈ بھی پگھل کر جوڑ کا حصہ بن جاتا ہے۔ ان کے علاوہ ویلڈنگ کے بہت سے دیگر طریقے ہیں لیکن چونکہ یہ صنعتوں میں عام استعمال نہیں ہیں لہذا ان کا ہم یہاں ذکر نہیں کریں گے۔

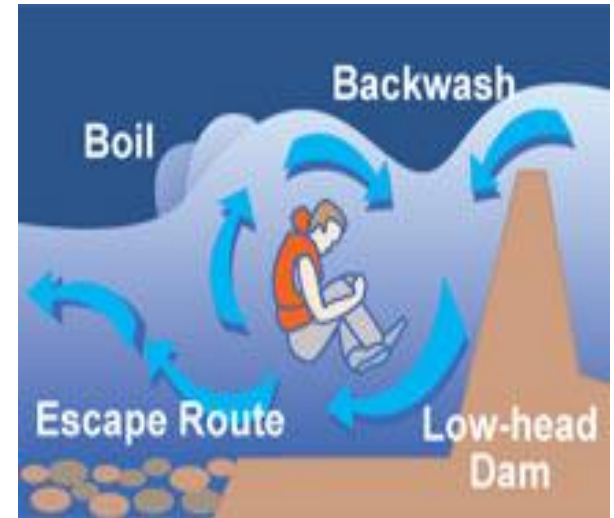
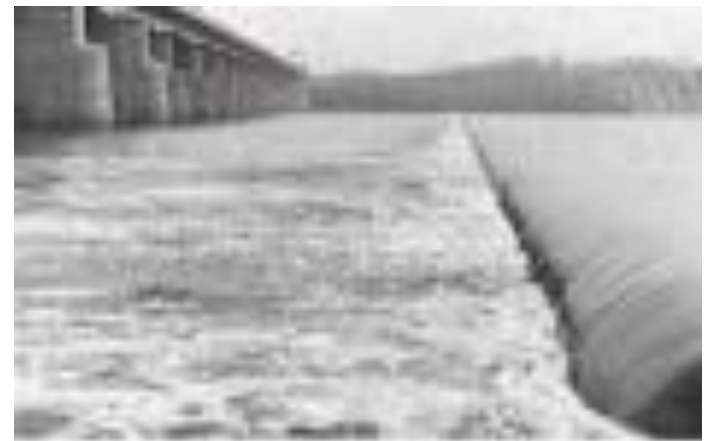
Low Head Dams

- Also known as drowning machines
- Can be both man made and natural
- Have a current that sinks boats and holds objects in a circulating current
- **STAY AWAY, DON'T PLAY**
