## PAKISTAN: New Bong Escape Hydropower Project Environmental and Social Issues Compliance Report (July to September 2012)

# **Environmental and Social Issues Compliance Report**

**July 01, 2012 – September 30, 2012**

**Laraib Energy Limited**

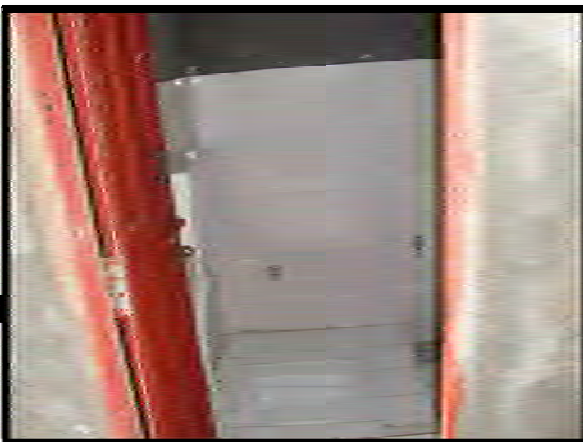
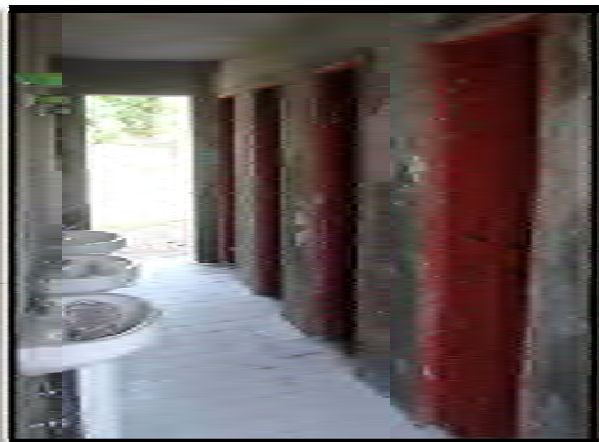
9. As CSR activity 5 washrooms is under construction in government school which is necessary requirement of the school. Following are the pictures of toilet construction progress.

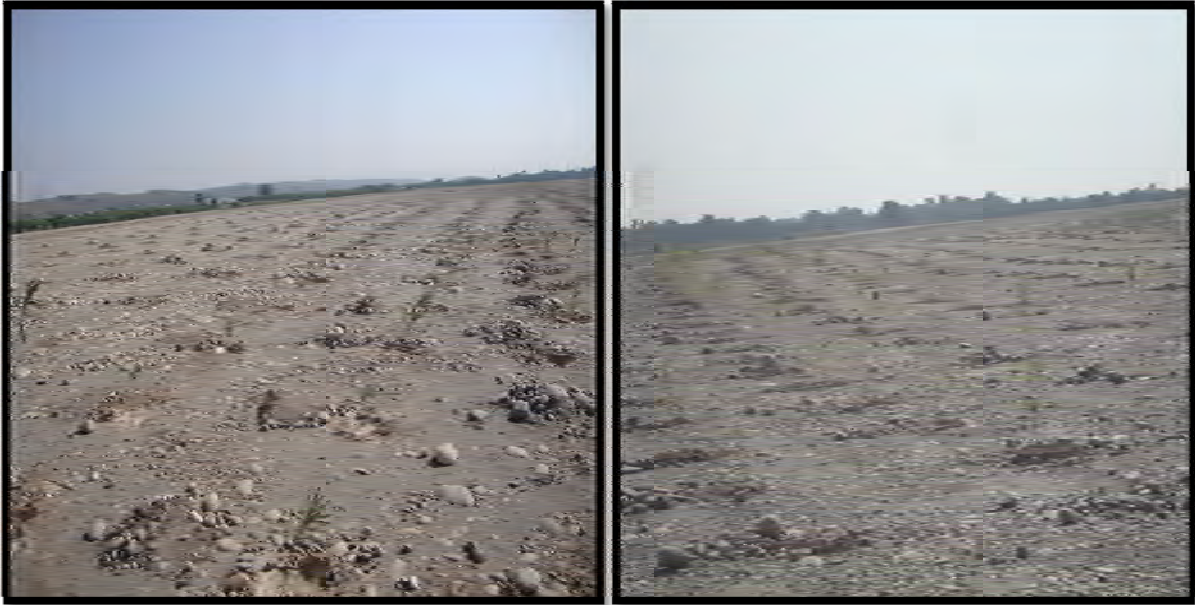
10. As part of obligations under the IEE, Plantation at flood protection dike has been completed. Total 14,000 plants have been planted at flood protection dike. Following are the pictures of plantation.

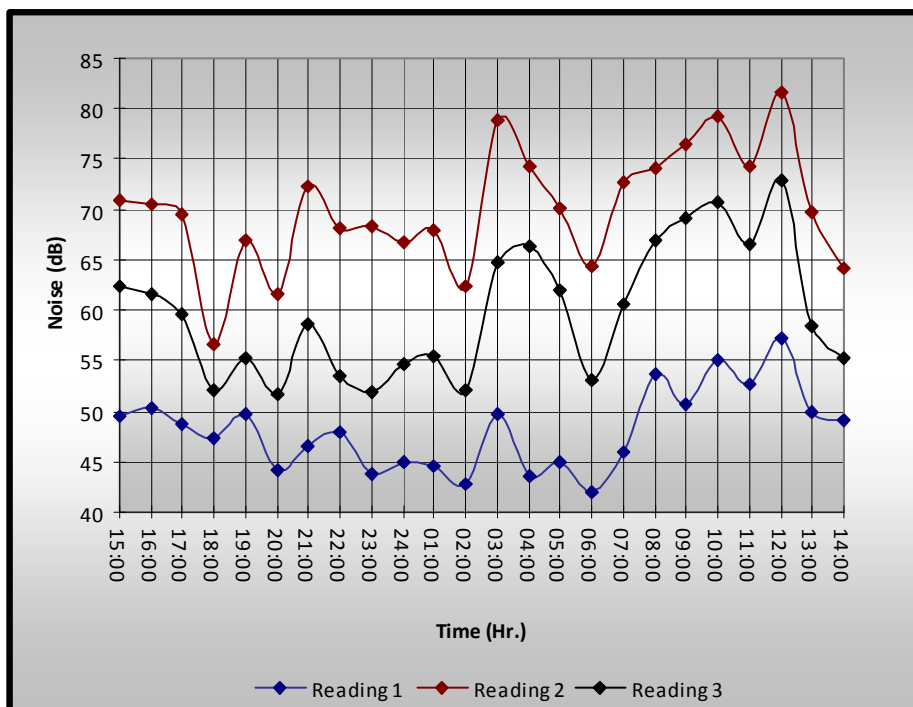
**Graph 2:** Variation of Noise with Time

24 Hours Noise level monitoring was conducted at Ferozabad Village. One hour noise level monitoring was conducted at power house, lehri and chechian village. Results are attached as **Annexure-III** of the report and results are compared with guidelines of IFC. **Graph-2** shows the values (Leq Reading-1, Lmax Reading-2, L90 Reading-3) obtained during noise level monitoring at Ferozabad Village.
