# Environmental and Social Monitoring Report

Project Number: 41924-014

## Nam Ngiep 1 Hydropower Project (Lao People's Democratic Republic)

### Quarterly Monitoring Report 2014 – Q4 Environmental

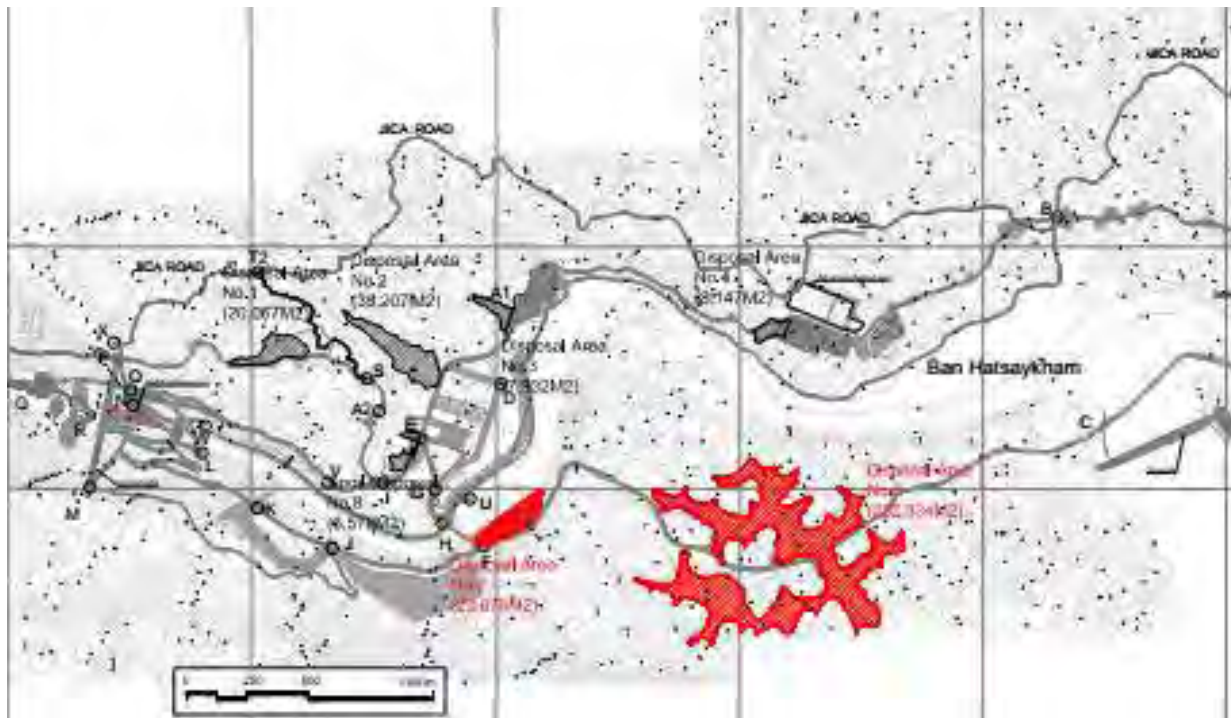
Figure 3 Right bank Spoil Disposal Areas

On the right river bank two Spoil Areas (6 and 7) were being prepared.

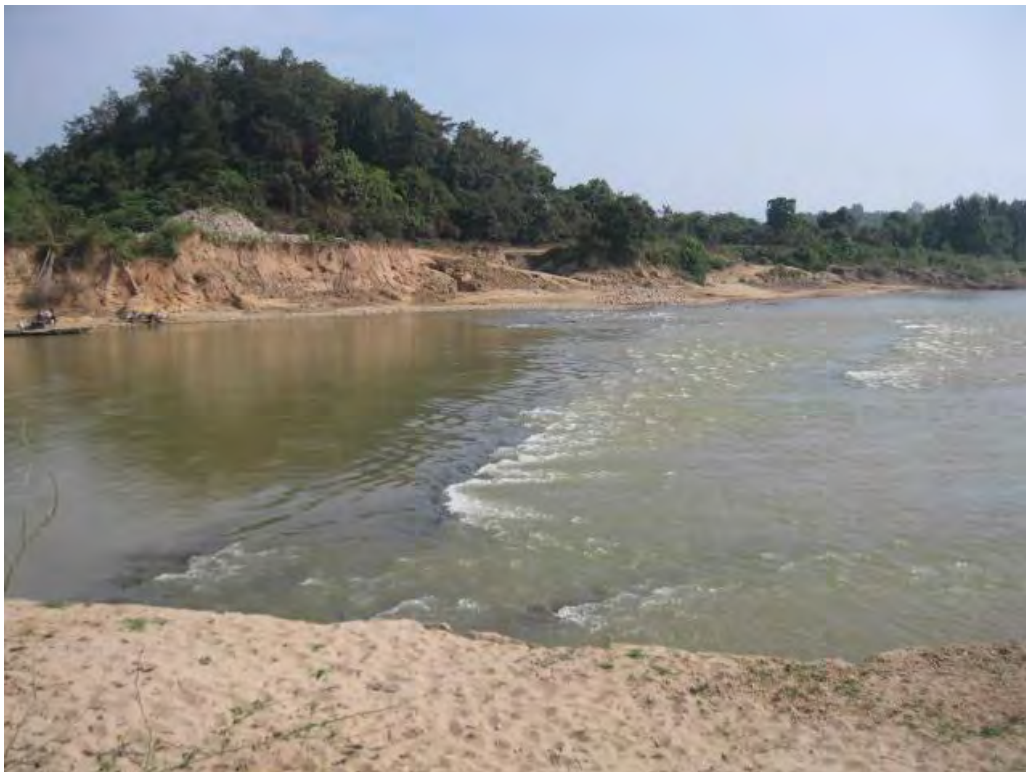
**Photo 1 Series taken of left bank excavations at the regulation dam site**

Vegetation clearing and preliminary earth works (basic site preparation) commenced in February 2014, but was then suspended for the wet season. Work recommenced in October and by December 2014 10% of the excavation was completed, along with 7% of the regulation dam river diversion levee. Work on the regulation dam commences on the left bank with the construction of the river diversion levee, and then excavation into the river bed behind the levee for the construction of the regulation dam power station.

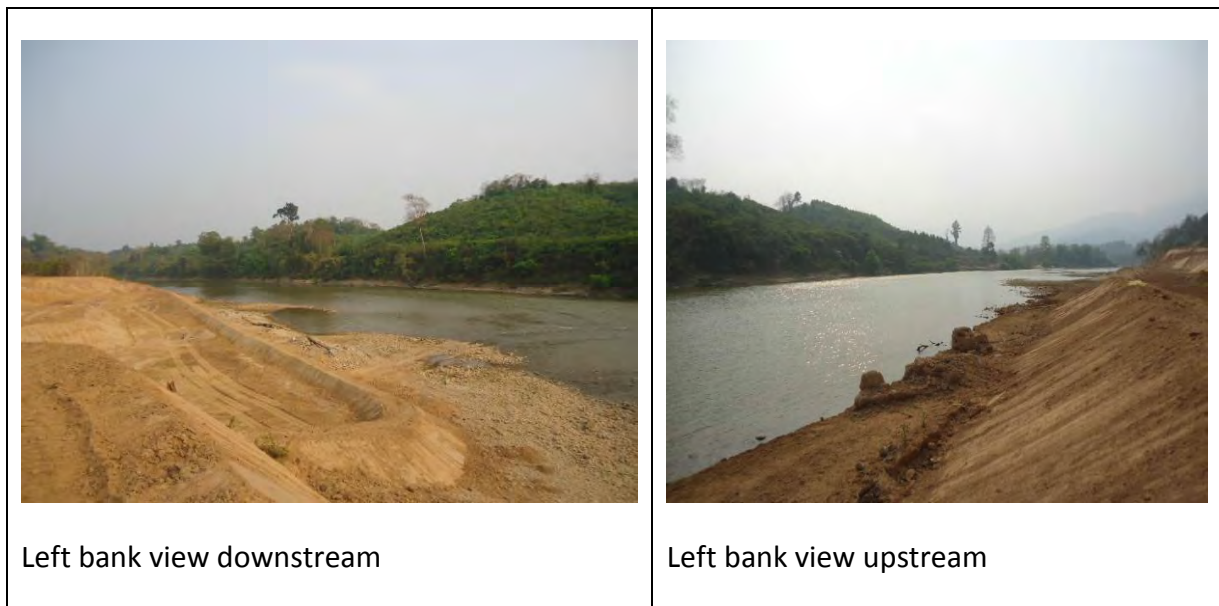
Site conditions of the left bank (background) prior to construction

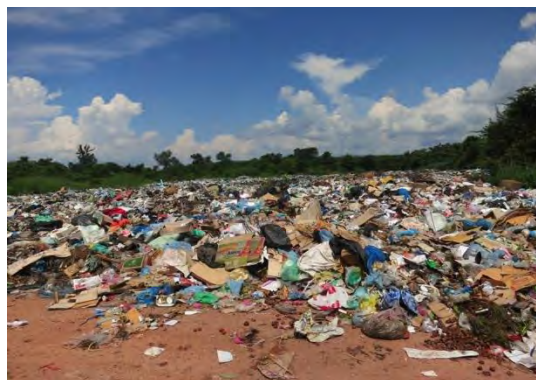
**Photo 2 Paksan Landfill reverse-and-empty operation**

The Paksan Landfill is a 5ha site, 8km south of Paksan Town, and about 70km from NNP1 Project area. An inspection by NNP1 of the landfill on 10<sup>th</sup> September 2014 found it did not meet environmental and social safeguard requirements. There was no overall plan of management for the site. Waste was neither segregated nor buried. The site operated on a reverse-and-empty basis, with waste even being dropped along it’s access road. There were no waste cells, leachate ponds, pits, water supply, drainage, electricity and traffic control. In addition, at the site were 16 casual workers separating recyclables. Working conditions were poor, and personal protection was low. Risks to worker health was high.

On 26 September 2014, the ESD requested formally to the contractor for immediate discontinuation of waste transfer to the Pakxan Landfill facility, and to provide new waste disposal area at site. It was requested that waste from the site be temporarily stored within the construction area until a landfill systems was constructed.

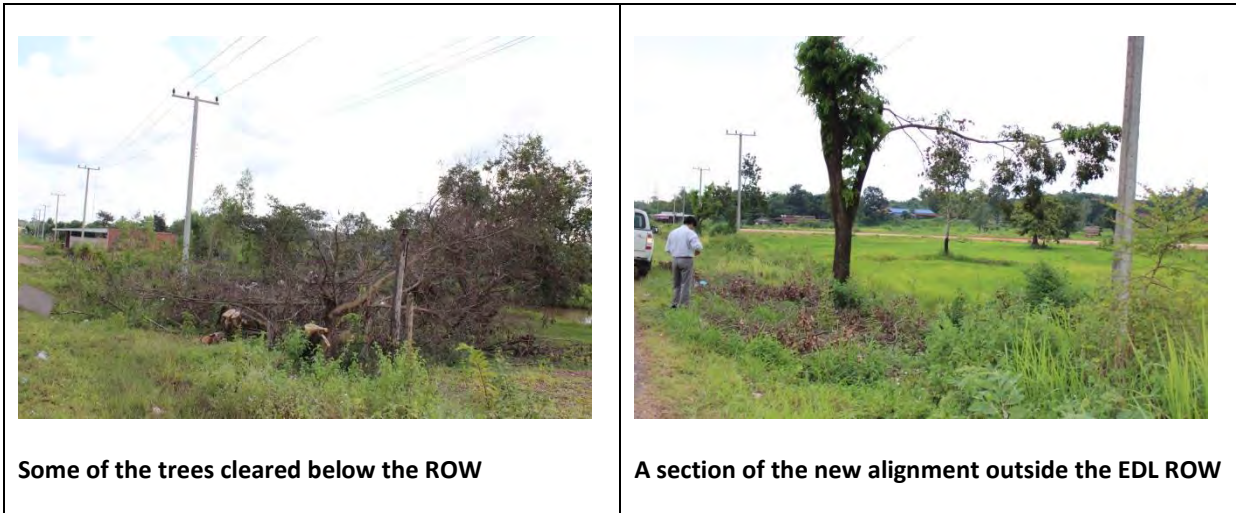
permanent vegetation loss / disturbance required in a new 1.12 km TL ROW required approximately 25 m<sup>2</sup> of land required for pole foundations (25 new poles x 1m<sup>2</sup>), some of which was vegetated prior to pole implementation. Approximately 12 trees were removed during construction, and some minor erosion and dust was created from pole placement.

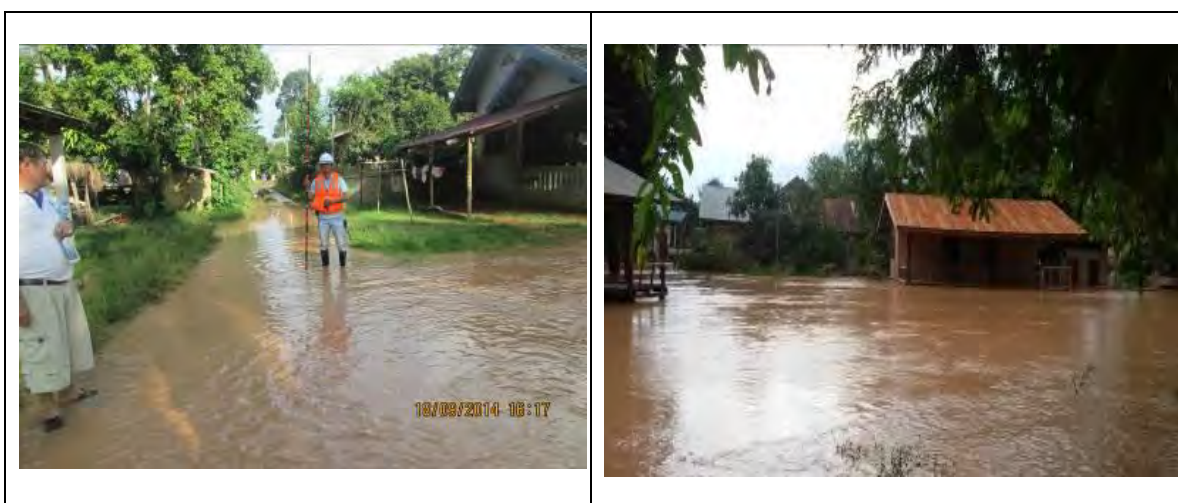
Photo 5 Ban Xomsen 18<sup>th</sup> September 2014

- B. Xomsern: area of flooded is approximate 25% of village residential area and ~10% of land agriculture land.
- B. Thaheua: 36 residential houses and 60% of residential area between 0.5-1.6 m. Village agriculture land is flooded to a depth between 1-3 m,
- The upper reservoir zone flooded including the villages of B. Poua (one house and 10 paddy plots), Hatsarmkhone (six houses and 77 paddy plots),

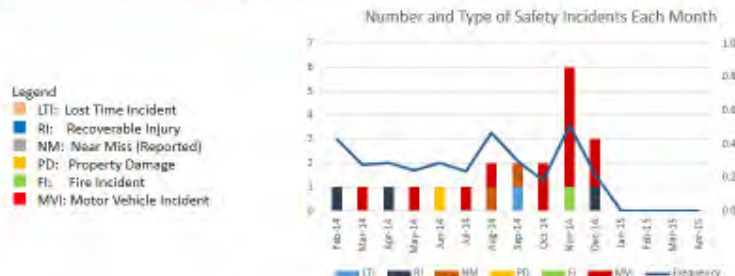
- The histogram shows the number of reportable accidents occurring in each month with the colour indicating the type of accident, incident or near miss.
- The graph shows the frequency of accidents, incidents or near misses with the number occurring each month expressed as a percentage of the number of Civil Works Contract workers employed in each month.
