Project Number: 41924-014

Nam Ngiep 1 Hydropower Project (Lao People's Democratic Republic)

Quarterly Monitoring Report 2015 – Q1 Environmental

**Quarterly Monitoring Report
ENVIRONMENT
January to March 2015**

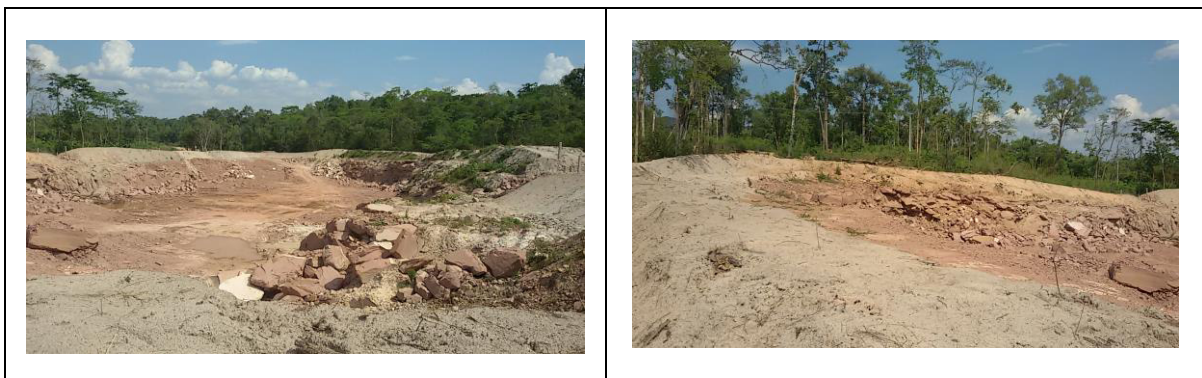
Photo 1 Main Access Road Quarry at STA9+400 – on standby

A quarry was established at 9.4km along the main access road in the vicinity of the Houay Ngua Provincial Protected Area. Clearing involved around 2ha, and the quarry has an expected aggregate and rock extraction capacity of 51,000m³. The quarry serviced the construction of the main access road and as this was completed within the 1st quarter of 2015, the quarry was placed on ‘standby’ for possible later use. Access restriction and site drainage were installed. A Site Closure Plan is being prepared by the contractor. Rehabilitation works will commence once confirmation notice is received that it is to be decommissioned. The quarry is adjacent to the Houay Ngua PPA boundary so when finally decommissioned the quarry rehabilitation will attempt to minimize impacts on the amenity of the PPA.

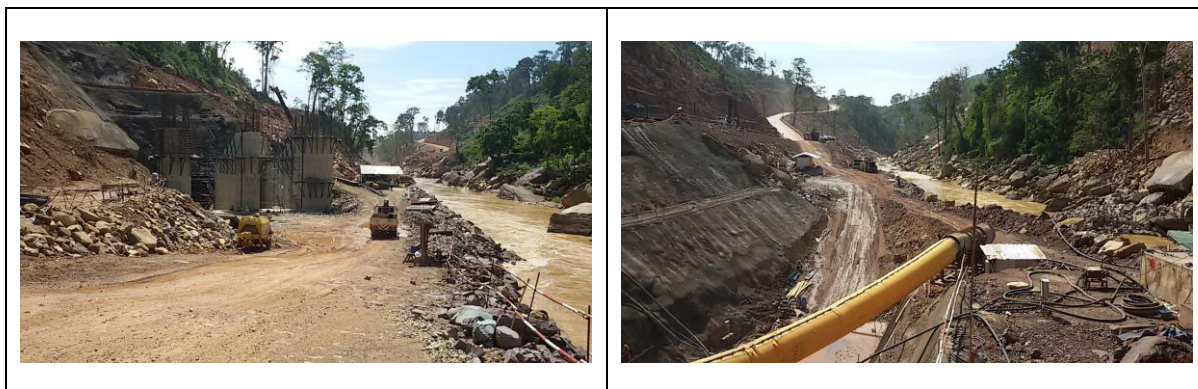
The river diversion tunnel when completed will be 620m long. Tunneling excavation is being undertaken from the downstream outlet end, and was 34.5% completed by the close of March 2015. Head works were also advanced at the upstream inlet.

Photo 3 Diversion Tunnel Inlet head works (left photo looking downstream) and Outlet excavations (looking downstream), April 2015

Note: in Photo 3 the Nam Ngiep River is to the right of shot. The photos were taken at about the same time. Importantly, the Inlet head works is the most upstream extent of NNP1 excavations and work areas. River water was naturally turbid before reaching the project site.

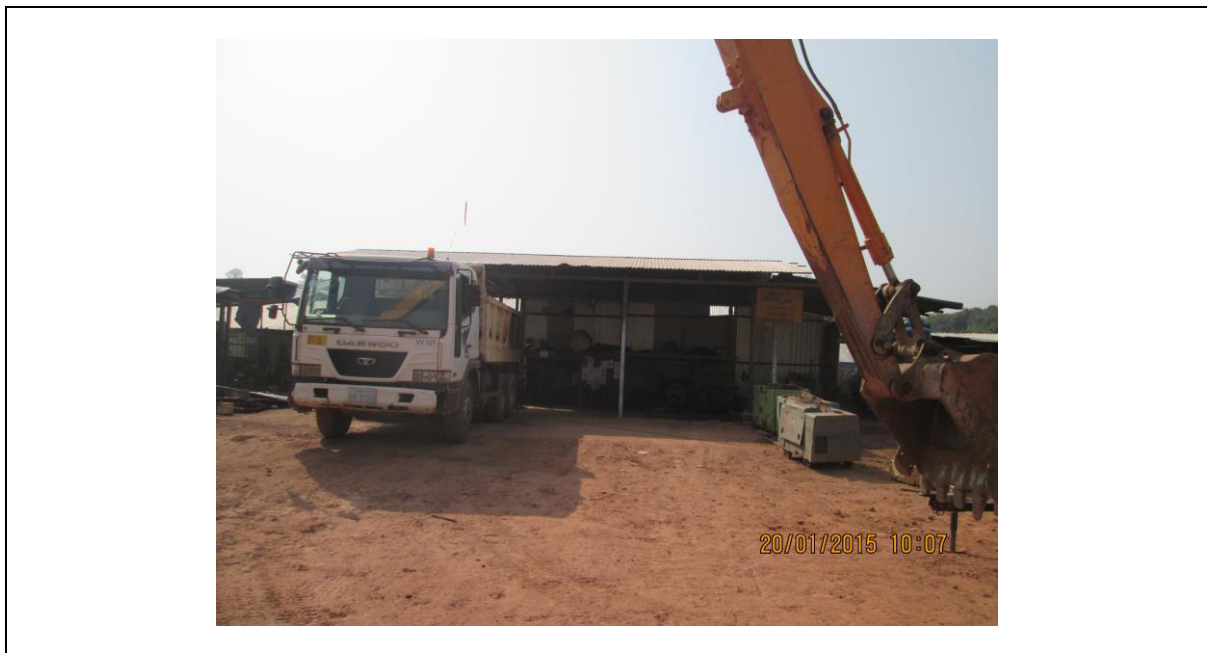
Photo 6 Typical subcontractor workshop (TCM Workshop)

Currently there are eight engineering workshops on site, one for each subcontractor. The layout and scale of each workshop relates to the types of works required. Generally a workshop will consist of two vehicle service bays, an engineering workshop, holding (stock) yard, a hazardous materials storage facility and an administration office.

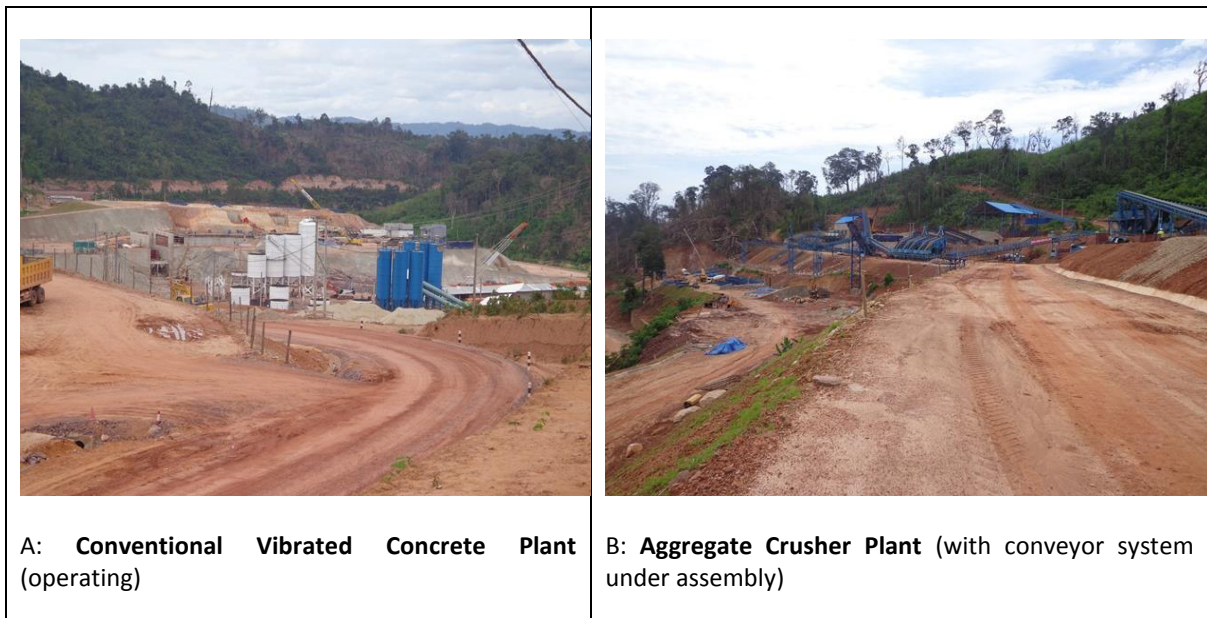
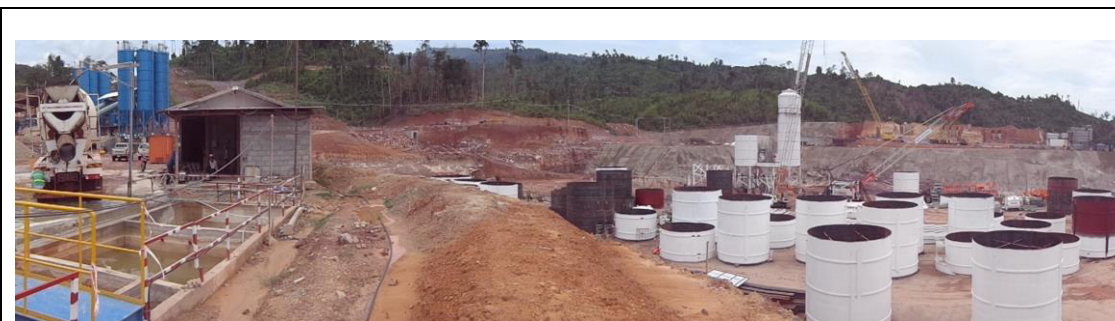
Photo 7 Construction related facilities

Under construction or operating are also the Conventional Vibration Concrete (CVC) Plant, Rolling Compacted Concrete (RCC) Plant, and Aggregate Yard. The RCC plant will receive sorted and proceeded aggregate to produce concrete to be used for the actual dam construction. The CVC plant is operational and produces conventional concrete mainly for shotcrete of the diversion tunnel excavation and re-regulation powerhouse.

C: Roller Compacted Concrete plant (to right of photo, under construction).

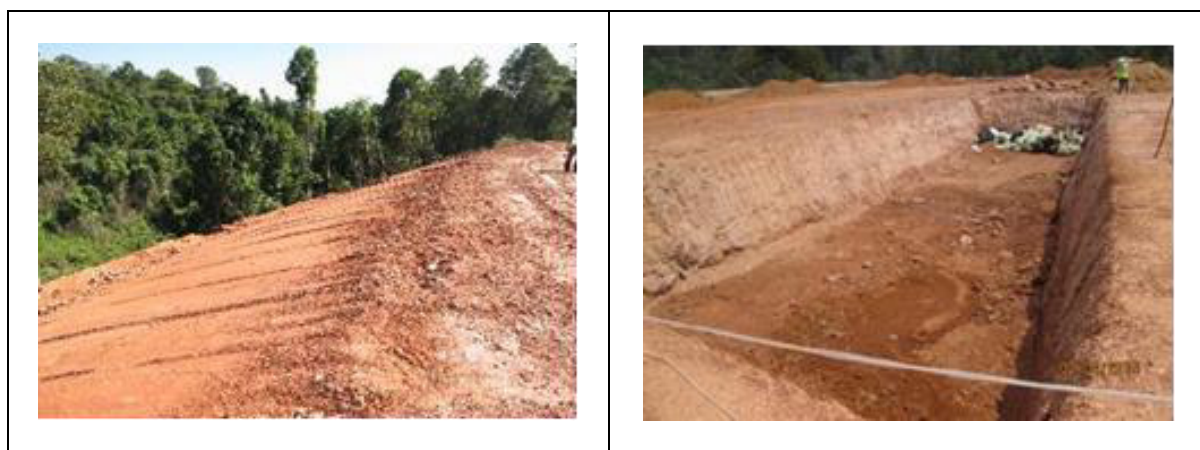
Two temporary pits were installed at the NNP1 Landfill facility and were being used as of March 2015. At the time when the landfill is completely operational, which is expected in the 2nd quarter of 2015, waste from these two pits are to be exhumed and transferred to 'completed' operational pits. Construction waste transfer offsite to the Paksan Landfill was suspended in March 2015. Except for hazardous waste, all other types of waste generated by NNP1 is processed on site.

Photo 8 NNP1 landfill embankment works and one of the temporary pits (January 2015)

Final landfill design and its operational aspects is now subject to independent expert assessment, who will advise on NNP1 on necessary changes. Conclusion of the review is expected in the 2nd quarter of 2015.

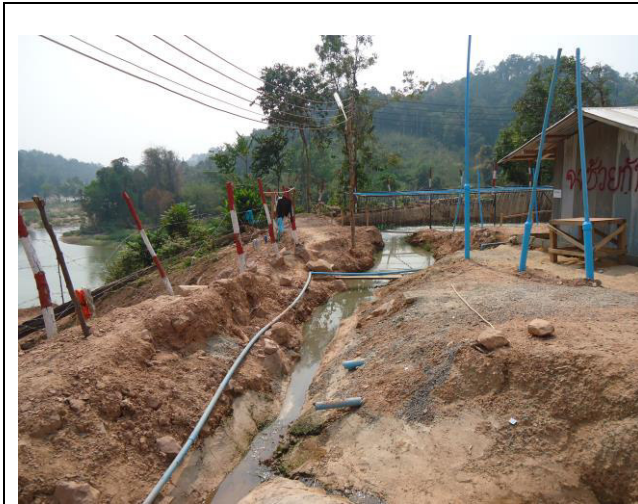
Right Tunnel Camp: BOD, COD, TSS, Fecal and Total coliform exceeded the guidelines for January 2015. During February and March an aeration system and water-hyacinth were installed as part of a system upgrade, however results for February and March suggest little improvement to water quality. Seepage from the system continues to be a problem and

Photo 9 Right Tunnel grey water treatment pond

additional improvements to the system have been requested of the sub-contractor. NNP1 has requested the waste water treatment system design for review.

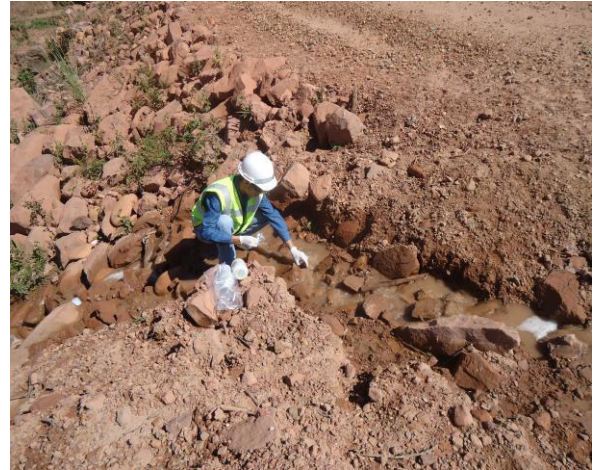
Photo 10 Right Tunnel Camp effluent discharge location

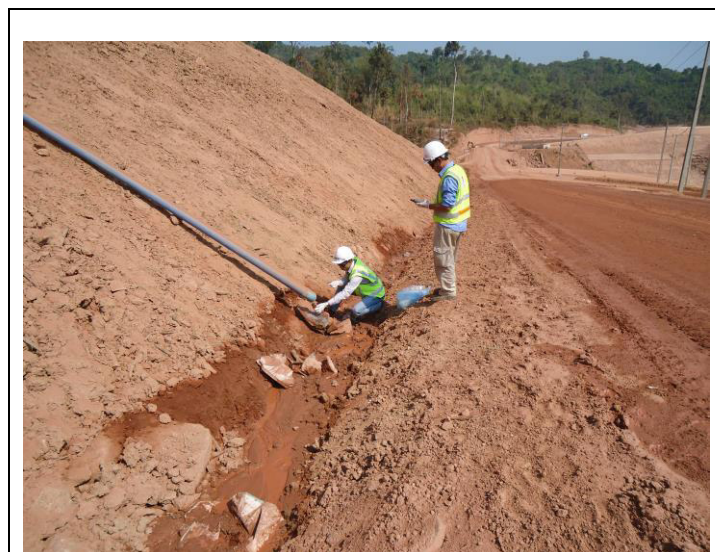
Sino Hydro Camp: BOD, COD, Ammonia-nitrogen, fecal coliform and Total coliform exceeded guidelines for the quarter. Discharge from this site WWTS enters a road side earth drain.

Photo 11 Sinohydro grey water treatment system discharge location

Waste water discharge from the camps continues to be a problem caused by ineffective systems (grey and black). NNP1 has requested that all camps provide detailed designs of the systems which will be subject to review of an independent specialist. From the review it is expected that camp systems will be overhauled. Sub-contractors will be required to monitor for effectiveness. The review is expected to be completed in the 2nd quarter of 2015.

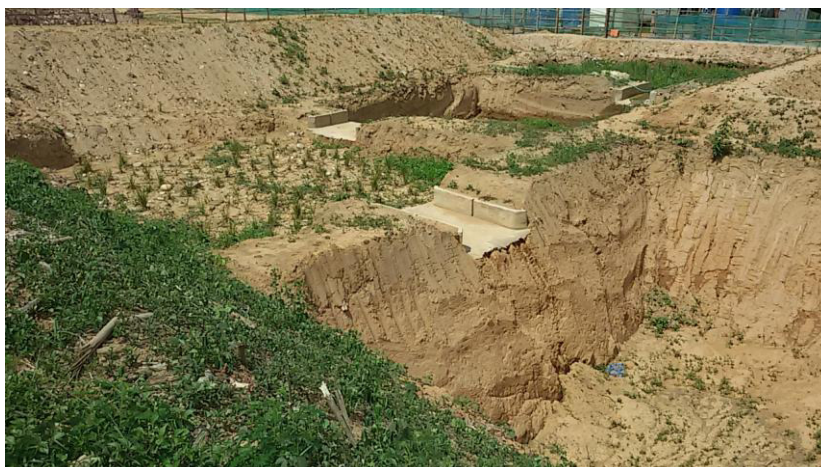
TCM Camp: The TCM grey water treatment system has had a history of being unable to adequately process grey water before discharge to the environment. Elevated counts for both Total and fecal coliforms were recorded in November and December 2014. In the period January to March 2015 no discharge was released from the camp. Completion of the WWTS

upgrade was in March 2015 and included an increase in grey water pond storage capacity, and the introduction of aquatic plants to help reduce nutrient levels.

Photo 12 TCM Camp WWTS upgrade

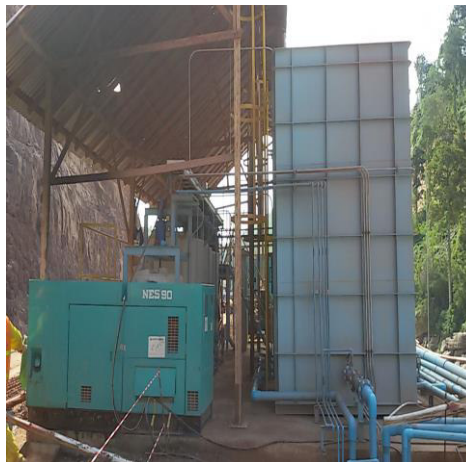
Photo 14 The effluent filtration system used at the tunnel outlet excavation site.

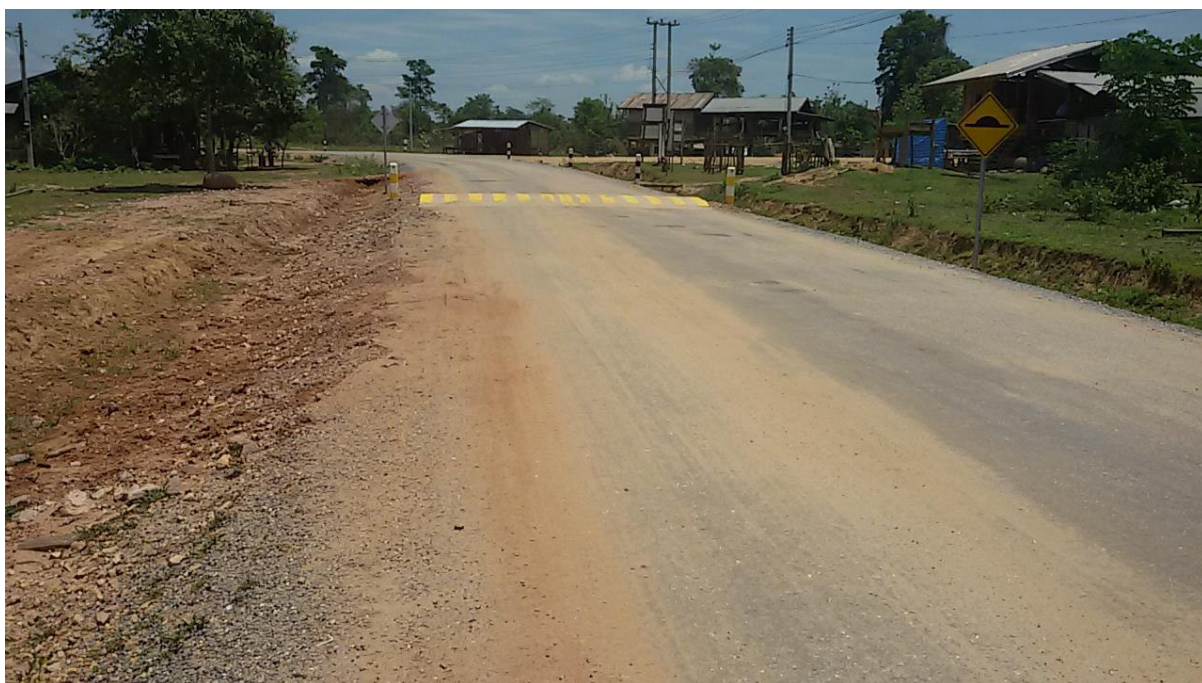
- All the road sections within three villages (Ban Hat Gnuin, Ban Nonsomboun, Ban Nonsomboun) were sealed in the first quarter of 2015.
- Speed bumps were also be installed to reduce vehicles speed through villages and improve safety.
- Access road nearby other sensitive receptors along the roads, such as ad hoc camps and construction area have increased the frequency of watering.

Photo 15 sealed road surface and speed bumps at Ban Hat Gnuin (April 2015).

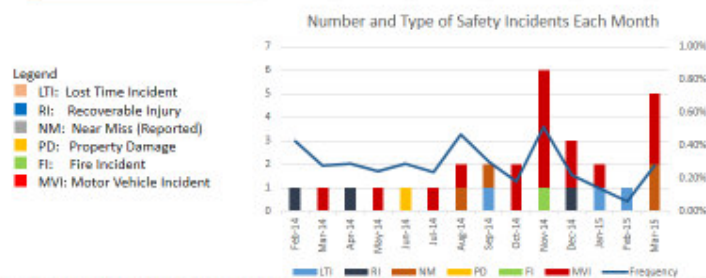
- The histogram shows the number of reportable accidents occurring in each month with the colour indicating the type of accident, incident or near miss.
- The graph shows the frequency of accidents, incidents or near misses with the number occurring each month expressed as a percentage of the number of Civil Works Contract workers employed in each month.
