Nam Ngiep 1 Hydropower Project (Lao People's Democratic Republic)

Quarterly Monitoring Report 2016 – Q3 Environmental

Nam Ngiep 1 Hydropower Project

Third Quarter of 2016

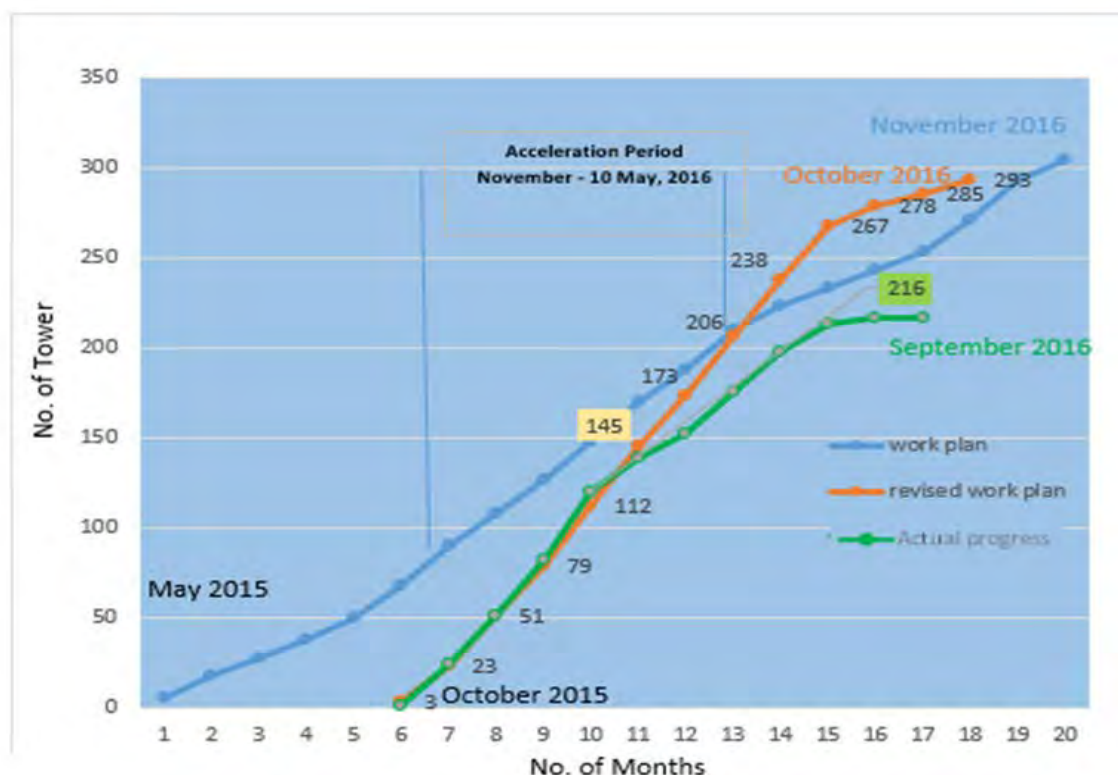
Figure 3-3: Cumulative Work Progress of Tower Foundation (Original Planned and Actual)

The Transmission Line Contract was executed between Loxley-Sri Consortium and NNP1PC on 11 July 2014 and on 03 October 2014, the NTP was issued to the contractor. The cumulative work progress of the Transmission Line works until the end of September 2016 was 52.6% (compared to planned progress of 63.2 %). The Transmission Line works is about 1 month ahead of planned by value as the procurement of material forms a large part of the payment to-date and this is ahead of schedule. Due to the fact that the actual tower foundation work and erection is behind schedule, work is being undertaken to ensure that stringing will commence in October 2016 and will be completed 3 months before COD.

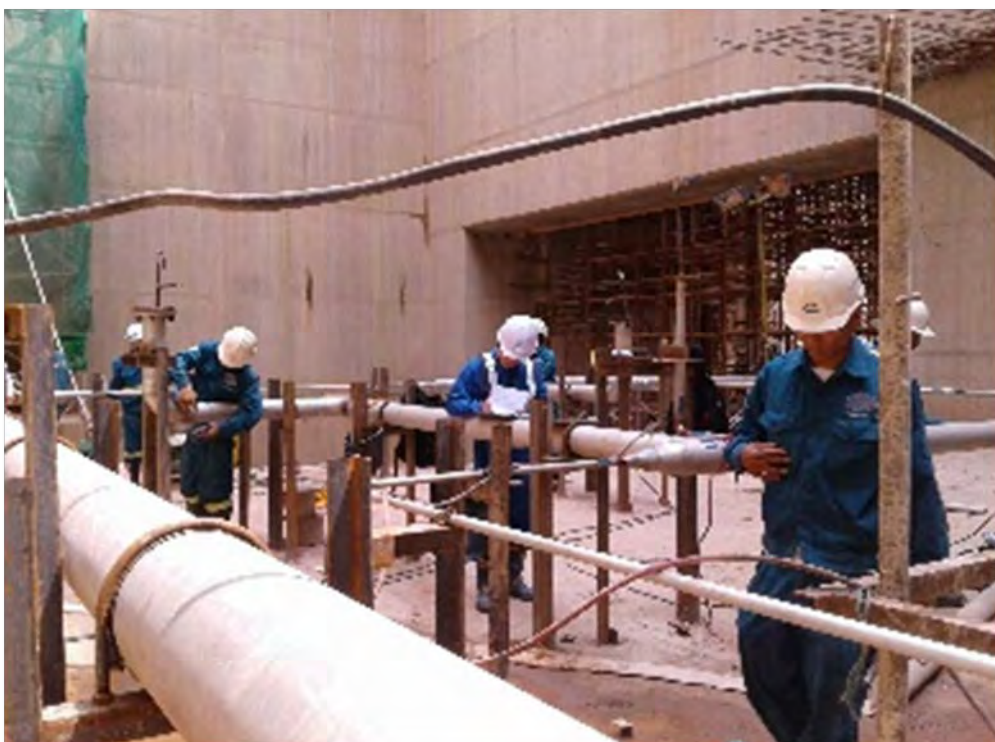
The grounding works for the main powerhouse and re-regulation power house are under way in coordination with concrete casting work.

Photograph 1: Embedded piping installation (Main powerhouse)

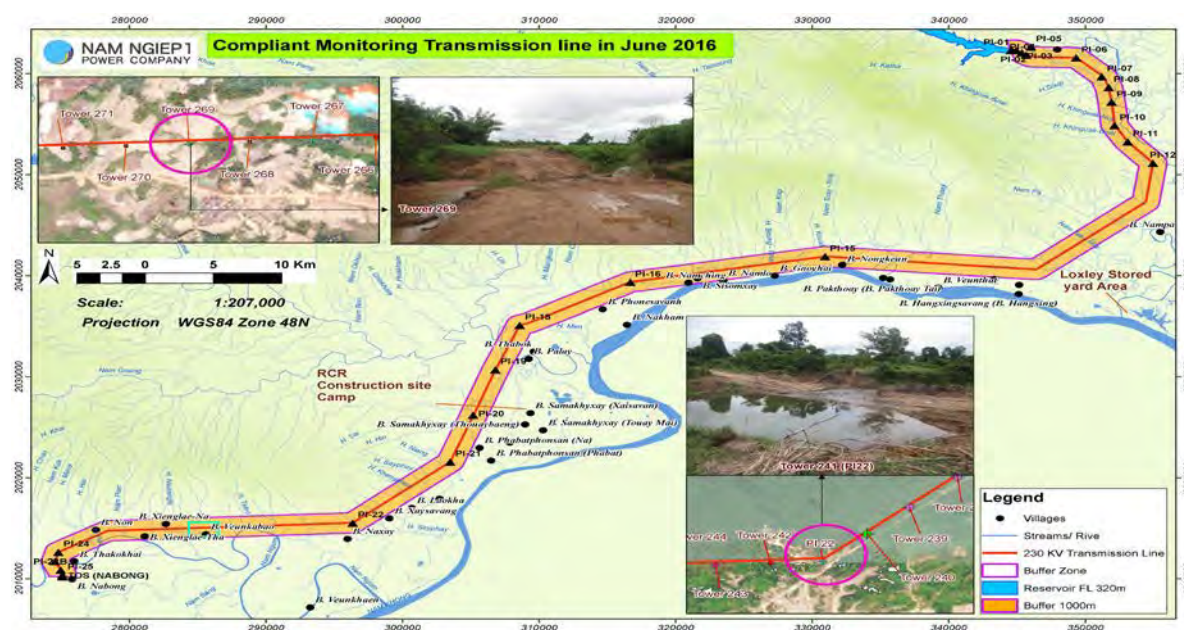
Figure 4-2: 230 kV Transmission Line construction monitoring

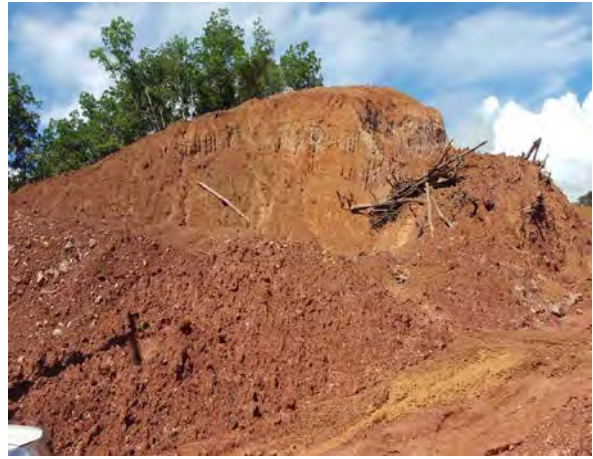
| <p>Photograph 4: Monitoring of borrow pit operation at Re-regulation Dam (joint bi-weekly inspection)</p> | <p>Photograph 5: Site inspection at the Transmission Line sub-contractor’s workshop (joint bi-weekly inspection)</p> |

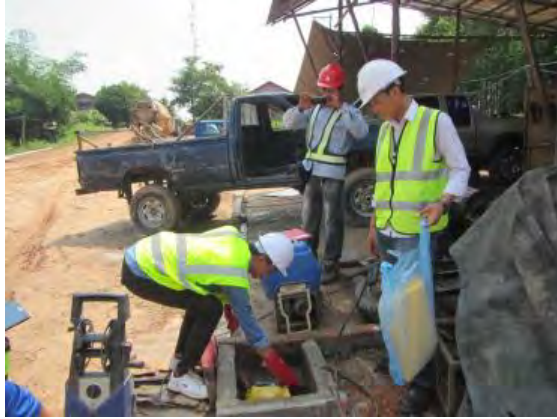
Photograph 8: Workplace hazardous waste management training for Loxley’s RCR sub-contractor (230 kV TL)

In addition, during September 2016, EMO provided the workplace's hazardous waste management induction for TL, IHI and HM Contractors. Approximately 10 supervisors attended. The induction focused on hazardous material spills protection and response through the "Control-Contain-Clean up

Principles”. NNP1PC-EMO used hydrocarbon and chemical absorbent sheets for demonstrations in this training (see Photograph 8 and Photograph 9).

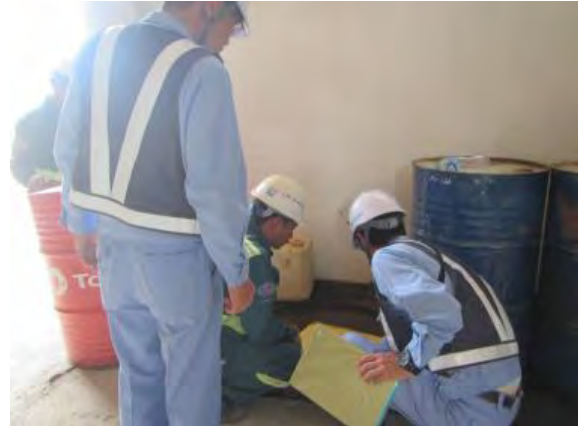
Photograph 9: Workplace hazardous waste management training for HM Hydro’s LILAMA10 Sub-contractor

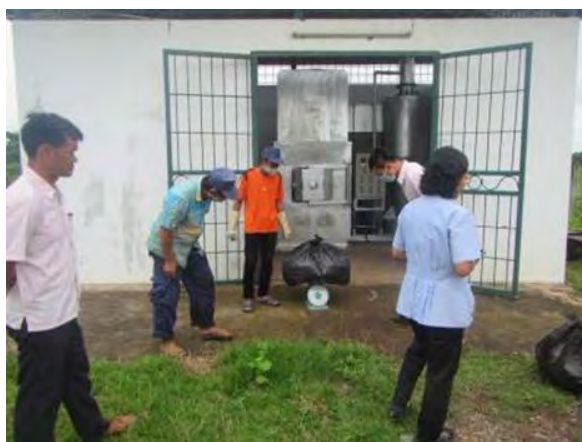
Photograph 10: Clinical waste was sent to an incinerator at the Vientiane landfill

Only small amounts of medical waste were generated at the site clinics (Owners’ Site Office and Village, Song Da Camp 1, 2 and OC Camp). During the third quarter of 2016, a total of 19 kg of such waste was collected from the clinics and sent to the Vientiane landfill for incineration (see Photograph 10 and Photograph 11).

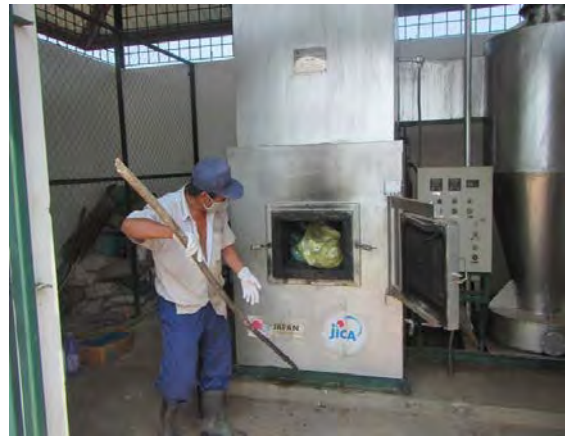
Photograph 11: Burning of clinical waste at Vientiane landfill’s incinerator

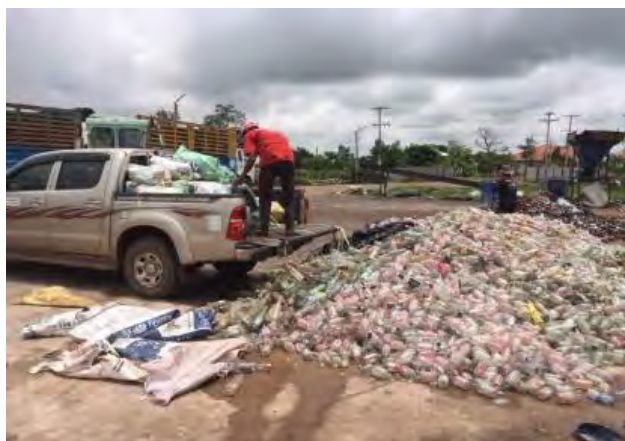
Photograph 12: Recyclable waste from the Recycle Waste Bank was sold to Keo Lao Factory in Vientiane

In addition, on 04 August 2016, a total of 415 kg of glass bottles from the Community Recycle Waste Bank at Hat Gniun village was sold to the Keo Lao Factory in Vientiane (See Photographs 13 and 14).

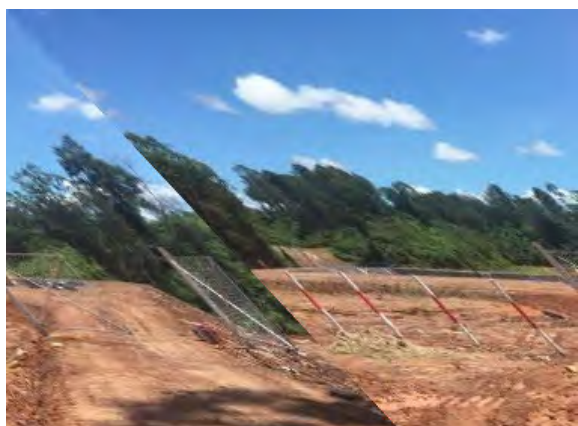
During the third quarter 2016, the first submission of the Detailed Work Plan and SS-ESMMP for Houay Soup Landfill construction was approved with conditions, and in September 2016 the first stage construction of Houay Soup Landfill was completed, which include a waste pit (P1: 3,000 m³ capacity), 02 leachate treatment ponds, a wetland, a groundwater monitoring well and temporary fences. The landfill was not operated officially and only the temporary waste pit was allowed for the HSRA's Contractors to dispose their solid waste. A total of 0.2 m³ of solid waste was disposed to the temporary waste pit. The Houay Soup landfill is expected to operate two days per week, i.e. Tuesday and Thursday from 09:30 to 10:30 am (see Photograph 16 and Photograph 17 below).

Photograph 16: Temporary fence and gate construction at HS Landfill

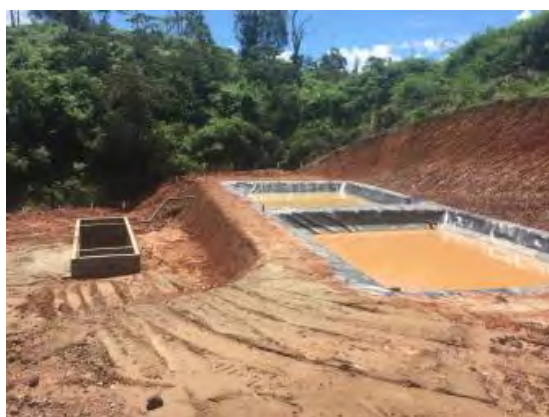
Photograph 17: Treatment ponds and Wetland Construction
