## Nam Ngiep 1 Hydropower Project (Lao People's Democratic Republic)

### Quarterly Monitoring Report 2016 – Q4 Environmental

# Environment Monitoring Report Fourth Quarter of 2016

October to December 2016

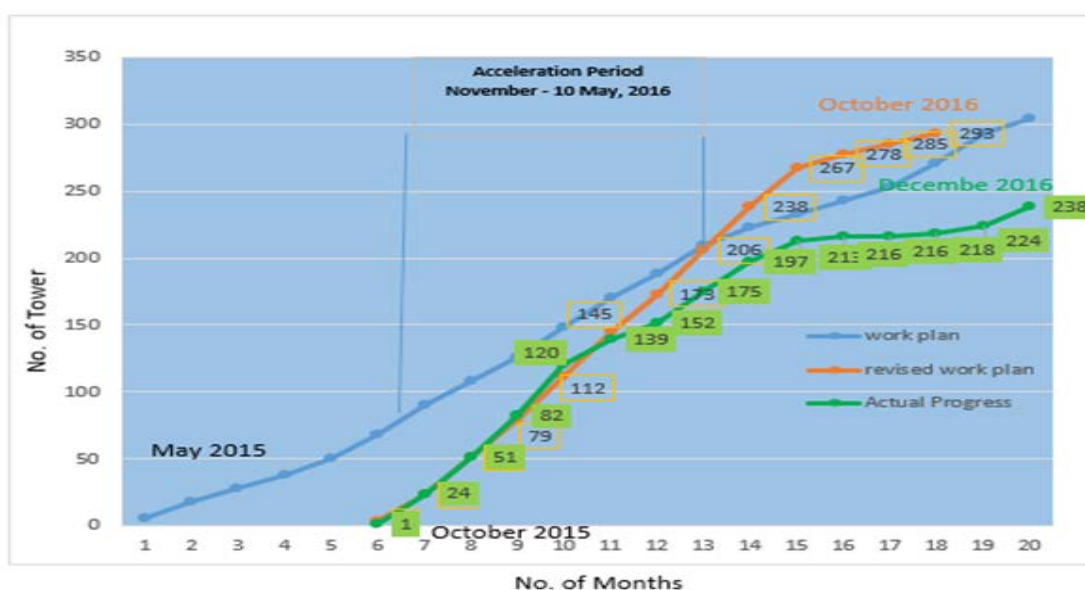
Figure 3-5: Cumulative Work Progress of Tower Foundation (Original Planned and Actual)

The Transmission Line Contract was executed between Loxley-Sri Consortium and NNP1PC on 11 July 2014 and on 03 October 2014, the NTP was issued to the contractor. The cumulative work progress of the Transmission Line Works until the end of November 2016 was 67.9% (compared to planned progress of 69.8%). The Transmission Line works is about 1 month ahead of planned by value as the procurement of material forms a large part of the payment to-date and this is ahead of schedule. Due to the fact that the actual tower foundation work and erection are behind schedule, work is being undertaken to ensure that stringing will commence in October 2016 and will be completed 3 months before COD.

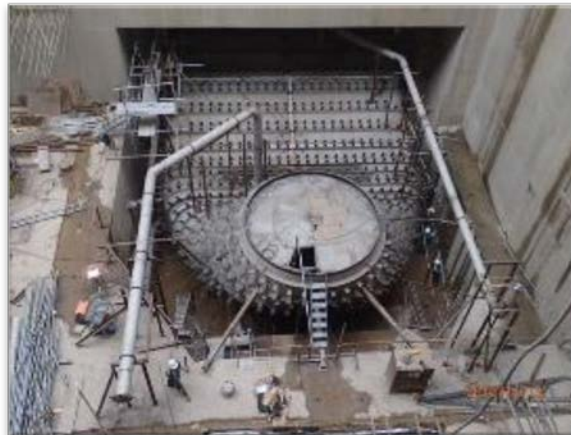
Figure 3-8: Installation of Draft Tube for 1 at the Main Powerhouse

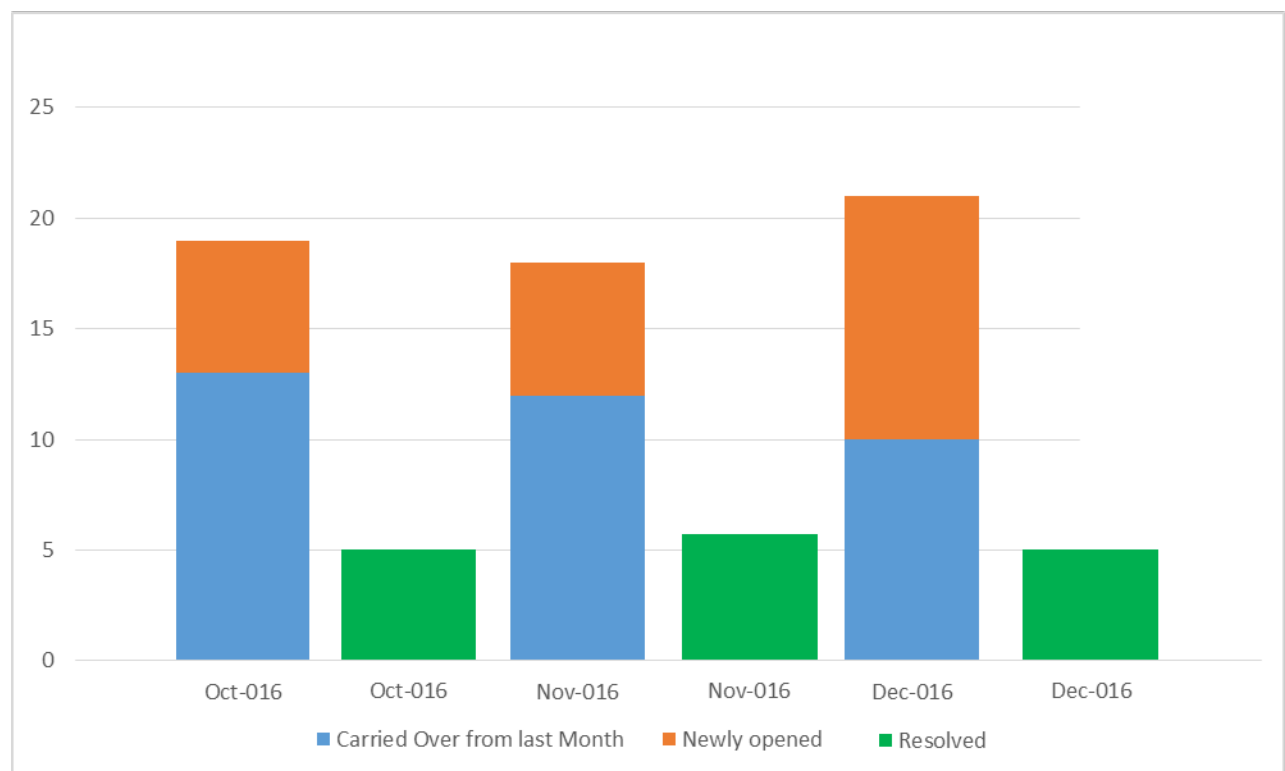
Figure 4-4: ONCs and NCRs during the Fourth Quarter of 2016

A total of 36 Observations of Non-Compliances (ONC), two Non-Compliance Level-1 and one Non-Compliance level-2 were recorded and considered as active during the reported period. Out of these,

13 ONCs and one NCR were carried over from the previous Quarter; 23 ONCs and one NCR were newly issued. The issued NCR level-1 was related to hazardous material management and the NCR-level-2 was related to the sedimentation control at the Aggregate Crushing Plant. A total of 14 ONC, one NCR level-1 and one NCR level-2 could not be resolved in this quarter and will be carried forward into the First Quarter of 2017. More details on the issued ONC and NCR as well as the corrective actions can be found in the **Table 4-2** and **Figure 4-3** and in the **Appendix 2: Environmental Monitoring Corrective Actions from October to December 2016**.

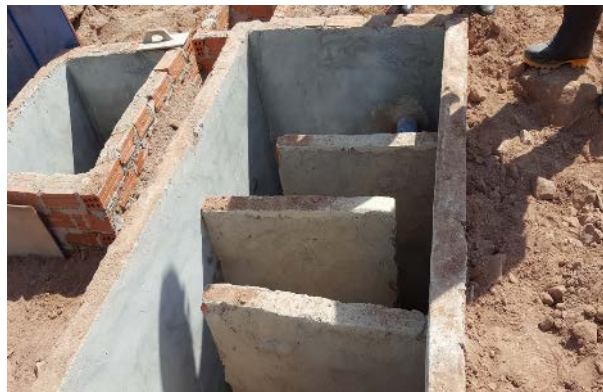
Photo 1: Chlorine Contact Tank at Song Da5 Camp No. 2 in November 2016

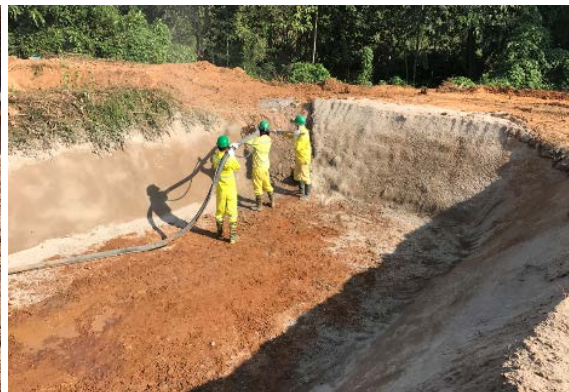
Photo 2: Progress of the WWTS Improvement at Song Da5 Camp No. 1 in November 2016

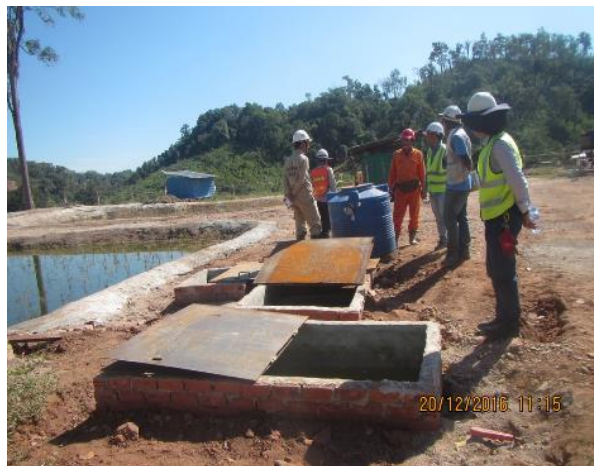
Photo 3: WWTS at Song Da5 Camp No. 1 in December 2016

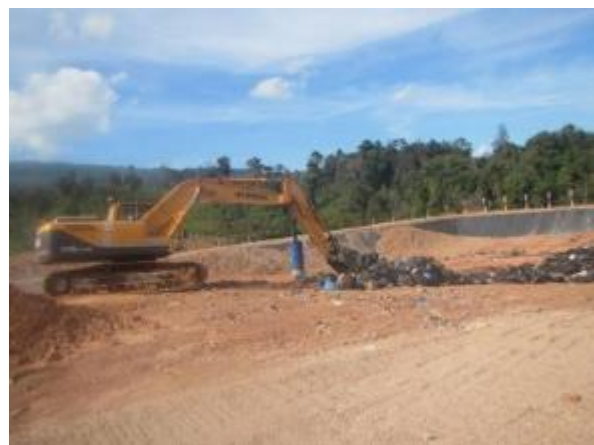
During October to December 2016, NNP1PC closely followed-up on the landfill operation. This included waste disposal record, waste compaction and conducting spot checks of the Contractors' waste bags. It was evident that during October and November 2016, the waste segregation by some sub-contractors was inadequate - recyclables, general and construction wastes were mixed with the solid waste to be disposed at the landfill. The main Contractors and sub-contractors were instructed to properly segregate the mixed waste prior to disposal at the landfill. An amount of approximately 529.5 m<sup>3</sup> of solid waste was disposed at the NNP1 Project landfill (See **Photographs 5 and 6**) during the reporting period.

Photo 5: Waste Compaction and Soil Cover at the NNP1 Project Landfill

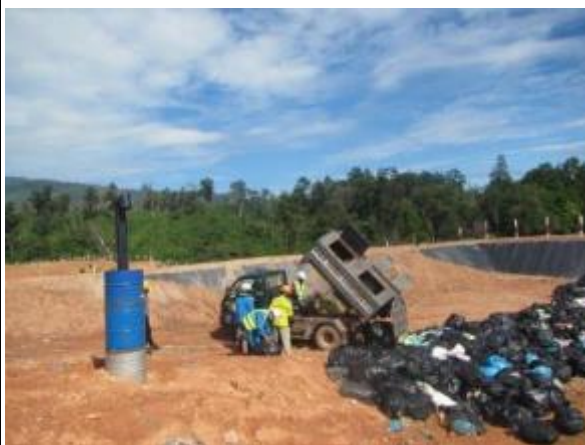
Photo 6: Waste Disposal Spot Checking by NNP1PC staff at NNP1 Project landfill

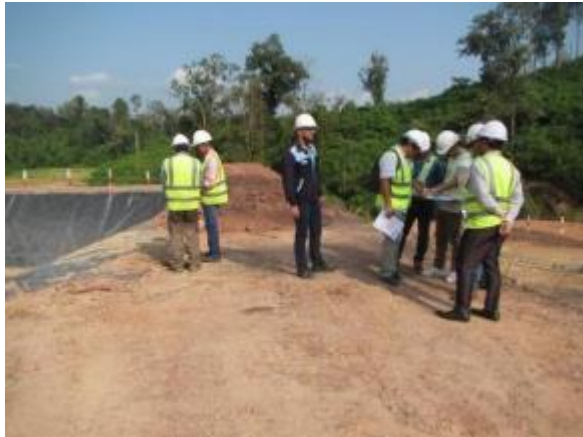
The construction of Houay Soup landfill was completed, and the final inspection of the 1<sup>st</sup> stage was done jointly between the NNP1PC and the contractor in October 2016. The landfill has been in operation since then and has received waste from the host village, resettles and contractors in the Houay Soup Resettlement Area. The landfill is open for business every Tuesday and Thursday from 09:30 to 10:30 am through individual arrangement with NNP1PC-EMO staff. During October to December 2016, a total of 10.81 m<sup>3</sup> of solid waste from HSRA’s Contractors was disposed at the landfill. (See photo 19 and 20 below).

Photo 89: A final inspection of the 1<sup>st</sup> stage Houay Soup Landfill construction

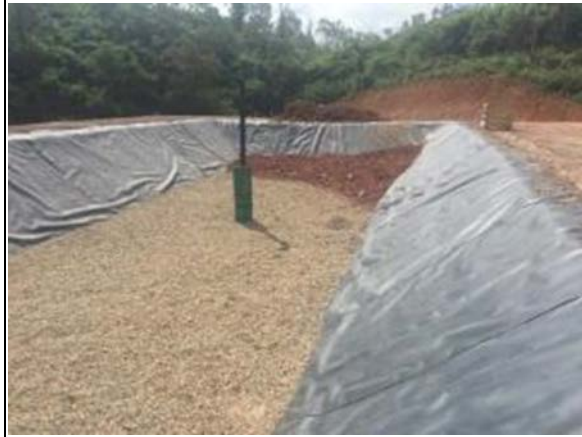
Photo 20: HSRA's Contractors disposed waste at the Houay Soup Landfill
