# Quarterly Implementation Progress Report No. 1 and Response of Nam Ngiep 1 Power Company Limited

## Nam Ngiep 1 Hydropower Project (Lao People's Democratic Republic)

**Quarterly**  
**Implementation Progress Report No. 1**

**NNP1/Ph.2/001**

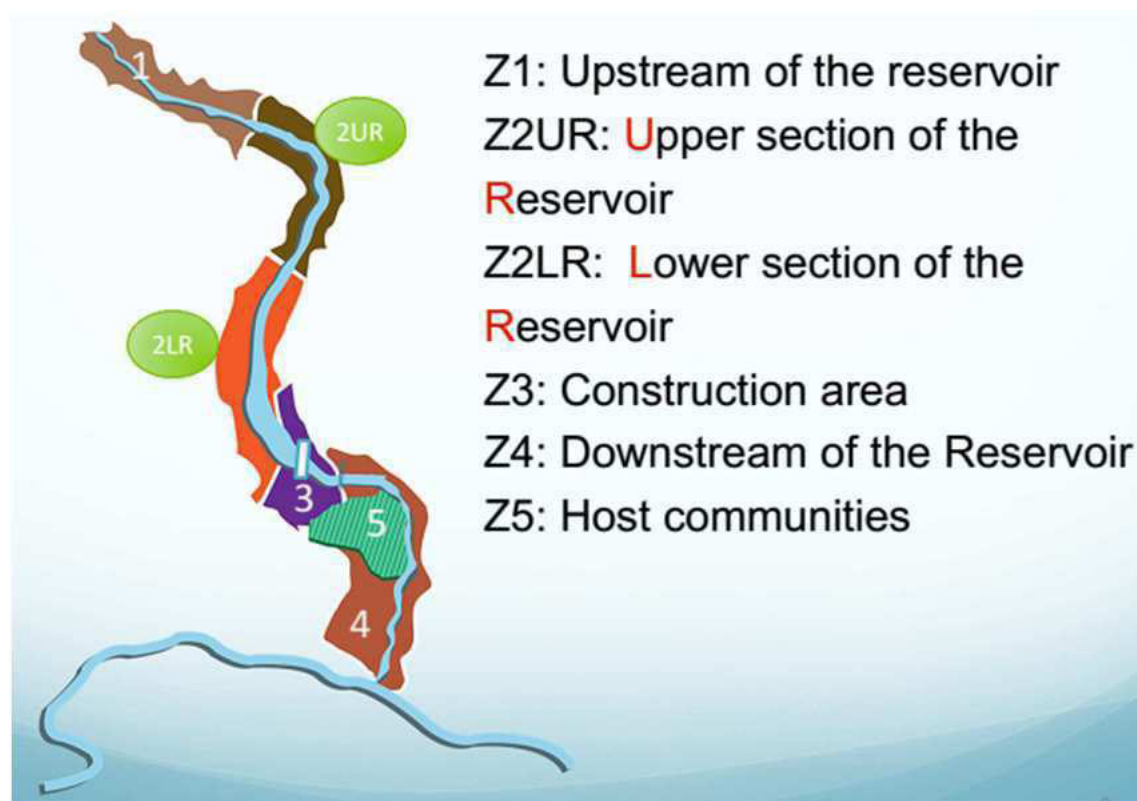
Figure 7.2 Areas Affected by the Project

The areas affected by the project development are shown in the following Figure 7.2.

- **Z1** Upstream of the reservoir: no impact
- **Z2UR** Upper section of the Reservoir: Relocation for some families within their village and livelihoods restoration for all impacted households:

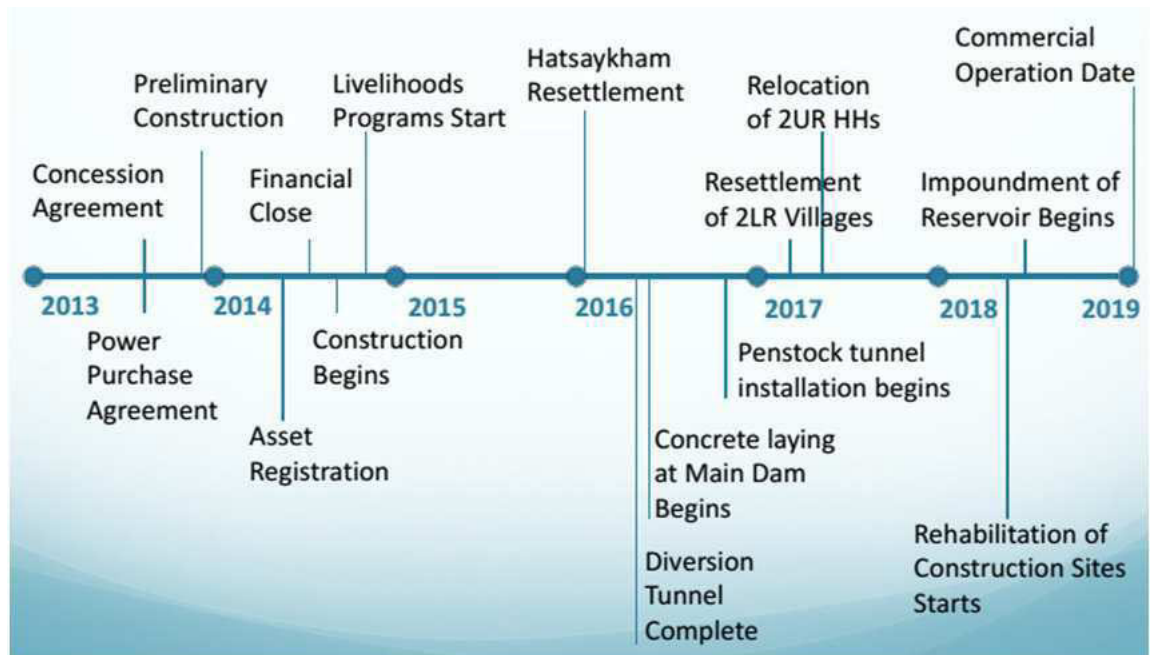
Figure 7.3 General Time Schedule of the Main Resettlement Activities

The general time schedule of the main resettlement activities, as outlined by the SMO during the LTA visit, are shown in the Figure 7.3

In relation to previous plans, the main change is the postponement to early 2016 of the resettlement of the Hatsaykham village. The reasons for this delay are related to the difficulties being faced in the development of the Houay Soup resettlement area, as commented in the following Section 7.2.2.3.

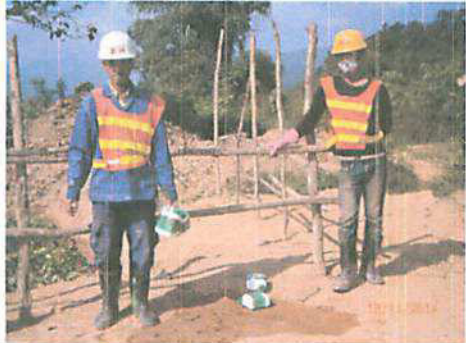
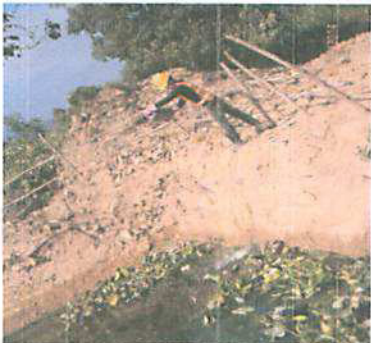
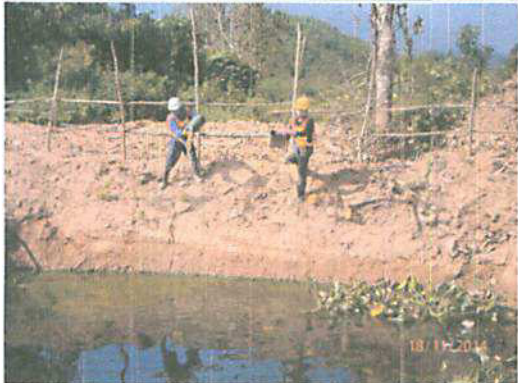
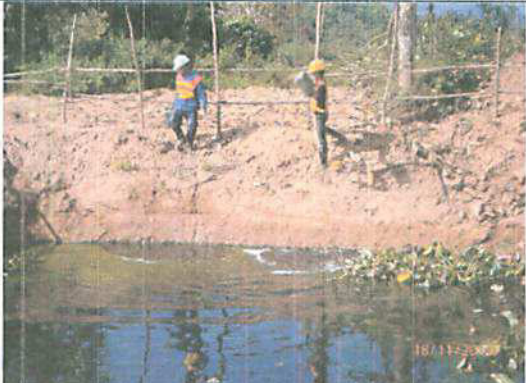
<p>18<sup>th</sup> November 2014</p>	<p>18<sup>th</sup> November 2014</p>
<p>Date: 18-Nov-2014</p> <p>Total EM Mixing water 100L (Usage 5L of EM, mixing 1L with 20L water)</p> <p>(EM Mixing ratio for strong smell treatment 2-3L : 1 m<sup>3</sup> water)</p>
