Environmental Monitoring Report

Nam Ngiep 1 Hydropower Project (Lao People's Democratic Republic)

Quarterly Monitoring Report 2015 – Q2 Environmental

Prepared by Nam Ngiep 1 Power Company Limited for the Asian Development Bank

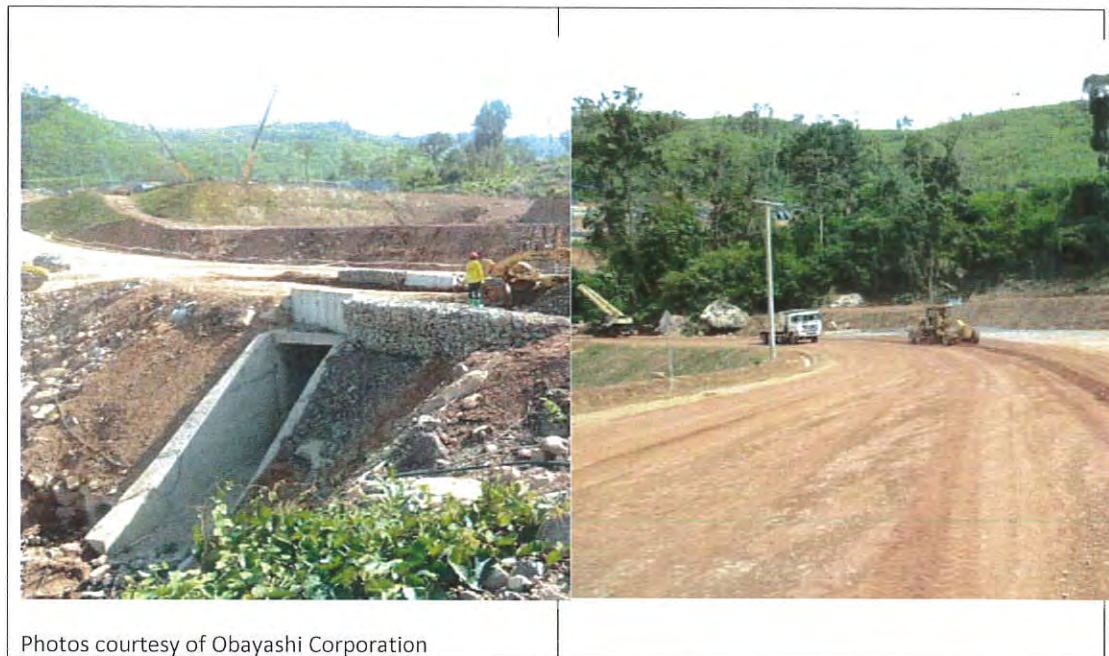
Photo 1 and 2: Completion of Access Roads by June 2015

The main project access road links Ban¹ Nonsomboun in Bolikhamxay Province to the dam site at a distance of 52km. The upgrade was required to improve the drainage and hauling capacity. At the dam site there are 13 internal temporary roads that link construction facilities. By the end of June 2015, all internal road construction was completed.

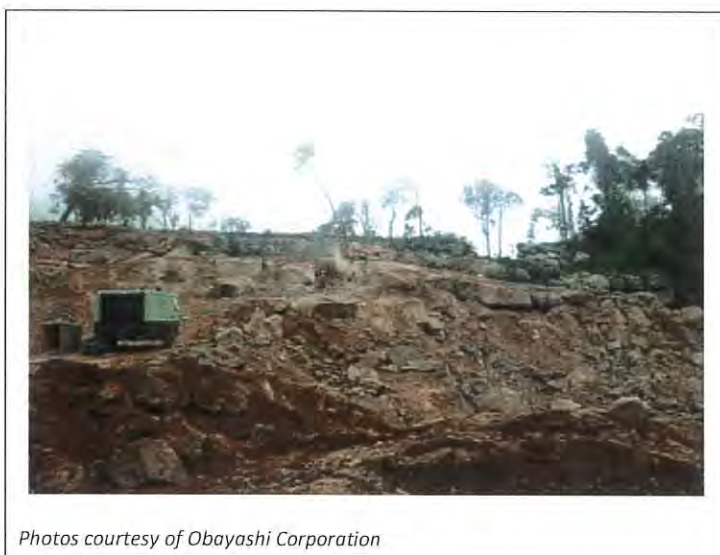
Photo 3: Main Quarry Overburden Removal, June 2015

and is 4.8 km away from the nearest village of Ban Hatsaykham. The quarry will have an area of 7 hectares and a capacity of 1,784,553 m³. Trucks will haul materials to the nearby Aggregate Crushing Plant for processing.

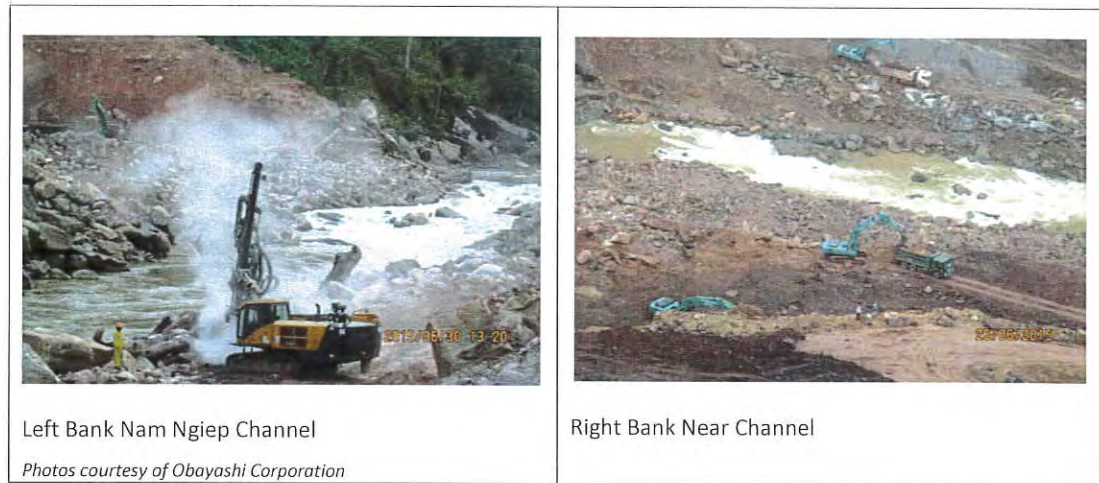
Photo 4 and 5: Main Dam Excavations, June 2015

The main dam is located 6km upstream from the re-regulating dam. At the conclusion of the reporting period (June 2015), approximately 82% of the main dam foundation excavations were completed.

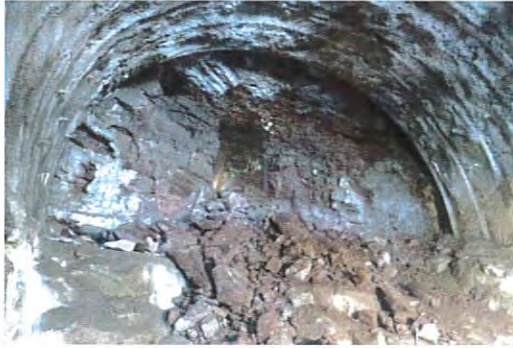
The river diversion tunnel when completed will be 625.9m long and a breakthrough was achieved on 30 June 2015. Tunneling excavation continues with concrete casting and arch lining applied to completed sections.

Photo 6: The Breakthrough at the Top Bench on 30 June 2015

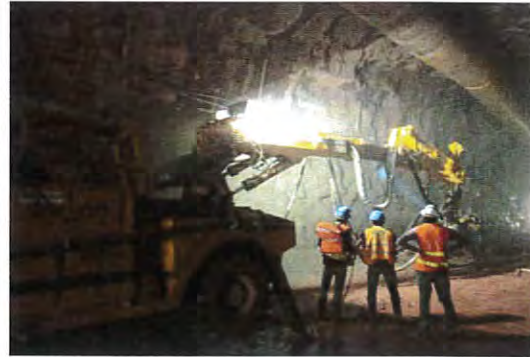
Photo 7: Shotcrete Lining of the Tunnel Wall

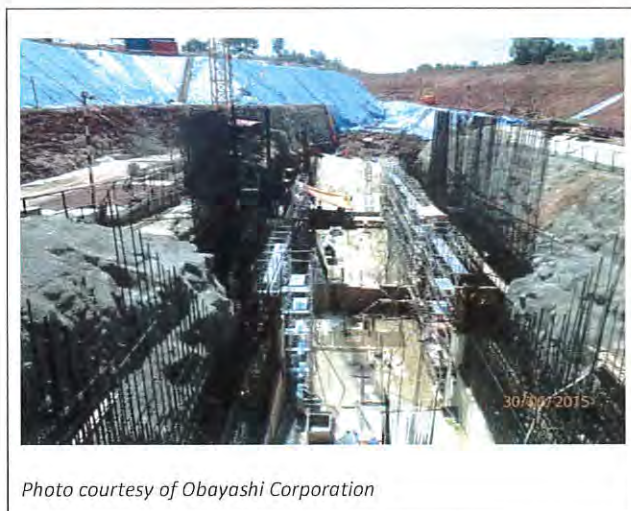
Work on the re-regulating dam commenced on the left bank with the construction of the river diversion (flood protection) levee, and then excavating into the river bed behind the levee for the construction of the regulating dam power station. Vegetation clearing and preliminary earthworks (basic site preparation) commenced in February 2014, but was suspended for the wet season. The work was recommenced in October 2014 and by June 2015 all earth works were completed, which included the left bank flood protection levee. Approximately 27% of main body work were also completed.

Photo 10: Regulation Excavation (left bank) the background, June

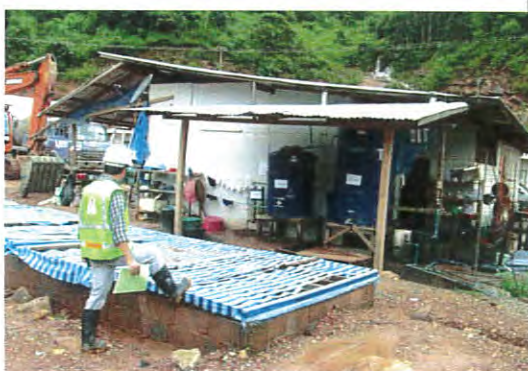
Photo 13: Grey Water Treatment System at the RT Camp Located next to the Kitchen

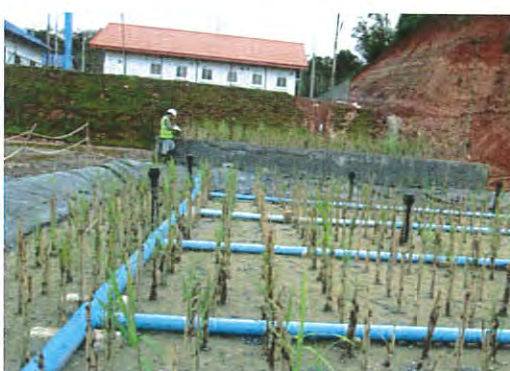
Photo 14: Grey Water Treatment System at the Owner Base Camp

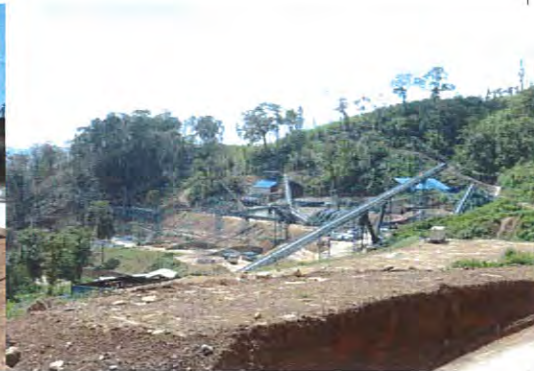
Under construction or operation are also the Conventional Vibration Concrete (CVC) Plant, Rolling Compacted Concrete (RCC) Plant, and Aggregate Yard. The RCC plant will receive sorted and proceeded aggregate to produce concrete that will be used for the actual dam construction. The CVC plant is operational and produces conventional concrete mainly for shotcrete of the diversion tunnel excavation and re-regulation powerhouse.

Photo 16: Aggregate Crusher Plant (with conveyor system under assembly), June 2015

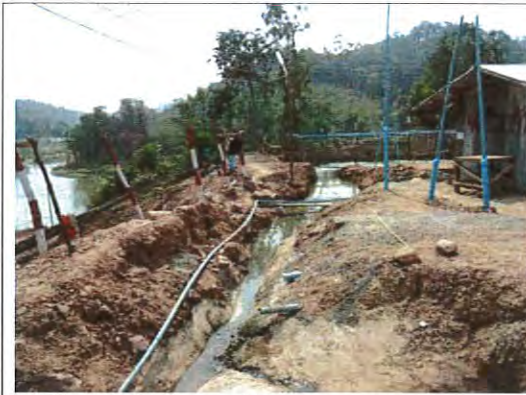
Right Tunnel Camp: It was found that the BOD, COD, TSS, Fecal and Total coliform exceeded the National Standards for the quarter. The estimated volume being discharged was approximately 21.6m³ per day.

During the 1st quarter an aeration system and water hyacinth were put in place as part of a system upgrade, however results for the 2nd quarter suggested that little improvement was achieved to water quality. Seepage from the system continues to be a problem and additional improvements to the system have been requested to the sub-contractor. Thus, the EMO has requested that the waste water treatment system (WWTS) designs for all contractors were reviewed (see also section 3.5.2.1).

Photo 34: Right Tunnel Grey Water Treatment Pond

Waste water discharge from the camps continues to be a problem caused by ineffective systems (grey and black). The EMO has requested that all camps provided detailed designs of the systems which would be subject to review of an independent consultant. From the review it is expected that camp systems will be overhauled by the 4th Quarter of 2015. Sub-contractors will be required to monitor for effectiveness. The review was implemented in June 2015 with a report expected in July 2015.

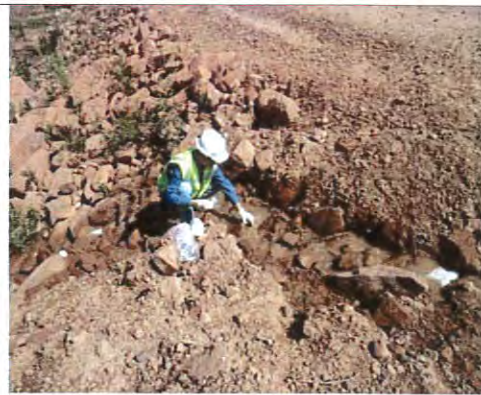
Photo 35: Right Tunnel Camp Effluent Discharge (seepage) Location

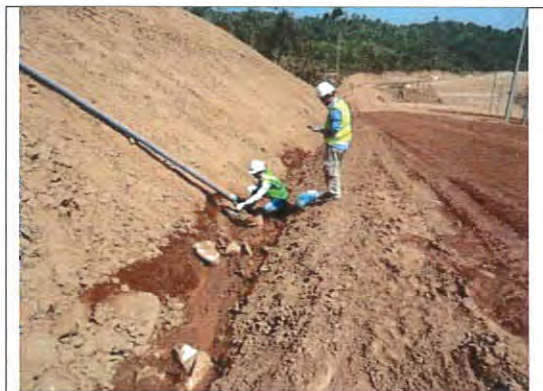
Sino Hydro Camp: It was found that the BOD, COD, Ammonia-nitrogen, fecal coliform and Total Coliform exceeded the National Standards for the quarter. Discharge from this WWTS enters a road side earth drain. Total volume was not estimated during the quarter but was significantly less than Right Tunnel.

Photo 36: Sinohydro grey water treatment system discharge location

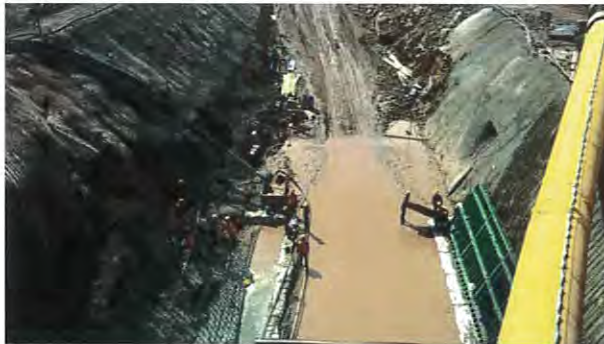
Over the reporting period, two construction sites were discharging effluents into the natural environment: *Regulation Dam* and *Diversion Tunnel Outlet*. These sites produce potentially large volumes of water both underground and/or trapped surface water. Both sites operate for 2x10hour shifts per day and for six days a week, but the requirement to treat the sites waste water is 24hrs a day, seven days a week. An effluent filtration system that controls pH and removes some total suspended solids is now operating at both sites. The trapped effluent water is tanked and then pumped to a series of sediment ponds to settle sediments and other particulate matters before pumping to the filtration system. Sediment ‘cake’ is disposed of at Spoil Area 6. Once the water is filtered and treated to meet the required guideline, it is discharged directly into the Nam Ngiep.

Photo 37: Pooled Effluent Water at the Tunnel Outlet Excavation Site (April, 2015)

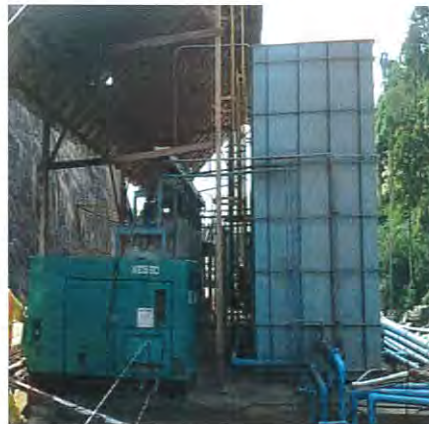
Photo 38: The Effluent Filtration System used at the Tunnel Outlet Excavation Site which is Situated on the Upper Left Bank of the Tunnel Excavations

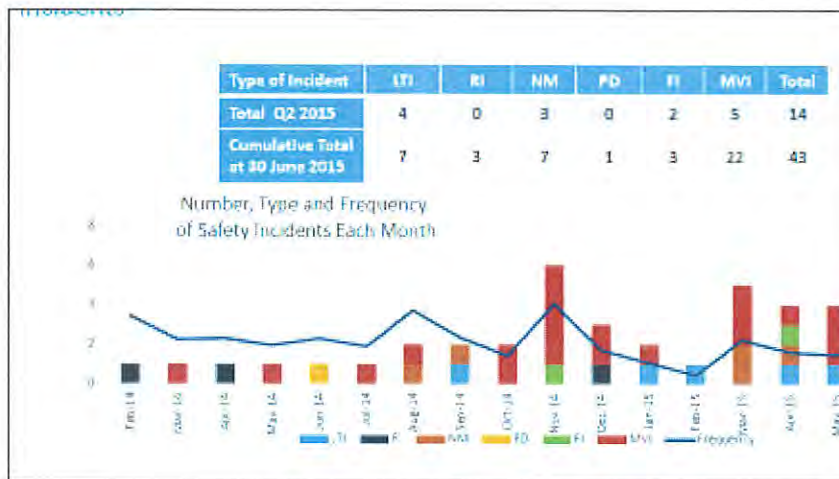
Fig. 5: Summary of Safety Incidents from February 2014-June 2015

Motor Vehicle Incidents (MVI) have again been the largest number of incidents (5 out of 14 in Q2 of 2015 and 22 out of 43 cumulatively). There were no injuries sustained in the Q2 MVI incidents. All have been due to vehicle malfunction, loss of concentration or lack of good sense by drivers. This continues to be a focus of attention for safety inspection and training. With the steep increase in the number of vehicles using the near completed access roads in areas of the construction site, with steep escarpment, for purposes of disposal of excavated material for dam, powerhouse and tunnel excavations, there is still a significant emphasis on vehicle maintenance and driver ability to keep workers safe in these circumstances.

The distribution of incidents by type and over time can be seen in the histogram and graph in the illustration below. The different categories of incident and number each month are represented by different coloured blocks. The graph shows the frequency of incidents and is the number of incidents divided by the number of workers on site expressed as a percentage, plotted against time. The highest recorded number of incidents in any one month was 6 in both November 2014 and June 2015 when the number of workers was 1,177 and 2,187 respectively with the greatest frequency to-date being 0.5% or 1 incident per month per 200 workers in November 2014. This compares with an average over the Project to-date to 30 June 2015 now reduced to 0.04%, or 2.5 incidents per month and an incident every 435 man-months.
