## Nam Ngiep 1 Hydropower Project (Lao People's Democratic Republic)

### Quarterly Monitoring Report 2016 – Q1 Environmental

# Environment Monitoring Report

## First Quarter of 2016

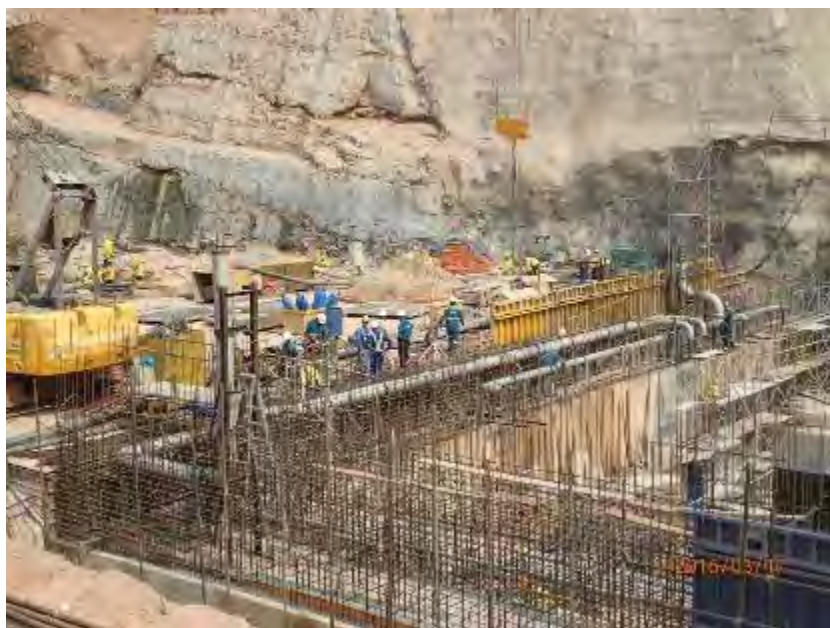
Figure 3-4: Embedded piping installation (Main powerhouse)

The grounding works for the main powerhouse and re-regulation power house are under way in coordination with concrete casting work.

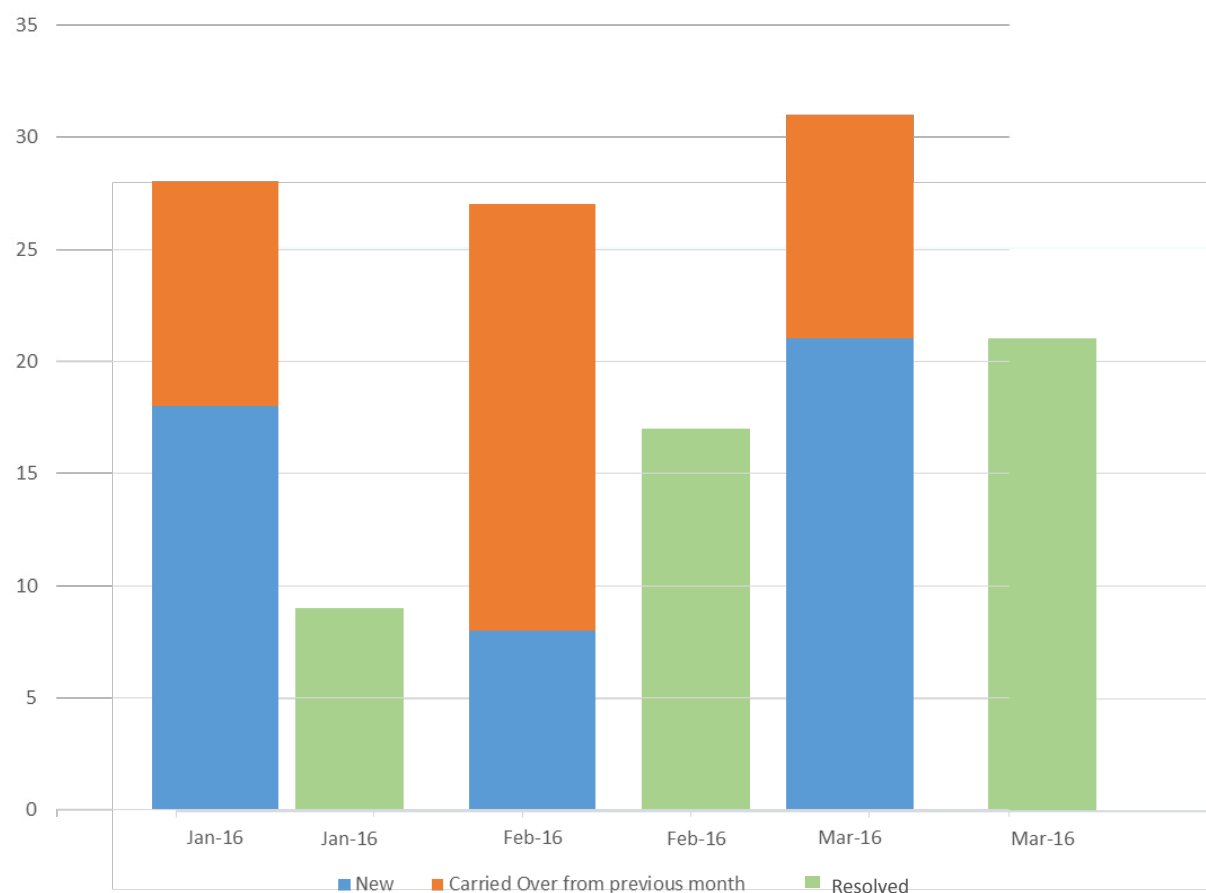
Figure 4-3: Summary of ONC and NCR During Q1 of 2016

A total of 57 Observations of Non-Compliances (ONC) were recorded over this Quarter. Out of these, 10 ONCs were carried over from the previous Quarter and 47 ONCs were identified during this Quarter. (See Table 4-1 and Figure 4-3 below). There was one NCR (Level 1) issued in January 2016 as a result of the slurry disposal off-Site at the aggregate crushing plant and y the sediment pond located below Spoil Disposal Area No.7. The slurry percolated through the rock/soil profile of the pond and entered into the Nam Ngiep below the Temporary Bridge. The implementation of a corrective action plan was followed up in February 2016 and closed. Ten (10) ONC which were mostly related to the Waste Water Treatment Systems (WWTS) of camps and could not be resolved in this Quarter and will be carried forward into the Second Quarter of 2016. NNP1PC will have internal meeting and with the contractors in April 2016 to agree on the corrective actions prior to issuing more ONC/NCR. More details on the status of ONC and NCR as well as the corrective actions can be found in Table 4-1: Summary of Environmental Non-Compliance Status During Q1 of 2016' in Appendix 2: Environmental Monitoring Corrective Actions From January to March 2016.

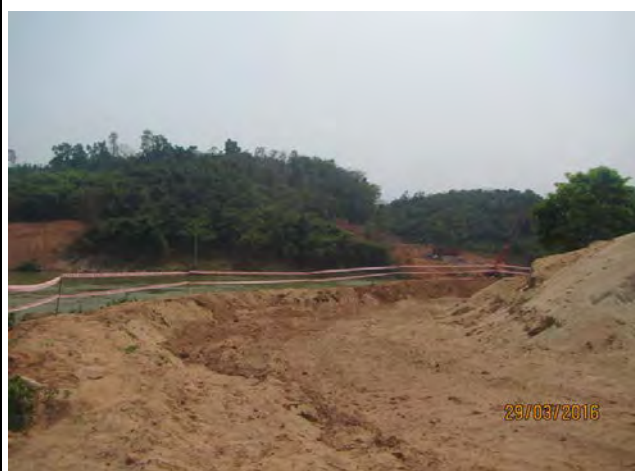
Photograph 3:  
Weekly follow up inspection on the erosion and sediment control at the temporary sand and aggregate material stockpile yard, Nam Ngiep River on the left bank

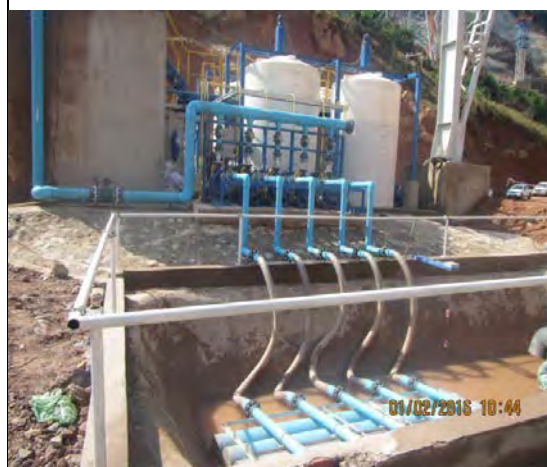
Photograph 4:  
Joint bi-weekly inspection on the improvement of the WWTs for main dam and powerhouse areas

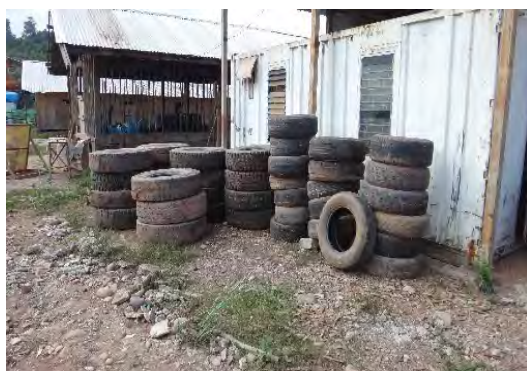
Photograph 5:  
Used tyres at the TCM Camp

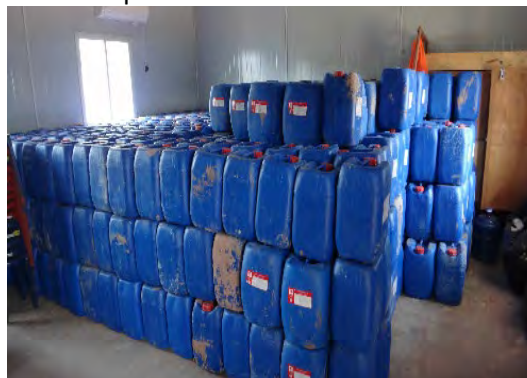
Photograph 6:  
Used chemical containers being stored at the TCM Camp

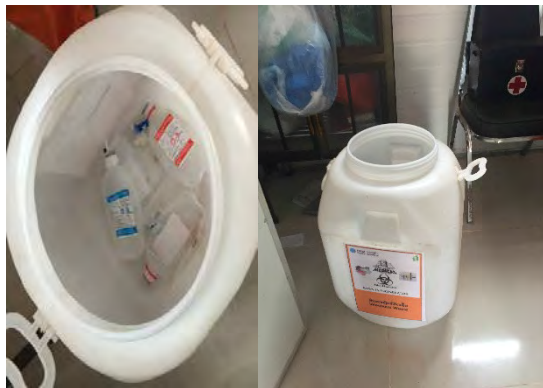
*Photograph 7:  
Medical waste at Song Da No.2 Camp*

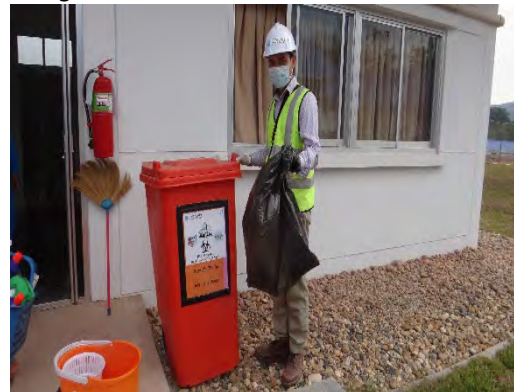
*Photograph 8:  
Medical waste at the Owner’s Site Office and Village*

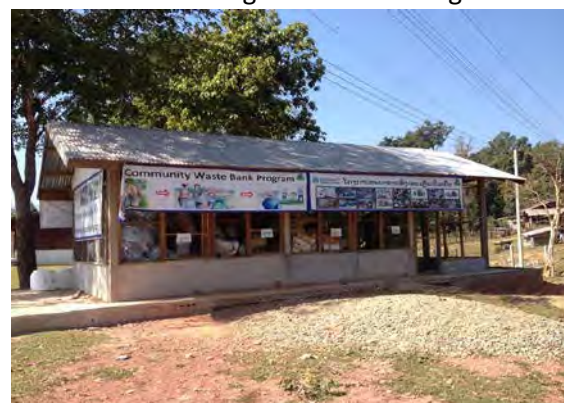
Photograph 13:  
The extended storage area for ressing machine

In order to provide an improved waste management system for the community, reducing the size of the storage space and increase the saleability of recycle materials, the EMO purchased a crushing machine to compress cans and plastic bottles received at the Recycle Bank and from the Owners' Site Office and Village. The extension of a storage area for the pressing machine was completed. The machine was installed and instructions were provided for its use. The machine will be tested for the first time in April 2016. The machine will be operational when all safety measures have been approved by NNP1PC, as shown in the photograph below.

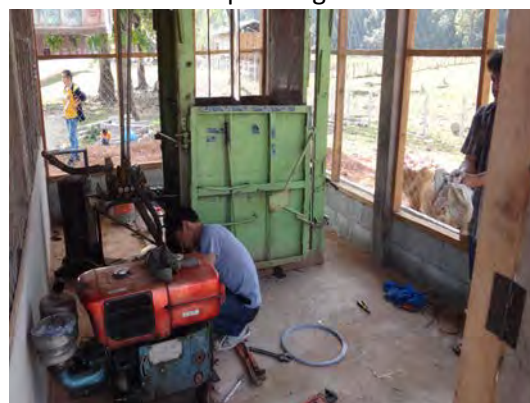
Photograph 14:  
Installation of the pressing machine
