## Nam Ngiep 1 Hydropower Project (Lao People's Democratic Republic)

### Quarterly Monitoring Report 2016 – Q2 Environmental

# Environment Monitoring Report Second Quarter of 2016

April to June 2016

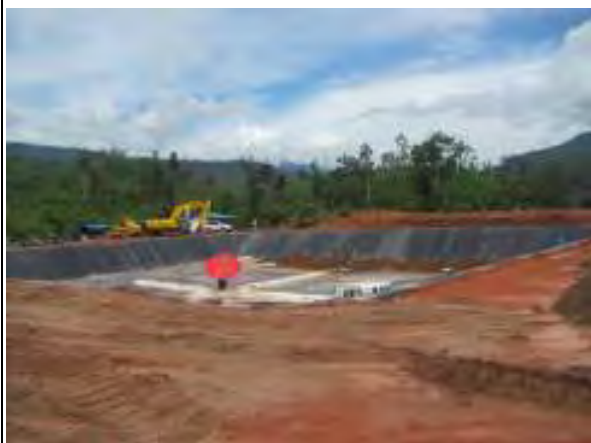
Photograph 5: Completed HDPE lining of sanitary solid waste pit

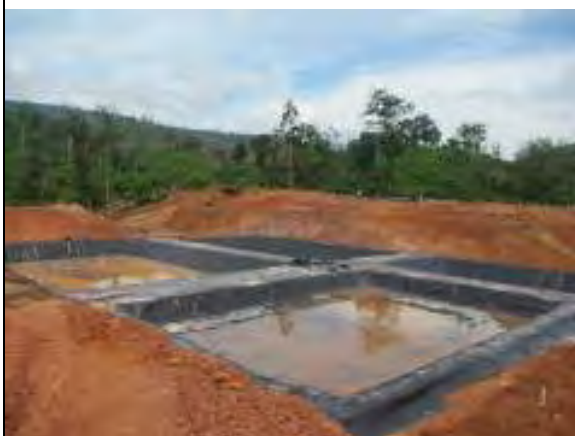
Photograph 6: Completed HDPE lining of treatment ponds

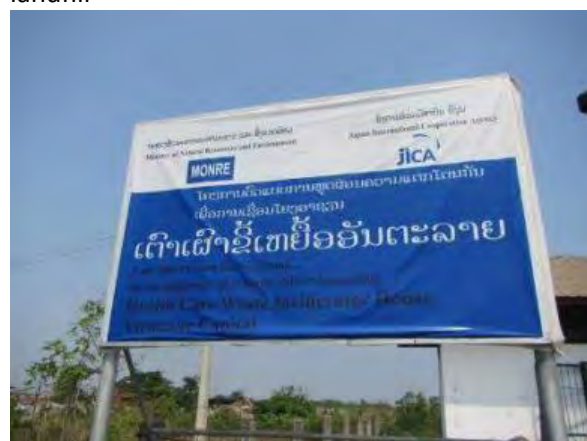
Photograph 9: An incinerator at the Vientiane landfill

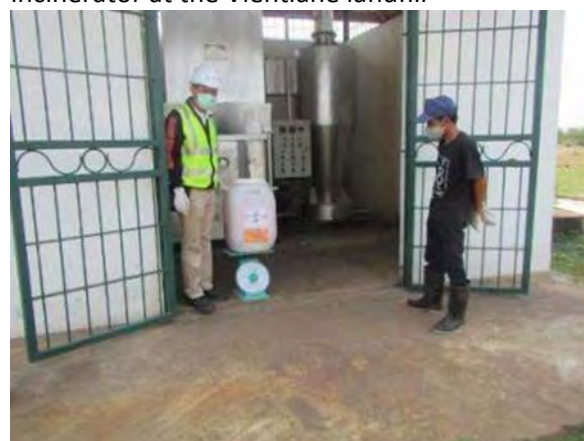
Photograph 10: Clinical waste was sent to the incinerator at the Vientiane landfill

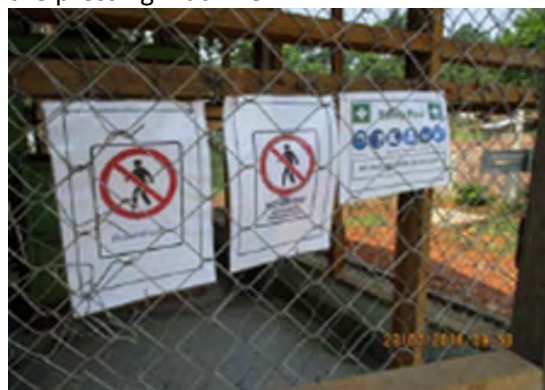
Photograph 13: The extended storage area for the pressing machine

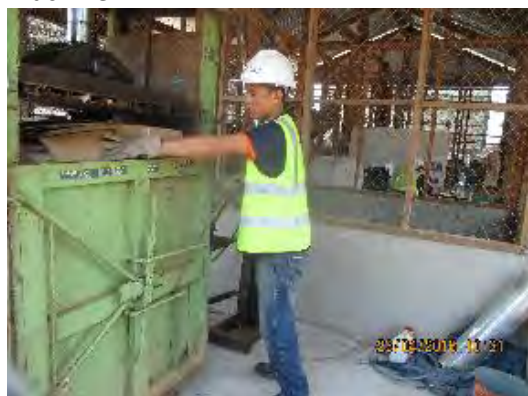
Photograph 14: Installation of the pressing machine

A trial test of the recyclable compactor was carried out for the first time in April 2016. This trial operation was done in collaboration with the NNP1PC-Technical Division's Safety Team and included an environmental assessment (noise monitoring). The results of the noise monitoring at different distances from the crushing machines are summarised below:
