Nam Ngiep 1 Hydropower Project (Lao People's Democratic Republic)

Quarterly Monitoring Report 2015 – Q4 Environmental

Fourth Quarter Monitoring Report (4th QMR)

October to December 2015

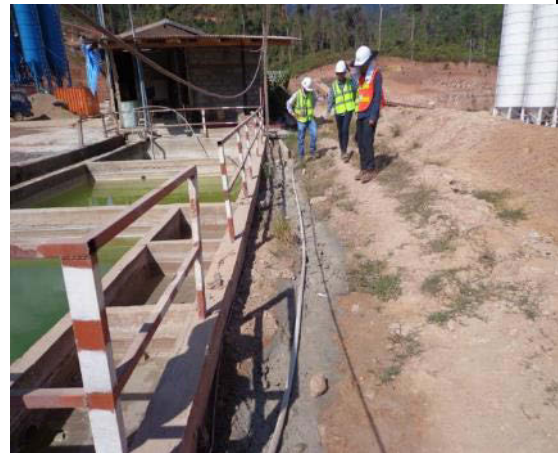
Photo 3: Sediment and Erosion Control Structure at the Road T10/T11

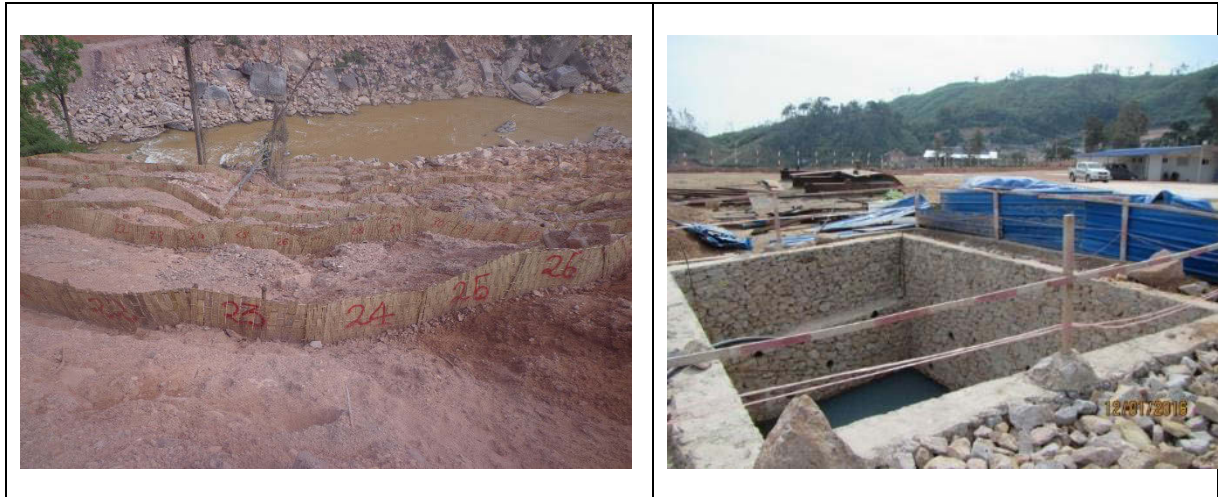
Photo 4 : Improvement of the WWTS of Sinohydro Camp

A total of 36 new ONCs were issued compared to 62 in the previous Quarter. A total of 48 Observations of Non-Compliances (ONCs), 1 NCR Level 1 on the Sinohydro camp’s WWTS and, 1 NCR Level 2 on erosion control below the Access Road T11 were resolved in this Quarter (Figure 7 and Table 1). More details of the non-compliance issues and corrective actions can be found in Appendix 2.

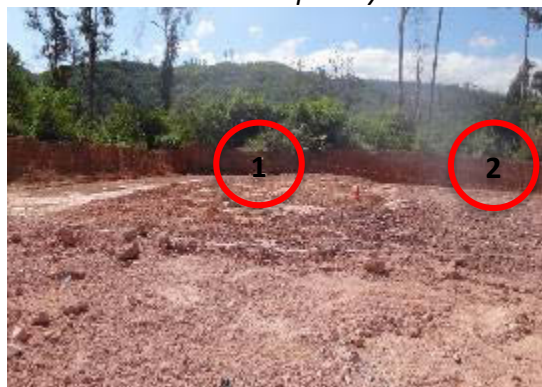
Photo 5: First Two Temporary Waste Pits

The EMO continues to monitor conditions at the landfill site, participate in the review of the consultants' report and encourage completion of the facility in the shortest possible time.

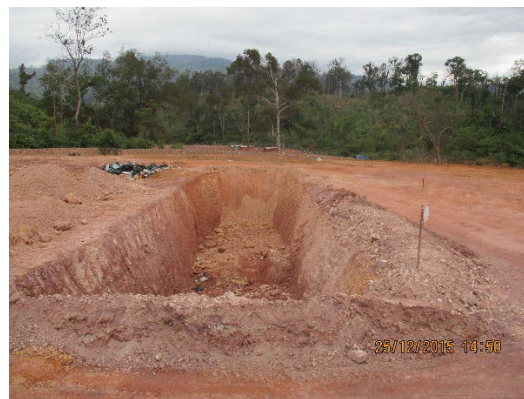
Photo 6: The Fourth Waste Pit

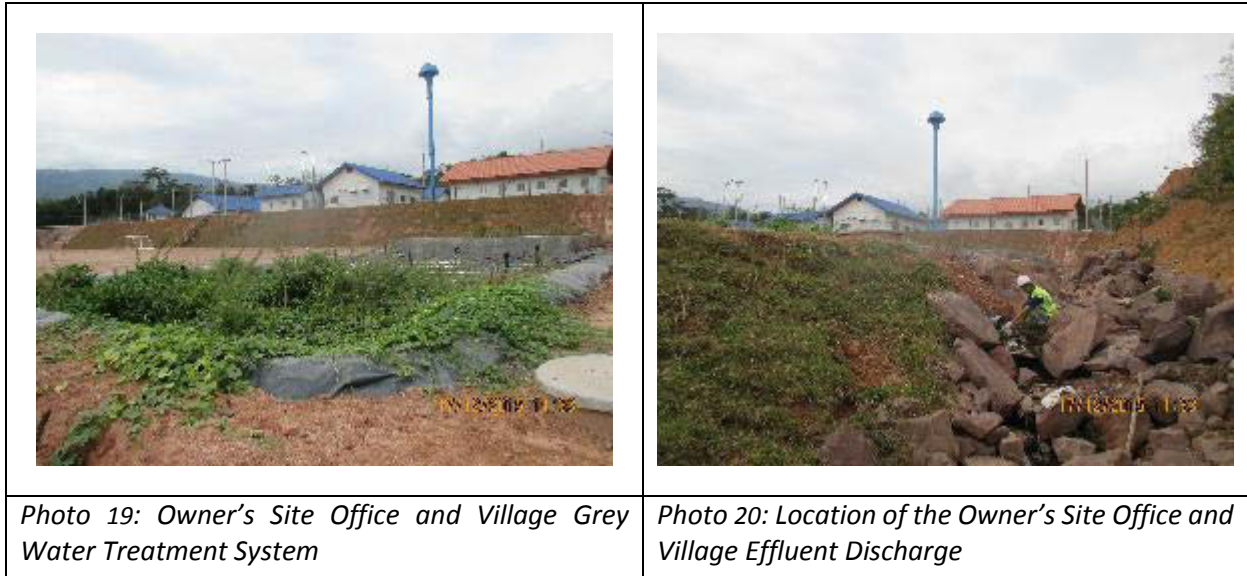
Owner's Site Office and Village (EF01): At this station, the total and faecal coliforms were recorded as 2,200 MPN/100 ml in December 2015, which was above the prescribed Standard

for total coliforms set at 400 MPN/100 ml. The estimated volume being discharged was approximately 70 m³ per day.

For more information on the corrective actions, refer to a section on **Error! Reference source not found.** in Appendix 2.

The Waste Water Treatment Systems (WWTS) at the construction camps has been reviewed by the Independent Consultant and an upgrade is in progress at V&K, RT and Song Da Camps.

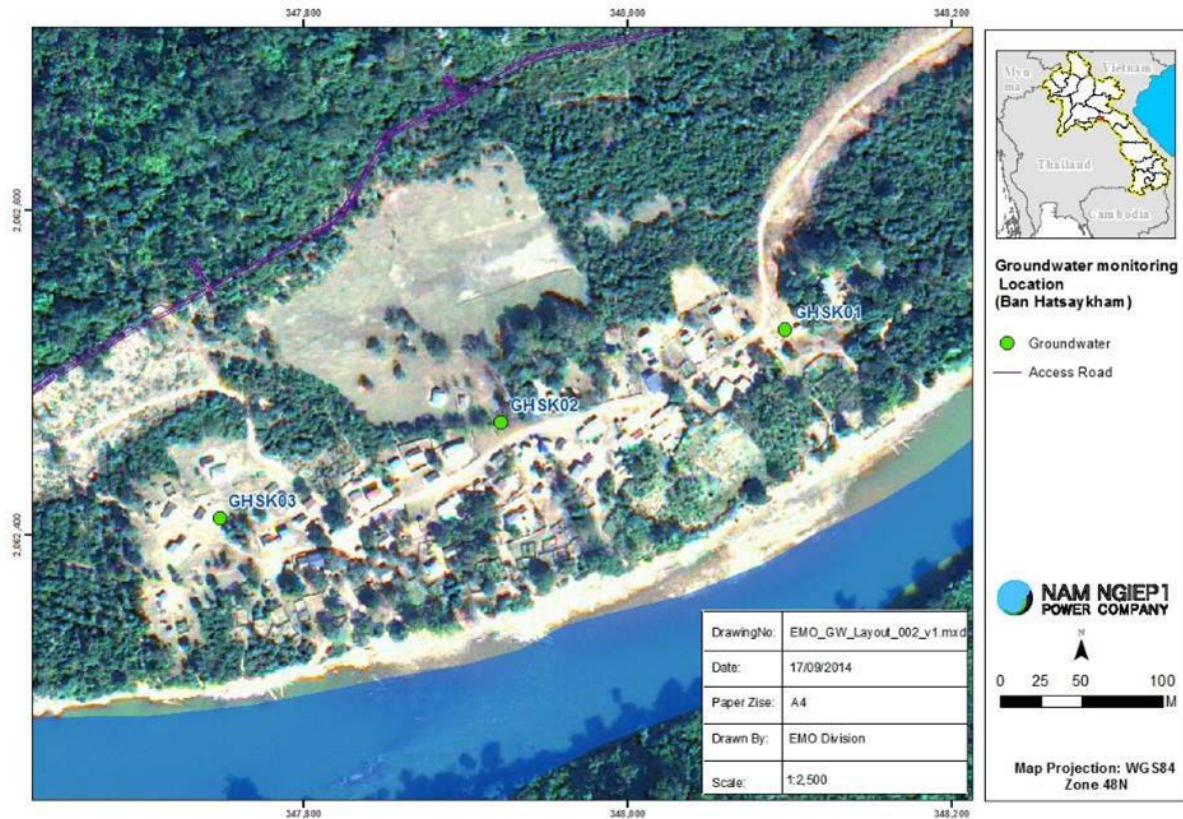
Fig. 8 Map of Groundwater Sampling Site at Ban Hatsaykham

Most water quality parameters in three boreholes of Ban Hatsaykham were below the National Environmental Standards, except pH, which decreased from the last Quarter of about 6.1 to slightly less than 6 (Table 12 above). The pH values observed are not considered

to have any significant health impacts on consumers, but it can cause odor and affect the taste of water.
