Environmental Monitoring Report

Bi-Annual Report

January to June 2015

MON: Western Regional Road Corridor Development Project

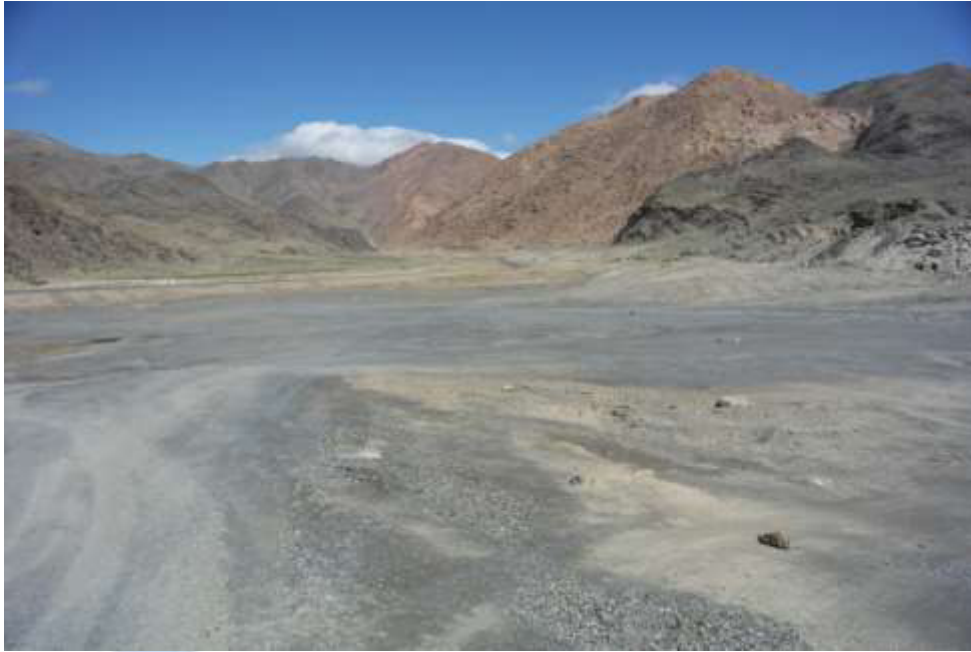
Figure 5: Rehabilitated borrow pit, Tsagduultiin am, STA.54, Package 1.

The Contractor is still using 5 borrow pits this year that are located at STA. 26.5, STA 31.16, STA.53, STA.74 and STA.98 respectively. These borrow points will be rehabilitated in August.

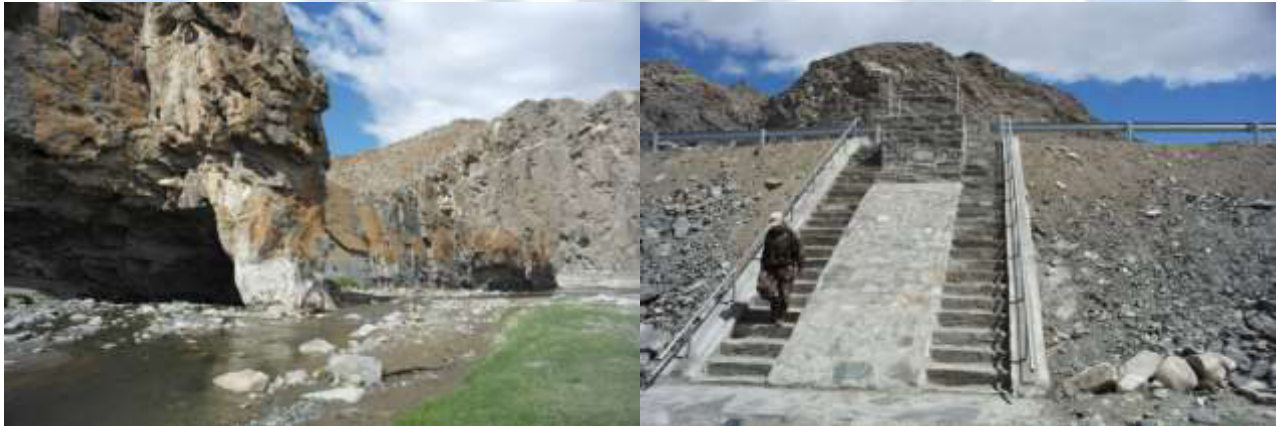
Figure 6: Innovative rehabilitation: A tourist point, STA.25, Package 1

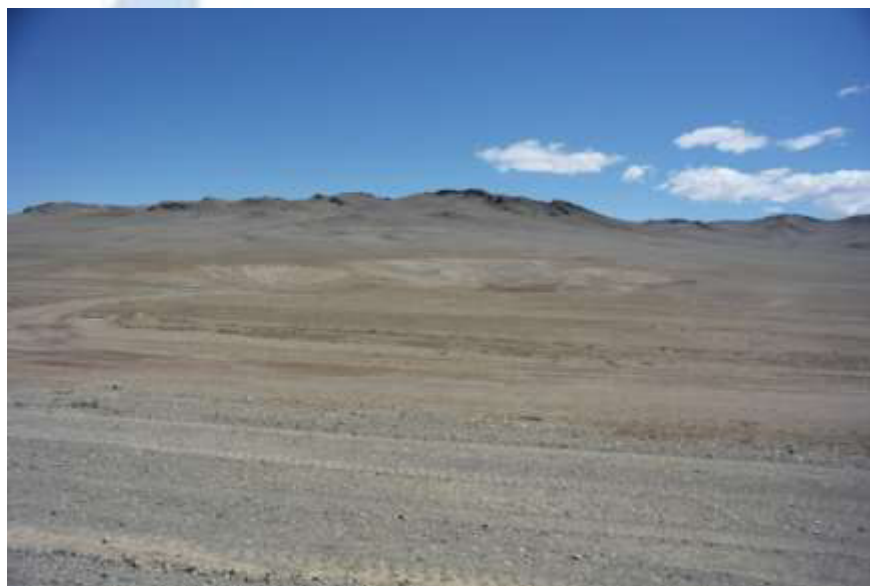
Figure 7: Rehabilitated borrow point along the Package 2 road.

After rehabilitation is completed, the borrow points were handed over to the local administrations. Altay and Must soum environmental inspection teams paid visits to the rehabilitated sites and issued a Letter of Acceptance in October, 2014.

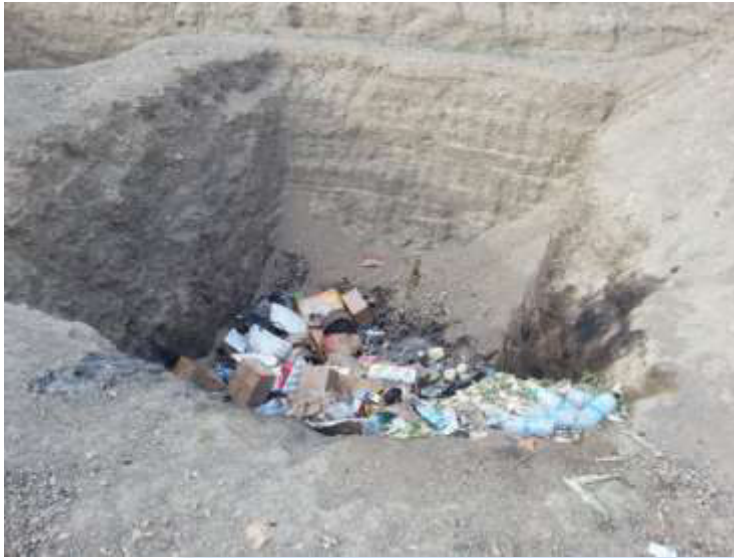
Figure 8: Designated waste collection point at the Main Camp.

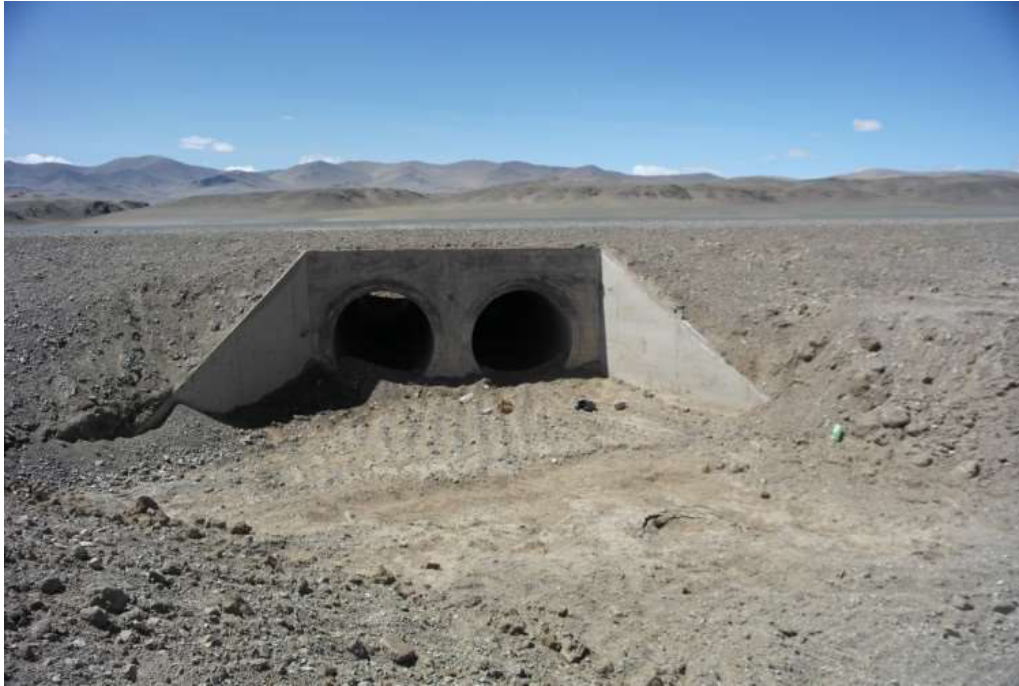
Figure 9: A culvert constructed under the road embankment

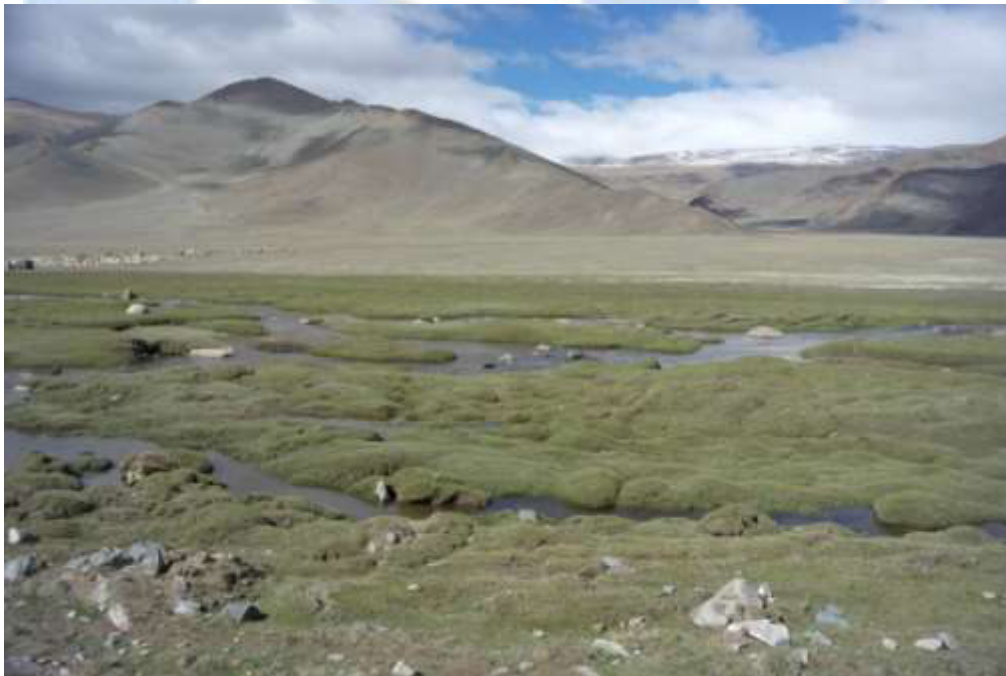
Figure 10: Bodonch river

Bodonch canyon which serves as the main tunnel between the northern and southern parts of the Altay mountain, is 90 km long valley along the Package 1 road starting from the Baga Ulaan Pass all the way to Altay soum center. Bodonch river which is considered an environmentally sensitive area flows through the Bodonch canyon.

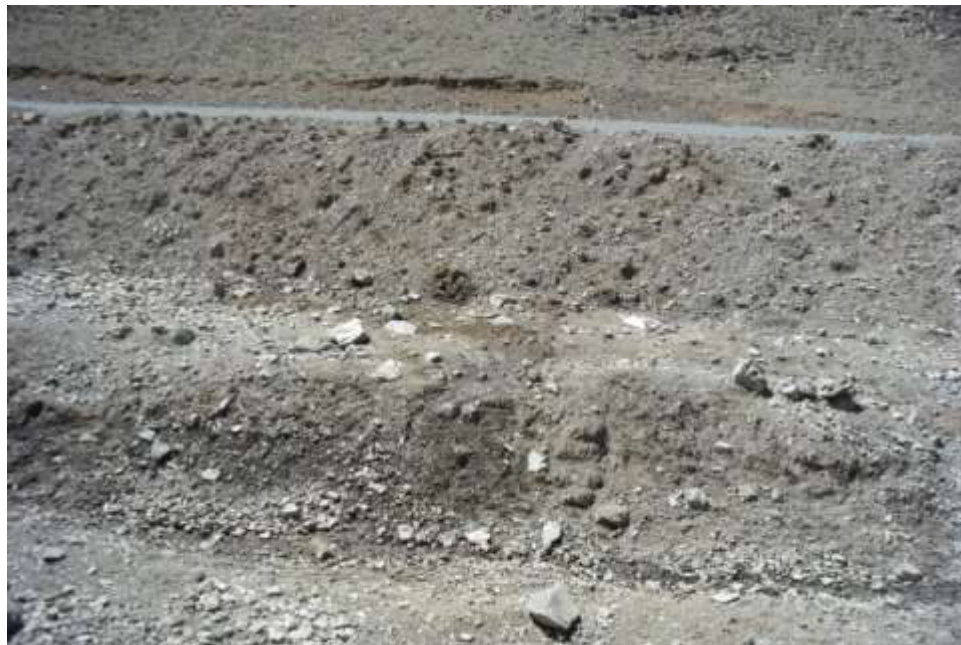
Figure 11: Spring “Ehen us” in Khavchig Canyon

- ❖ The road crosses 2 springs in the Khavchig canyon: Ehen Us and Dund Us. Water source protection actions have been planned for the springs. Since the springs are very important to

livelihood of local people, the contractor and its engineers have been paying a great attention to the river.

- ❖ Construction of culvert for the Dund Us spring.
- ❖ Installed septic tanks and sock well to treat waste water and sewerage water at campsites
- ❖ Construction of locally acceptable drainage system to treat surface water from camp sites and workshops

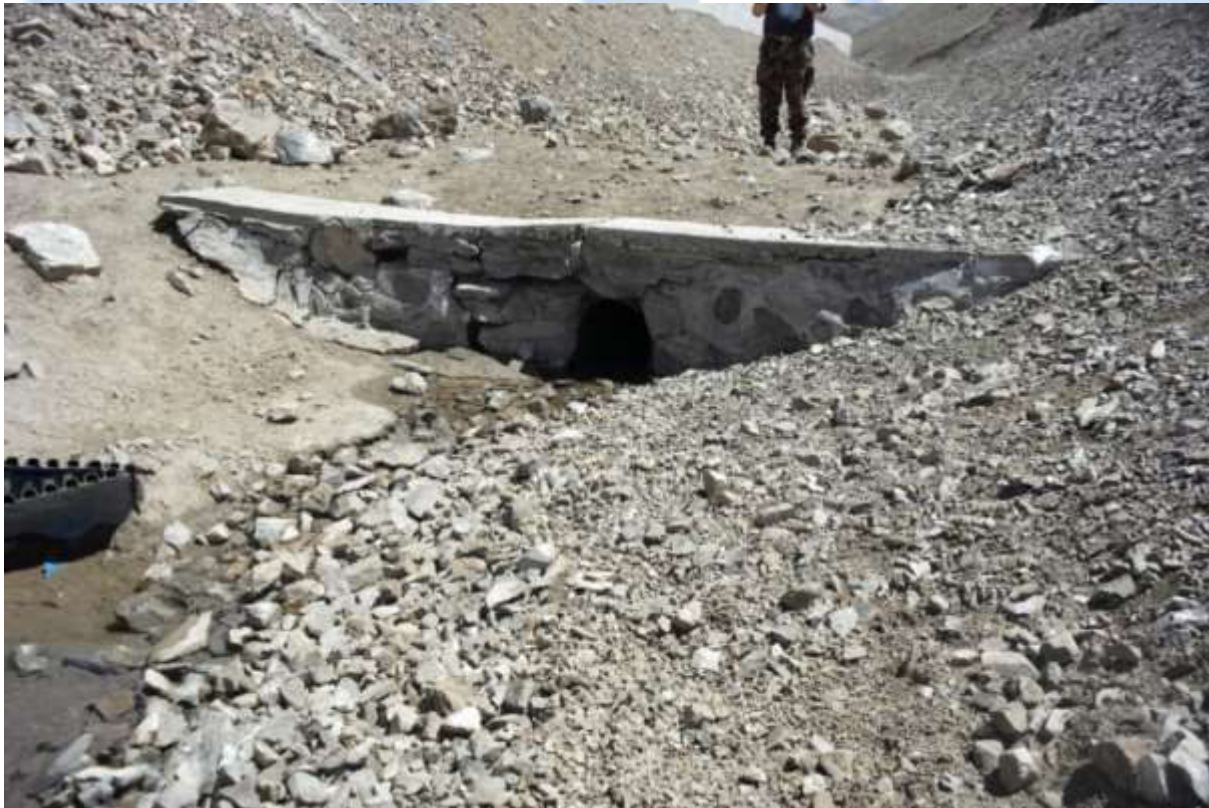
Figure 13: A culvert constructed to protect Dund Us spring in the Khavchig canyon

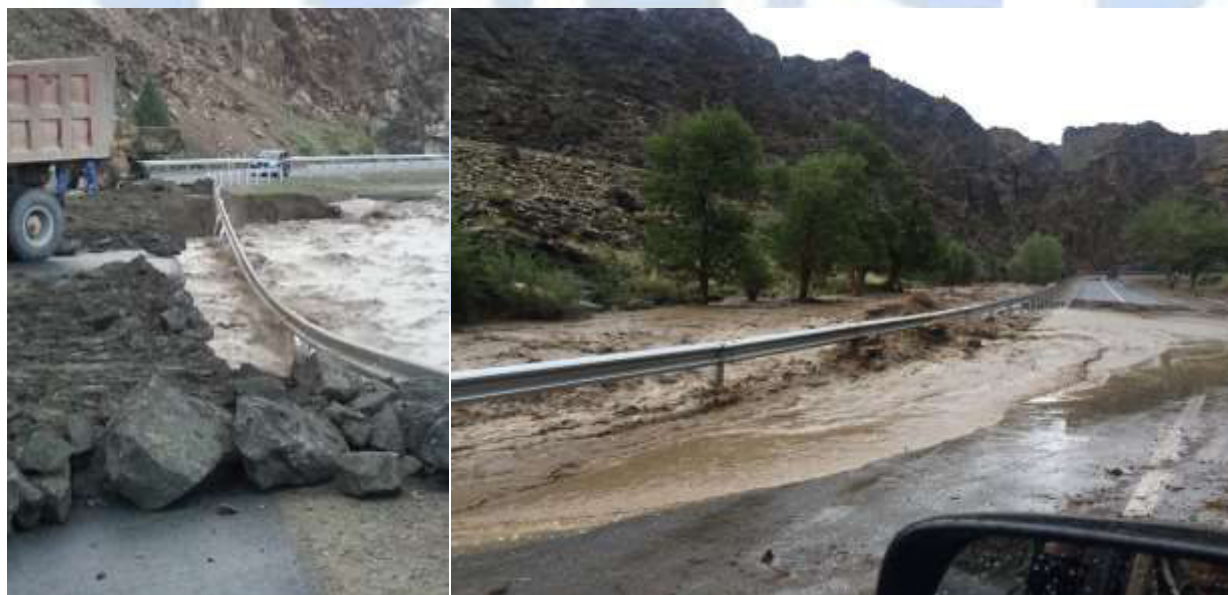
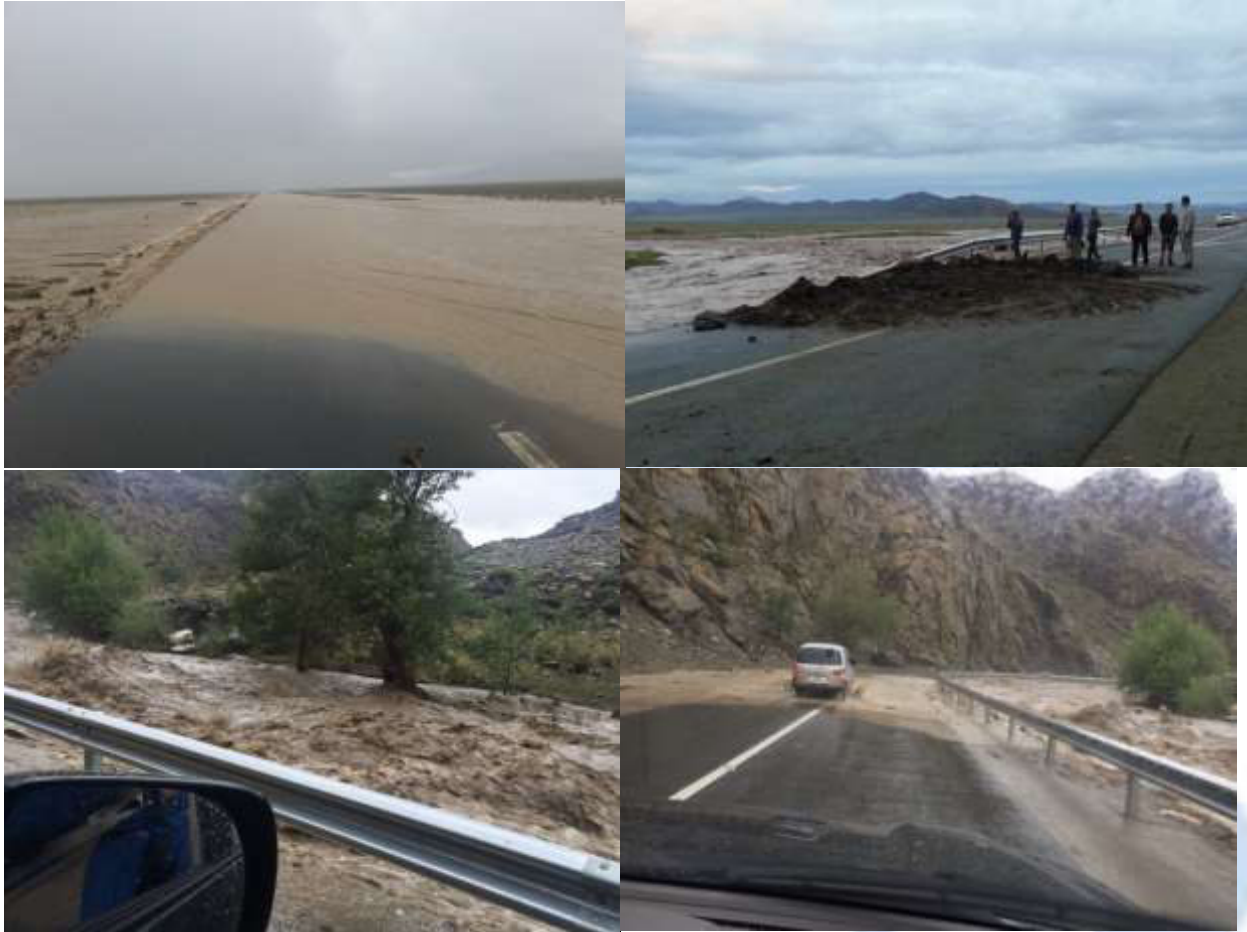
The maximum flood flow measured on June 29th was 33 m³/sec. The highest value of flood flow registered in the Bodonch canyon is 53 m³/sec during the flood occurred in 1987. The Bodonch river is meandering river thus very unstable for erosion banks which may result in destruction of productive land, bridges, bridge approaches, and control works. In this sense all sinuosity place is hydraulically critical area. But if take the damages of slope protection work or grouted stone pitching the section from STA.15+400 to STA 17+ is the most critical places.

Figure 14: Flood damage site at the end point of the Bodonch canyon, STA.15+400

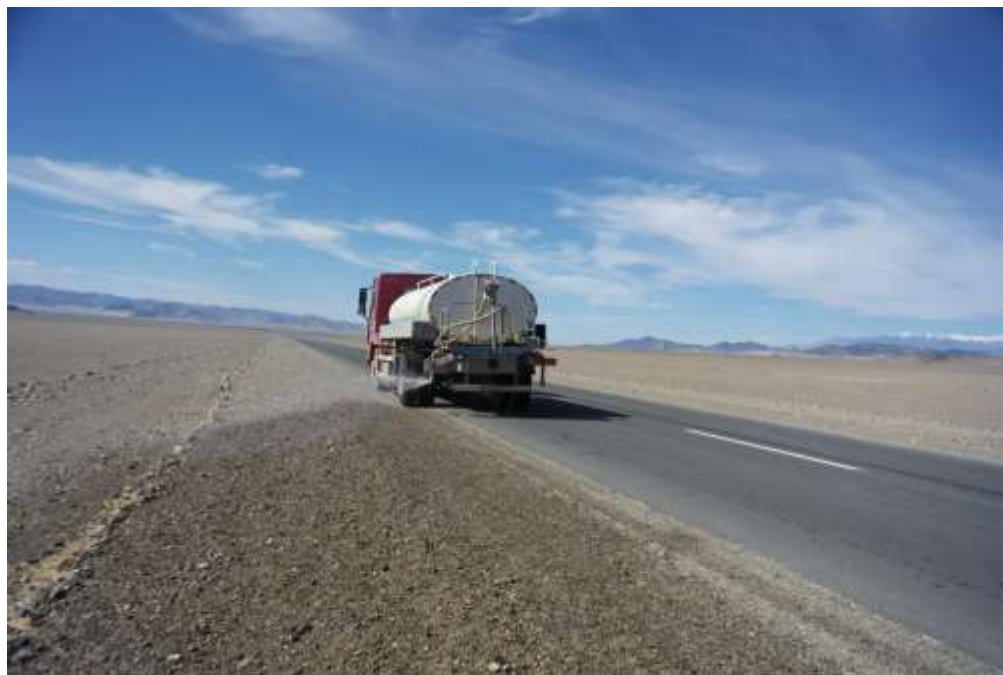
Figure 15: Water spray truck at Shar Khargana valley, Package 2

- ❖ Embankment sections – spraying water by water truck regularly

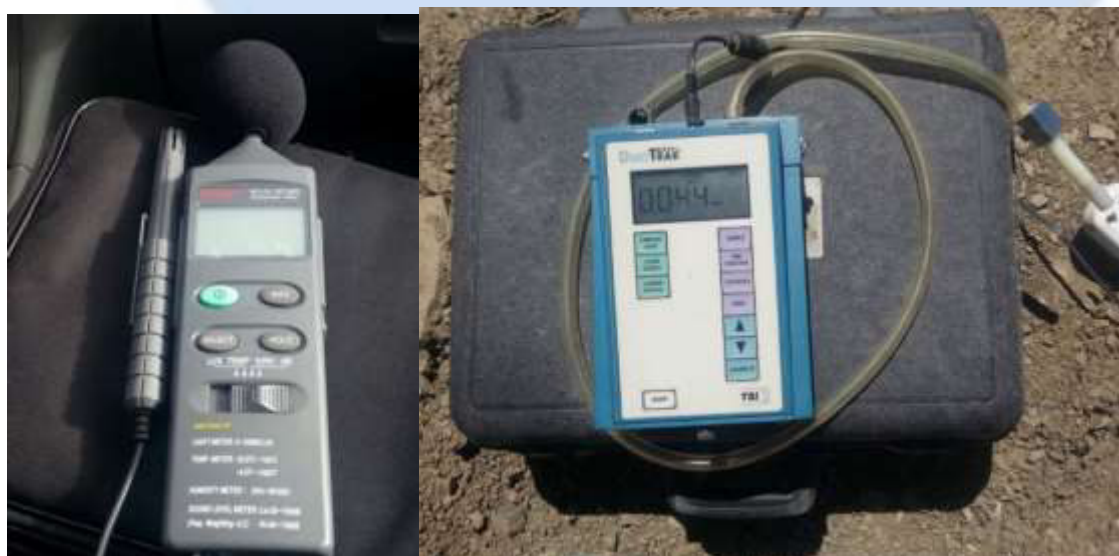
Figure 16: Noise and dust measurement device used for monitoring

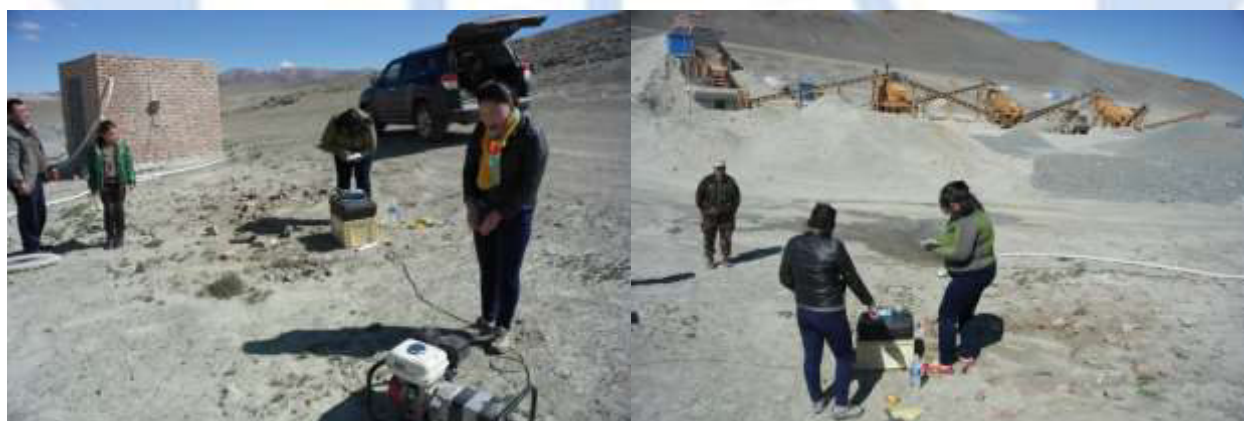
Figure 17: Dust measurement

Measured dust concentration levels were maintained well below the standard level at all 17 monitoring spots during. The measured dust levels were relatively higher at 2 points, namely 5 Ovoo quarry and Khujirt quarry, where mixing plant and concrete plants are operating. Overall, dust levels have been reduced significantly along the road corridor compared to year 2014 because the road construction is nearing its completion and the road is opened to traffic.
