Environmental Monitoring Report

Bi-Annual Report
Project Numbers: 41193-015 and 41193-019
November 2016

Mongolia: Western Regional Road Corridor Investment Program, Tranches 1 and 2

Document Title	EMR 2016 (covering January–June 2016)		
Prepared by	PIU	Issue Date	
Reviewed by		Review Frequency	6 Months
Approved by		Version	Revision
Drafted in August 2016, revised in September 2016		Total Pages	63

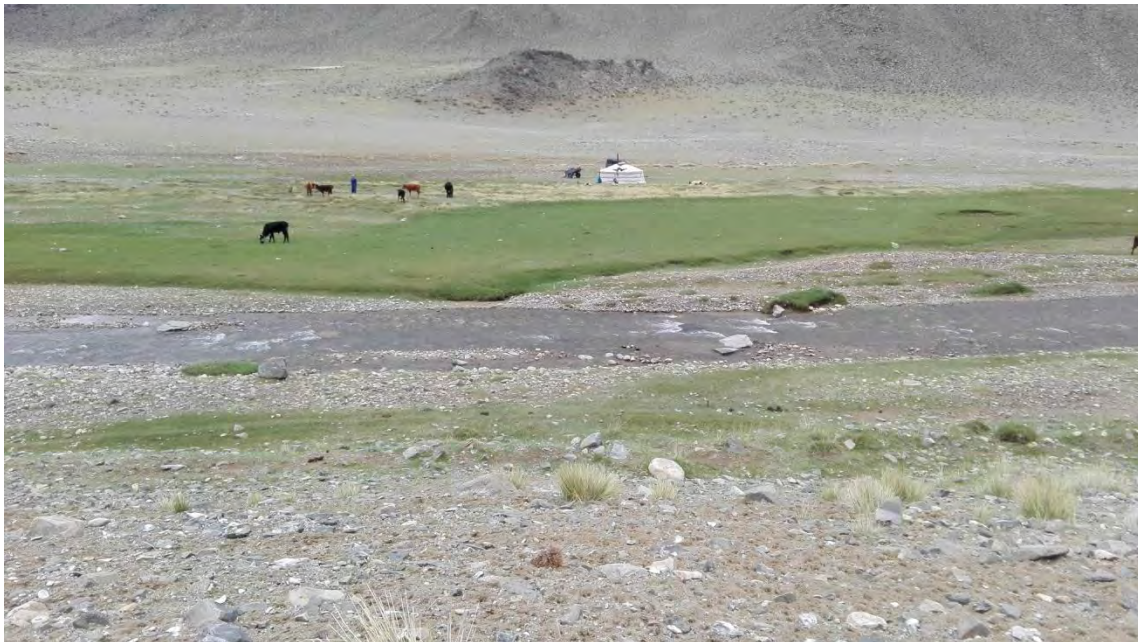
Figure 3: Hongio river valley, lot CW1-1, Tranche 2.

5. **Hongio river valley:** is located at the end of CW1-1 section between STA.5 and STA.19. This area has important historical remainings such as sculptures and tombs. The Hongio river is the main drinking water source for livestock during summer time. The river valley is tight (2-3 km wide at some points) with much of the valley is covered by grass and swash. Hongio river valley is one of the main pasture lands for herds people of Erdeneburen soum during summer time with 70-80 herder households residing.

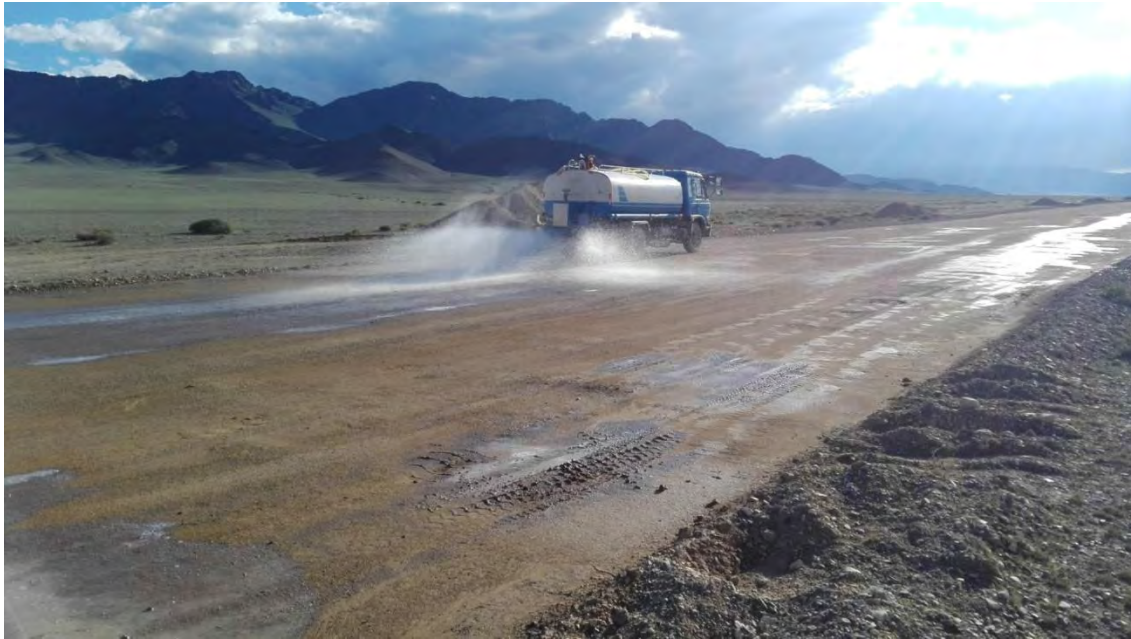
Figure 6. Water spray truck, CW1-1

- ❖ **Asphalt plants and concrete batching plants** is located at least 1000 m downwind from the nearest dwellings in order to reduce the impact of fumes on humans and to be fitted with necessary equipment such as bag house filters to reduce fugitive dust emissions.
- ❖ The location of the stockpile is on downwind of sensitive receptors.
- ❖ **Construction site management.** Water is sprayed on construction sites and material handling routes where fugitive dust is generated. The contractor employ 8 water spray trucks in order to control dust generation.
- ❖ **Air quality monitoring** is undertaken at the selected monitoring spots on monthly basis to ensure dust level is within the maximum allowed level.

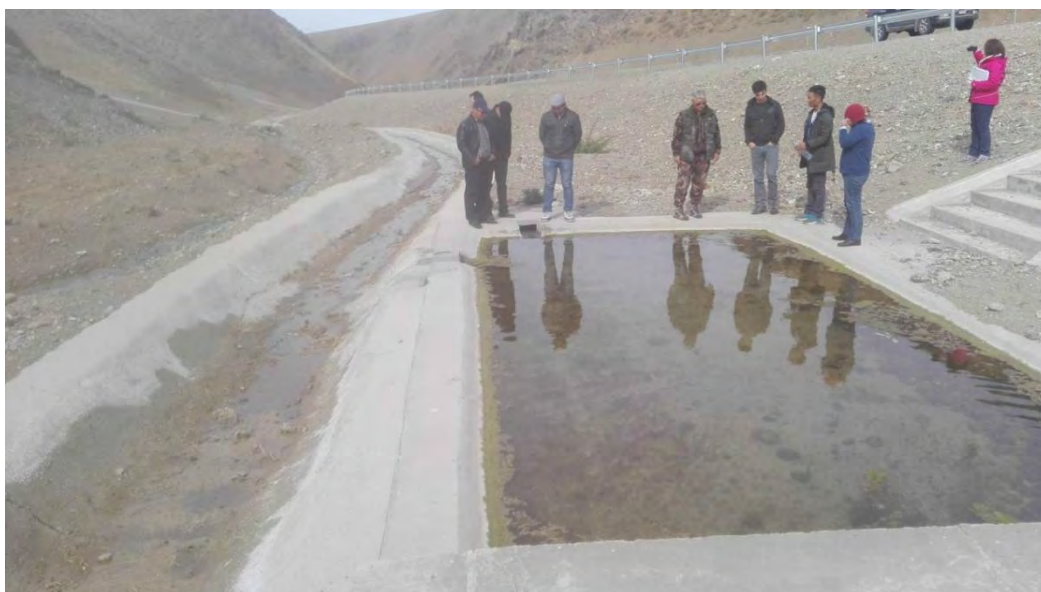
Figure 8. Control pond for Dund Us spring

There are a couple springs in the Khavchig canyon: Dund Us and Ehen Us. The contractor CJJC has constructed cumulation ponds for each spring that allows them to control direction and level of water flow. The contractor was instructed to repair the pond for Ehen Us spring and increase the flow by reducing the level at outflowing gate.

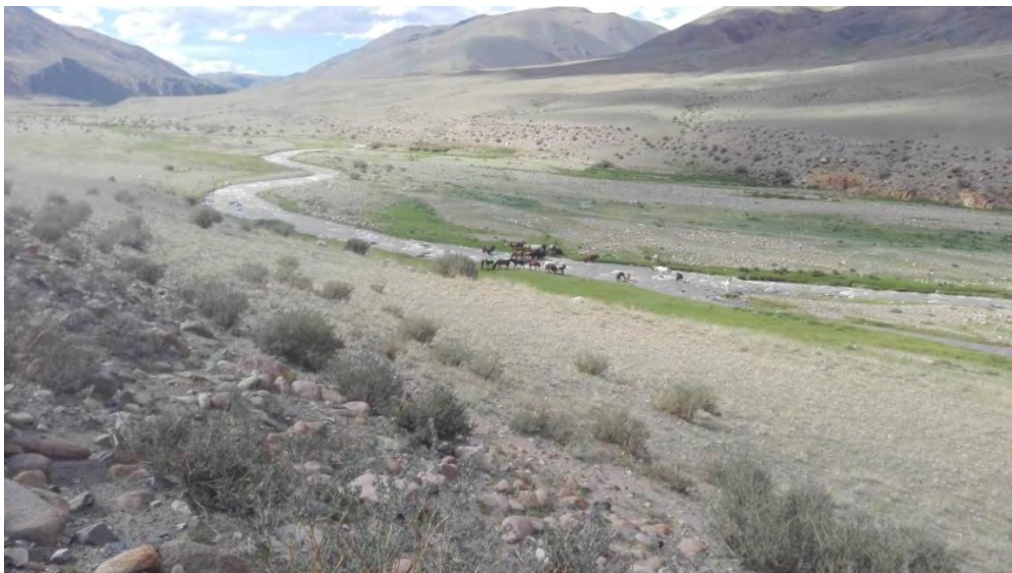
Figure 10: Hongio river

The road alignment crosses Shurga and Hongio rivers. he contractor will construct a new bridge on the Hongio river. Protection of Hongio river valley from potential pollution is important. About 70-80 herder households reside in the Hongio river valley between early June and late August. The Hongio river serves as an important drinking water resource for the herders' livestock. There will be temporary limited access to pastureland for the herder households who reside in the Hongio valley during summer season.

The contractor has obtained permission on water well drilling at 3 spots from the Erdeneburen soum administration. However, no well is created due to low water table. Thus, the contractor is using Shurga and Hongio river water for both drinking and construction purposes and has obtained a written approval from the Erdeneburen soum administration and Khar Lake and Khovd river basin administration to draw river water at 6 points.

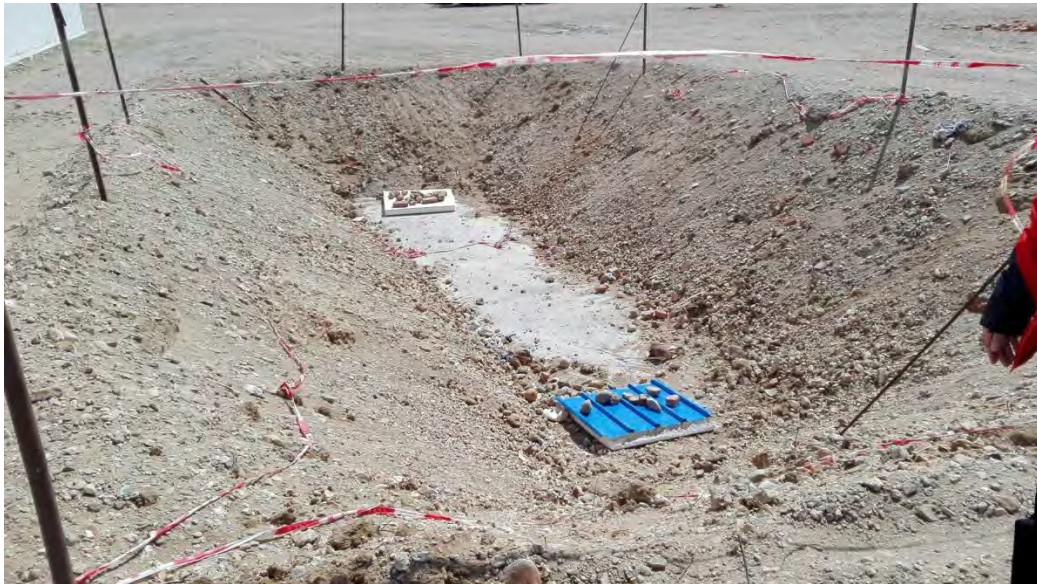
Figure 11: Designated waste water removal facility.

Waste water or sewage from the workers' camp will be disposed to a designated waster storage containers that are installed in a pit and covered with concrete path.

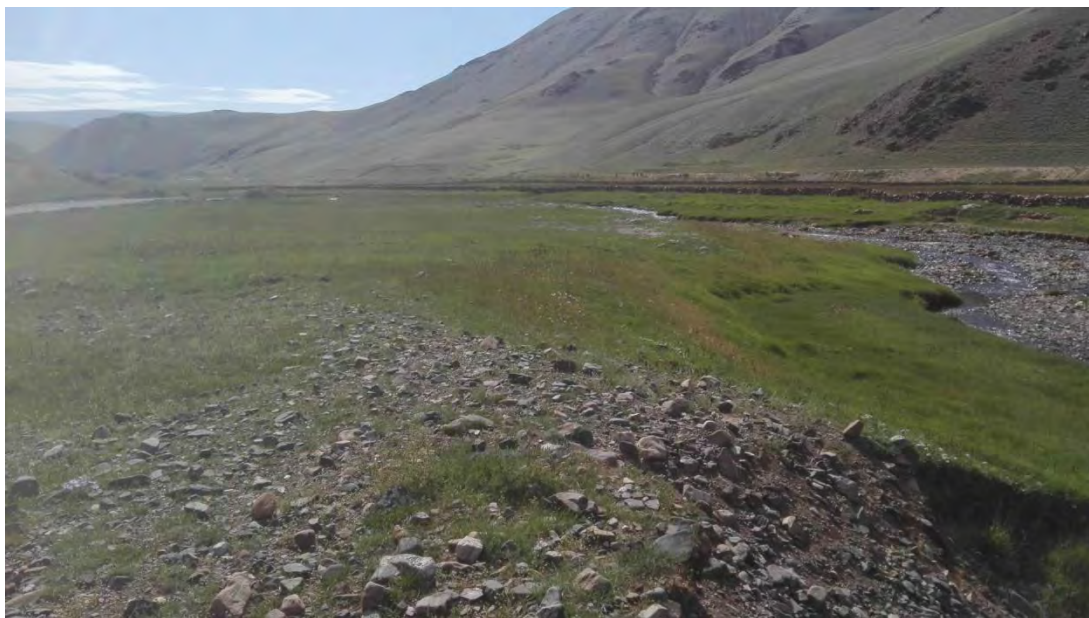
Figure 12: Buraat river valley

According to the road design, a diversion of the Buraat river was executed in July at STA.77. A flood survey is necessary at the site in order to prevent potential damage.

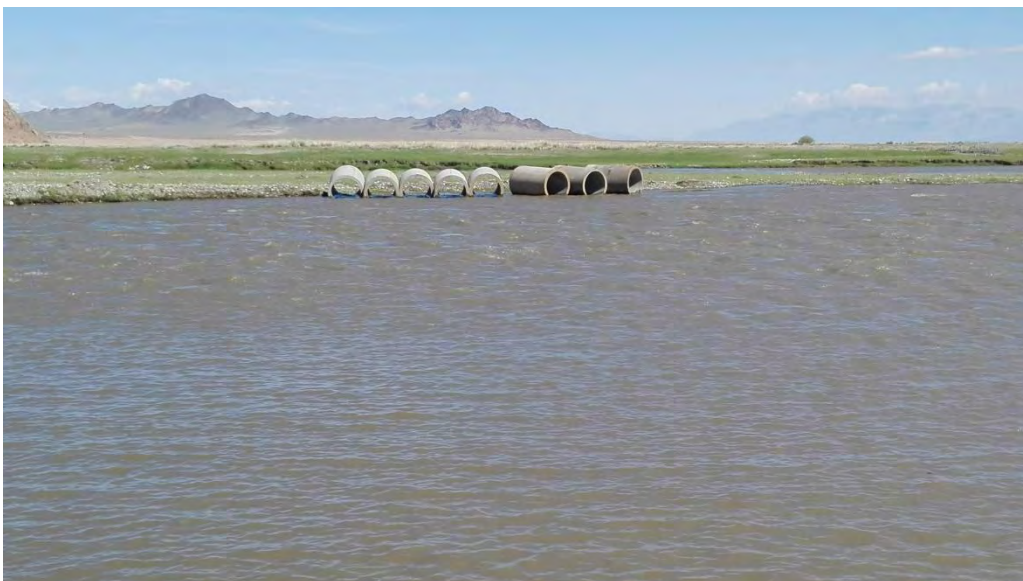
Figure 14. Buyant river.

The contractor is planning to use water from Buyant river and has obtained water use permission from the Khovd soum administration and Khar Lake and Khovd river basin administration bureau. There is one water well drilled at the main camp site, but the water table is very deep (160 m).

In order to prevent oil spillage which could pollute Buyant river, the contractor has constructed a temporary embankment over 3 streams of the Buyant river. A total of 146 culverts are being installed under the deviation road. It was a well planned mitigation measure that meets EMP requirements.

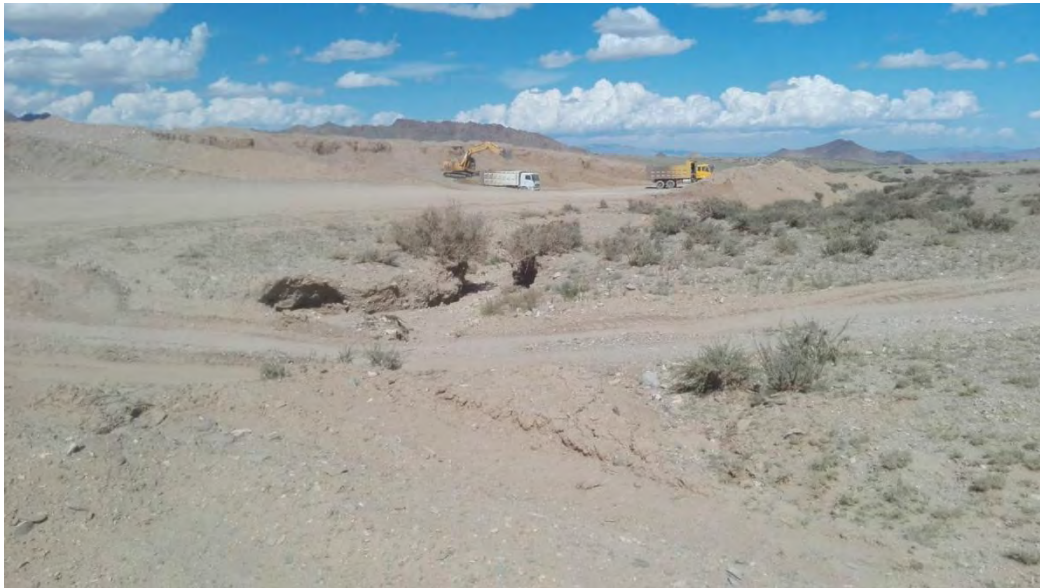
Figure 16. A borrow pit at CW1-1 section. STA.24

There will be 1 quarry site for the CW1-1 section which locates neaby workers' camp where the contractor will produce aggregates for cement and asphalt concrete, graded crushed stone base course material located. Necessary permissions were obtained for the quarry site. An explosion is planned at the quarry site which will be conducted by a local professional firm.

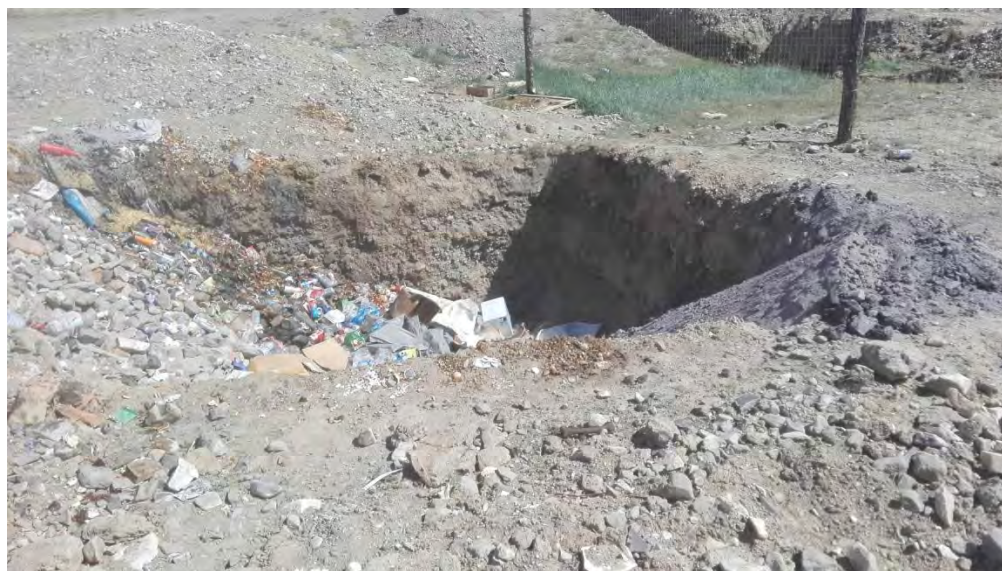
Figure 18. Waste collection point at main camp, CW1-3

- ❖ The contractors have signed "Agreement on waste handling" with the Tolbo and Erdeneburen soum administrations.
- ❖ In accordance with the "Agreement on waste handling", municipal waste from workers' camp will be disposed to the appointed landfill site nearby camp.
- ❖ Construction waste will be delivered to the central dumpsite of the soum center. In accordance with the "Agreement on waste handling", the contractor pays a waste disposal fee of 400,000 MNT per month to the soum administration for using the local dumpsite.
- ❖ Waste water or sewage from the workers' camp will be disposed to a designated waster storage containers that are installed in a pit and covered with concrete path.

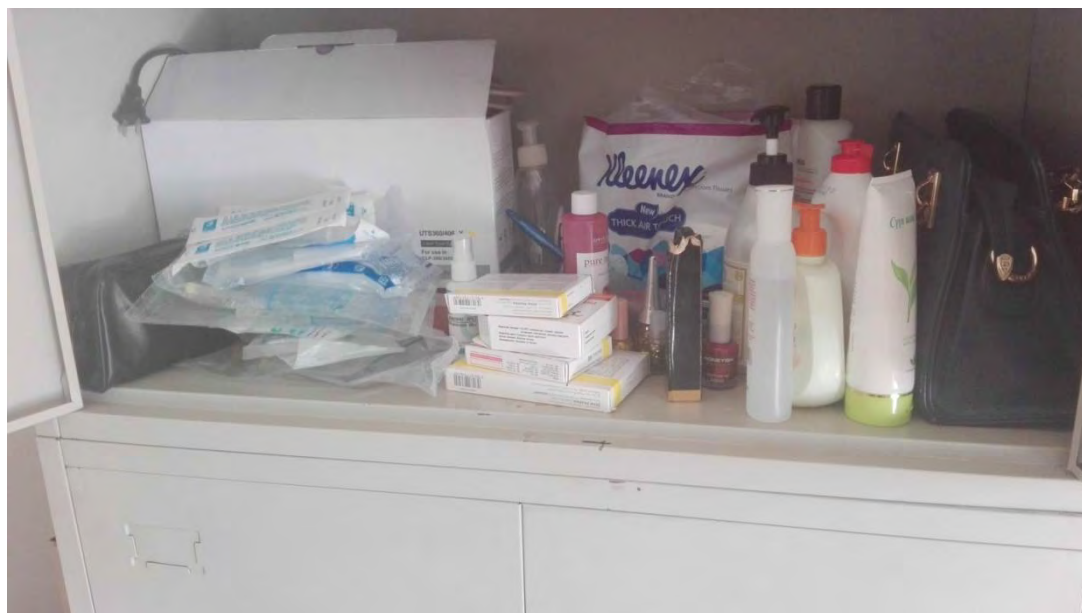
Figure 19. First aid tools possessed by the medician at the CW1-1 main camp.

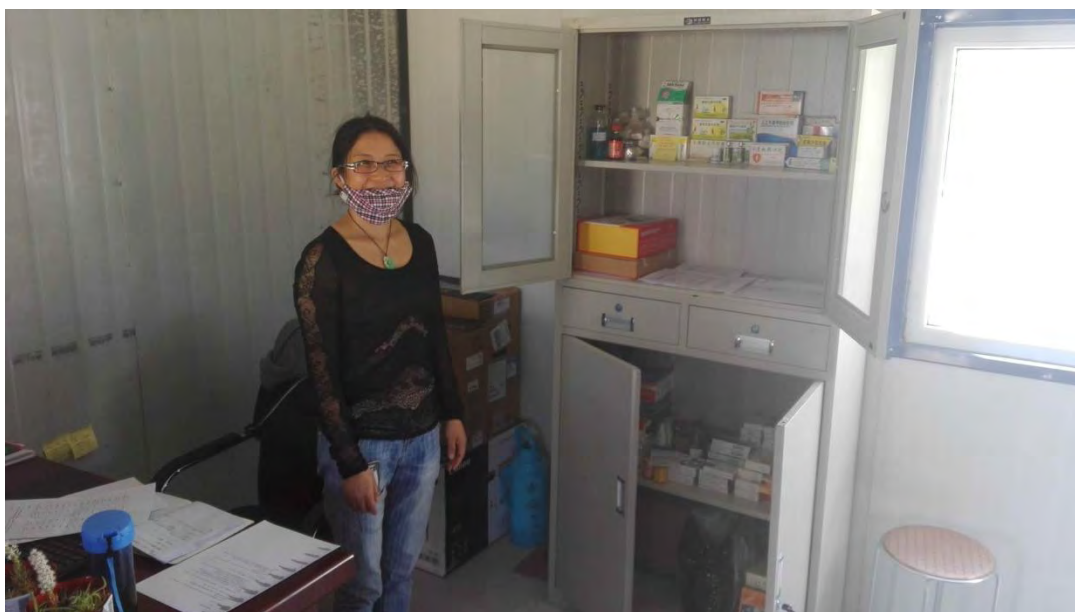
Figure 20. Medician and first aid tools employed at the CW1-3 main camp.

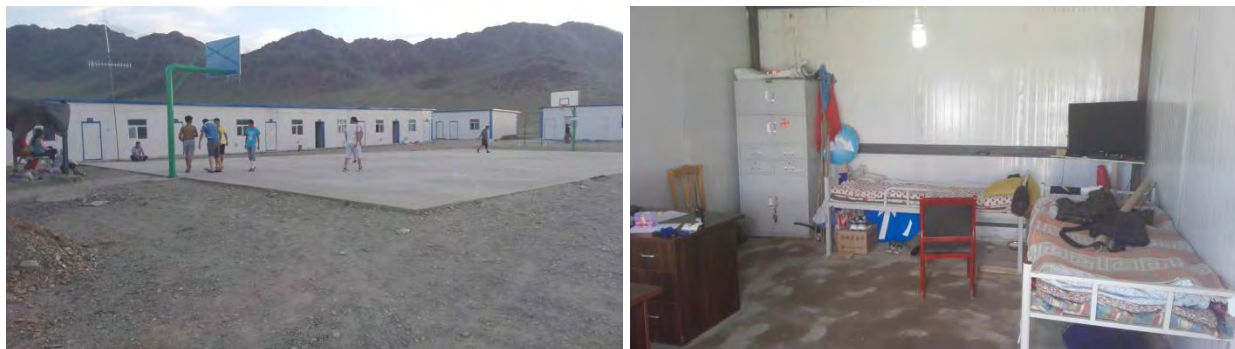
Workers camp sites were constructed before the commencement of the construction in April. Waste collection points, sanitation system, rest rooms, canteen, ventilator, dorms and office rooms are available in the camp. The camp site is protected by surrounding drainage and fences. In order to establish comfort, the camp site is provided with concrete basketball field and convenient dormitory rooms for staffs.

Figure 21. The main camp for the CW1-1 section.

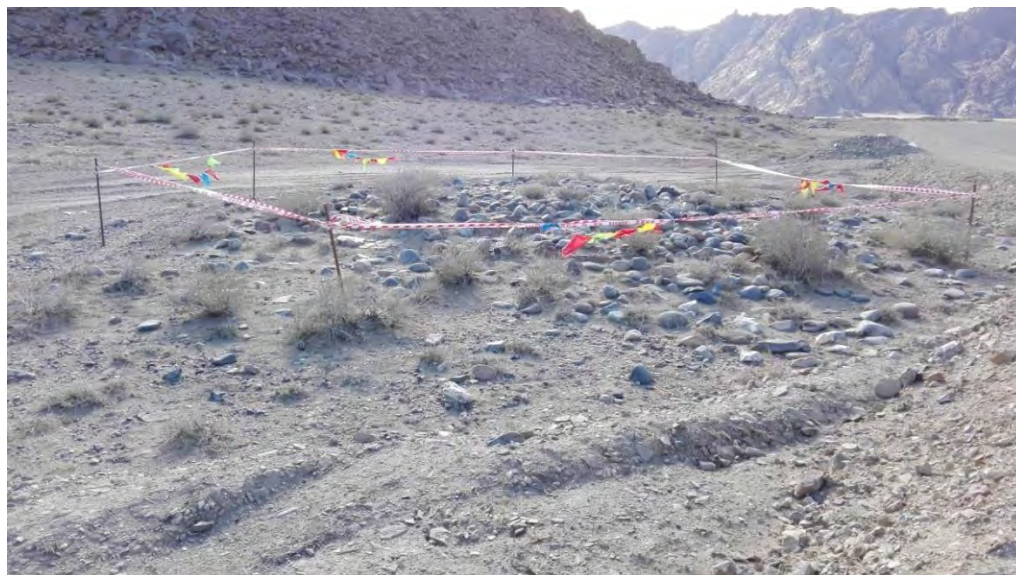
Figure 24. Visibility fencing for ancient tombs

There are 4 ancient tombs and 1 ancient sculpture have been discovered along the CW1-3 road alignment. The 4 tombs are located at STA.86+400, 95+800 and 107+400 (2 tombs) marks respectively. There is an ancient sculpture on the Buraat pass (STA.84). The contractor has raised awareness of physical cultural resources among its construction staffs.

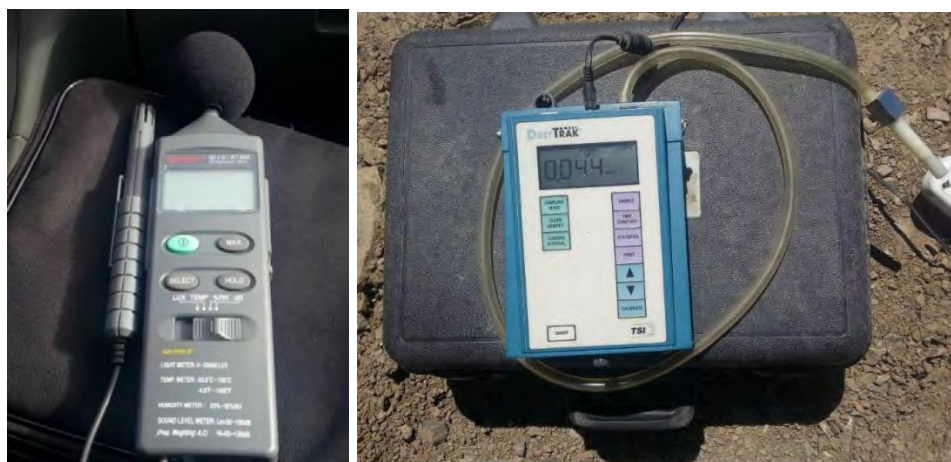
Figure 25: Noise dust measurement devices used for monitoring

- ❖ Noise emission level (mega Hertz)
- ❖ Water chemical contents: turbidity, mineralization, hardness and contents of other chemicals
- ❖ Water contamination: contents of Pb, Zn, Cd, Cr and Ni.
- ❖ Soil chemical contents: sand, mud and contents of other chemical elements.
- ❖ Soil contamination: contents of Pb, Zn, Cd, Cr and Ni.
- ❖ Hygiene inspection: inspection on waste and sewage removal, physical condition of camp sites, hygiene condition of kitchen and canteen, drinking water standards.

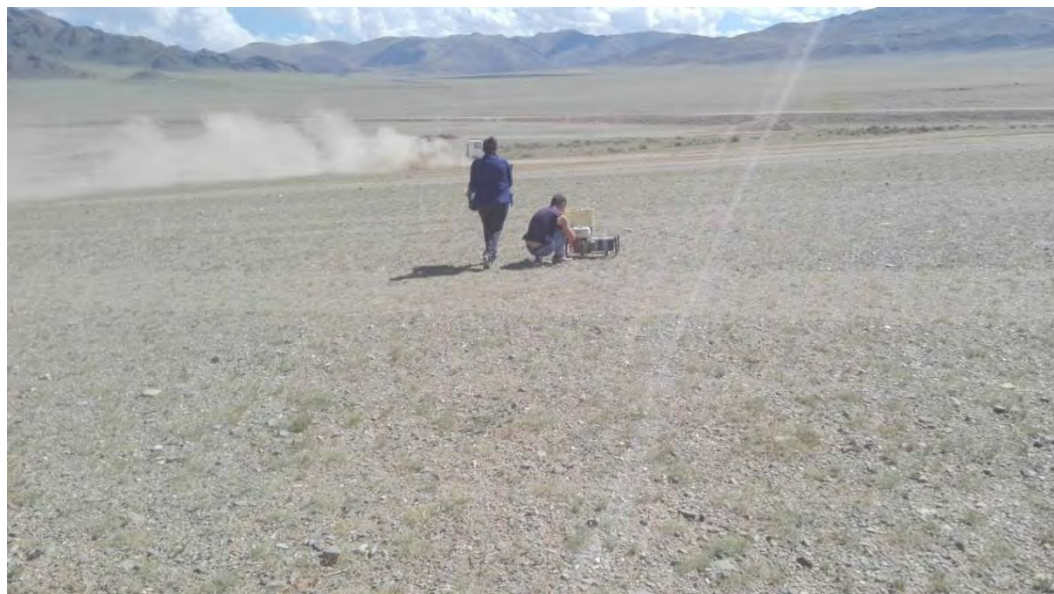
Figure 26. Dust measurement activity on July 1.

Monitoring Spot No.	Name of the monitoring spot	Average dust concentration level /per hour/, mg/m3			Standard level mg/m3
		May	June	July	
1	Nearby Shurga river bridge	0.053	0.048	0.033	0.1
2	Ontsiin Khutul	0.078	0.075	0.039	
3	Shar nuur	0.069	0.079	0.078	
4	Nearby construction camp	0.067	0.072	0.052	
5	Hongio bridge	0.042	0.053	0.1	
6	Hongio valley 1	0.021	0.018	0.098	
7	Hongio valley 2	0.012	0.014	0.045	
8	Hongio valley 3	0.009	0.01	0.013	
9	Bayan Enger	0.021	0.017	0.015	
10	Khashaat pass	0.005	0.009	0.01

- ❖ All trucks transporting earth materials shall be covered with tarpauling
- ❖ Fine particle stockpiles nearby the crusher need to be covered with tarpaulin.

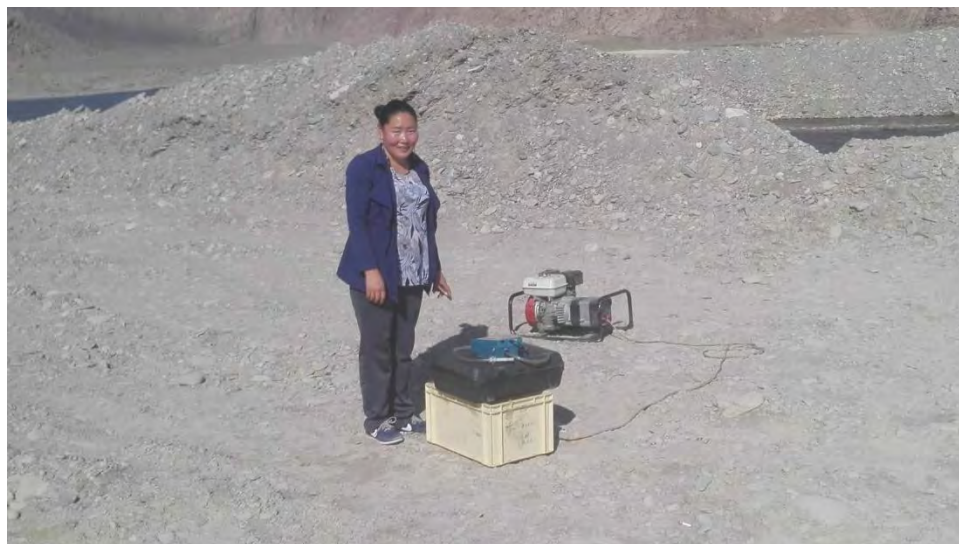
Figure 27. Dust measurement

Monitoring Spot No.	Name of the monitoring spot	Average dust concentration level /per hour/, mg/m3			Standard level mg/m3
		May	June	July	
1	Nearby waste water treatment plant	0.018	0.012	0.009	0.1
2	Nearby bridge No.1 at Buyant river	0.006	0.009	0.097	
3	Nearby bridge No.2 at Buyant river	0.007	0.008	0.073	
4	River crossing point at stream No.1	0.013	0.011	0.059	
5	Ulaan Bogoch spring	0.063	0.055	0.023	
6	Nearby quarry site	0.097	0.078	0.1	
7	Nearby main camp	0.085	0.083	0.067	
8	Nearby a herder's cattle yard	0.076	0.047	0.021	
9	Nearby a herder's spring shelter	0.038	0.031	0.013	
10	Nearby Shurga river bridge	0.026	0.016	0.01

- ❖ All trucks transporting earth materials shall be covered with tarpauling
- ❖ Fine particle stockpiles nearby the crusher need to be covered with tarpaulin.
