Environmental Monitoring Report

Annual Report

Project Number: 41193-015 and 41193-019

Mongolia: Western Regional Road Corridor Investment Program, Tranches 1 and 2

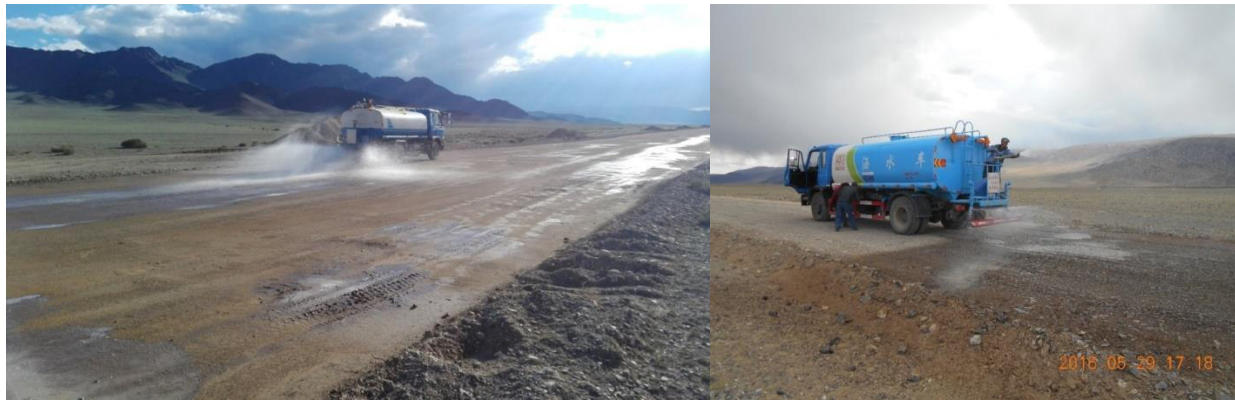
Figure 5. Water spray trucks

The contractors have employed water spray trucks to reduce dust generation at the active construction points. Dust emission level could be at its highest and might disturb the road side communities and workers, thus the contractor is taking the appropriate mitigation measure by operating the water spray trucks that will make the embankment construction sites, side roads and diversion roads. Additionally, dust and noise monitoring works are carried out each month.

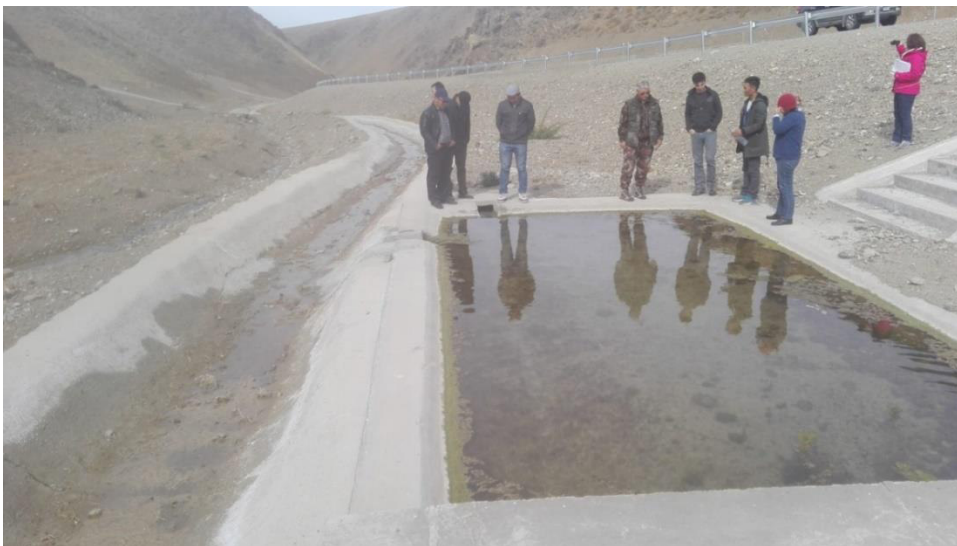
Figure 6. Control pond for Dund Us spring

There are a couple springs in the Khavchig canyon: Dund Us and Ehen Us. The contractor CJJC has constructed cumulation ponds for each spring that allows them to control direction and level of water flow. The contractor was instructed to repair the pond for Ehen Us spring and increase the flow by reducing the level at outflowing gate.

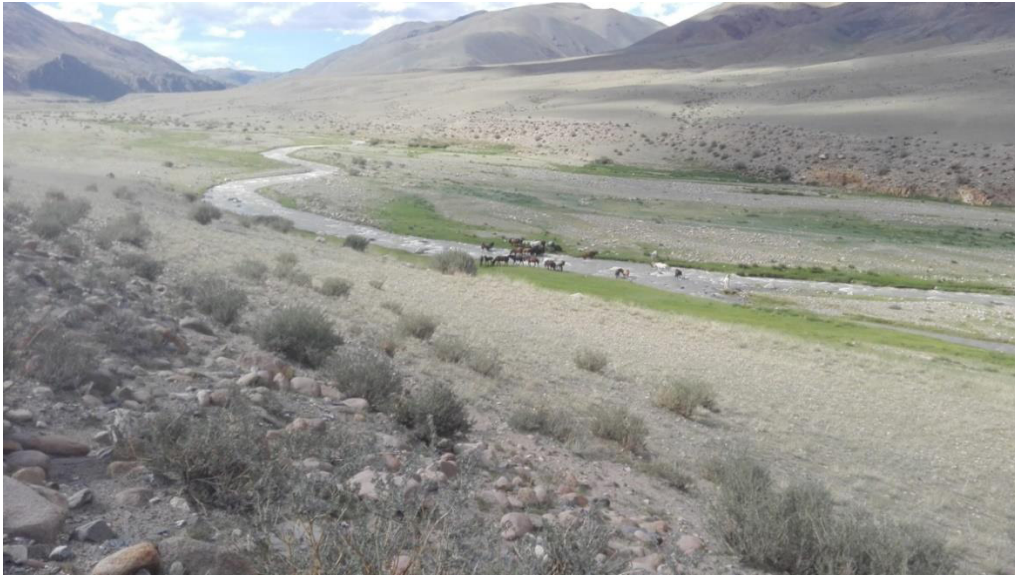
Figure 8: Hongio river

The road alignment crosses Shurga and Hongio rivers. Protection of Hongio river valley from potential pollution is important. About 70-80 herder households reside in the Hongio river valley between early June and late August. The Hongio river serves as an important drinking water resource for the herders' livestock. There will be temporary limited access to pastureland for the herder households who reside in the Hongio valley during summer season.

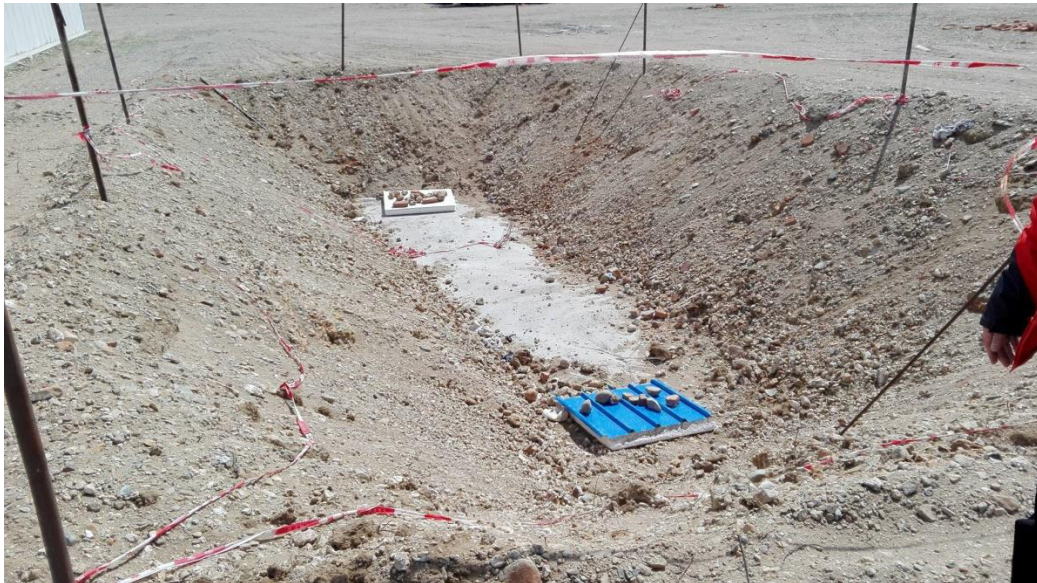
Figure 9: Designated waste water removal facility.

Sewage generated from the workers' camp is disposed to a designated waster storage containers that are installed in a pit and covered with concrete path.

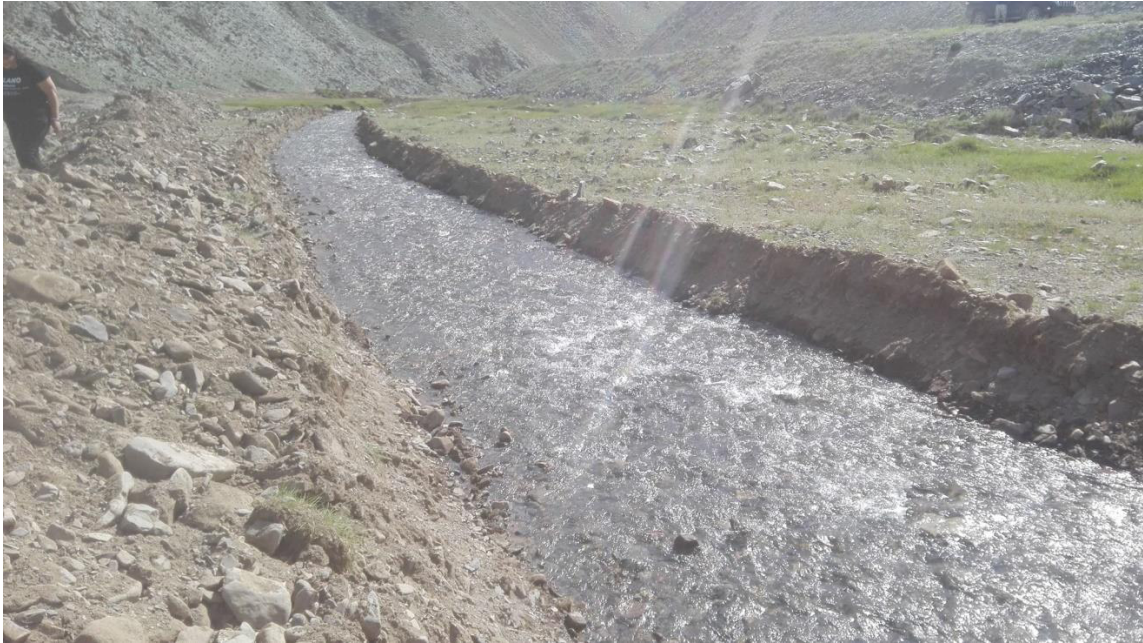
Figure 11. The point where the Buraat river has been diverted.

Buraat river diversion was executed in July at STA.77. A flood survey is necessary at the site in order to prevent potential damage.

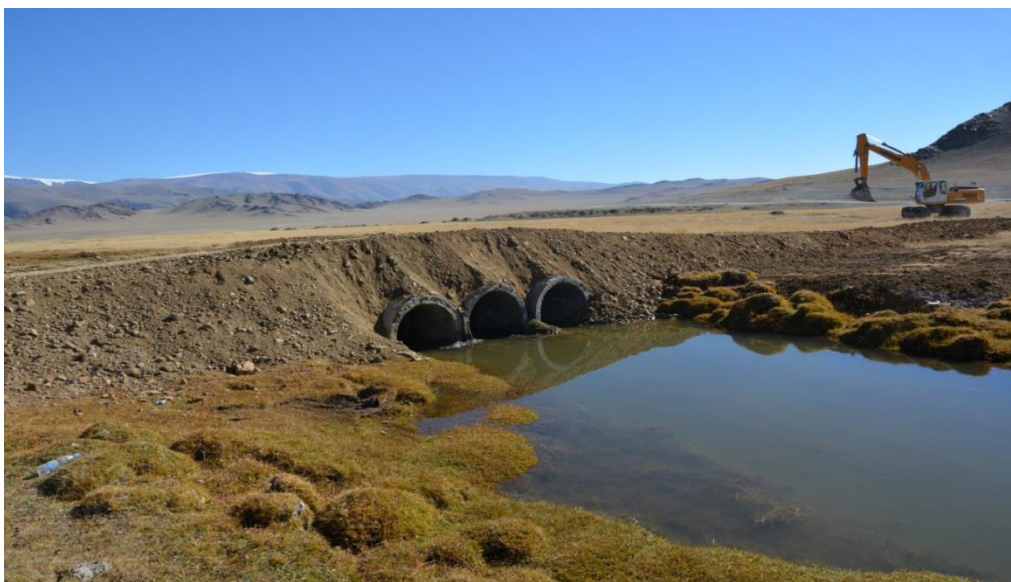
Figure 12. Deviation road embankment over the Hongor Ulun river. STA.100+700

The contractor has constructed water protection embankments at 3 points where the deviation road crosses Buraat and Hongor Ulun rivers to prevent from oil spill, at STA.72+500, STA.75+800 and STA.100+700 respectively. Culverts will be installed under the deviation which allows water flow.

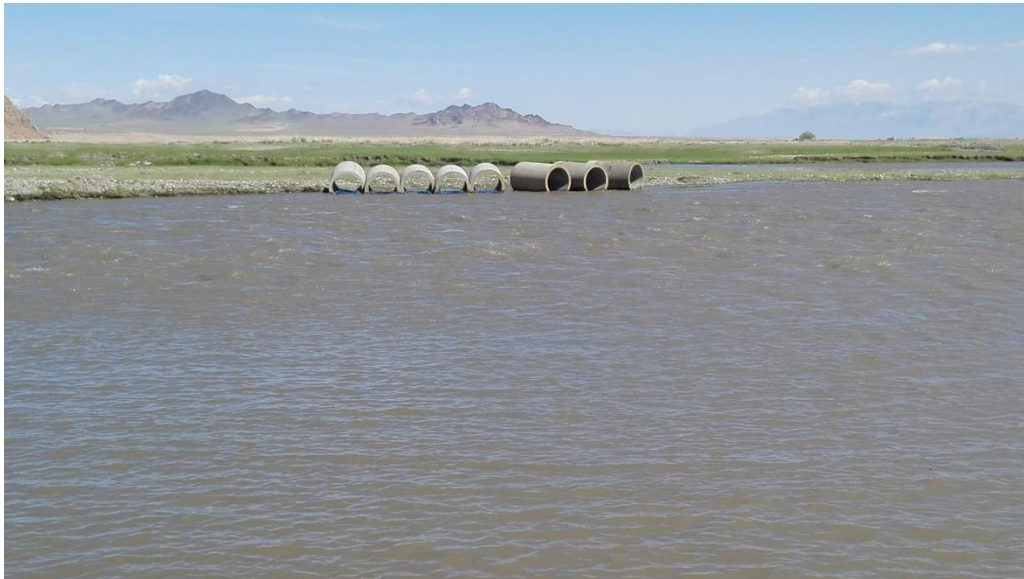
Figure 13. Buyant river.

The contractor is been using water from Buyant river and and has obtained water use permission from the Khovd soum administration and Khar Lake and Khovd river basin administration bureau. There is one water well drilled at the main camp site, but the water table is very deep (160 m).

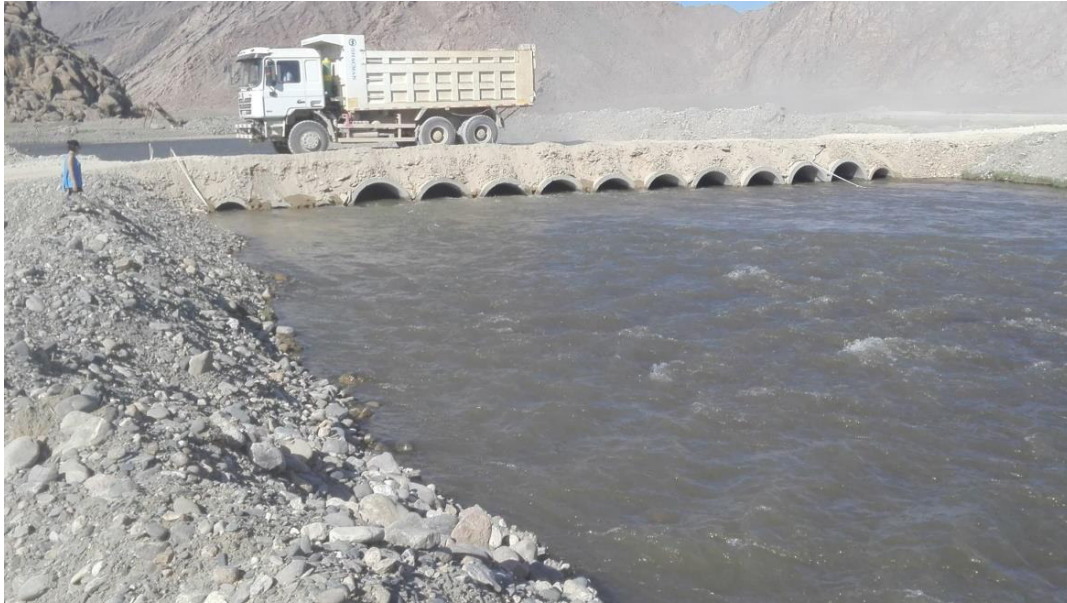
Figure 14: A deviation road embankment over the Buyant river

In order to prevent oil spillage which could pollute Buyant river, the contractor has constructed a temporary embankment over 3 streams of the Buyant river. A total of 146 culverts are being installed under the deviation road. It was a well planned mitigation measure that meets EMP requirements.

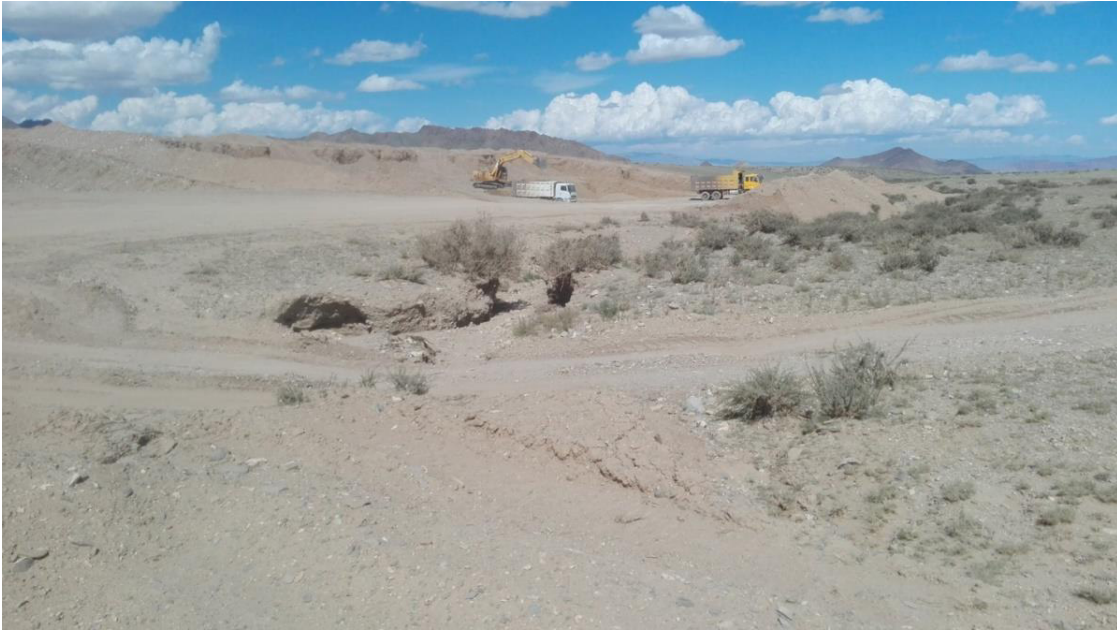
Figure 15. A borrow pit at CW1-1 section. STA.24

The CW1-1 construction team has exploited 14 borrow pits along the CW1-1 road alignment. For all 14 borrow points, the contractor has obtained written approval from the local governor of the Erdeneburen soum. The contractor has nearly completed embankment construction between STA.24 and STA.50. There are 3 borrow pits in the Hongio river valley, 1 nearby Hongio bridge and 2 others at midway point of the valley.

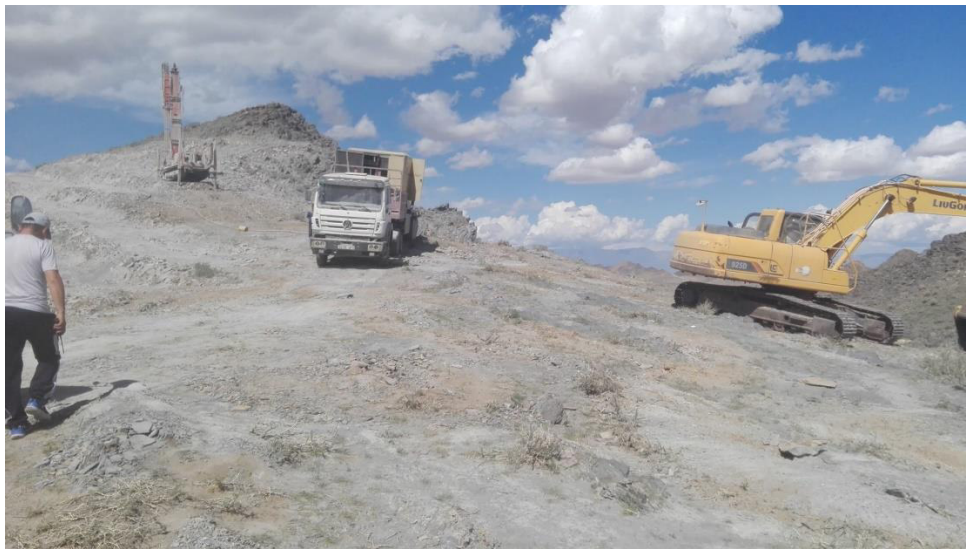
Figure 16. Preparation for a blast work at the quarry site. CW1-1.

The quarry site for the CW1-1 section is located nearby the main camp where the contractor produces aggregates for cement and asphalt concrete, graded crushed stone base course material located. Necessary permissions were obtained for the quarry site. A blasting was executed at the quarry site by a local professional firm in August. There is no herder households residing in 5 km radius of the quarry site, thus any noise and vibration impacts were minimal.

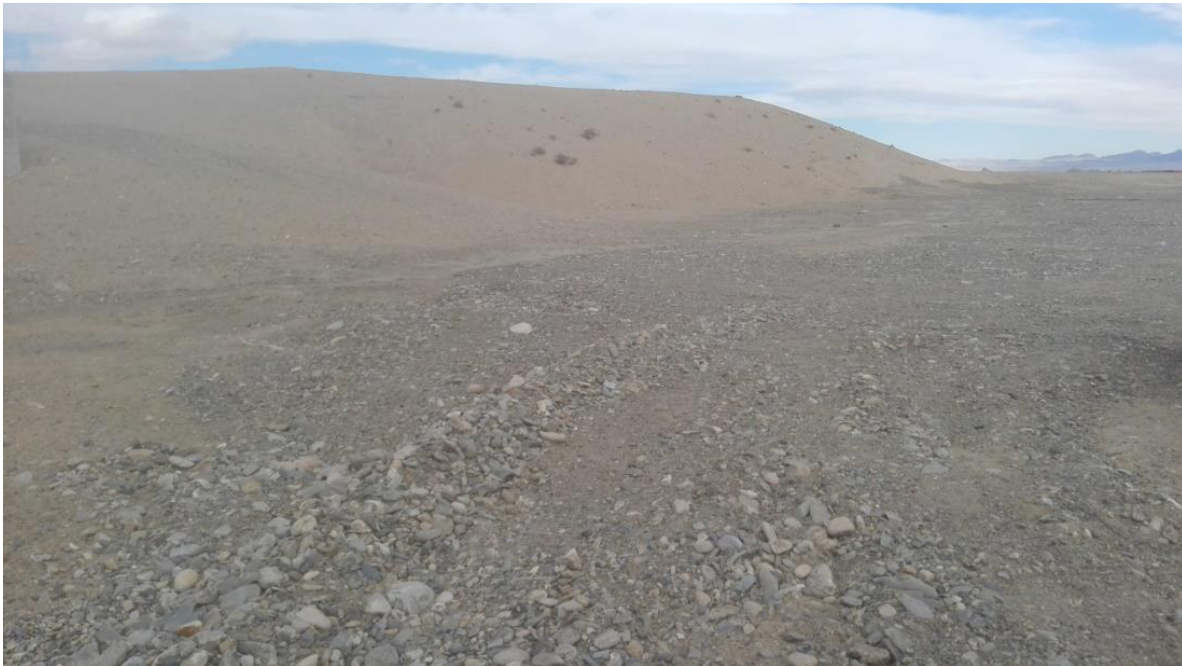
Figure 17: Rehabilitation at the old quarry site

The old quarry site was demolished and rehabilitated properly. Technical rehabilitations have completed, however a concrete stone was left for the request from the local administration.

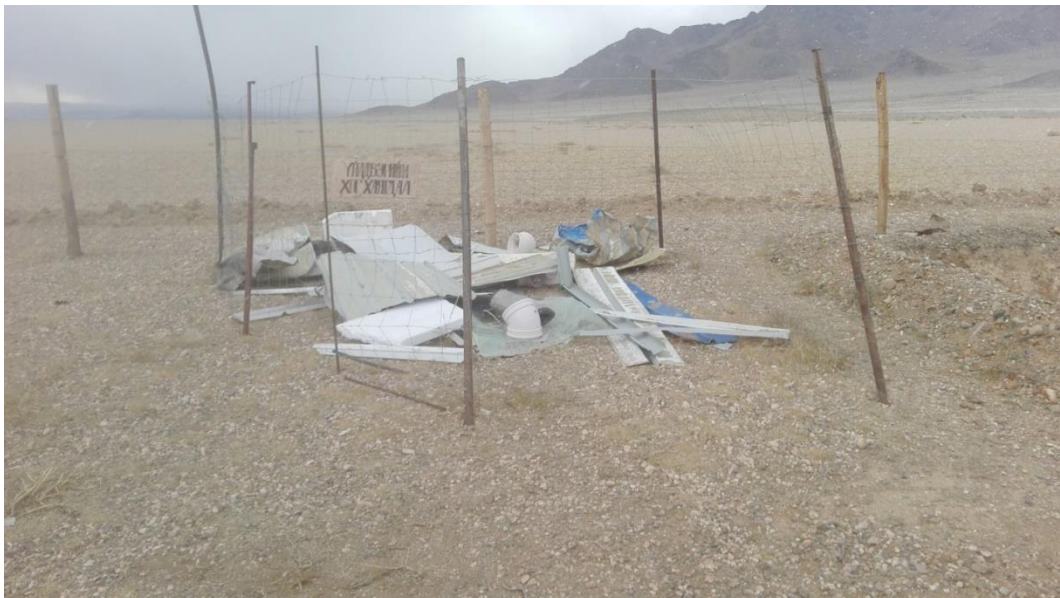
Figure 18. Waste collection point at the main camp site, CW1-1.

As part of its contract duties, the contractor HKB has executed cleaning and landfilling works at the central dumpsite of the Khovd provincial center in September, 2015. CW1-3 construction team is also planning to execute cleaning and landfilling works at Tolbo soum's dumpsite with its own machineries. There will not be any fees for using the central dumpsite of the Tolbo soum.

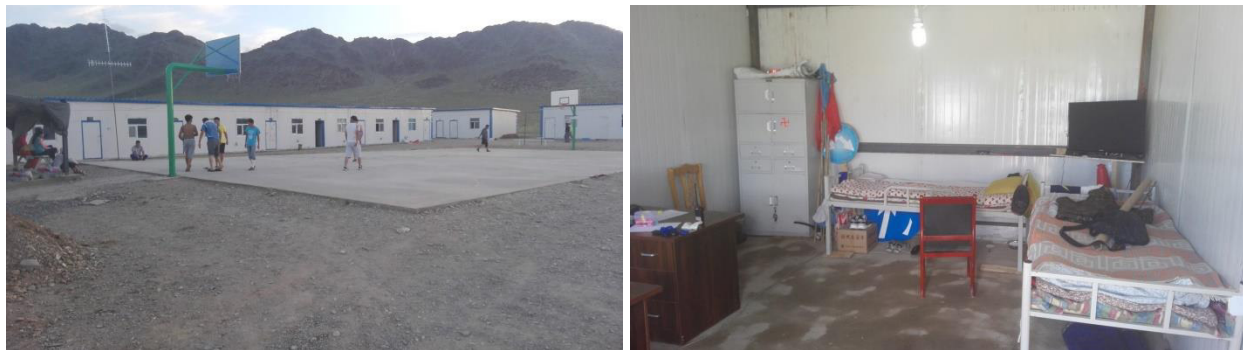
Figure 19. The main camp for the lot CW1-1.

Waste collection points, sanitation system, rest rooms, canteen, ventilliator, dorms and office rooms are available at all camp sites. The camp site is protected by surrounding drainage and fences. Necessary permissions were obtained from local government for all of the camp sites. In order to establish comfort for workers, the camp sites are provided with concrete basketball field and convenient dormitory rooms for staffs. As shown in the Appendix A, the camp site meets all the basic requirements.

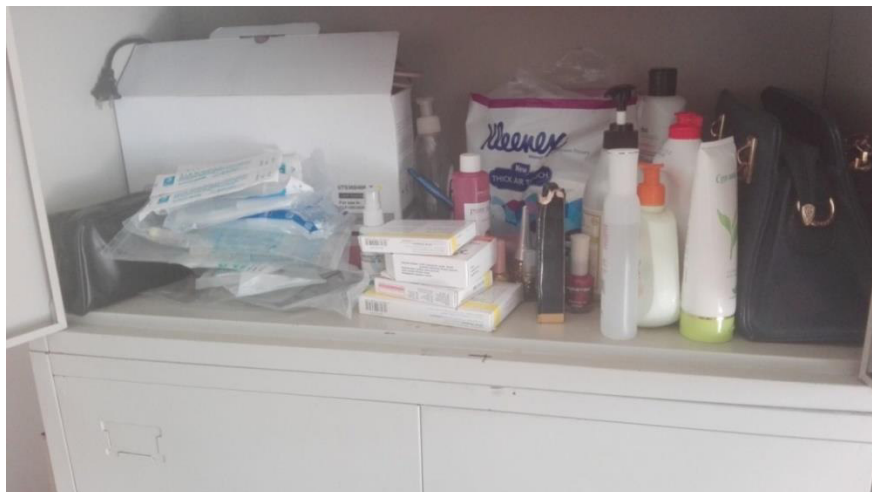
Figure 21. First aid tools possessed by the medician at the CW1-1 main camp.

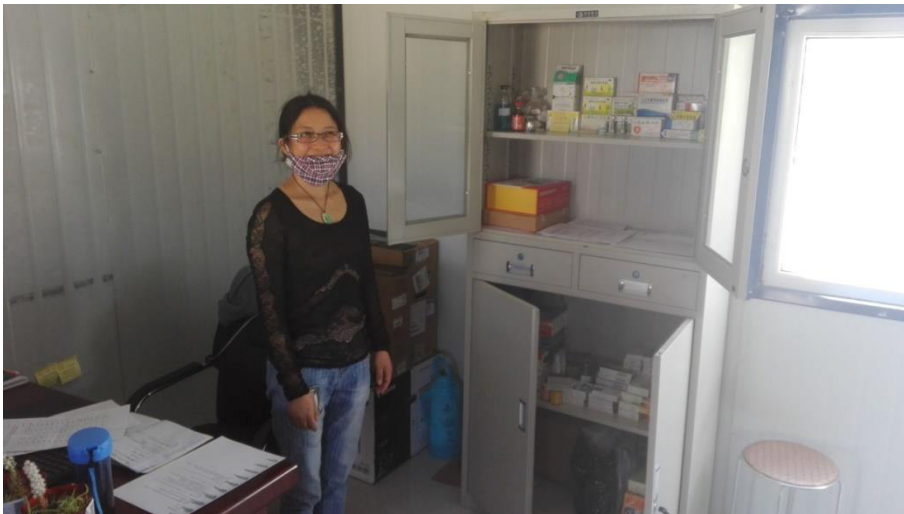
Figure 22. Medician and first aid tools employed at the CW1-3 main camp.

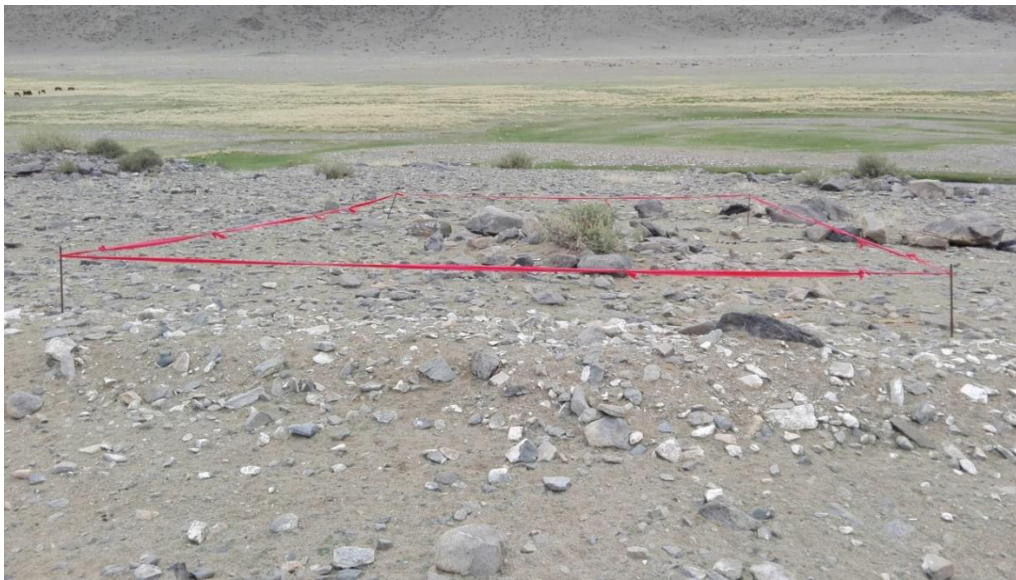
Figure 23. An ancient tomb protected in Hongio river valley

There are 23 ancient tombs exist within 20m distance of the road alignment in the Hongio river valley. Of which, 13 tombs are located under or very close to the road alignment, thus need to be removed by professional organization. 16 tombs have been protected with visibility fencing. Below table shows locations of the tombs that need to be removed.

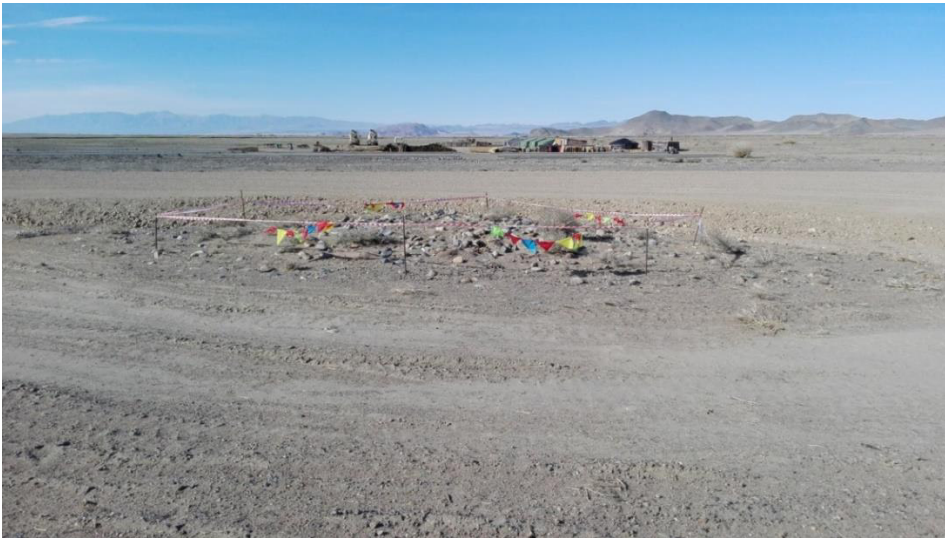
Figure 24. Visibility fencing for ancient tombs

All these tombs have been protected with visibility fencing back in May and removed by professional archaeological team in October.

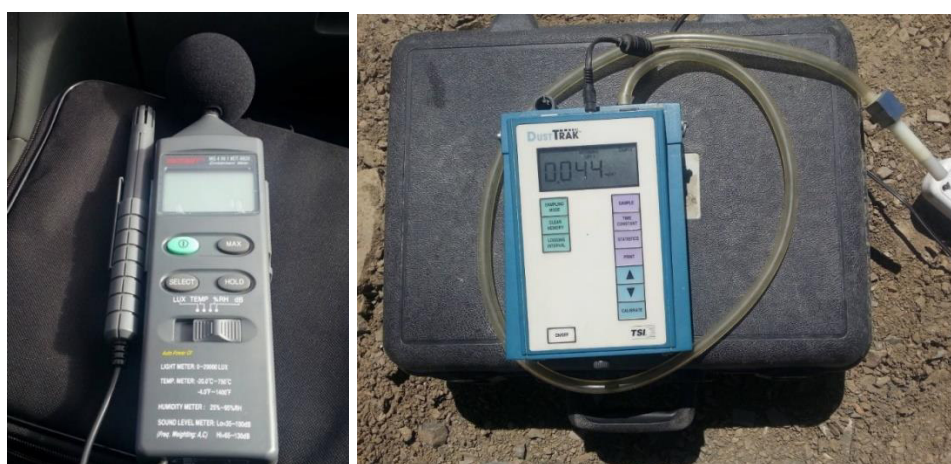
The contracted local laboratories sent a team of experts to carry out field monitoring works every month. The environmental monitoring team has conducted dust and noise level measurements using devices Dust Trak and VoltCraft, taken soil and water samples at the selected monitoring spots. Test analysis for soil and water samples were conducted at the Laboratory of National Geographic Academy in Ulaanbaatar and at the Laboratory of Khovd province Institute of Meteorology.

Figure 25: Noise dust measurement devices used for monitoring

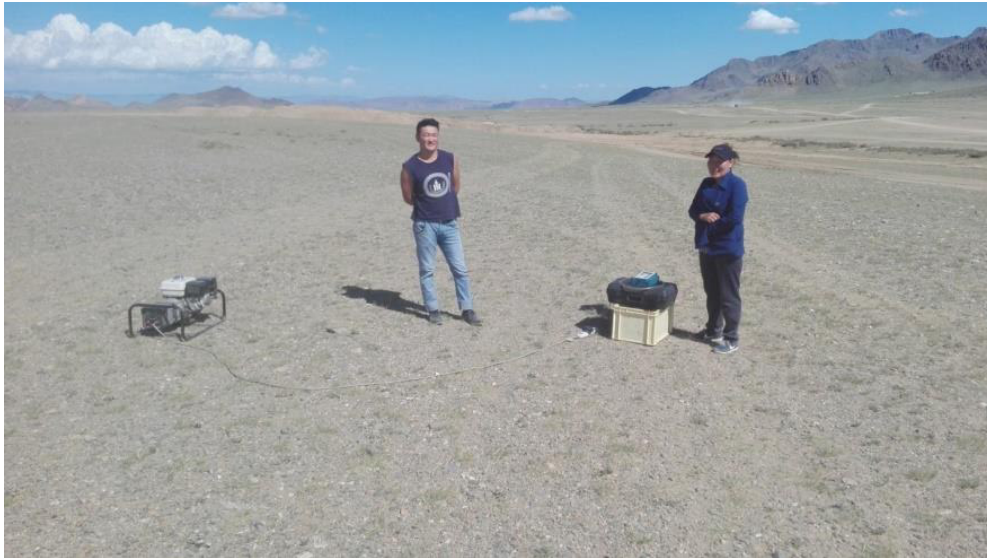
Figure 26. Dust measurement activity on July 1.

- ❖ All trucks transporting earth materials shall be covered with tarpauling
- ❖ Fine particle stockpiles nearby the crusher need to be covered with tarpaulin.
