BI-ANNUAL ENVIRONMENTAL MONITORING REPORT

*Project Number: 43405
July - December 2013*

Georgia: Urban Services Improvement Investment Program (Tranche 1)

PREPARED BY "UNITED WATER SUPPLY COMPANY OF GEORGIA", LLC

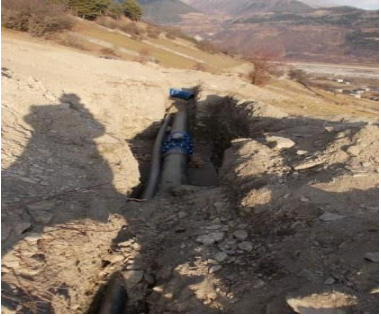
No	Impact	Required actions	Corrective actions	Status
1	Impacts caused by excavation and generation of waste soil	Utilize surplus/waste soil for other construction activities or to raise the ground-level of low level sites	<p>The majority of works is accomplished but still there are some places at the construction sites where reinstatement activities are not completed and some additional works has to be done by graders.</p> <p>In some cases waste soil is used for road surface covering works.</p>	<p>Corrected partially</p>

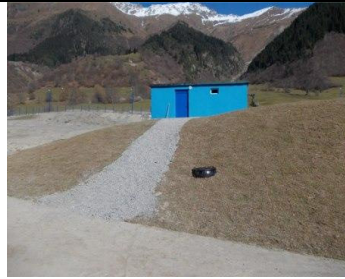
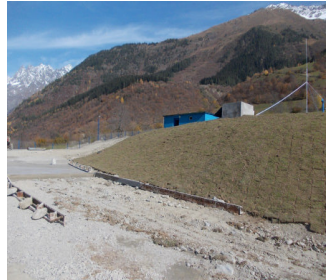
2	Loss of top soil	Top soil shall be removed and stored separately during excavation work, and after construction the same soil shall be replaced on the top	<p>After the instructions given by the EPTISA and UWSCG, reinstatement and disposal of top soil at the place of reservoir has been carried out by contractor.</p> <p>Reservoir site is properly fenced and lighted as well.</p>	<p>Corrected</p>

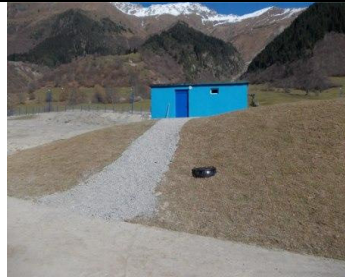
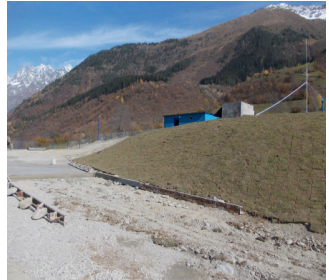
3	Erosion due to excavation/refilling; Removal of vegetation/trees for construction	Avoid tree cutting by small change of layout plan/alignment; In unavoidable cases, plant two trees of same species for each tree that is cut for construction; No trees shall be removed on the slopes; clearing of shrub, bushes and grass shall be limited to actual construction area only; Proper compaction of refilled soil: the material shall be refilled in	Clearing of bushes and grass was limited to actual construction area only; no clearance was allowed for material and waste storage, and concrete mixing. Despite the very detailed instructions given by Eptisa and UWSCG no proper refilling is observed at some project sites.	<p>Corrected to some extent</p>

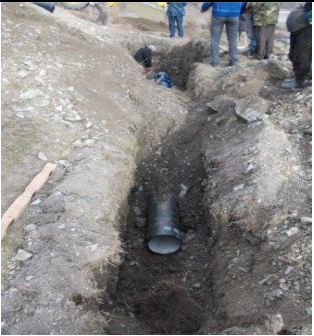
5	Impact on surface water bodies due to construction under rain	Avoid scheduling excavation work during the rainy season; In unavoidable circumstances, protect open trenches from entry of rain water by raising earthen bunds with excavated soil; Confine construction area including the material storage (sand and aggregate) so that runoff from upland areas	During rainy periods excavation works were interrupted; In several cases trenches were left open for some periods until testing took place.	Corrected in some places, still pending in others.

doesn't enter the site; Ensure that drains are not blocked with excavated soil.

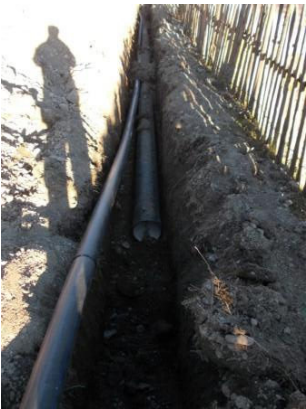
after the several verbal instructions made by Eptisa and UWSCG; Special warning/informational signs is finally installed at the entrance of the site as well.	
11	Historical, archeological chance finds during excavation	In case of suspected archeological find, contact archeological authority and take any action they require to ensure its removal or protection.	During this reporting period no historical or archeological finds were discovered.	Corrected

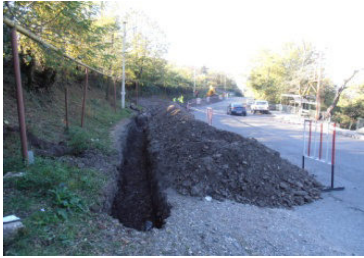
3	Impacts due to excavation and generation of surplus soil	Utilize surplus/waste soil for beneficial purposes such as in construction or to raise the ground-level of low lying sites. Dispose extra waste soil at Local Municipal Landfill in correct manners (slope should be 60°)	<p>Surplus/waste soil is transported to the preliminary selected remote site and local landfill</p> <p>In the places with enough space availability refilling materials are disposed as a piles next to trenches</p> <p>As of preliminary discussion with the Municipality it is foreseen to use surplus/waste soil for municipal purposes like repairing of roads and low level sites rising</p>	<p>Partially corrected</p>

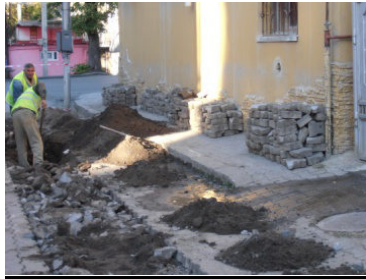
cles			
6	Removal of vegetation/trees for construction	Avoid tree cutting by local and small change of layout plan/alignment; In unavoidable cases, plant four trees of same specie for each tree that is cut for construction; Bushes and grasses shall be cleared only in actual construction area all other preparatory works (material storage) shall be conducted on barren lands where there is no vegetation;	No tree cut cases were observed during reporting period however there are some sensitive sites where additional biodiversity survey to be carried out	Mainly Corrected
7	Erosion due to excavation/refilling	No trees shall be removed on the slopes; clearing of shrub, bushes and grass shall be limited to actual construction area only; no clearance is allowed for activities such as material/waste storage, concrete mixing, etc. Ensure proper compaction of refilled soil and there shall not be any loose soil particles on the top; the material shall be refilled in layers and compacted properly layer by layer	In most cases refilling and compaction is done according instructions to avoid erosion processes	Mainly Corrected

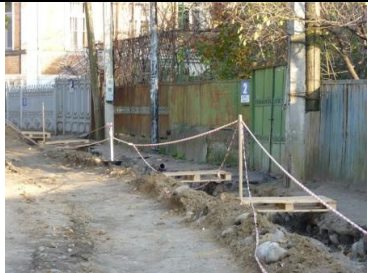
8	Impact on Traffic	Informing all residents and businesses about the nature and duration of any	Local residents and nearby private and public institutions are informed	Mainly corrected

<p>work well in advance so that they can make necessary preparations if necessary; Providing wooden walkways/planks across trenches for pedestrians and metal sheets where vehicle access is required;</p> <p>Increasing workforce to complete the work in minimum time in these stretches; Initial situation of private proper ties has to be re-established after construction</p>	<p>verbally about constructions activities schedule</p> <p>Wooden walkways are provided for pedestrians across trenches</p>

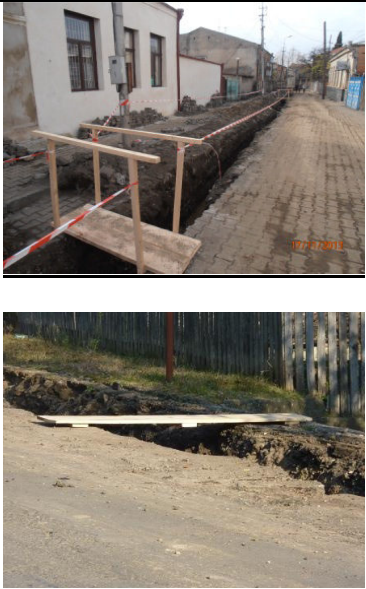
<p>socio-cultural resources due to construction work</p>	<p>duration of any work well in advance so that they can make necessary preparations if necessary; Install additionally hard barricade at the School Building site. Post the signs with hazards coming from the construction site; Provide wooden walkways/planks across trenches for pedestrians and metal sheets where vehicle access is required; Increasing workforce to complete the work in minimum time in the town</p>	<p>police before construction works start</p> <p>In most of cases crossing trenches by vehicle and people the metal or wooden temporary sheets are used at the applicable places</p>

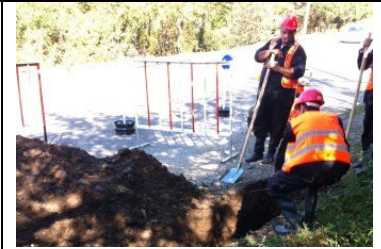
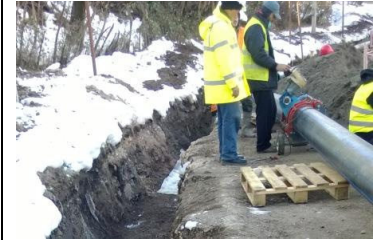
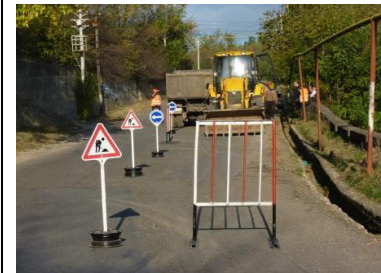
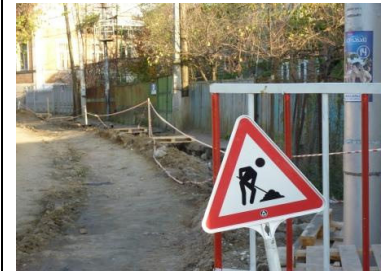
14	Impact on surface water bodies due to construction under rain	Avoid scheduling excavation work during the rainy season; Complete pipe laying work in excavated stretches and refill before monsoon; Complete the excavation and foundation during dry season; In unavoidable circumstances, protect open trenches from entry of rain water by raising earthen bunds with excavated soil; Confine construction area including the material storage (sand and aggregate) so that runoff from upland areas doesn't enter the site; Ensure that drains are not blocked with excavated soil	<p>During raining time excavation works are interrupted according to relevant instructions</p> <p>Some trenches were observed to be left open for several days for the reason to undertake technical tests of pipeline</p> <p>Because of delays of filling tranches there were cases of over-flooding during rain time, situation was improved after the instructions given by Eptisa and UWSCG</p>	<p>Partially corrected</p>
