Environmental Monitoring Report

Semestral Report
February 2016

GEO: Urban Services Improvement Investment Program – Project 1

Prepared by United Water Supply Company of Georgia, LLC, Government of Georgia for the Asian Development Bank.

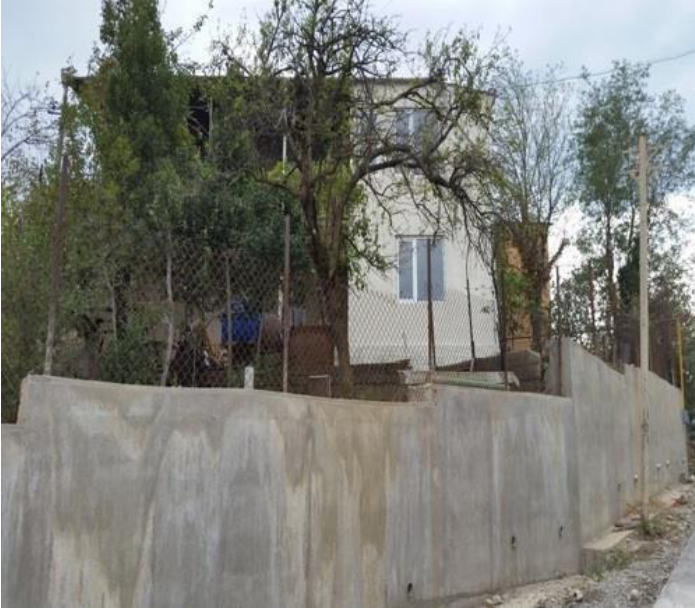
Kutaisi Reg-01: Rehabilitated house and wall of #9a Koguashvili street

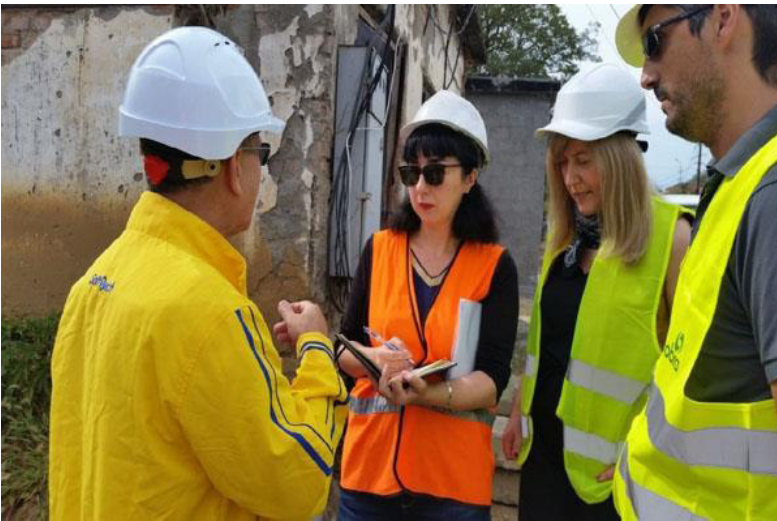
Kutaisi Reg-01: Vaja-Pshavela reservoir, ADB mission carried out on 7-9 October 2015

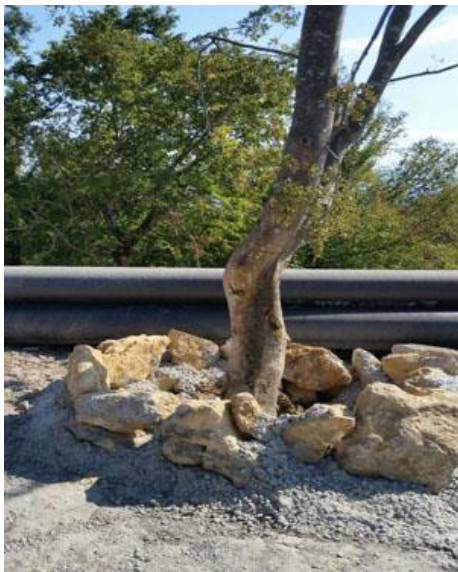
TETRAMITSASITE

- All trees located at the construction site should be fenced;
- Site trees should be isolated properly so that there is no risk of its damage;

- Household and Hazardous Waste containers should be installed properly with relevant signs;
- Accumulated waste soil and construction waste should be taken out of the site immediately
- Site access and gate should be installed properly
- Vehicles should be parked in only dedicated place

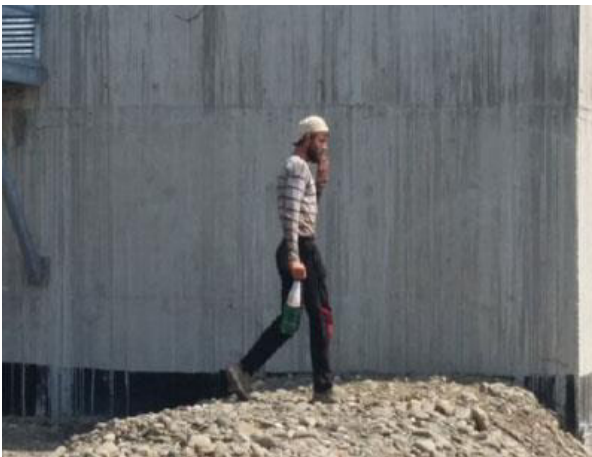
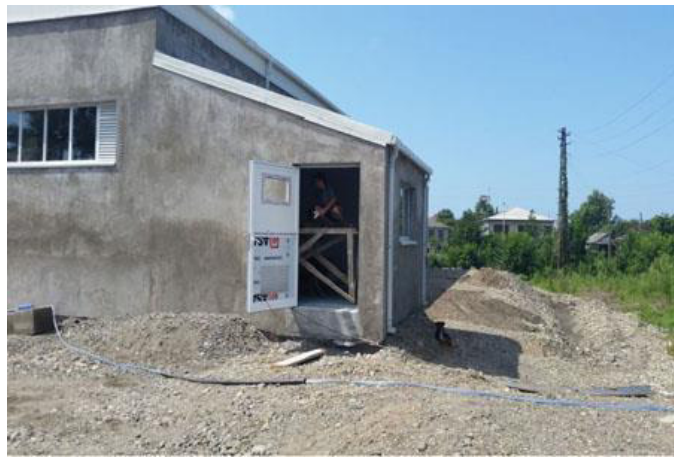
NABADA SITE

- Fuel and lubricants spill elimination items have no special indication sign and sawdust container is empty;
- Non of workers (even personnel of subcontractor) were equipped with PPE at site even the construction supervisors;

- Site internally should be arranged properly and cleaned regularly. All construction materials should be properly stored
- Parking area is arranged but there is NO proper parking sign and vehicles are not parked in right place;
- Trucks wheel washing platform does not exist anymore!
- Household and Hazardous waste containers does not exist anymore!

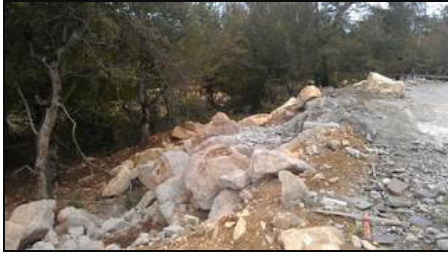
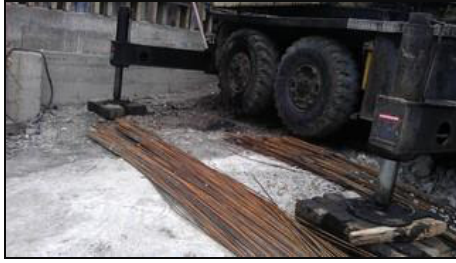
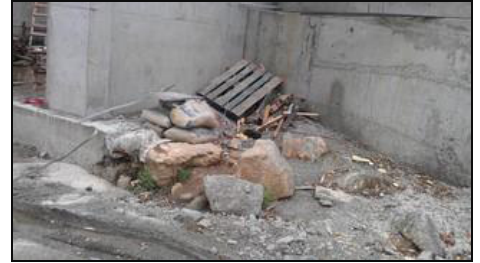
TETRAMITSA SITE

- Site trees should be fenced and protected to avoid its damage
- All construction materials should be properly segregated and stored adequately
- Household and Hazardous Waste containers should be installed properly with relevant signs
- The crane operating at the site is spilling oil that needs urgent action
- Accumulated waste soil and construction waste should be taken out of the site immediately

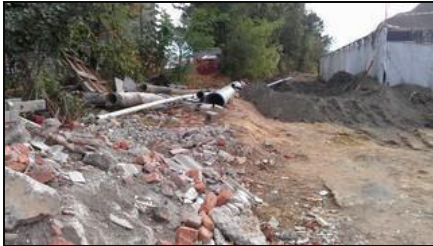
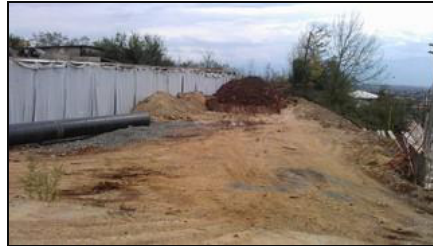
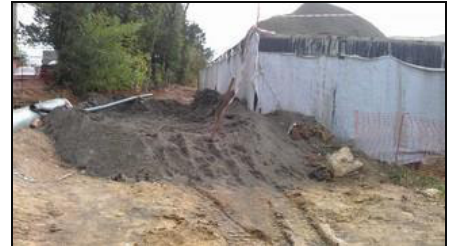
VAZHA PSHAVELA SITE

- Enough and proper safety signs should be installed on the site
- Proper fuel/oil spill response items should be available at the site as per SEMP
- Hazardous waste container should be installed on the site
- Site internally should be arranged properly and cleaned regularly
- Construction waste should be removed timely
- All accumulated surplus soil should be taken away from site for its final disposal

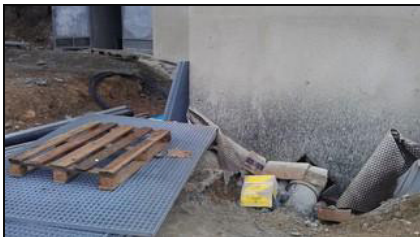
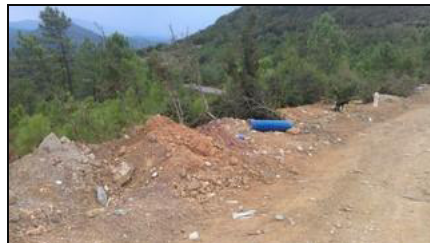
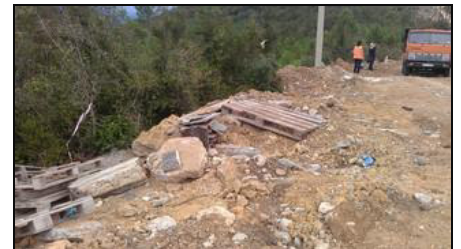
TV TOWER SITE

- Site internally should be cleaned regularly, and all rubbish should be taken away
- Relevant and enough warning signs should be installed
- All accumulated surplus soil should be taken away from site for its final disposal

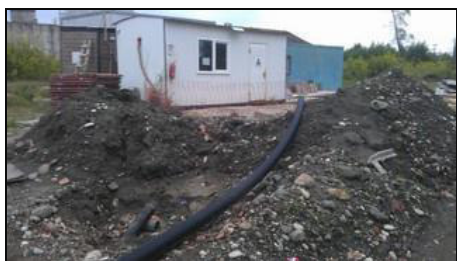
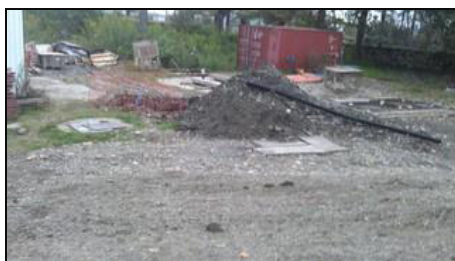
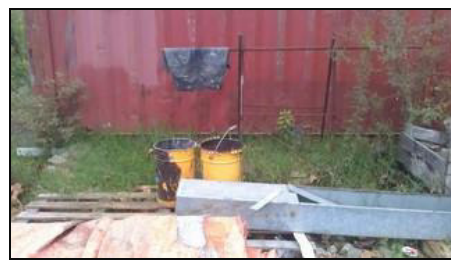
NABADA SITE

- All construction materials should be properly stored
- Trucks wheel washing relevant platform and its drainage should be installed
- Chlorine container that should be disposed in safe place
- Proper Household and Hazardous waste container should be available permanently on site

- improperly disposed containers with hazardous materials that should be removed
- Surplus soil should be removed from construction site or stored and fenced in proper remote place
- Site should be cleaned regularly

All these conditions have to be remedied within five days by the prime Contractor (Cobra).

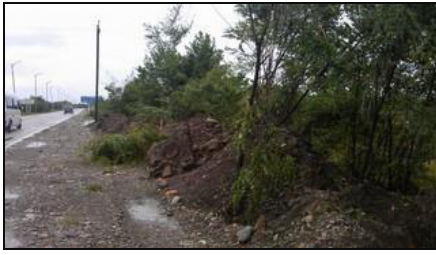
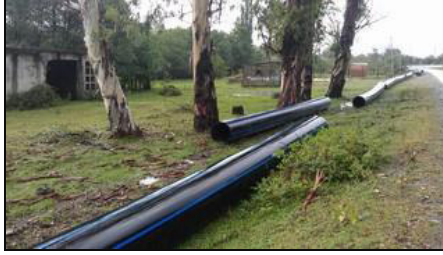
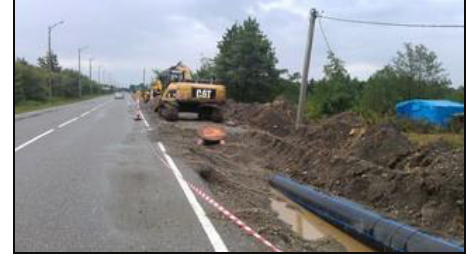
NETWORK

- Construction materials should be brought when needed to avoid its long time disposal in the streets
- Protect trees to avoid its damage during transmission line construction
- All open tranches should be fenced with safety lines to avoid accident
- Accumulated waste soil should be removed from construction area and disposed in a proper place

All these conditions have to be remedied within four days by the prime Contractor (Peri).

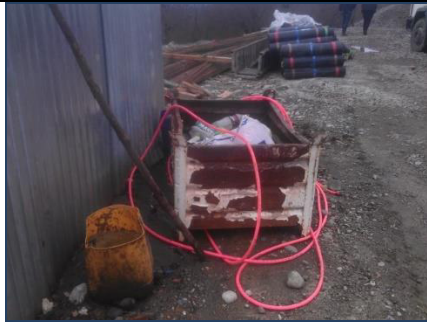
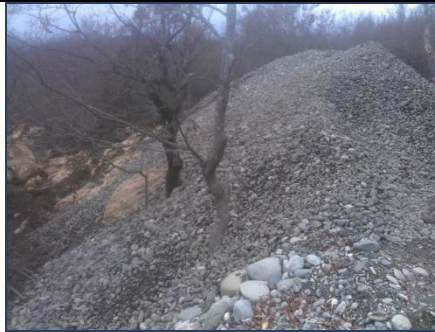
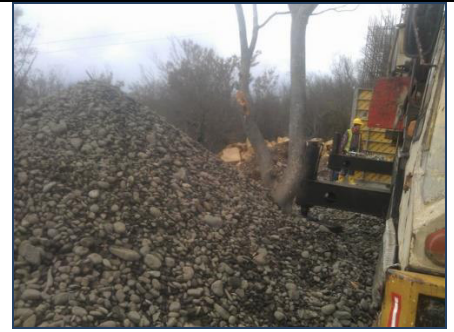
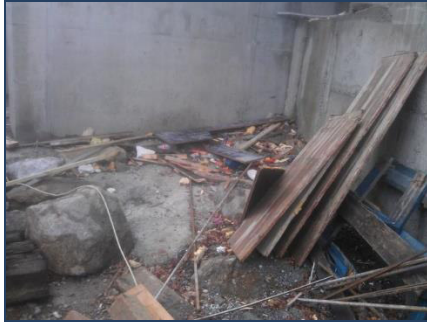
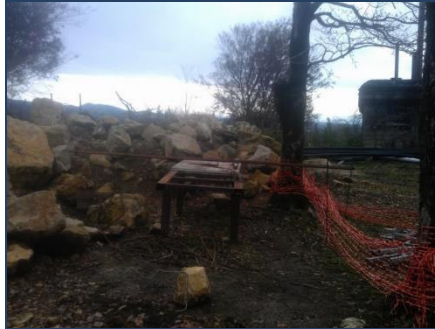
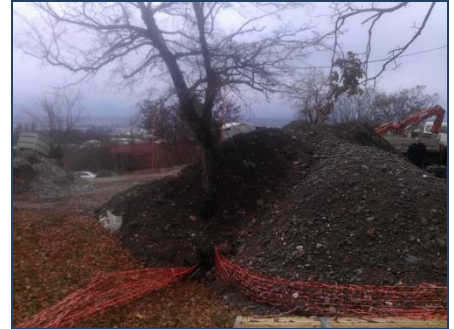
Project:USIIP	Non-compliance Notice KUTAISI
Contract No:REG-01	
Contractor: COBRA	
Reference: Kutaisi –Tetramitsa site; Vazha Pshavela site	
This notice is to advise you, the prime Contractor, on the referenced Contract, of the following notice on health, safety and environmental measures to be implemented urgently .	
<u>NON-COMPLIANCE IN KUTAISI</u>	
TETRAMITSA SITE	
<ul style="list-style-type: none"> ▪ Site trees should be fenced and protected to avoid its damage ▪ All construction materials should be properly segregated and stored adequately ▪ Proper Household and Hazardous Waste containers should be installed with relevant signs ▪ Accumulated waste soil and construction waste should be taken out of the site immediately

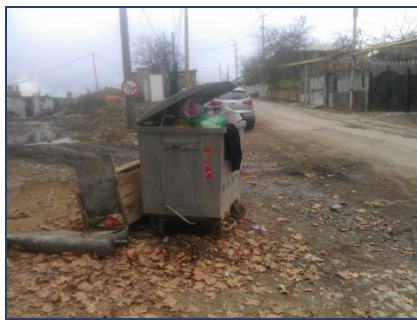
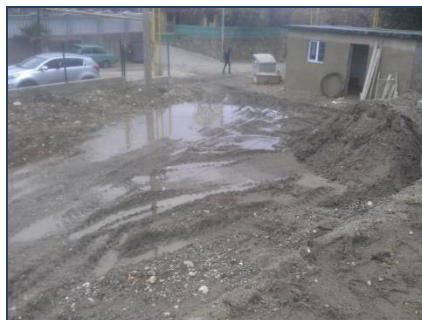
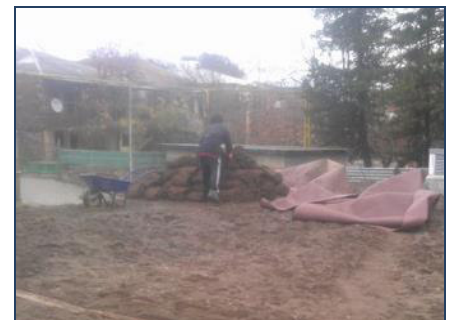
VAZHA PSHAVELA SITE

- Arrange lockable gate in entrance with relevant information signs
- Proper Hazardous waste container should be installed on the site
- Non-hazardous waste container should be collected timely to avoid overfilling
- Personnel should be fully equipped with PPE

All these conditions have to be remedied within four days (by 11.12.2015) by the prime Contractor (Cobra).

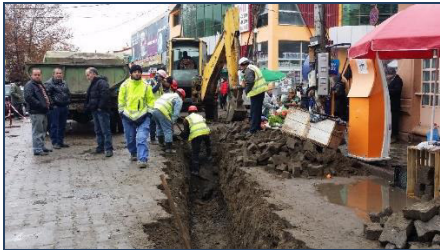
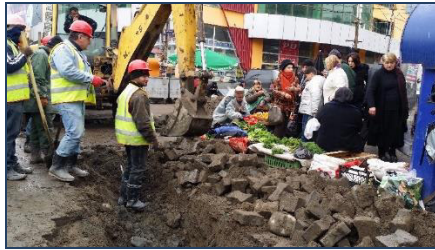
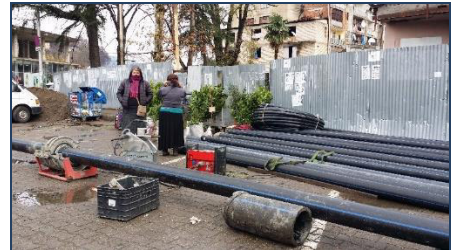
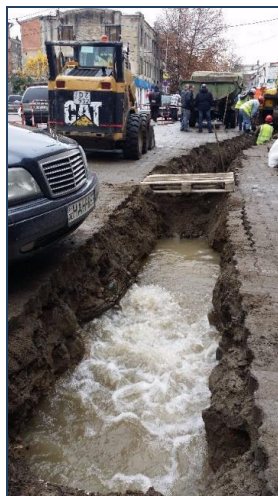
NETWORK

- It is prohibited stay of residents in the excavation zone (all safety norms are ignored)!
- All construction materials should be properly segregated and stored adequately to avoid disturbance of residents and businesses!
- Around open tranches proper warning signs and safety types should be installed
- Water should be pumped immediately from the tranche!
- Proper walkways/planks should be installed across open tranches

All these conditions have to be remedied within one day (by 08.12.2015) **URGENTLY** by the prime Contractor (Cobra).
