Environmental Monitoring Report

Semestral Report March 2017

GEO: Urban Services Improvement Investment Program – Project 2

Project Number: 43405-023 July-December 2016 Loan Number 2807-GEO (SF)

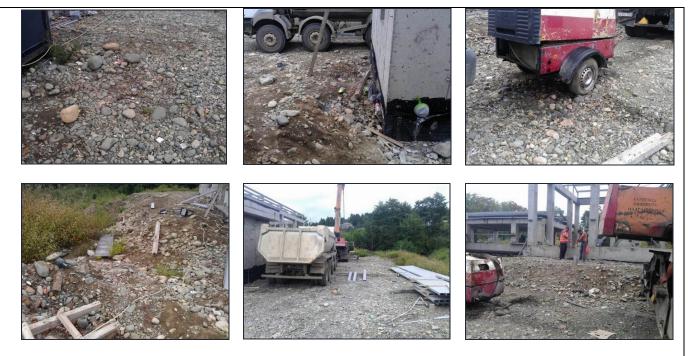
Project: USIIP	
Contract No: URE-01	Non-compliance Notice
Contractor: PERI	UREKI
Reference:	
UREKI - UREKI PAMPING STATION	
This notice is to advice you, the prime Contractor, on the referenced Contractor is to be implemented urgently .	ontract, of the following notice on
NON-COMPLIANCE IN UREKI	
PAMPING STATION	
- Proper place for Parking with relevant sign should be arranged	
- All construction materials should be properly segregated and store	
 Fuel/oil spill response items (sand, sawdust, special containers) sl relevant signs 	nould be equipped with
 Machinery and equipment should be in standard technical condition lubricants) 	on (no leakage of fuel and
- Use tarpaulins to cover during materials transportation	
 All workers (even personnel of subcontractor) should be equipped 	with complete PPE
- Site internally should be arranged properly and cleaned regularly

All these conditions have to be remedied within five days (by the 25 September 2016) by the prime Contractor (Peri).

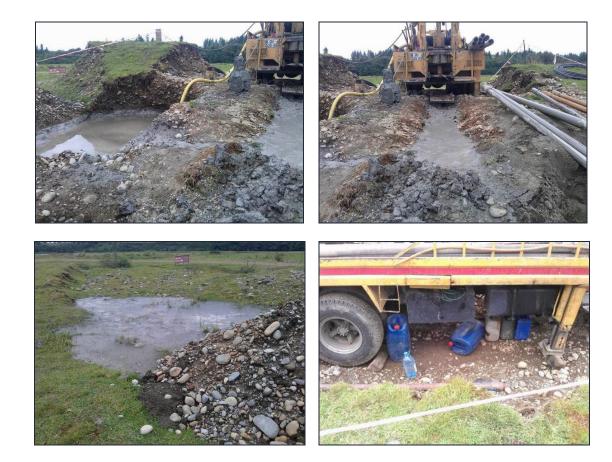
WELLFIELD

- Fuel/oil spill response items (sand, sawdust, special containers) should available
- Fencing of the site is to be established
- Topsoil should be managed according to the SSEMP
- Machinery and equipment should be in standard technical condition (no leakage of fuel and lubricants)
- All containers of fuel and lubricants should be placed in a special place with roofing
- Bentonite waste should be managed according to SSEMP

All these conditions have to be remedied within five days (by the 25 September 2016) by the prime Contractor (Peri).

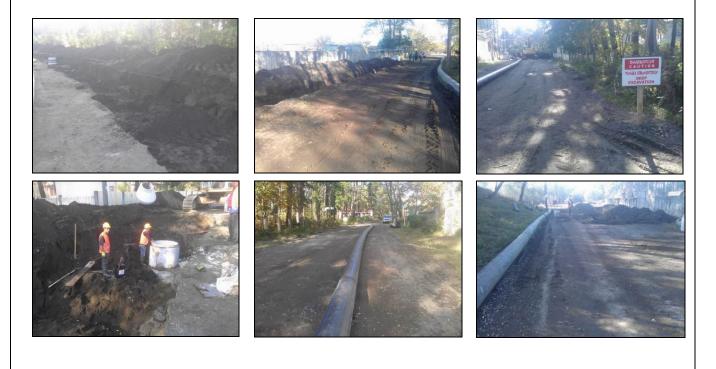
NETWORK

- Protect trees to avoid its damage during transmission line construction
- Enough and high visible safety signs/tapes and trench side barriers around of deep open trenches should be installed to avoid accident of population
- Walls of the deep trenches (>1.5m) should be strengthened by boards to avoid landfall of the soil and accidents
- Accumulated waste soil should be removed from construction area and disposed in a proper place
- Use tarpaulins to cover during materials transportation
- Workers always should use complete PPE

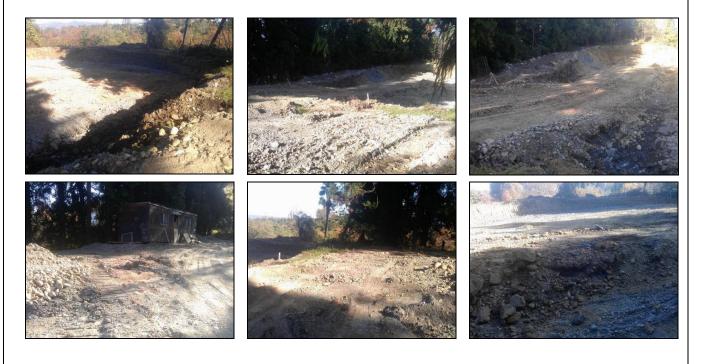
RESERVOIR

- Trees at the construction site should be protect to avoid its damage
- Site should be fenced from all sides and equipped with lockable gate with proper warning and information signs
- Proper warning and information signs should be arranged at the entrance, perimeter and inside of construction site
- Safety signs/tapes and trench side barriers should be installed around of excavation of reservoir
- Household Waste containers with relevant sign should be installed in proper place
- Hazardous Waste containers with relevant sign should be installed in proper place
- Workers always should use complete PPE
- Site internally should be arranged properly and cleaned regularly

All these conditions have to be remedied within five days (by the 20 November 2016) by the prime Contractor (Peri).
