# Bi-annual Environmental Monitoring Report

Project Number: 43405-026

July-December 2016

GEORGIA: URBAN SERVICES IMPROVEMENT INVESTMENT PROGRAM (TRANCHE 4) (FINANCED BY THE ASIAN DEVELOPMENT BANK)

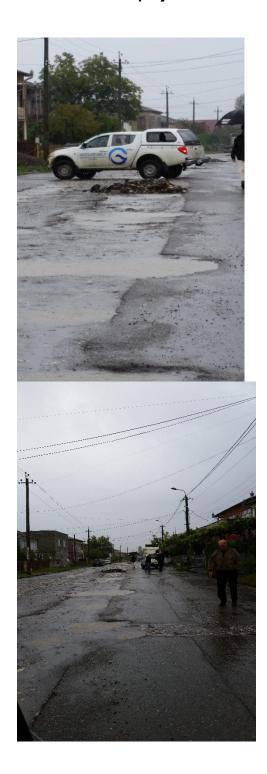
Pot-01: Poti Streets after termination of project

15. Temporary mitigations will be implemented by UWSCG. Local Service Centers of Company will fill in and maintain dangerous potholes and tape off damaged sunken manholes with high visibility tape, as at present the Contractor will not return and maintain. All associated costs for further reinstatement and compaction of sites will be included in the new contract amount and will be implemented by the new contractor.
