Environmental Monitoring Report

#2 Semestral Report
December 2014

GEO: Sustainable Urban Transport Investment Program – Tranche 2

GEORGIA: GEORGIAN SUSTAINABLE URBAN TRANSPORT INVESTMENT PROGRAM, Tranche 2

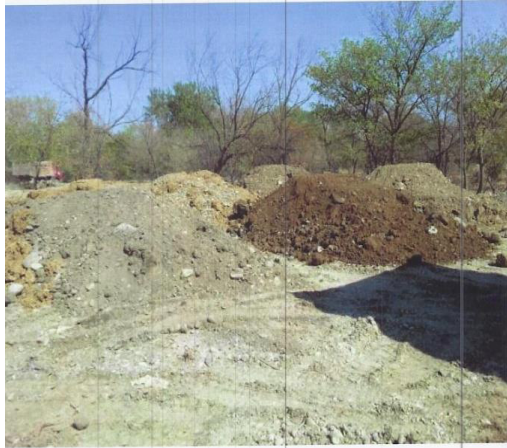
Section 3; PK132.80
Stored topsoil was mixed with gravel

26.09.2014	Mixing of topsoil with gravel	PK132.80	Protect topsoil from damage; dispose topsoil separately from other materials; Deadline- 28.09.2014	Top soil has been separated from gravel on 27.09.2014

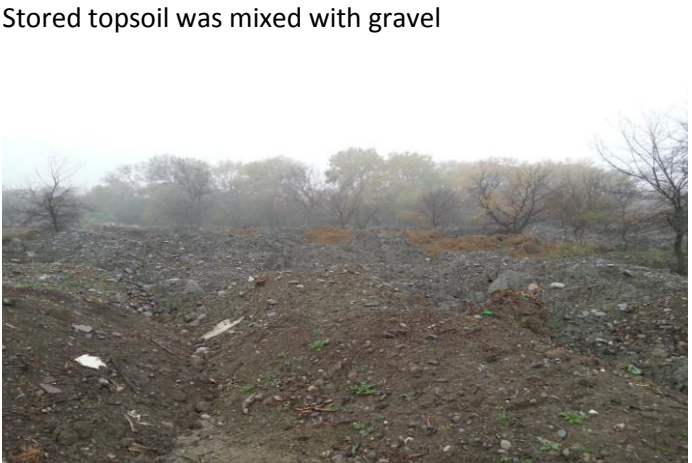
Private land plot (PK112)
Mixing of topsoil and subsoil

08.09.2014	Mixing of topsoil with subsoil	PK112	Protect topsoil from damage; dispose	Top soil has been separated from

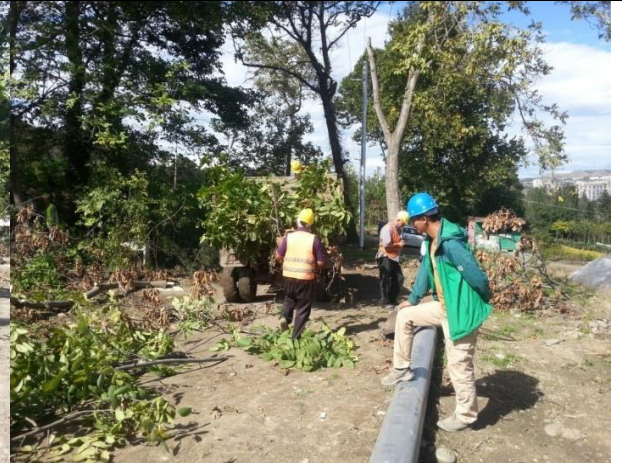
Section 1; PK32
Cutting of red data trees

29.09.2014	During cutting of trees at PK32 the Contractor's HS representative was not on construction site	PK32	Attend HS specialist during implementation of all hazardous activities. Deadline-immediately	HS officer was attended to the activity on 29.09.2014
