Managing Flood Risk in Guyana

The Conservancy Adaptation Project 2008-2013

This report was prepared by Isabella Bovolo with the Disaster Risk Management team of the Latin American and Caribbean Unit of the World Bank and the Agriculture Sector Development Unit (ASDU) of the Ministry of Agriculture, Guyana. The content is based on material produced by The Ministry of Agriculture (Guyana), Mott MacDonald (UK), Dewberry (USA) and Tecnalia (Spain) for the Conservancy Adaptation Project (TF 91692) which was funded by a Global Environmental Facility (GEF) Special Climate Change Fund grant. This publication was funded by the European Union in the framework of the ACP-EU Natural Disaster Risk Reduction Program managed by the Global Facility for Disaster Reduction and Recovery. The views expressed in this publication are entirely those of the authors. They do not necessarily reflect the views of the European Union, the World Bank Group, its Executive Directors, or the countries they represent. The material contained herein has been obtained from sources believed reliable but it is not necessarily complete and cannot be guaranteed. © International Bank for Reconstruction and Development /

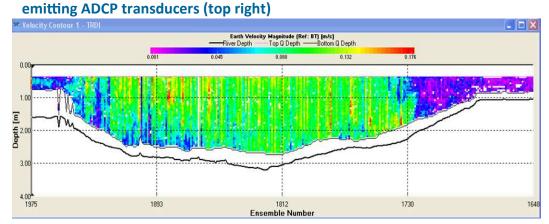
ACOUSTIC DOPPLER CURRENT PROFILER (ADCP)

Discharge (the volume of water flowing in a channel during a given time interval) can be measured using a Acoustic boat-mounted Doppler Current Profiler (ACDP) (see Figure which is manually pulled across the width of the river and to measure discharge. The ADCP transducer works by emitting 'pings' of sound at constant frequency into the water, which bounce off suspended particles or the riverbed back to device. The travelling time of the sound and the change of pitch (variable due to the Doppler effect) an estimate of gives from which distance velocity, and hence discharge can be calculated. collecting discharge measurements at particular location, at low,

medium and high water levels, a relationship can be developed so that discharge can be calculated for any river level.

ADCP (above), example river velocity profile (below) and the sound-

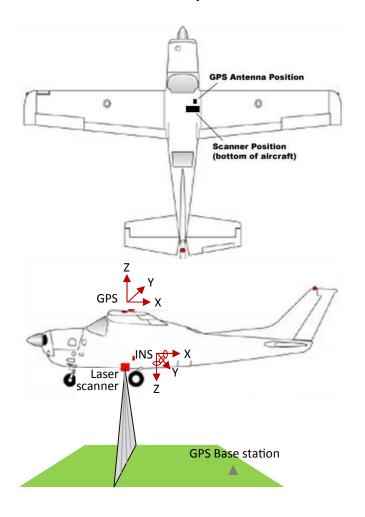
LiDAR (Light Detection And Ranging) is an airborne laser mapping and altimetry system which produces accurate and spatially georeferenced land elevation data. It works by sending a laser light signal to the ground and measuring how long the pulse takes to Data return. collection usually involves an aircraft-

mounted Global Positioning etailed topographic System (GPS) receiver (for keeping track of the aircraft location), an Inertial Measurement Unit (INS) (for keeping track of aircraft rotation) and a laser rangefinder (which includes the laser source and detector, scanning mechanism the and the timing processing system).

Aircraft-mounted LiDAR system

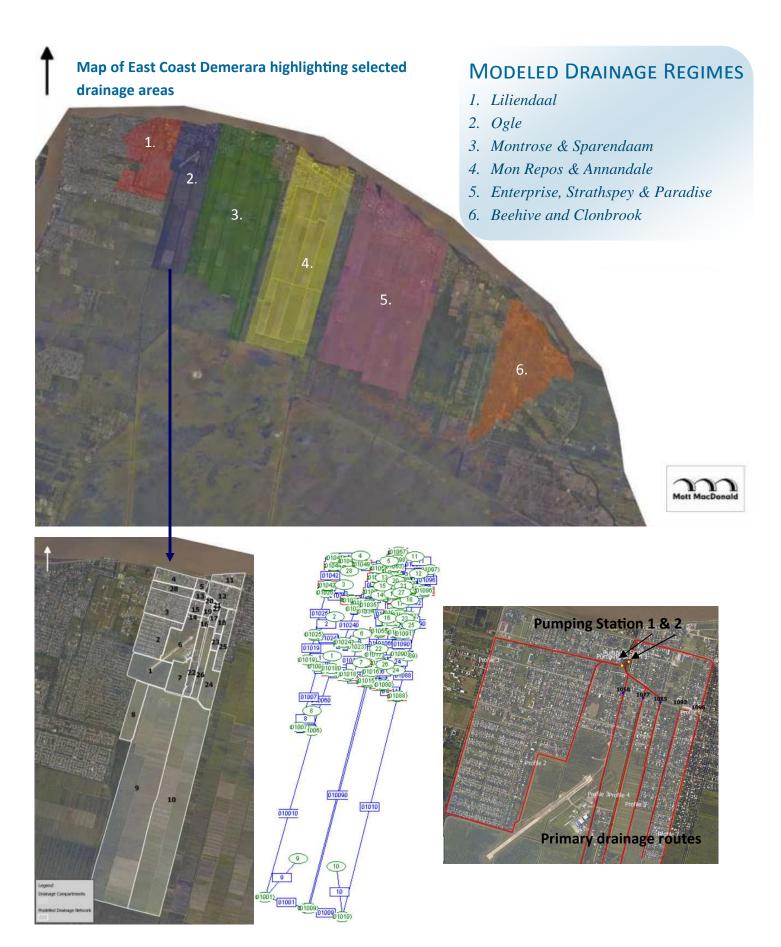
Schematic of Ogle drainage system model (lower centre), drainage compartments (lower left) and primary and secondary drains with their associated catchment areas (lower right).

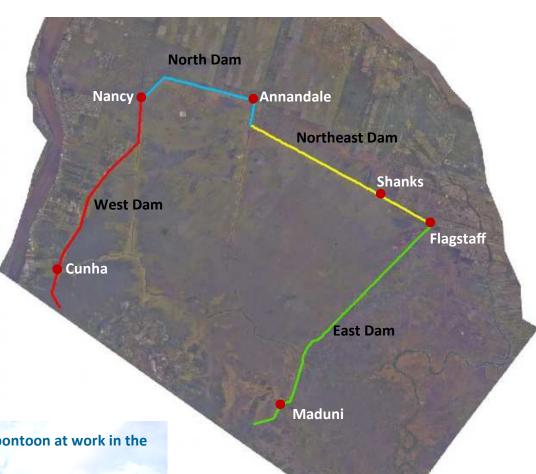
- → Bathymetry is the measurement of underwater relief, the equivalent of underwater topography.
- ♦ DEM stands for Digital Elevation Model, also known as DTM or Digital Terrain Model. It is a 3 dimensional representation of a terrain.
- ♦ Echo-sounder a device for measuring water depth using sound (sonar).
- ♦ GPS stands for Global Positioning System. It
 is a satellite navigation system used to provide
 ground position and time.
- ♦ LiDAR stands for Light Detection and Ranging. It is an airborne laser mapping and altimetry system which produces accurate and spatially geo-referenced land elevation data.
- → m GD stands for meters above Georgetown Datum, a local reference point set to 17.07m below mean-sea-level. In these terms, the EDWC dam crest-level is at 18.29 m GD.

Nomenclature of the EDWC dam for the purposes of the CAP
